Inspection Photos

Loc: 437862

Operator: PIONEER NATURAL RESOURCES USA INC

Inspection Date: 2/4/2025

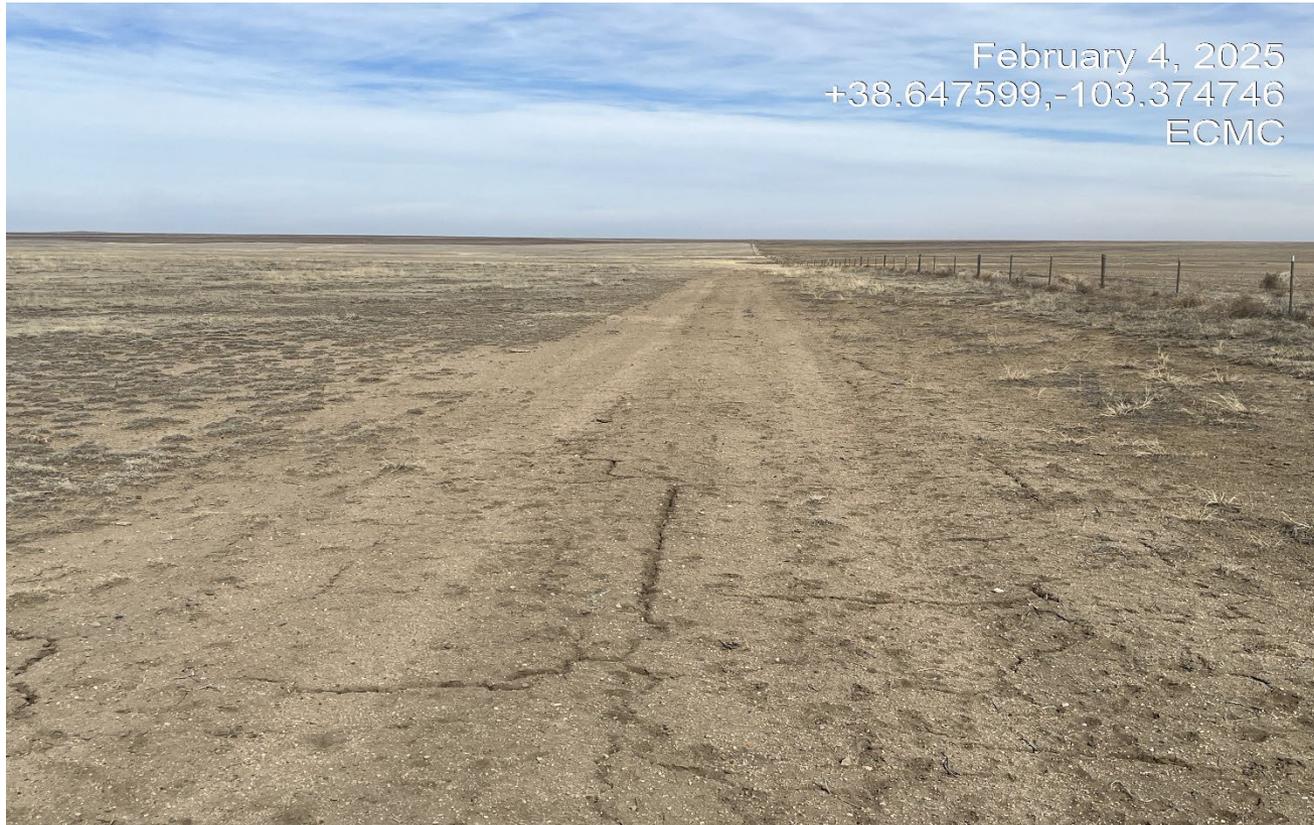
Photo 1. Facing north along the access road. The former access road has not established perennial vegetation and needs to be reseeded.

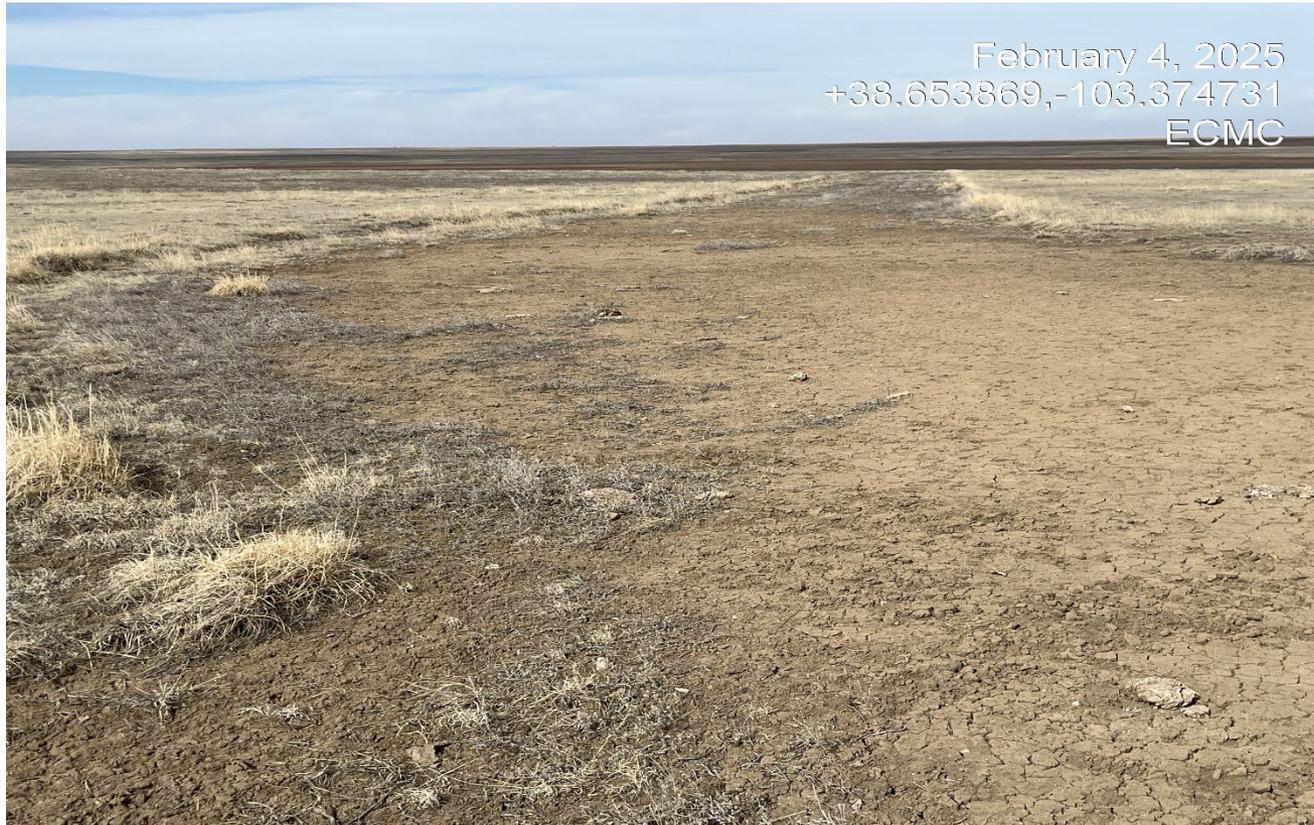
Photo 2. Facing northwest along the access road. The former access road has not established perennial vegetation and needs to be reseeded.

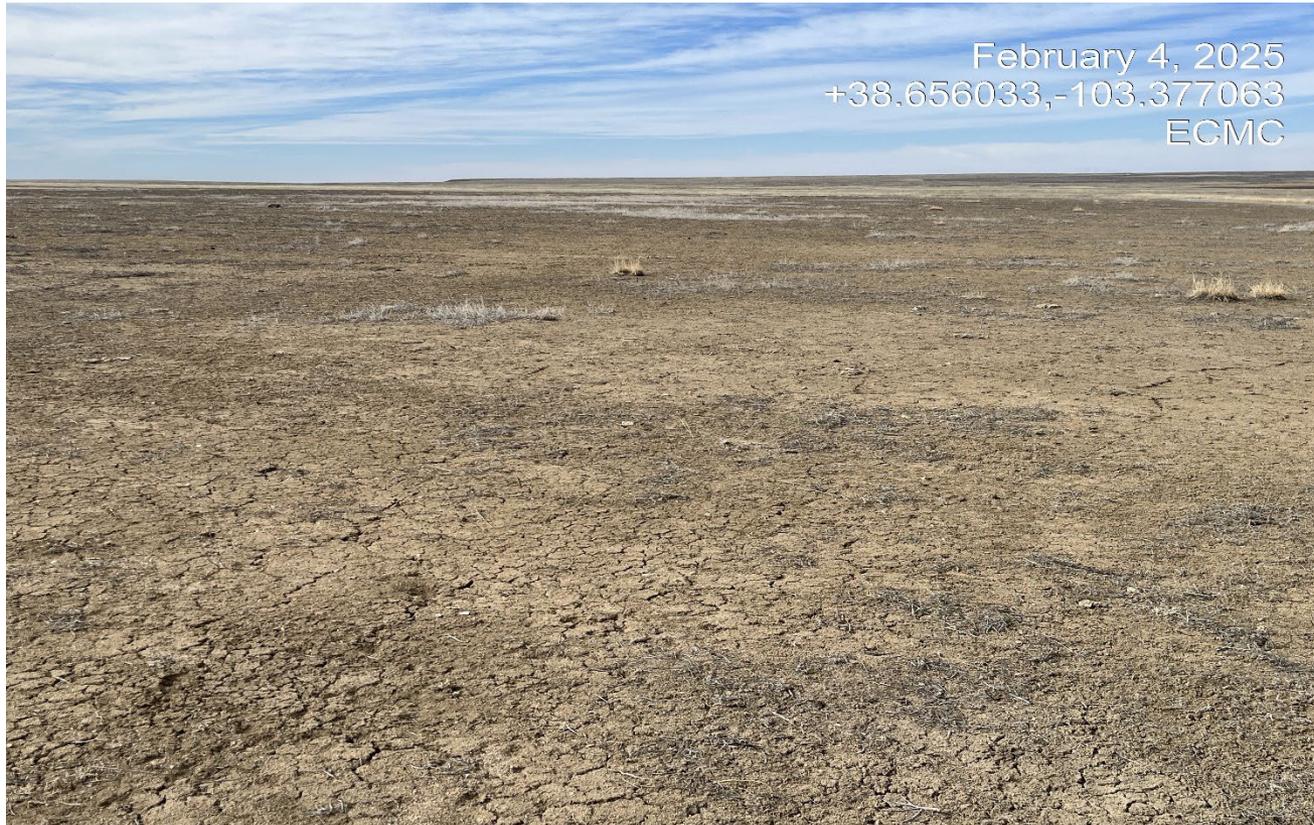
Photo 3. Facing west toward the location. Perennial vegetation has not established and the location needs to be reseeded.

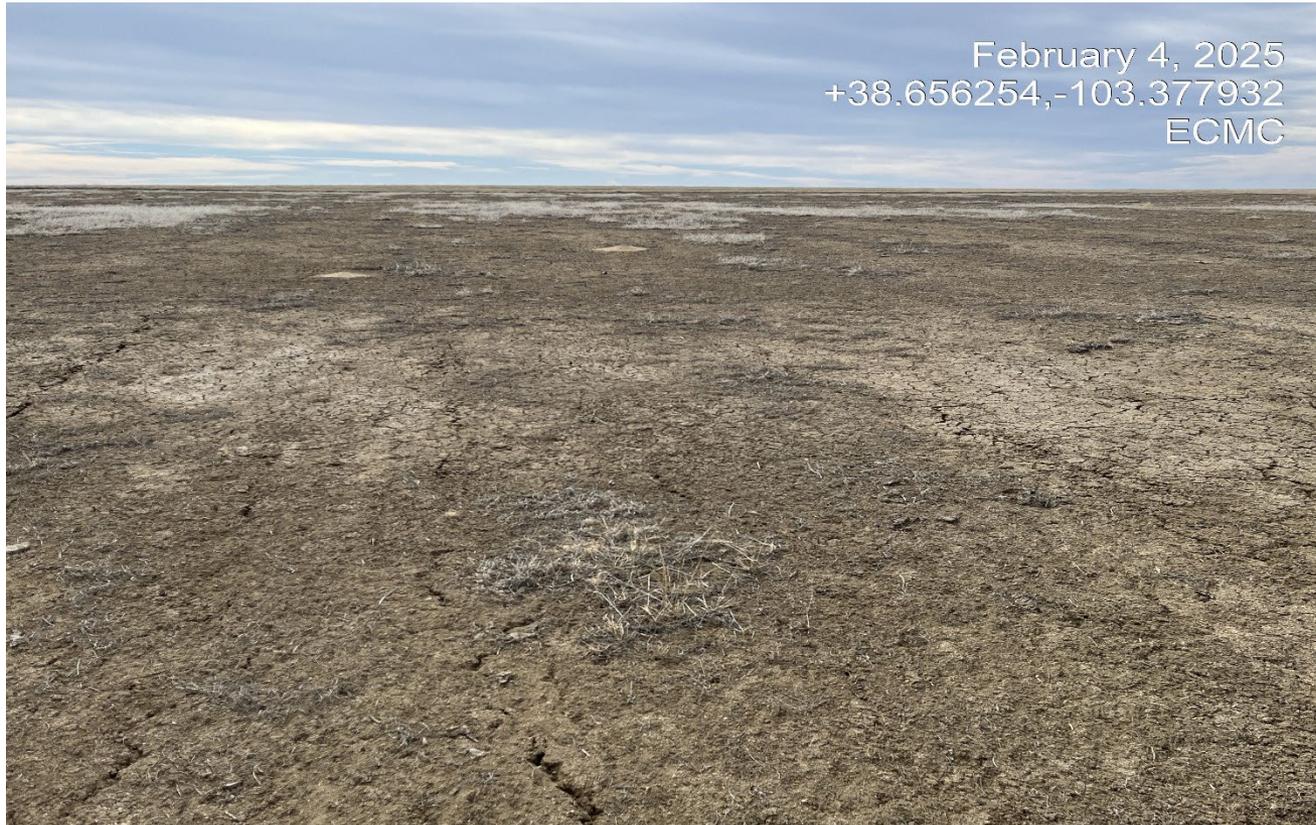
Photo 4. North side of the location facing south.

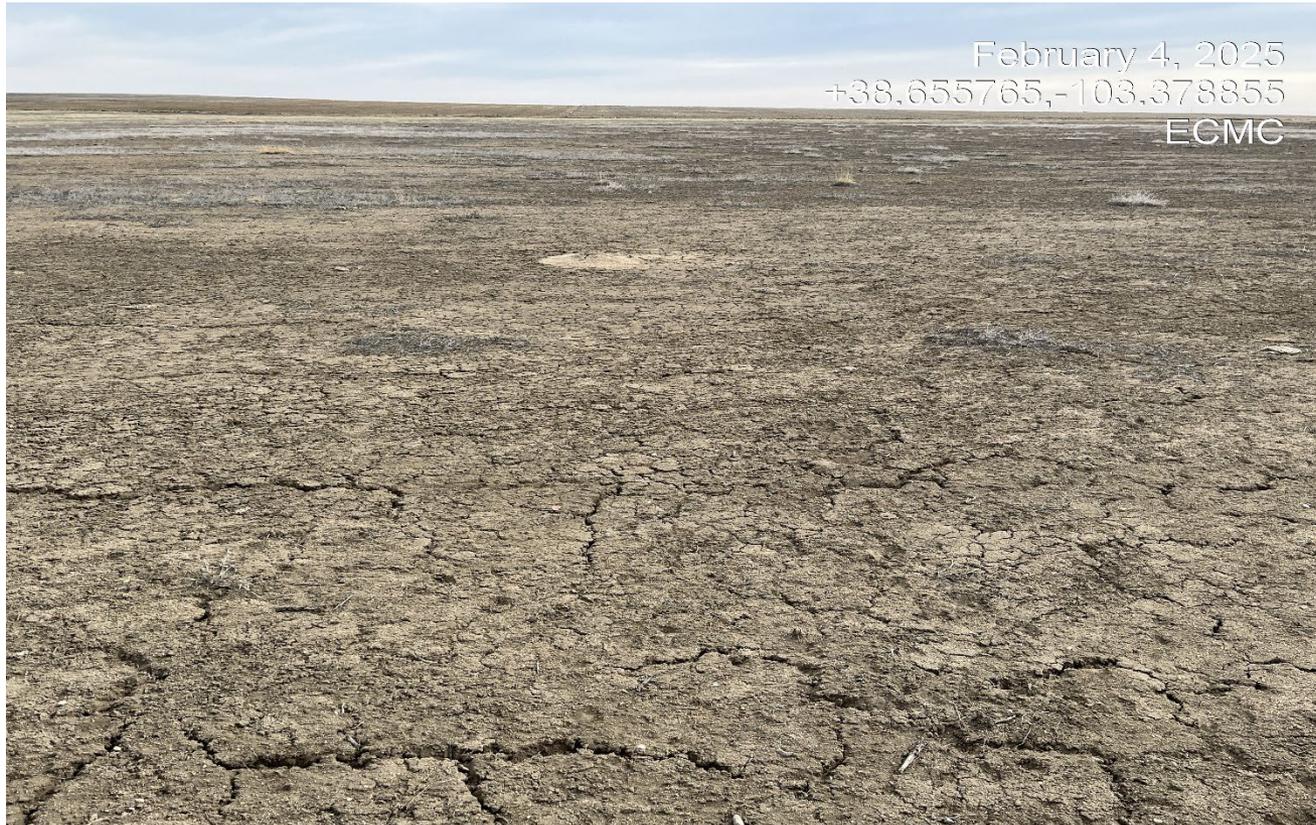
Photo 5. West side of the location facing east.

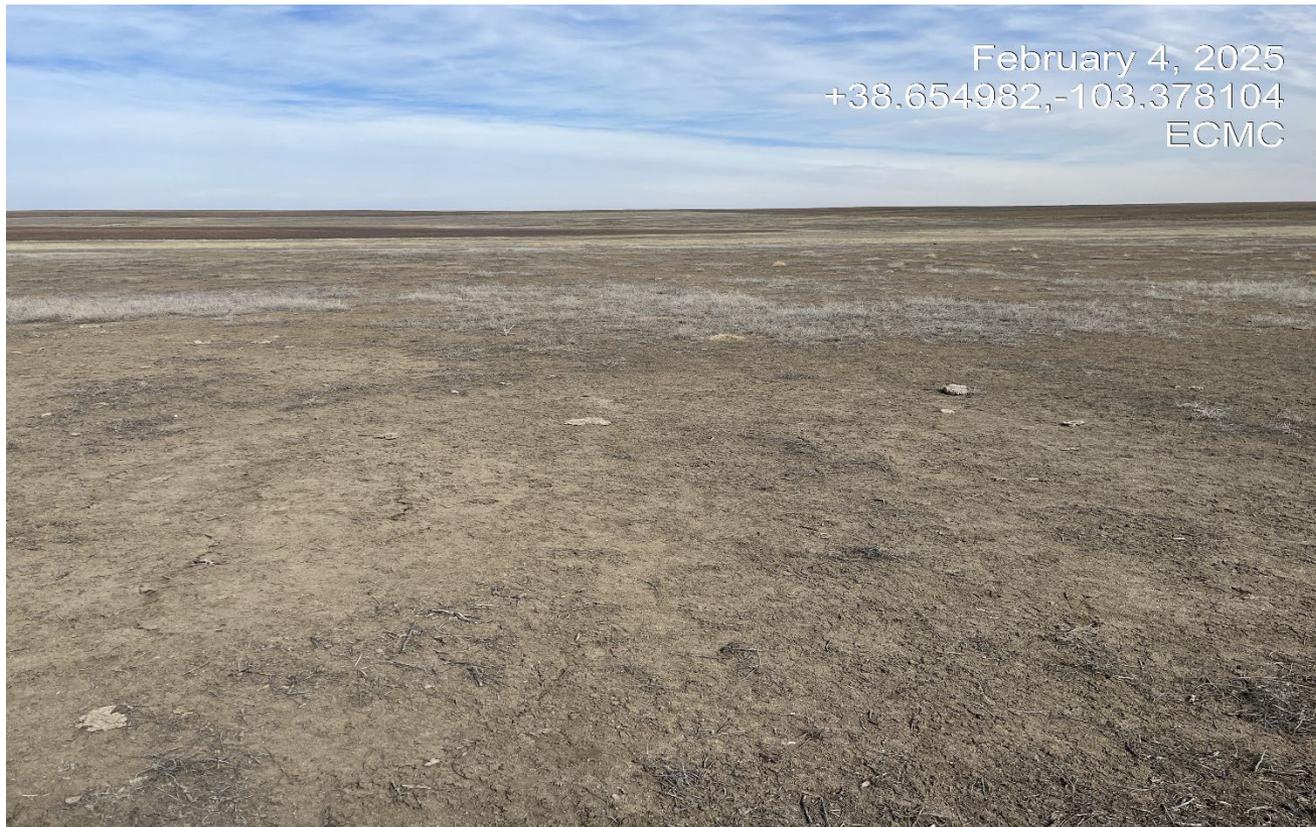
Photo 6. South side of the location facing north.

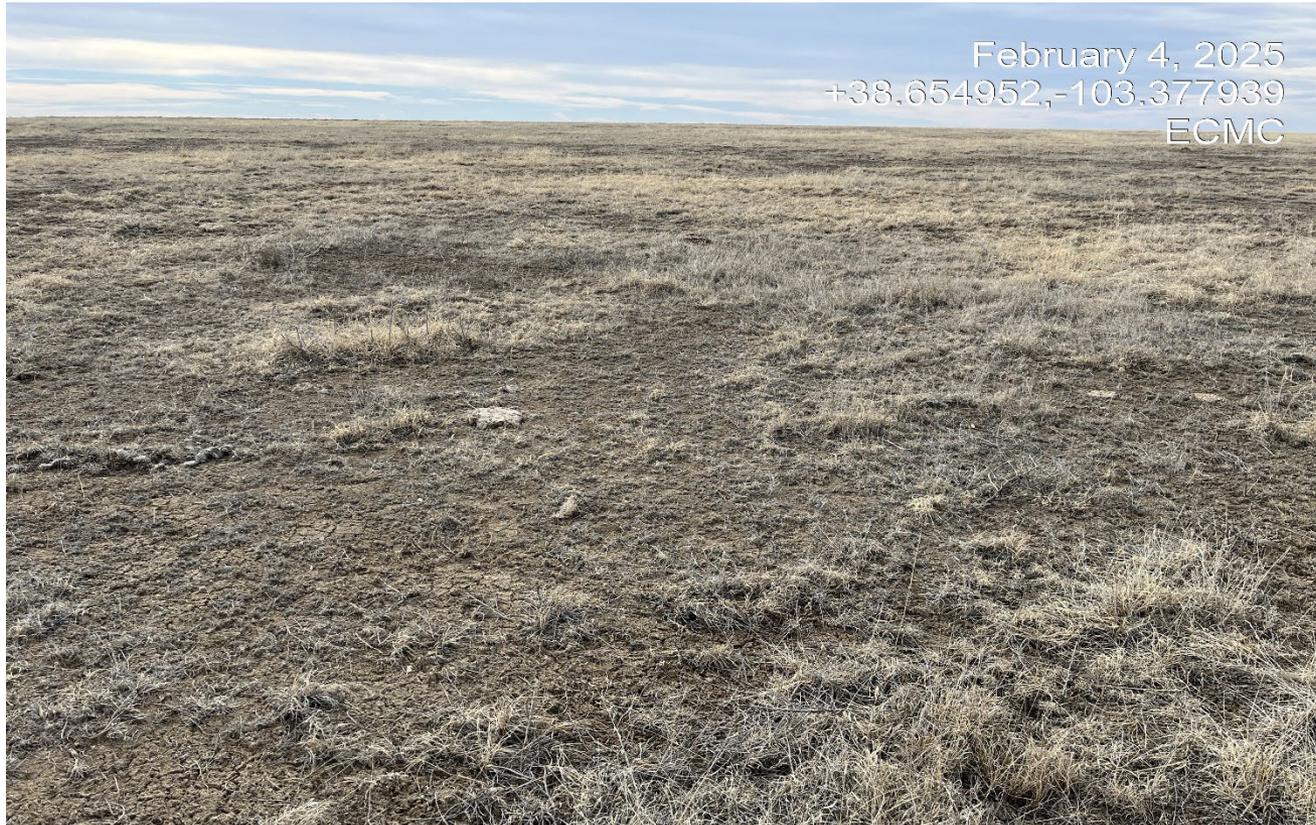
Photo 7. Facing north toward the reference area which consists of native Blue grama dominate grassland.
