Inspection Photos

Loc: 431583

Operator: PIONEER NATURAL RESOURCES USA INC

Inspection Date: 2/4/2025

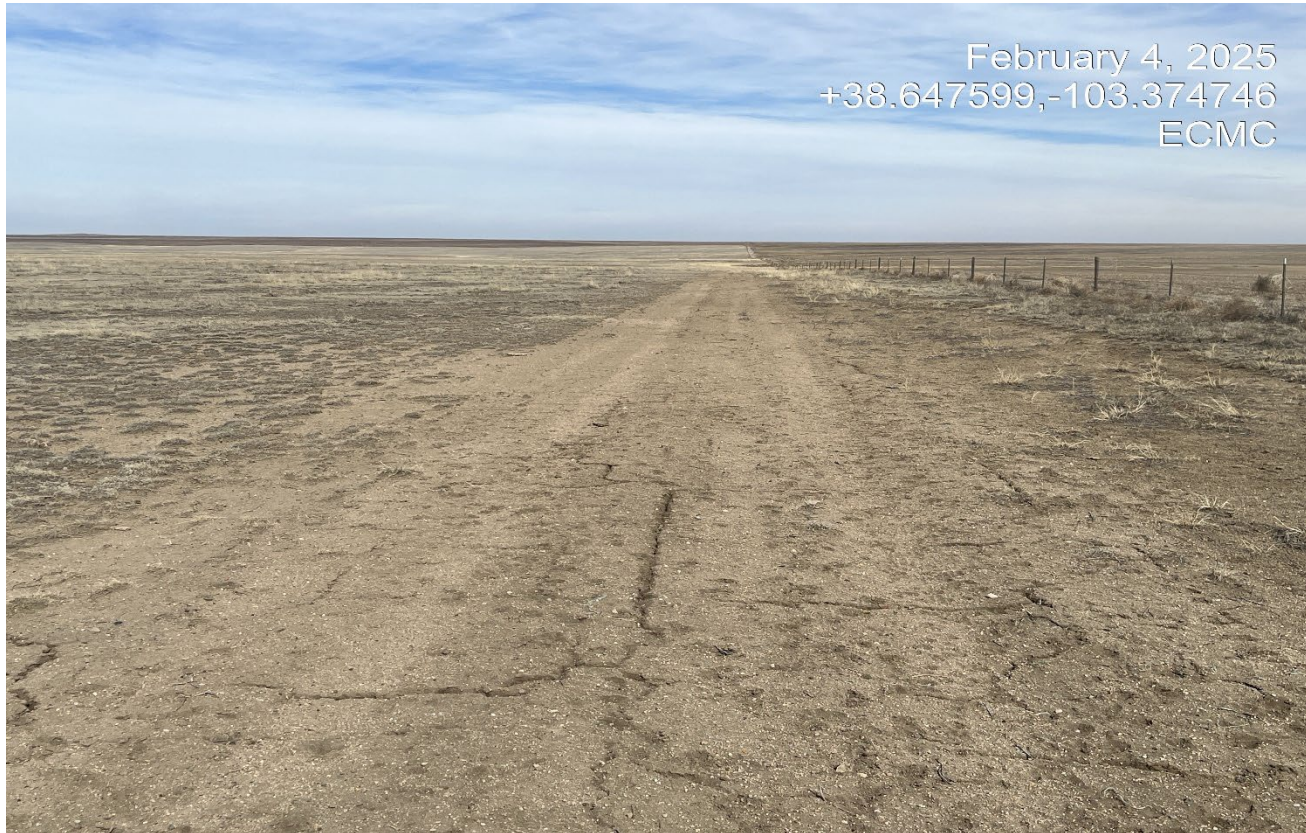
Photo 1. Facing north along the access road. The former access road has not established perennial vegetation and needs to be reseeded.

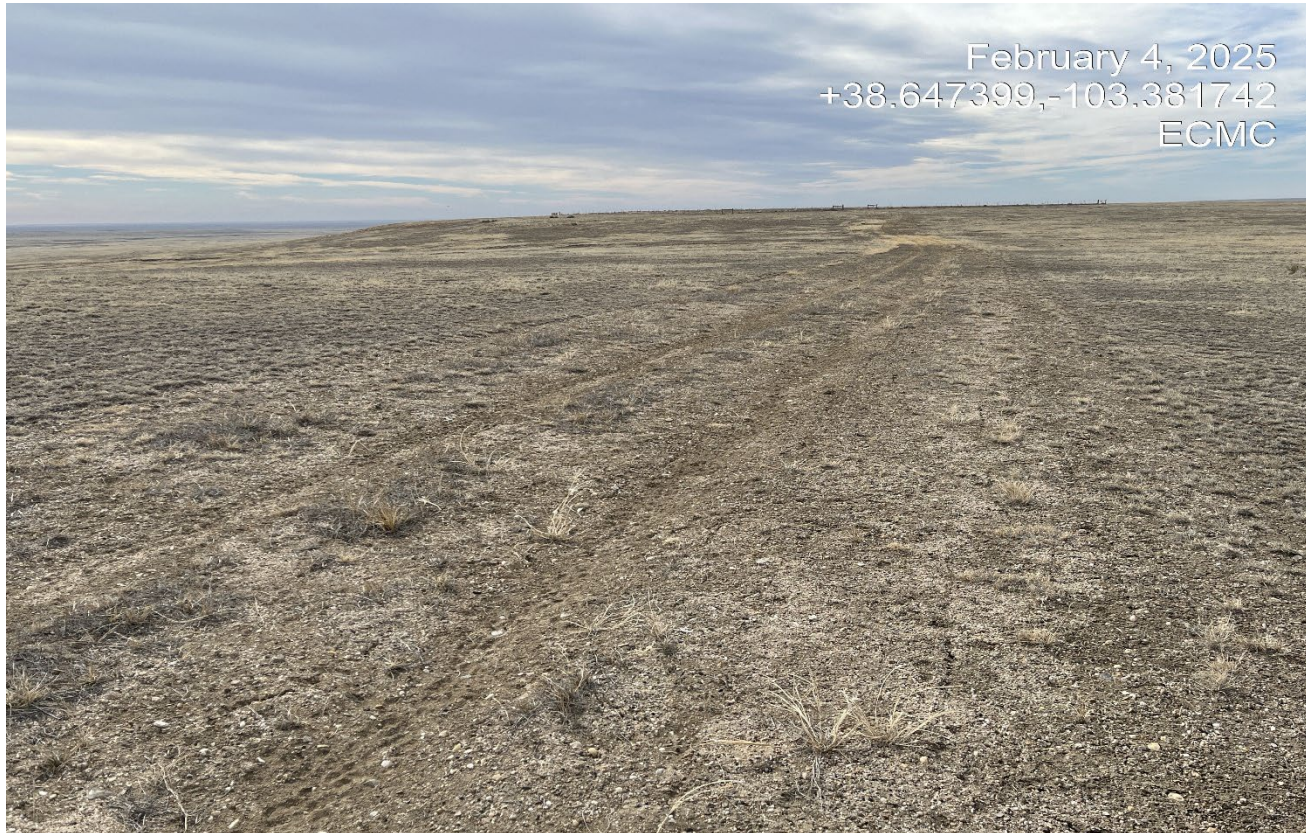
Photo 2. Facing southwest along the access road. The former access road has not established perennial vegetation and needs to be reseeded.

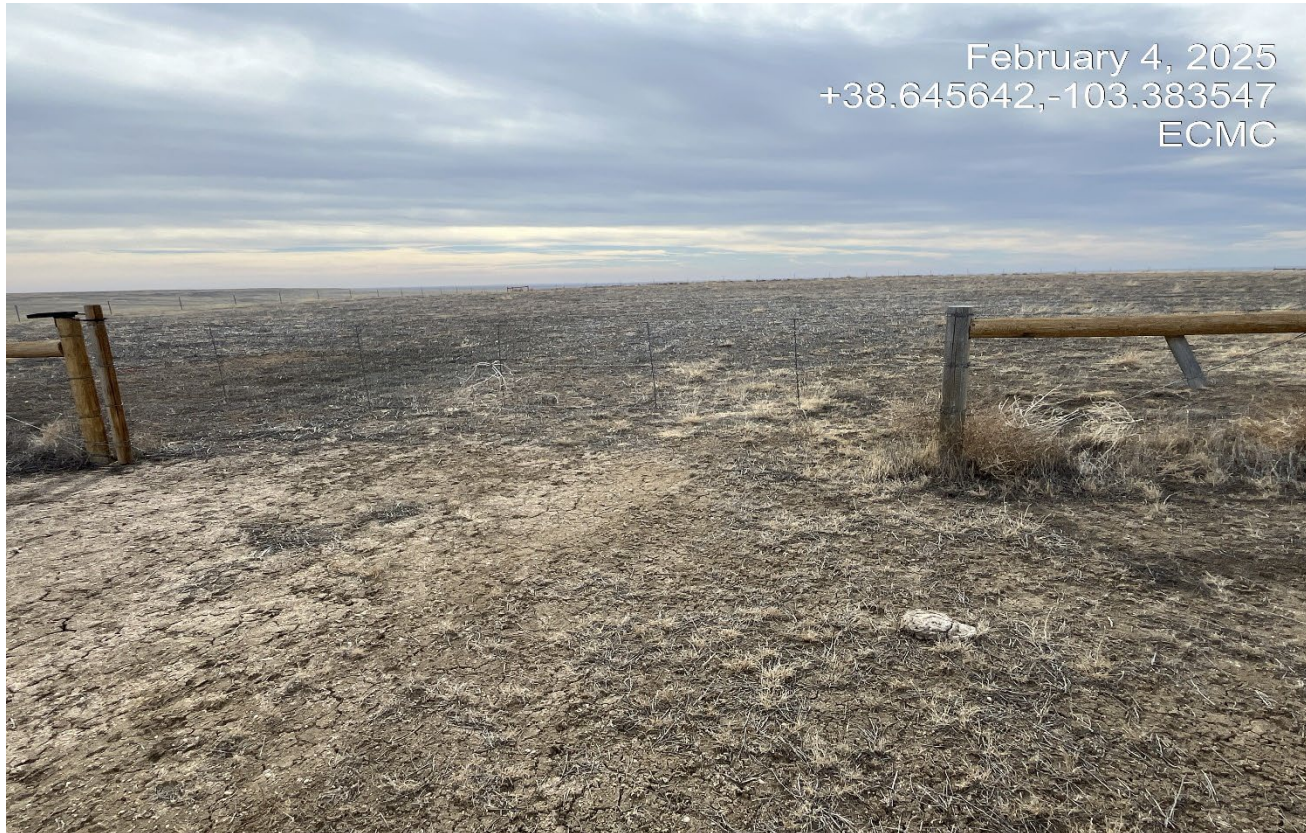
Photo 3. Facing south toward the location. Perennial vegetation has not established and the location needs to be reseeded.

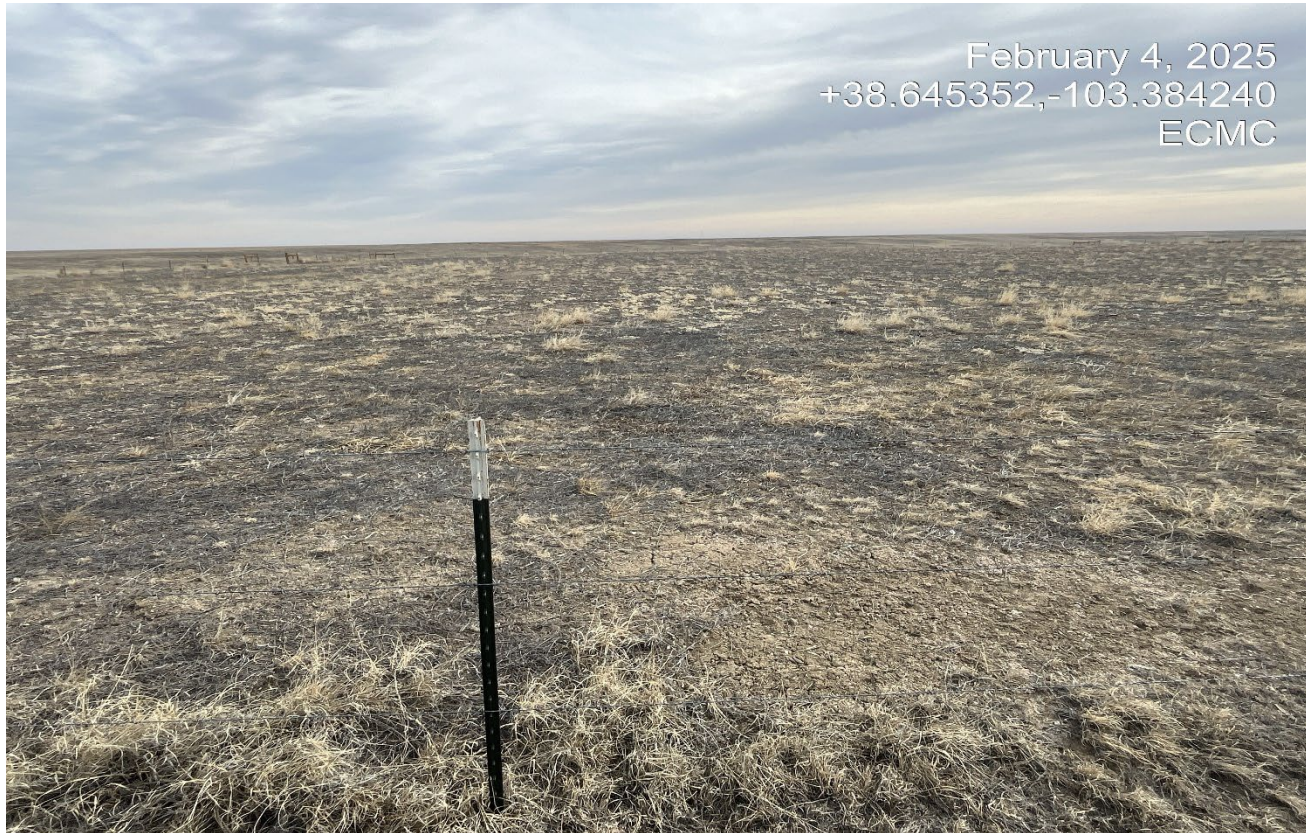
Photo 4. West side of the location facing east.

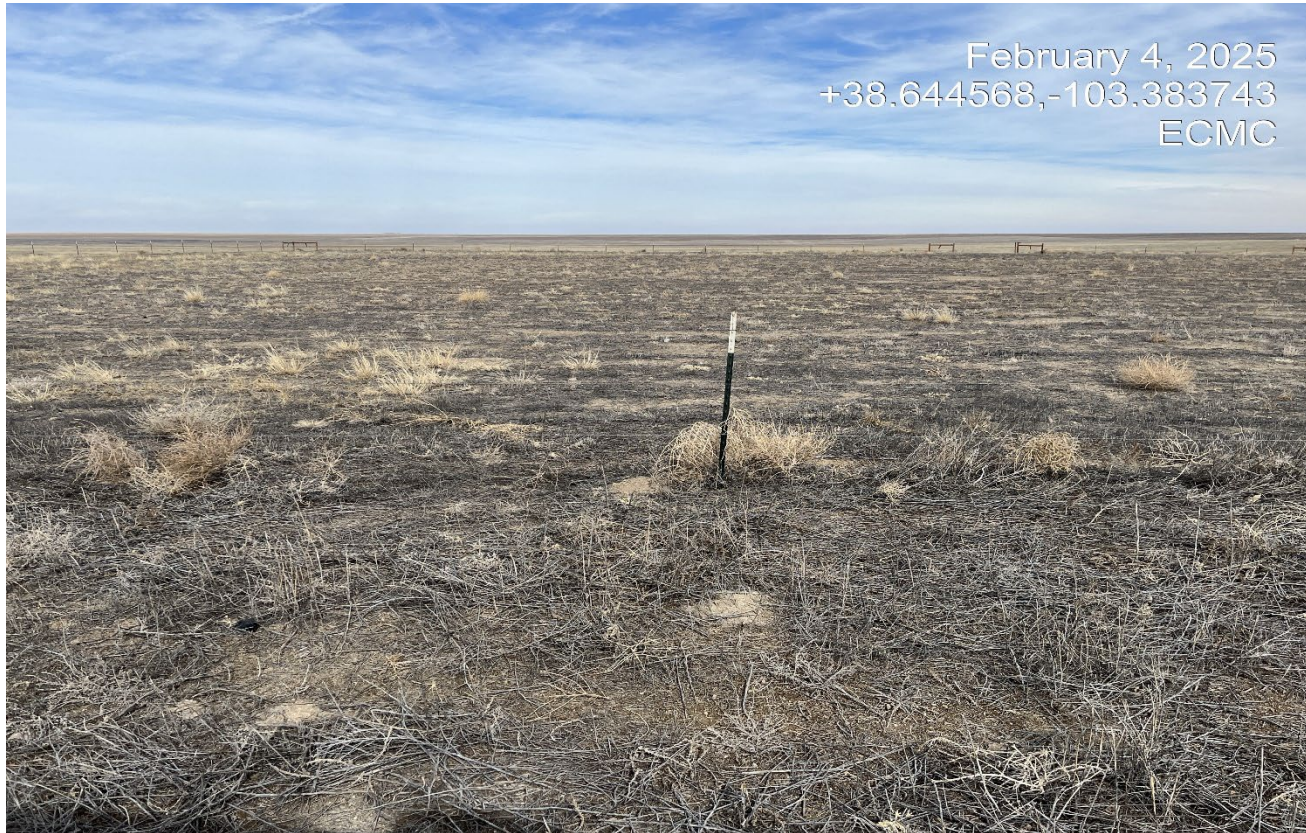
Photo 5. South side of the location facing north.

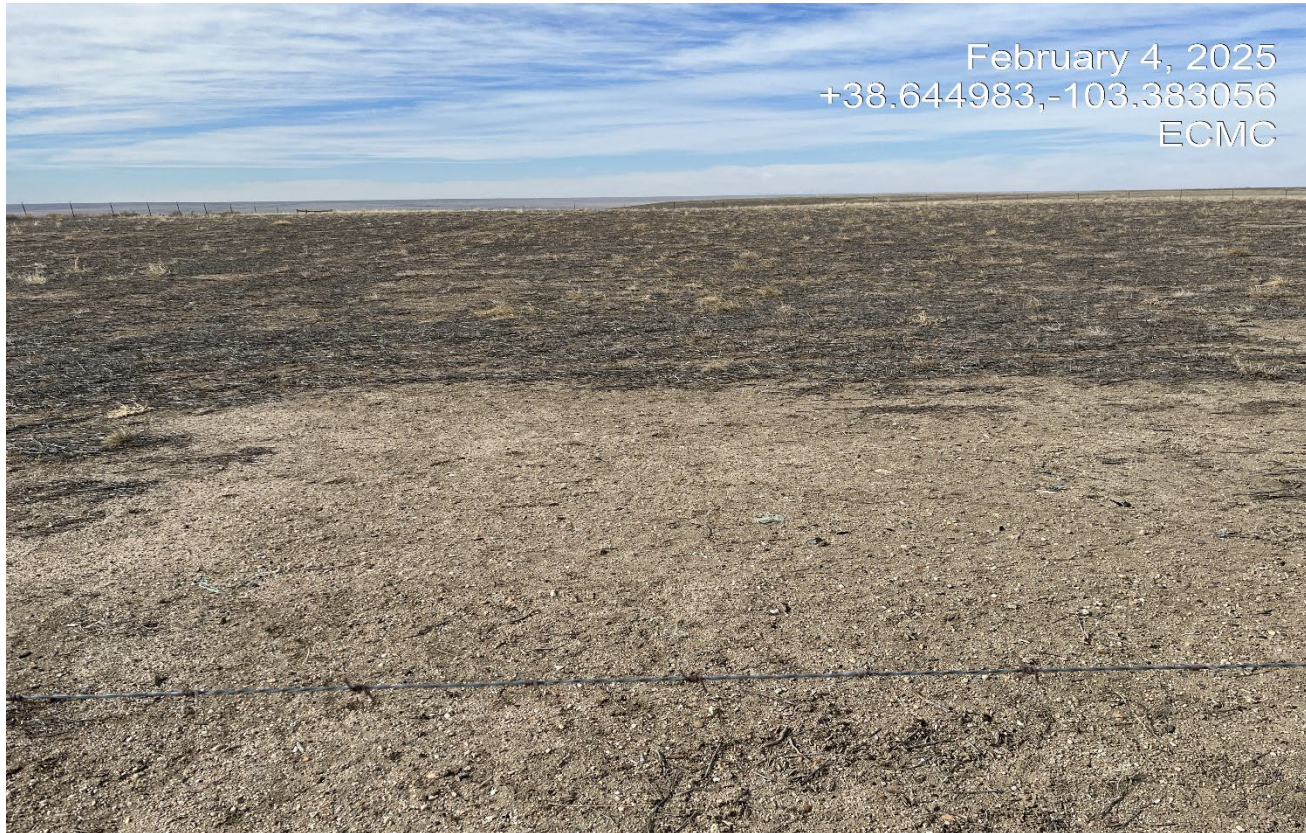
Photo 6. East side of the location facing west.

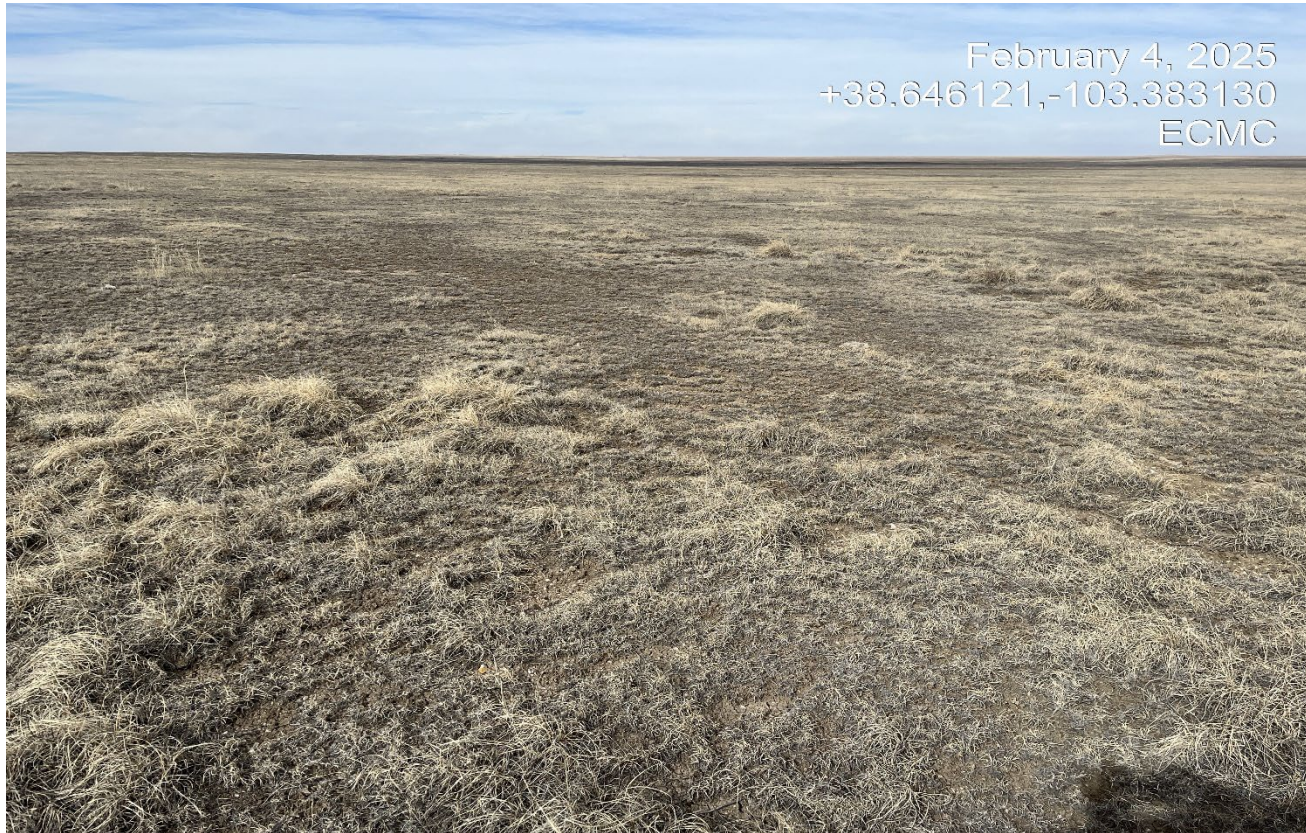
Photo 7. Facing northwest toward the reference area which consists of native Blue grama dominate grassland.
