# Inspection Photos

Operator: Simcoe LLC - 10749

Location ID: 333767

Inspection Photos  
Location Name: McCaw 34-15 2, 4  
Location ID: 333767

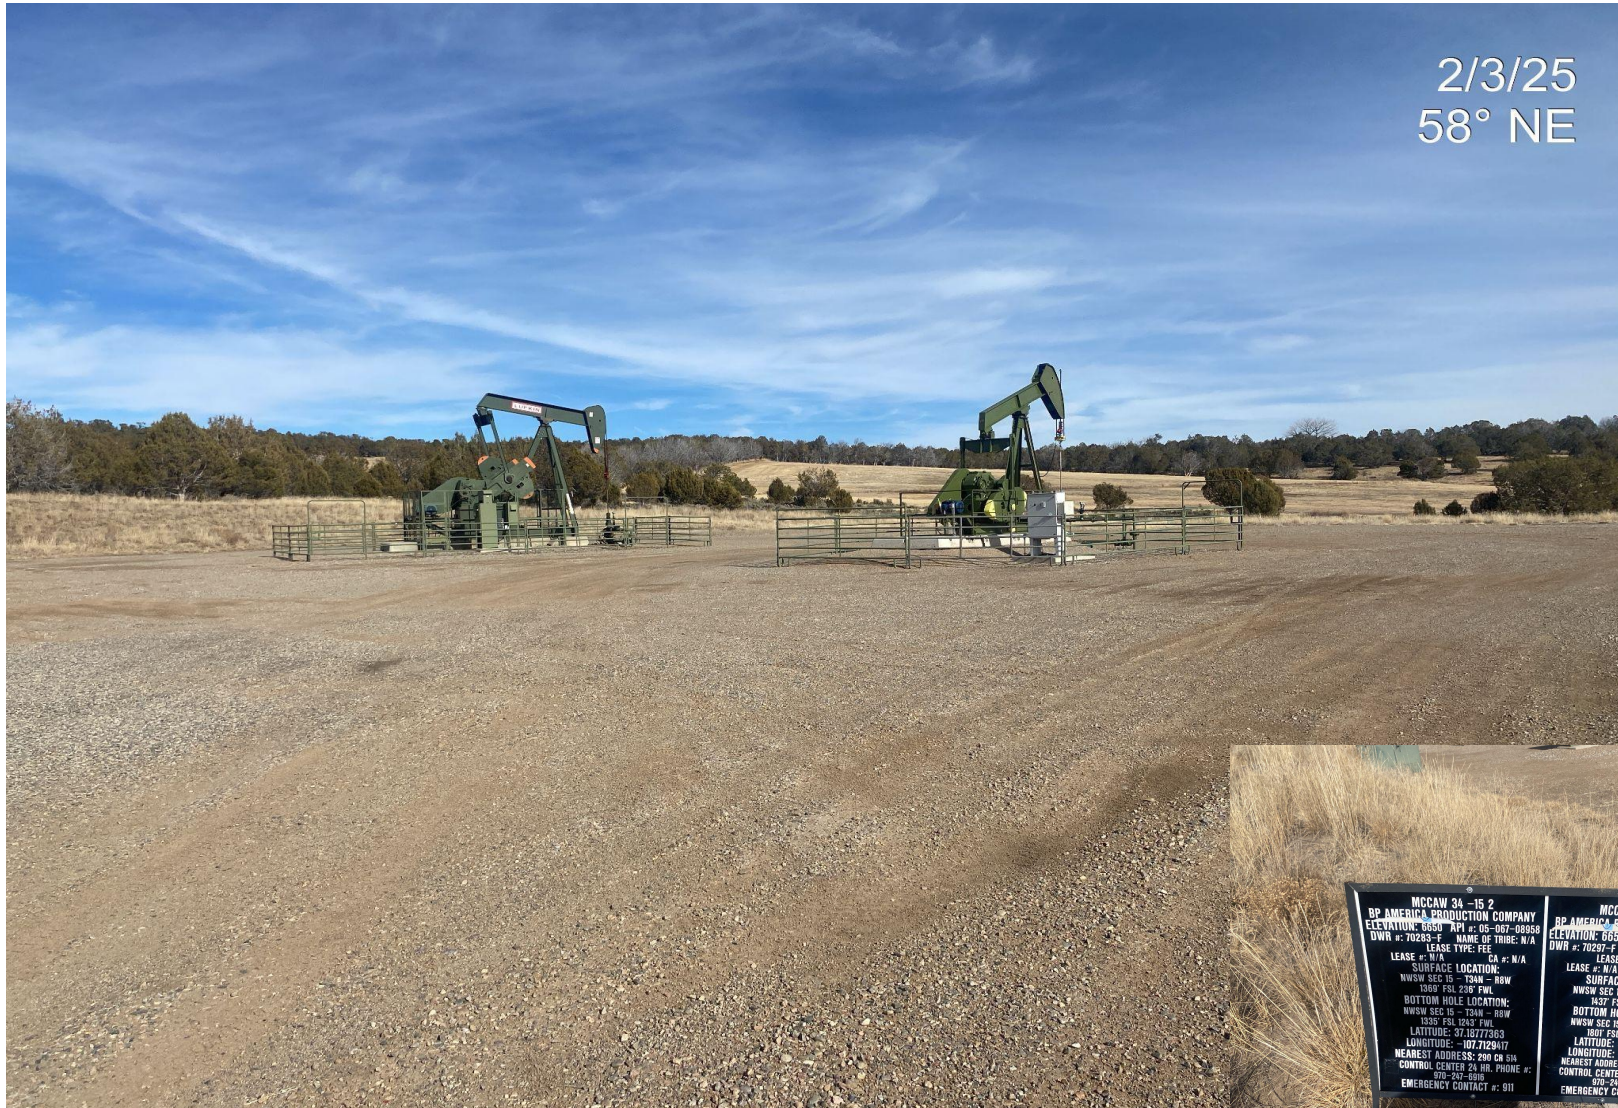
Photo 1. View of the well pad from the access point facing center.

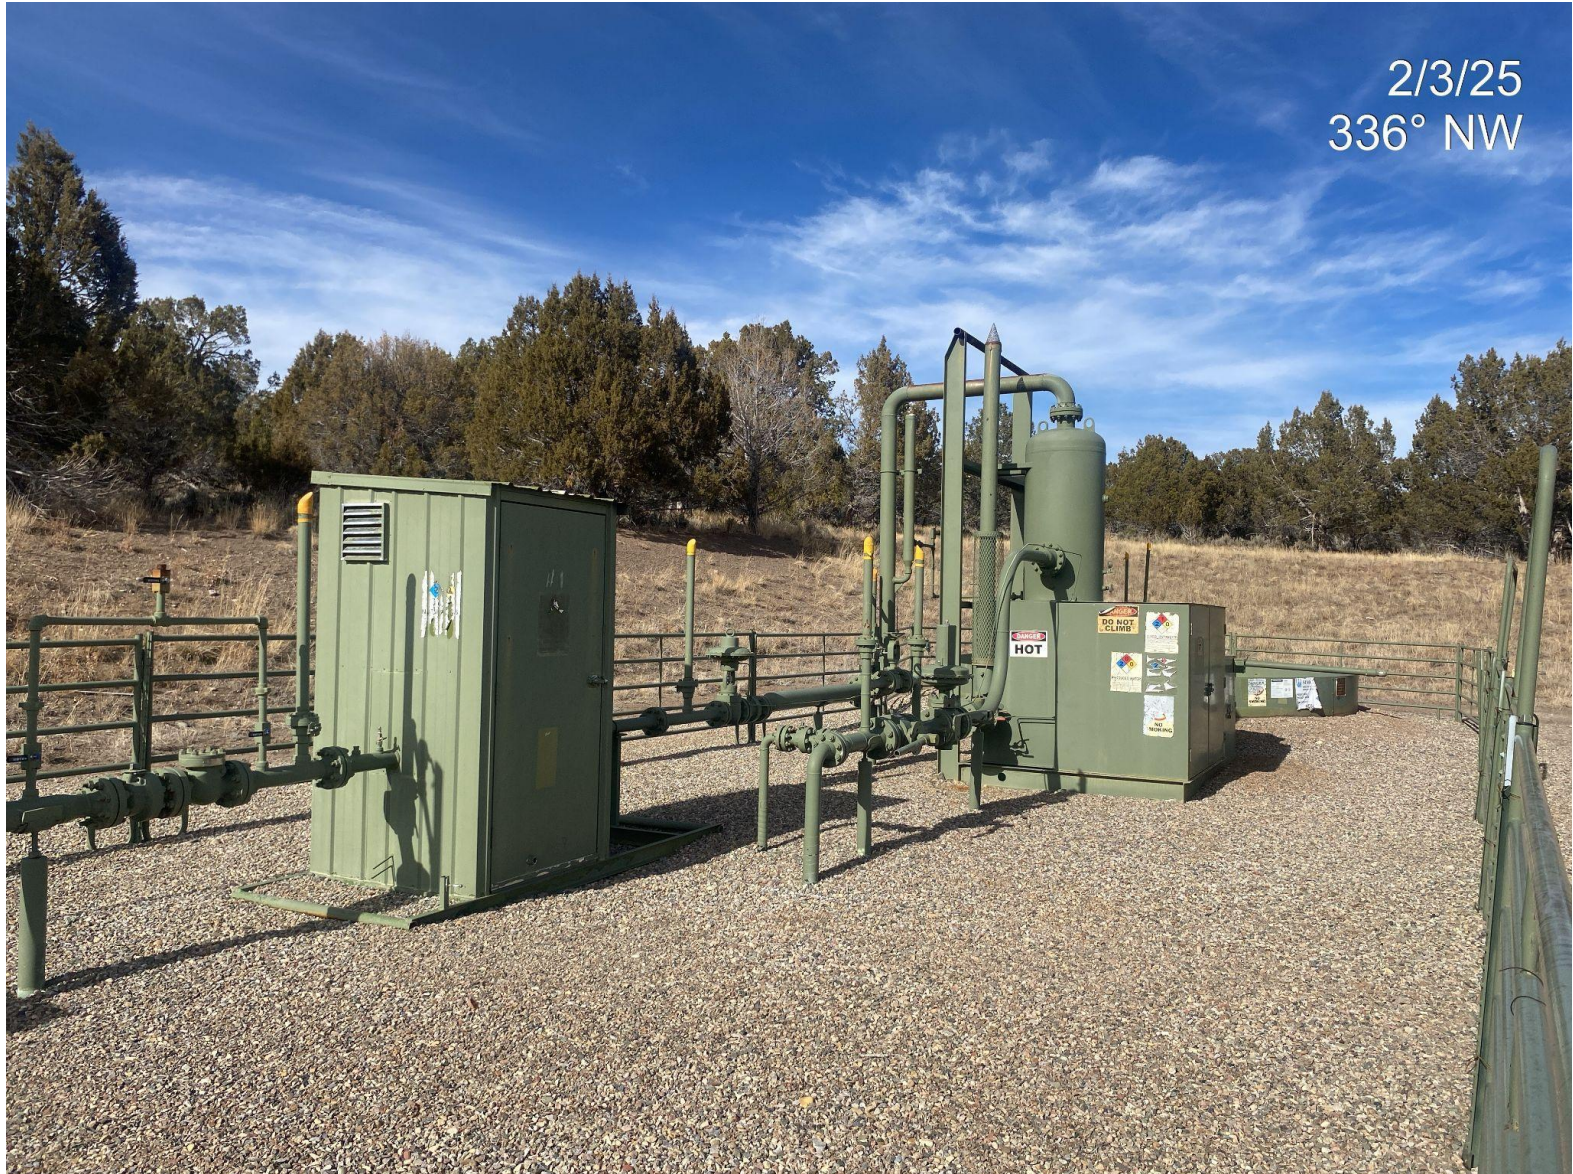
**Photo 2:** Separator labels have deteriorated and are no longer legible.

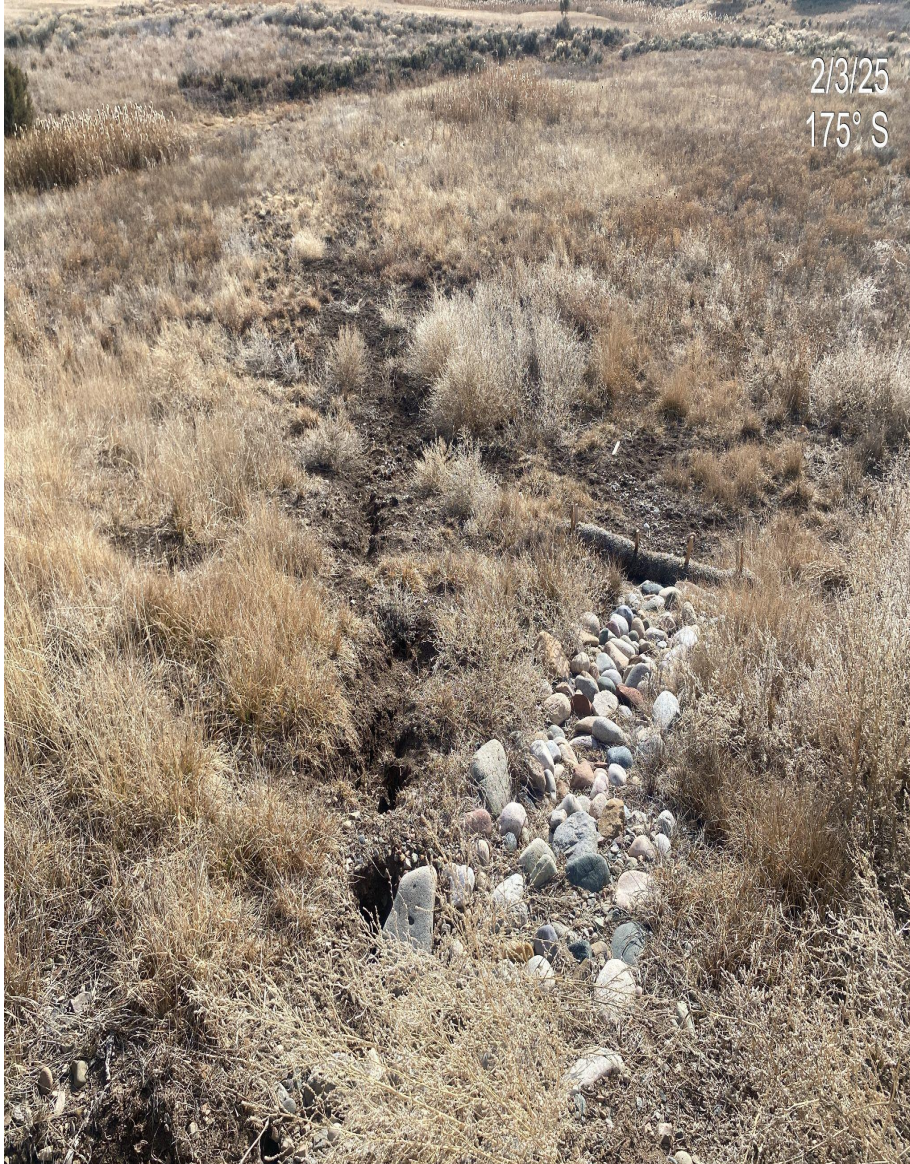
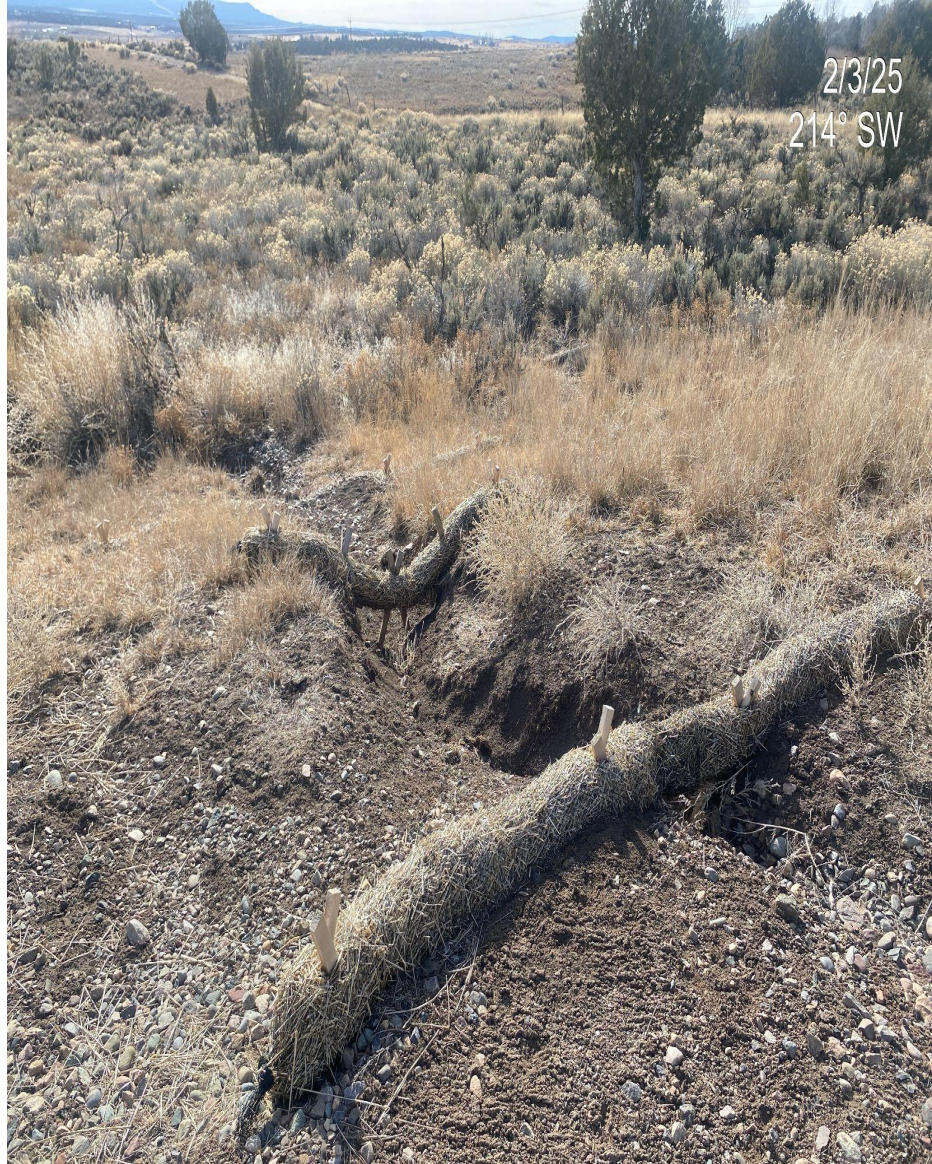
**Photo 3.** Stormwater issues persist in the southern interim reclamation area. BMPs have not been installed correctly.

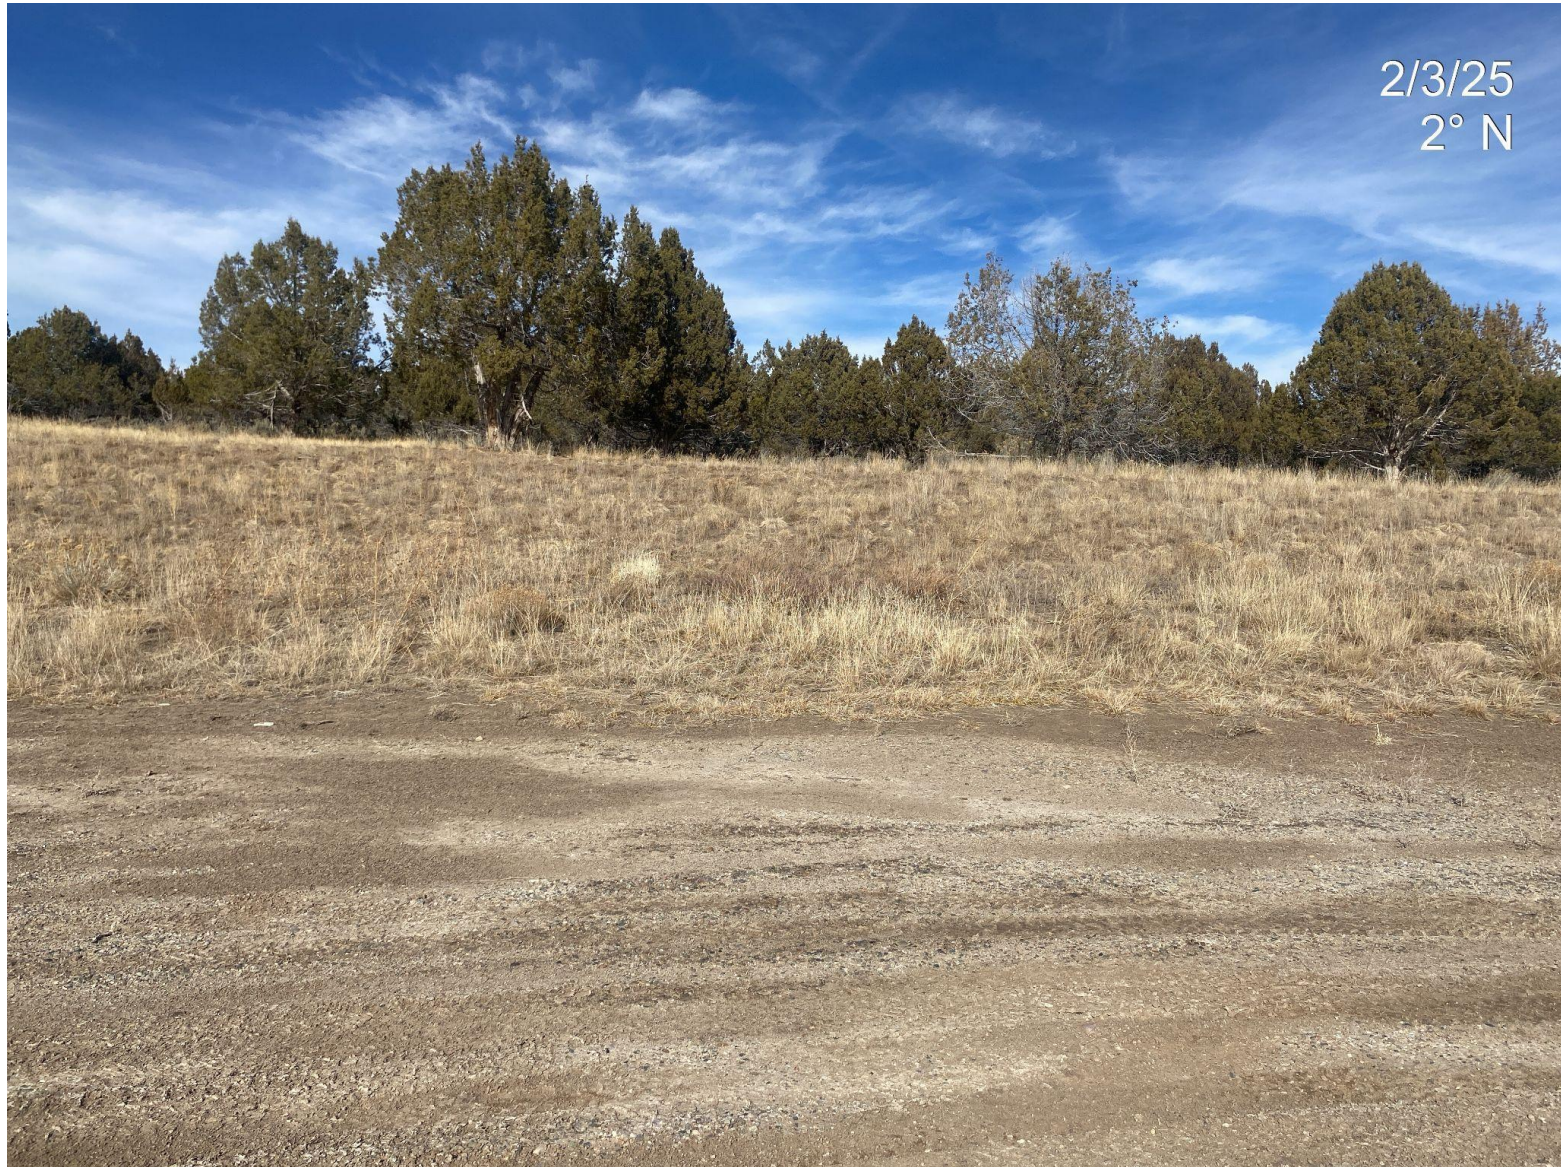
**Photo 4.** Northern interim reclamation area composed of Western Wheatgrass, Sand Dropeed and Broom Snakeweed.

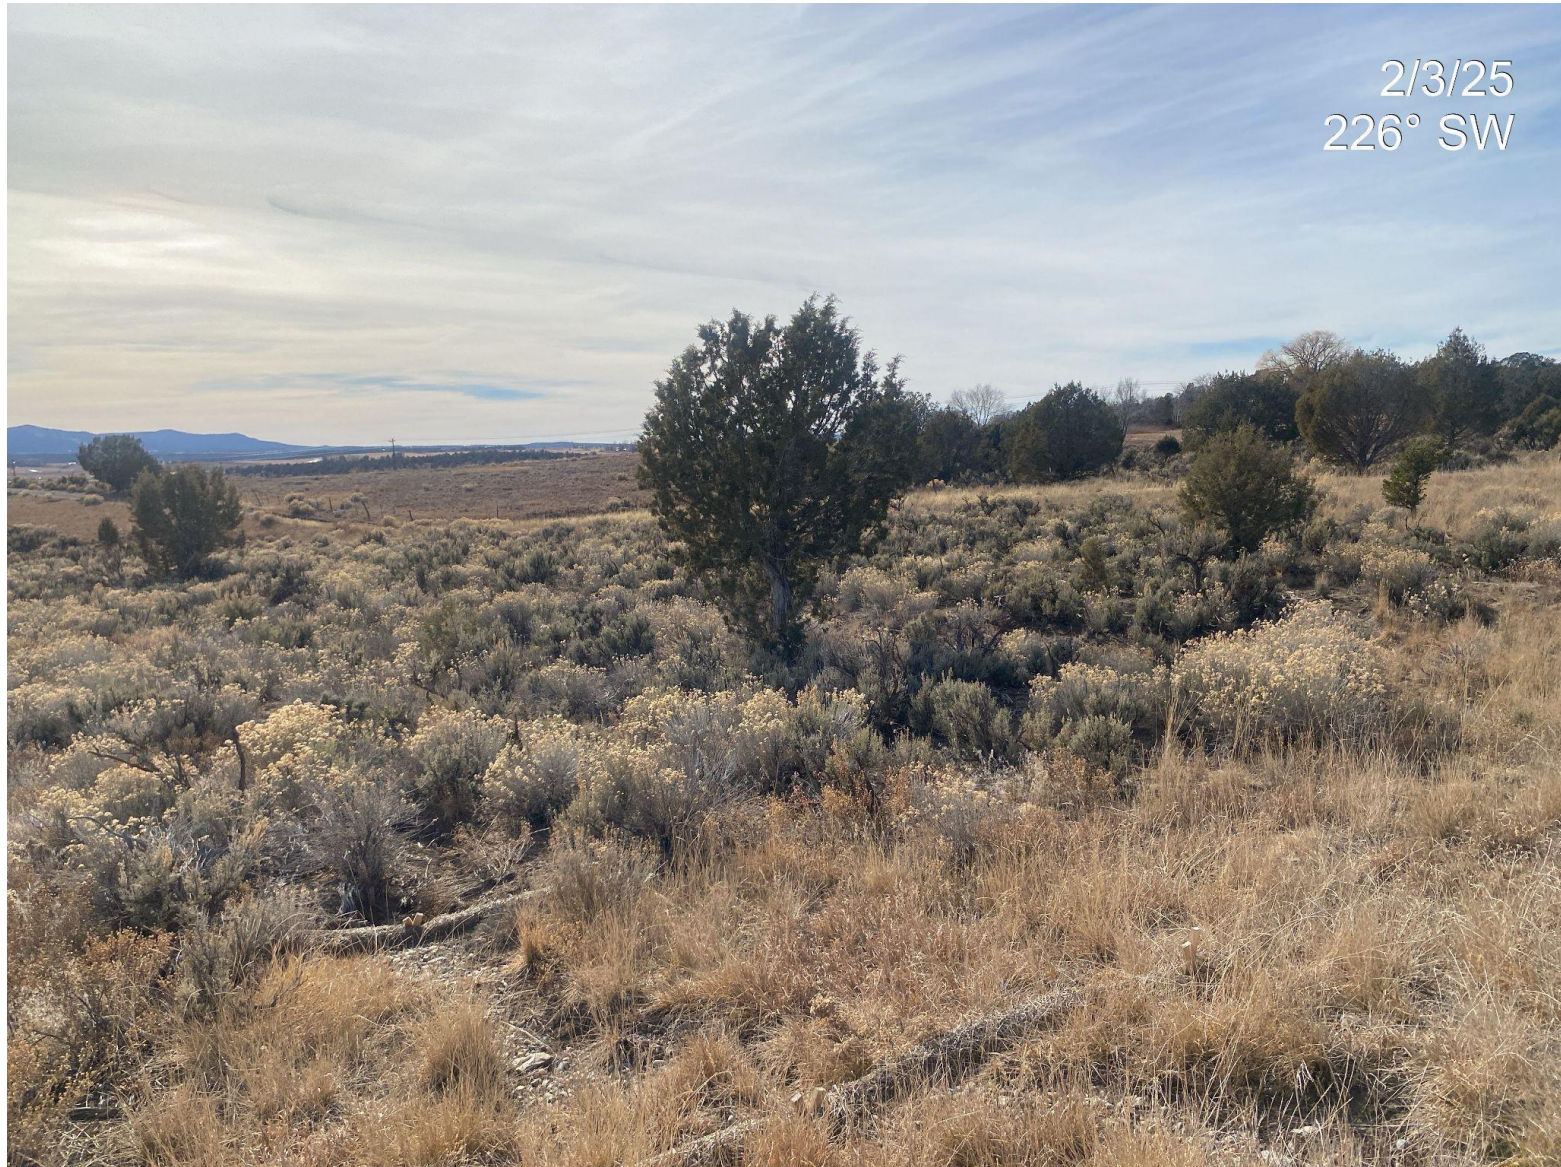
**Photo 5.** Reference area composed of Juniper, Sagebrush and Smooth Brome.
