Remediation Soil & Groundwater Sampling Fieldsheet

O&G Site Name	Labrisa 11-35HZ Facility	Client	Oxy	REM Project #	488519
Weather	Cloudy 53F	Surface Flow Direction	E-SE		
API/TB#	485208	Liner present?	N/A	Site Coordinates	40.090250°N -104.631710°W

Sampling Photographic Log

Labrisa 11-35 HZ Facility

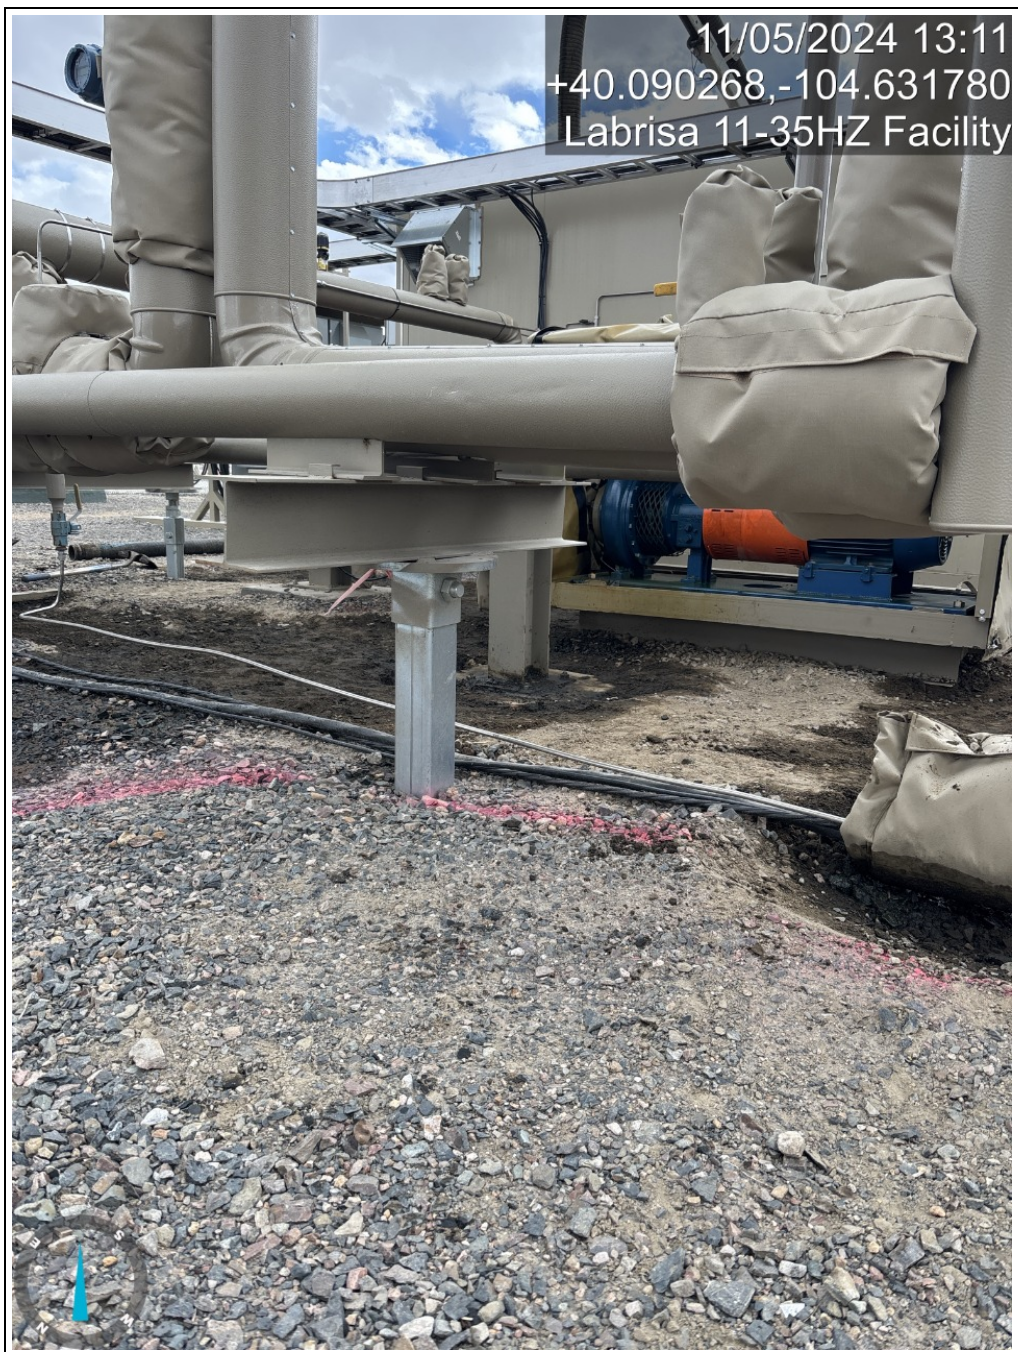
Waste Characterization
Photo 2, W. Boundary

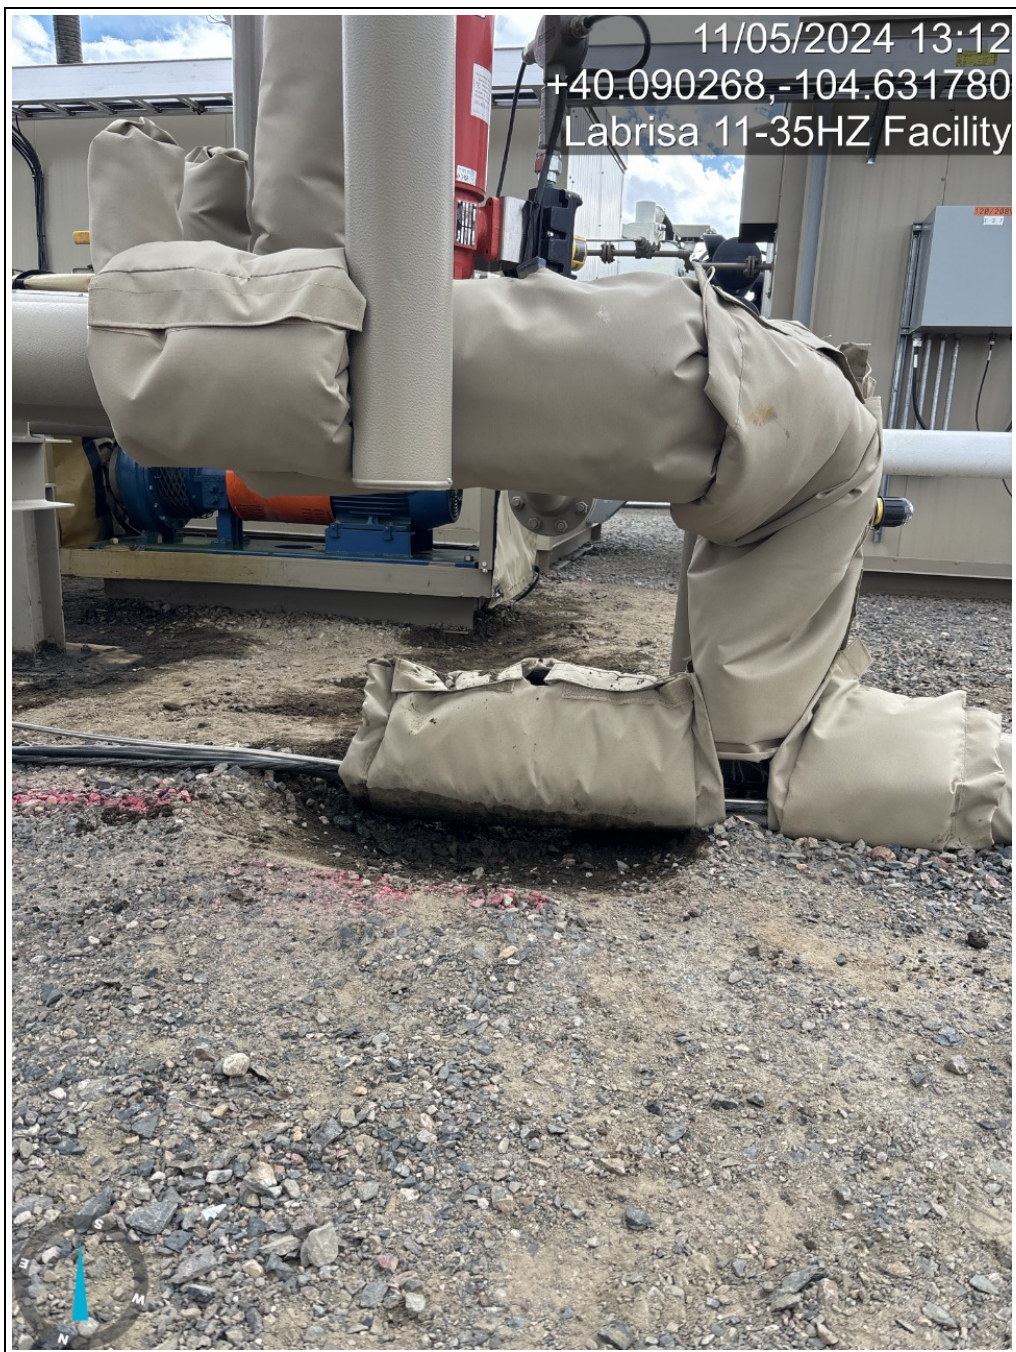
Waste Characterization
Photo 3, SW boundary

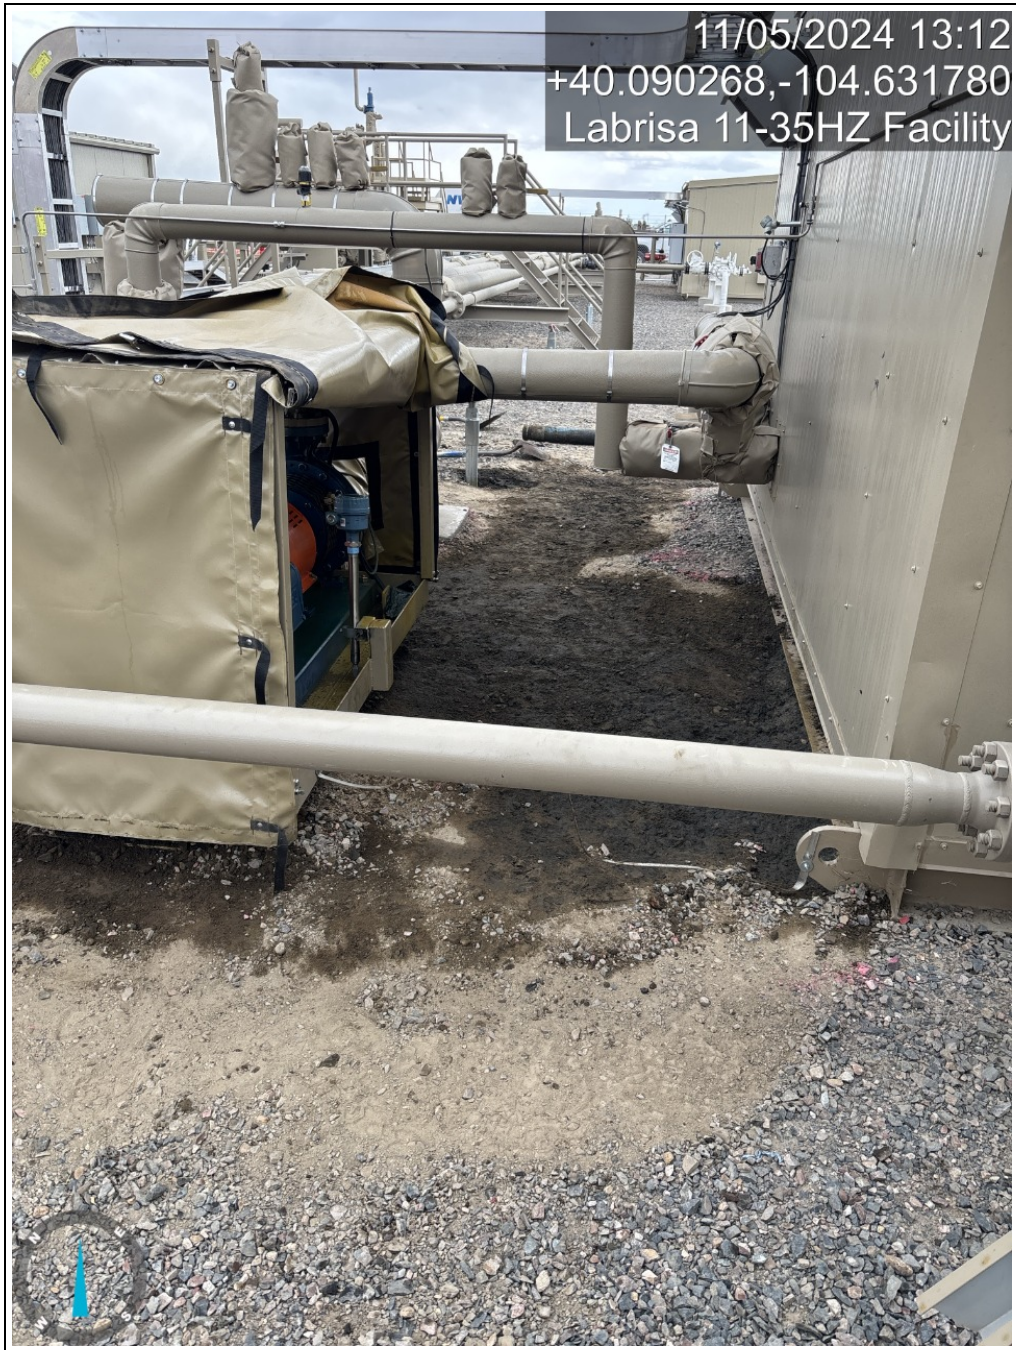
Waste Characterization
Photo 4, S. Boundary

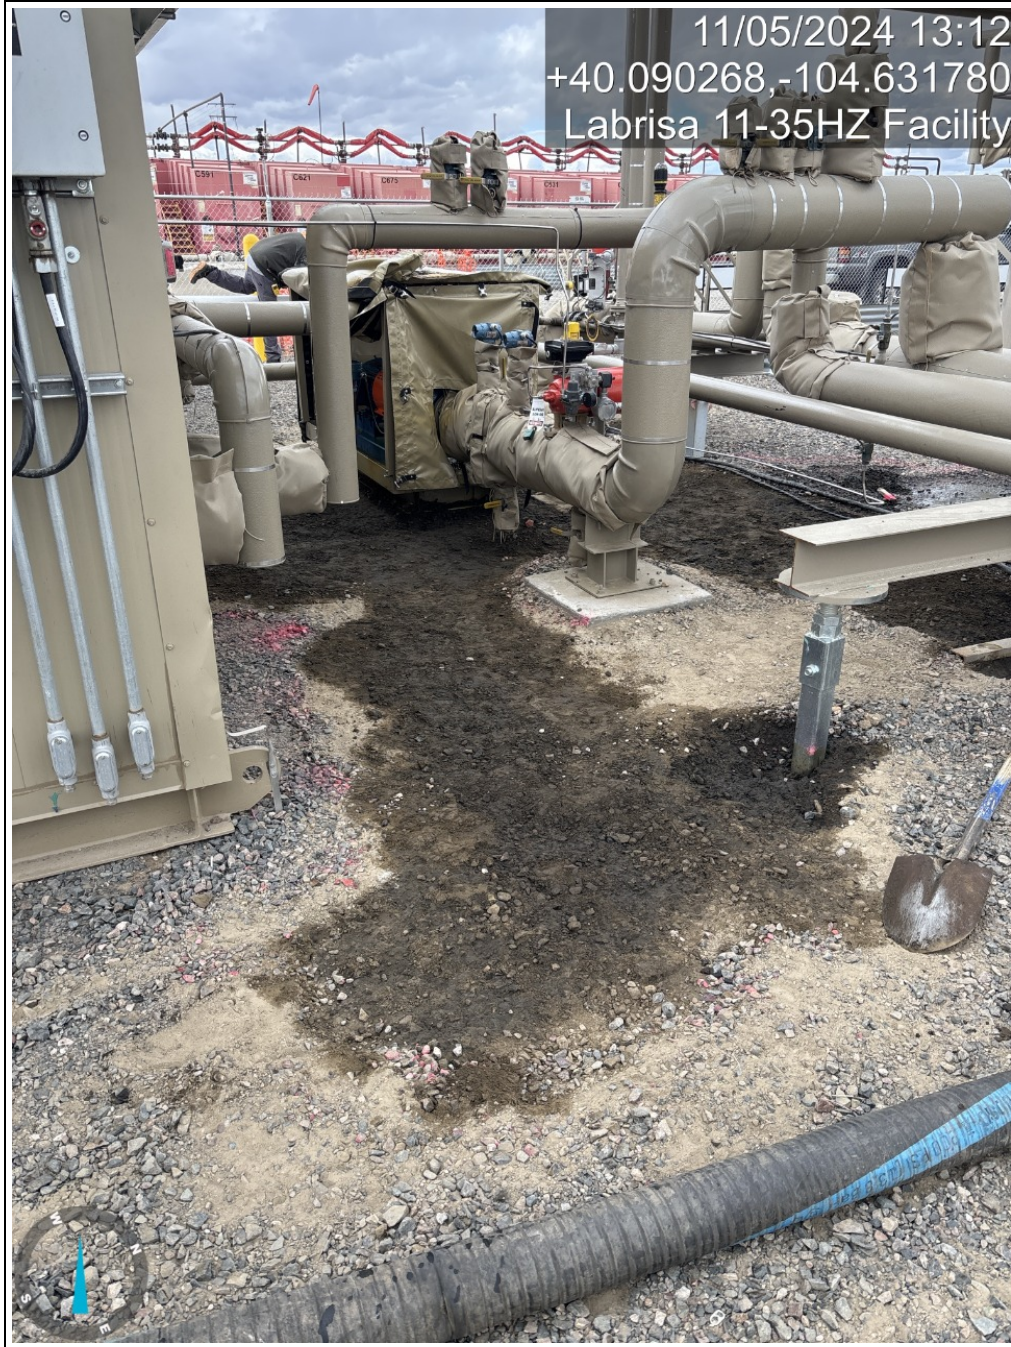
Waste Characterization
Photo 5, S. boundary

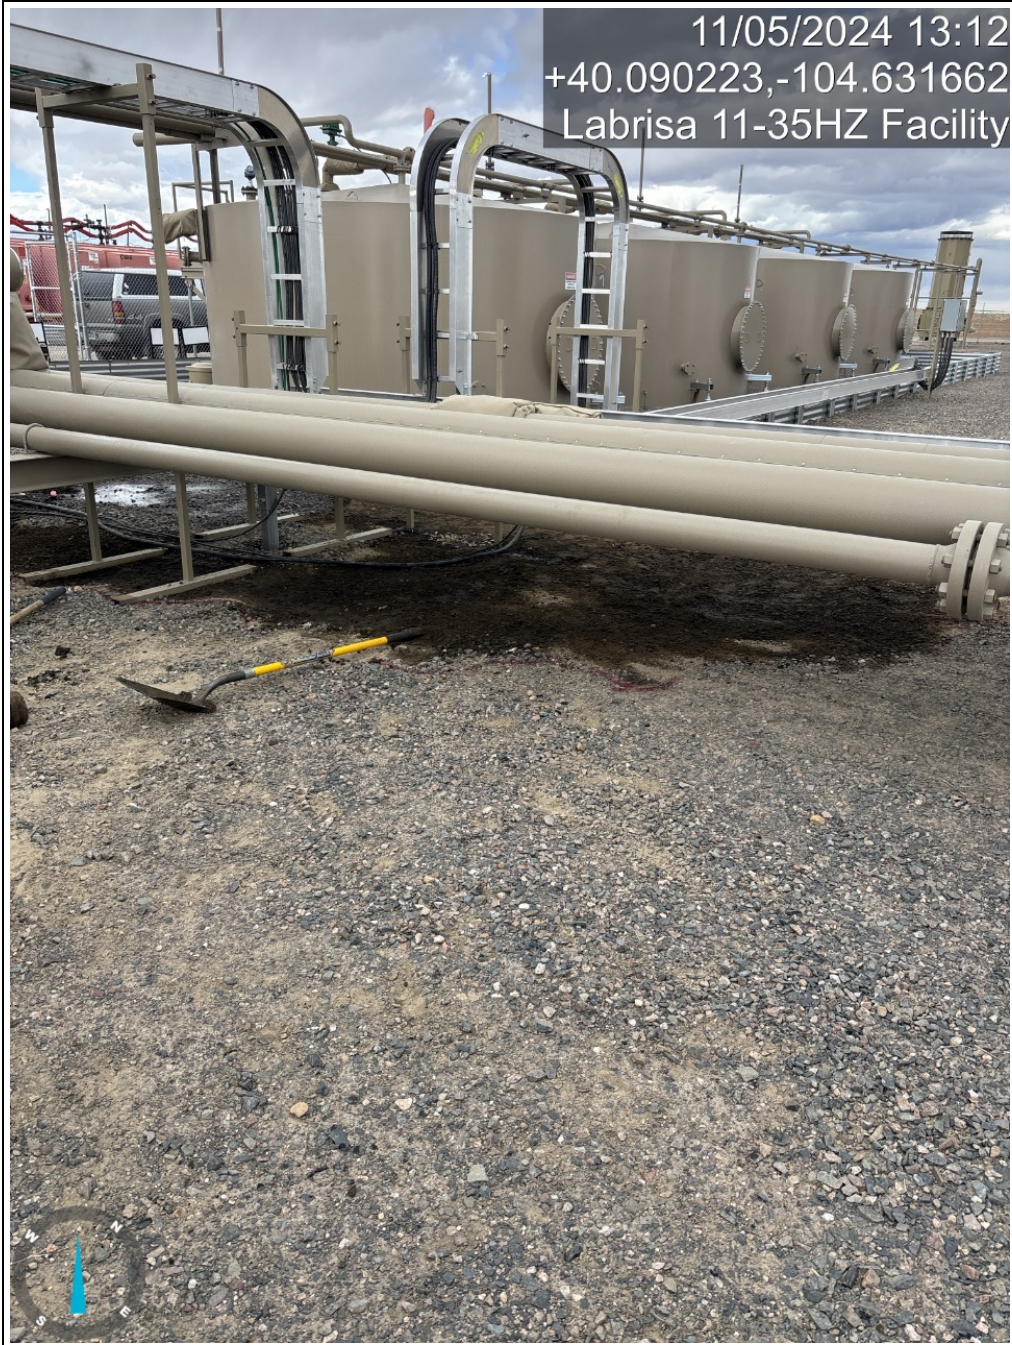
Waste Characterization
Photo 7, ESE boundary

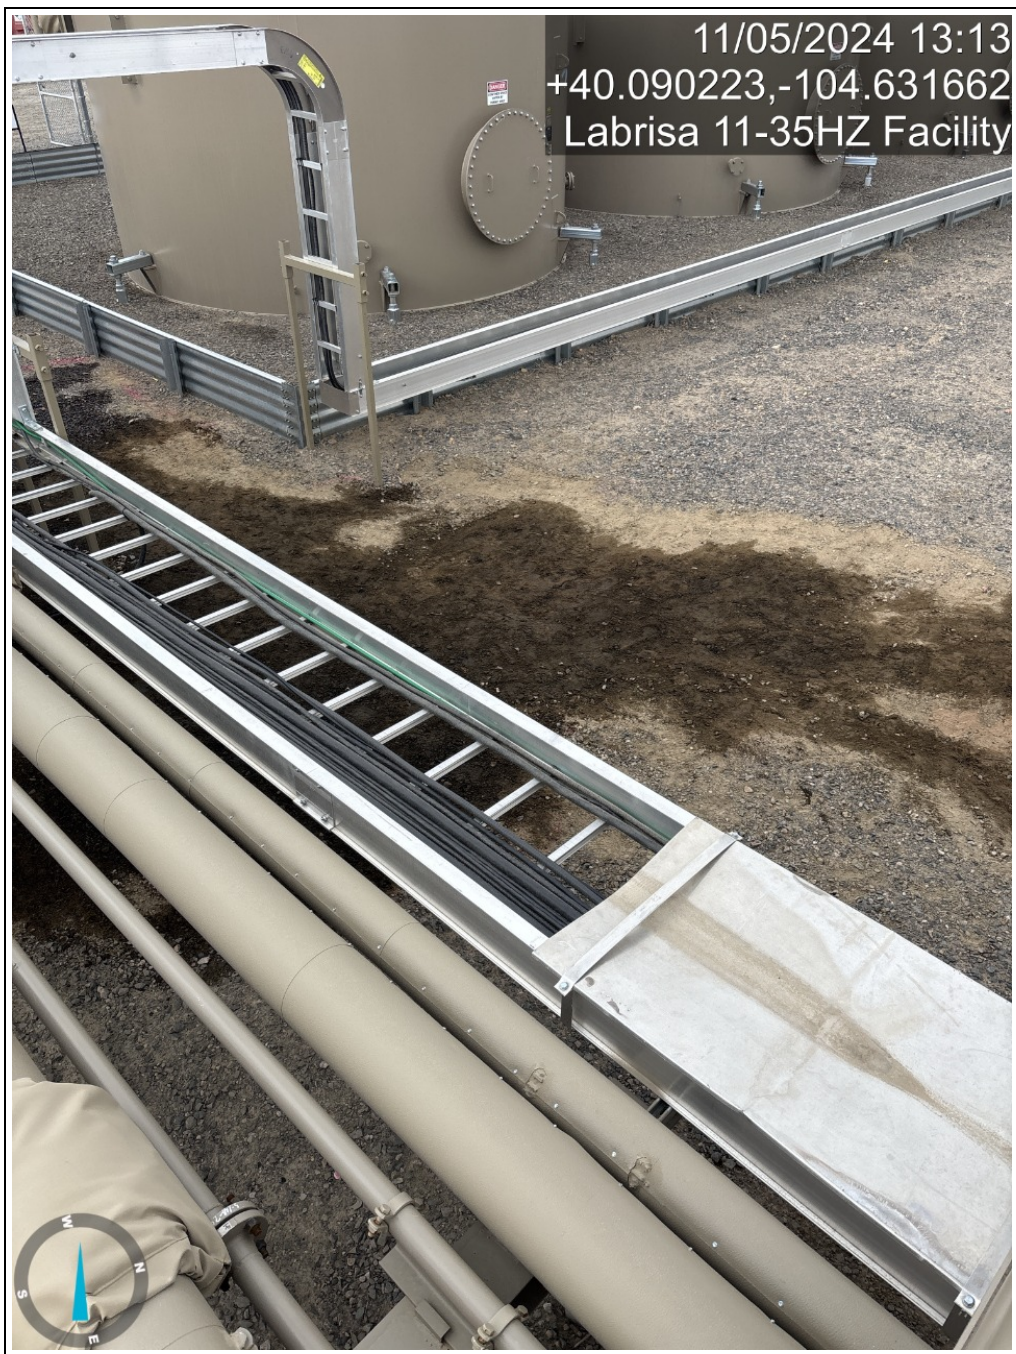
Waste Characterization
Photo 8, E. boundary

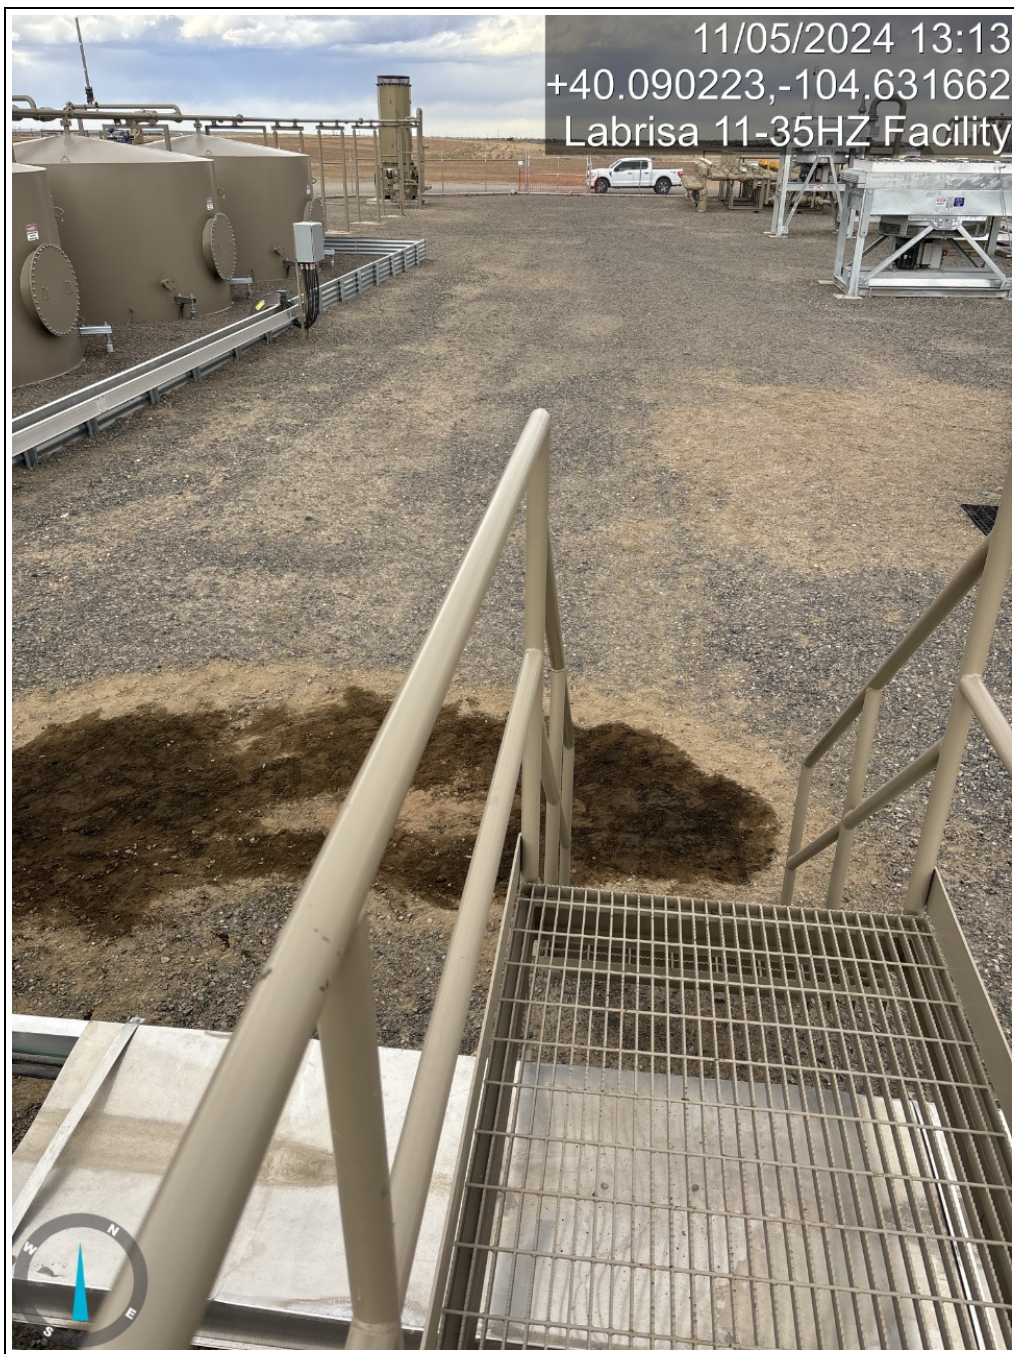
Waste Characterization
Photo 9, ENE boundary

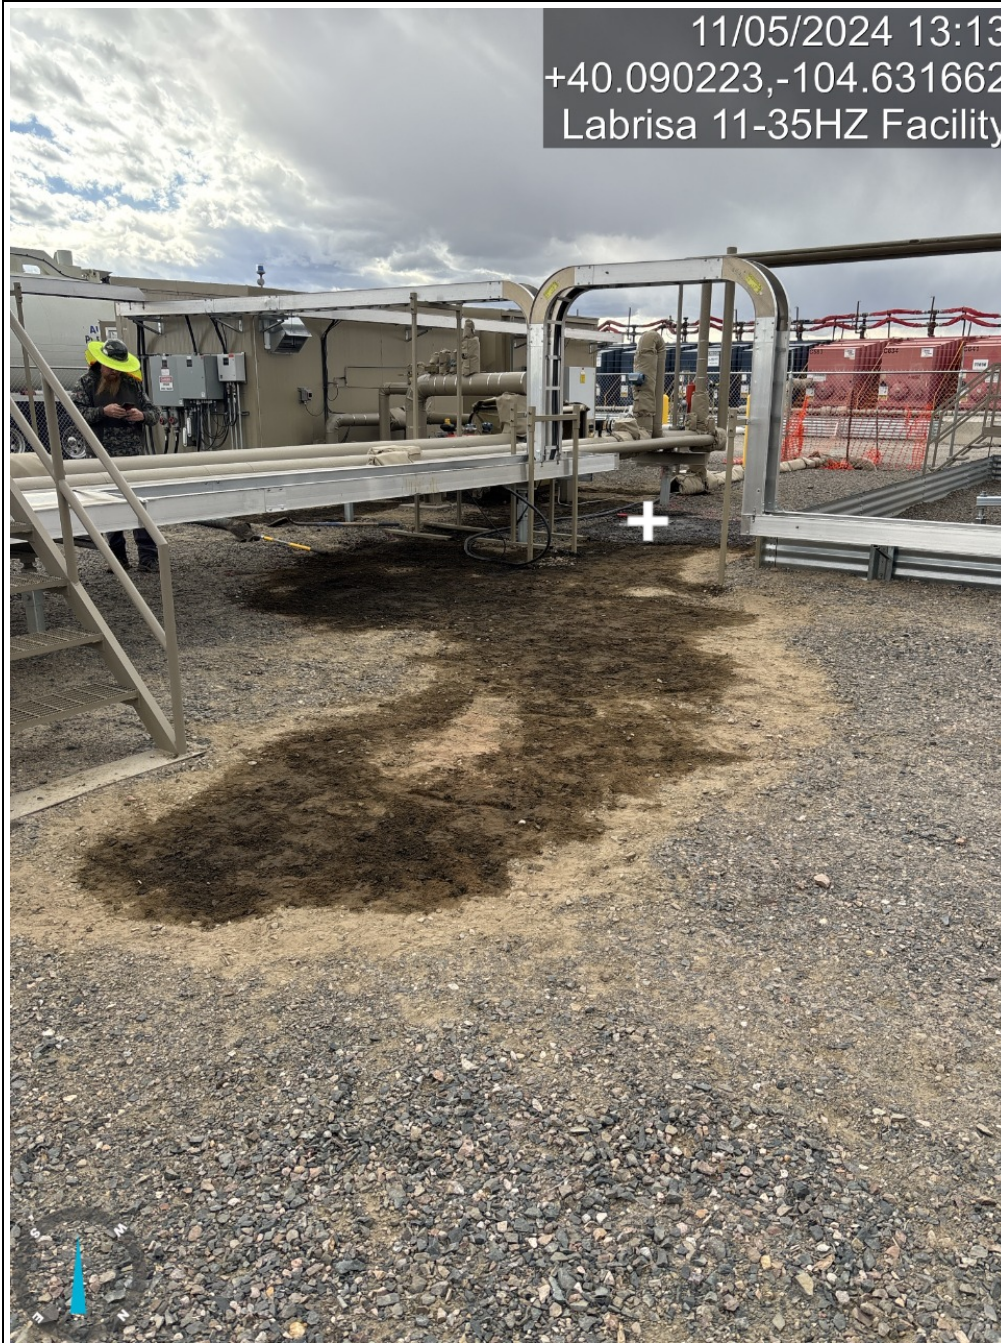
WC01@3"

Photo 10, N. Boundary
