Inspection/Audit Photos

Location: CHEVRON USA INC SKINNER RIDGE-66S98W/12NWSW (SKINNER RIDGE #698-12-1)

Location ID: 324306

Date: 02/4/2025

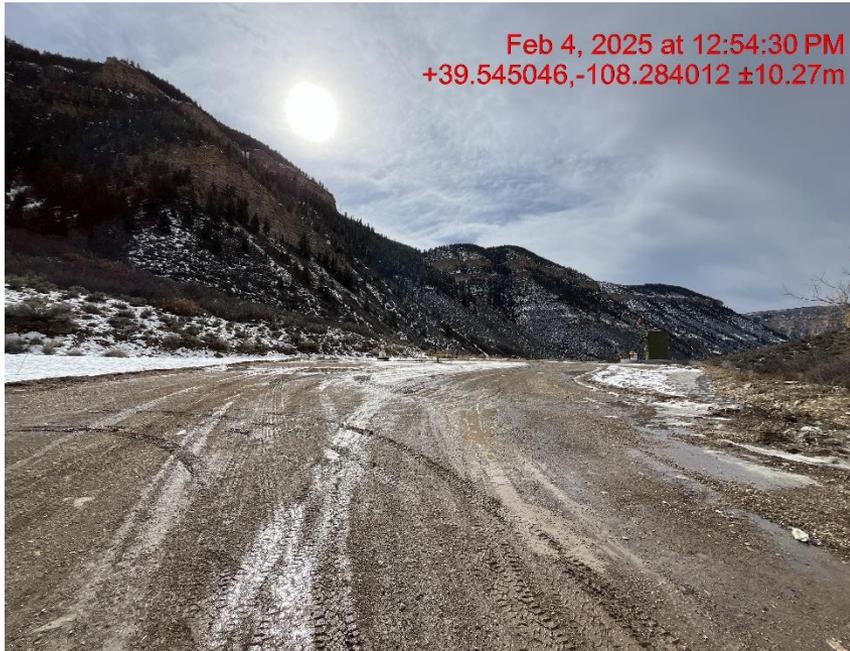
Photo # 4088 Entrance to location

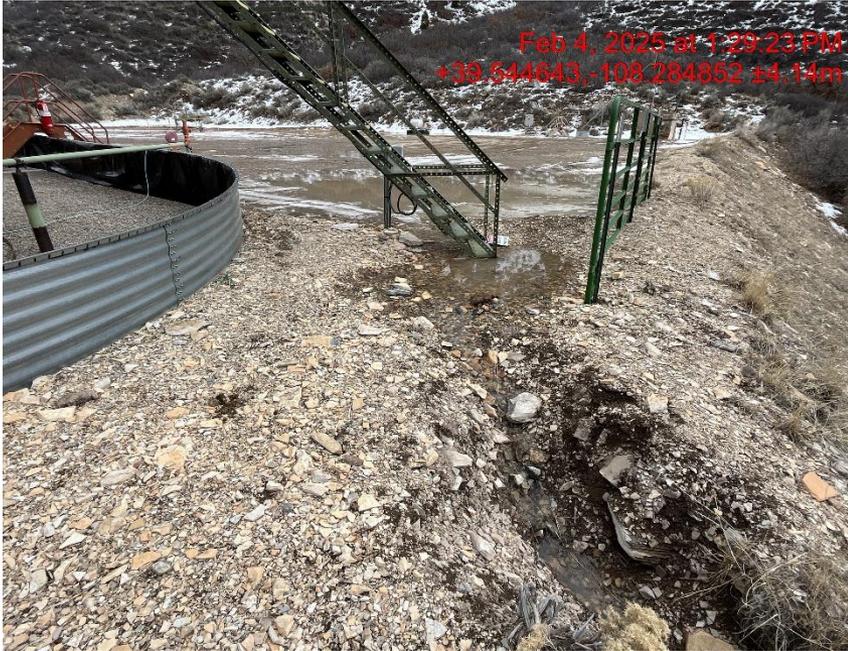
Photo # 4114 Failure to minimize erosion & transport of sediment off location/insufficient BMP's

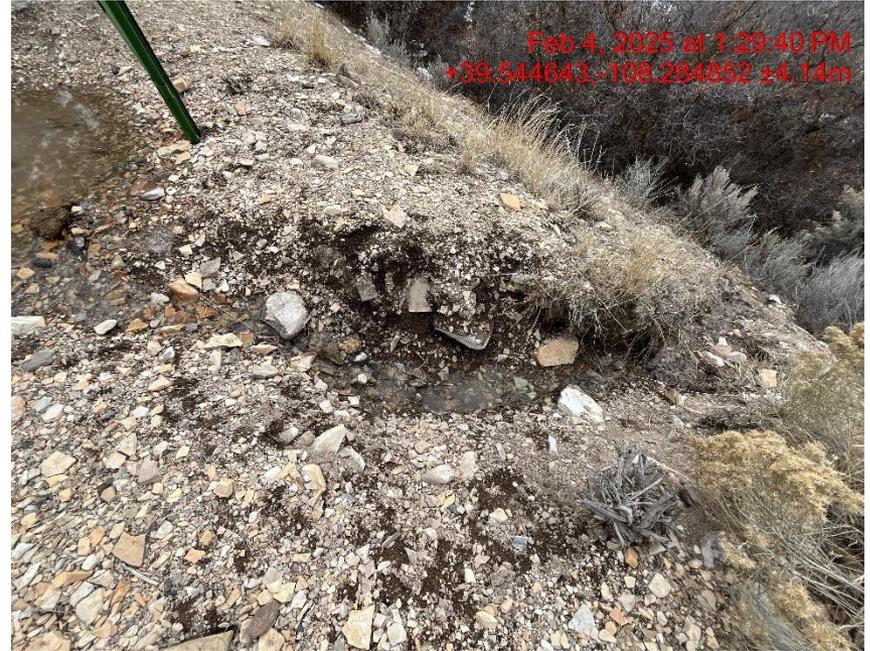
Photo # 4115 Failure to minimize erosion & transport of sediment off location/insufficient BMP's

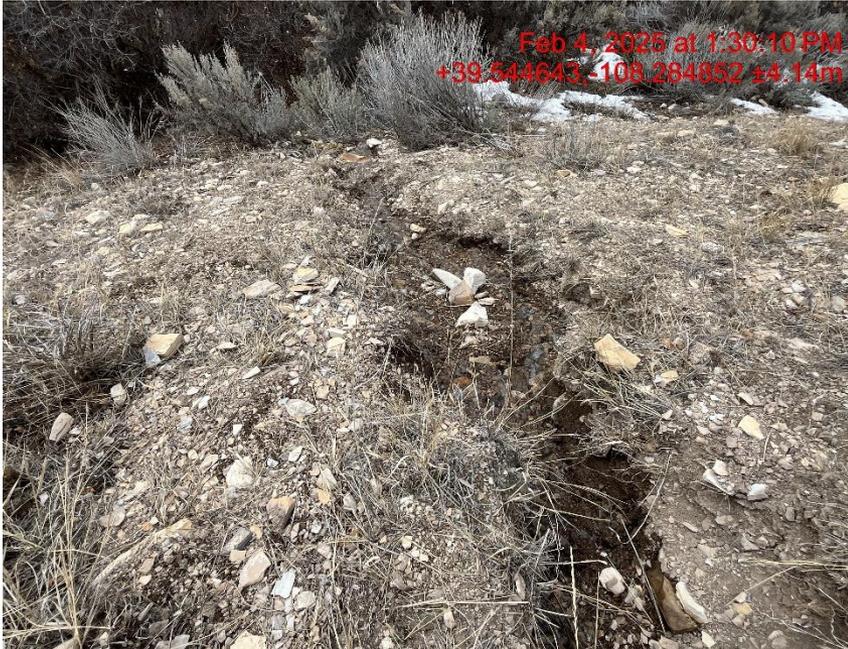
Photo # 4117 Failure to minimize erosion & transport of sediment off location/insufficient BMP's

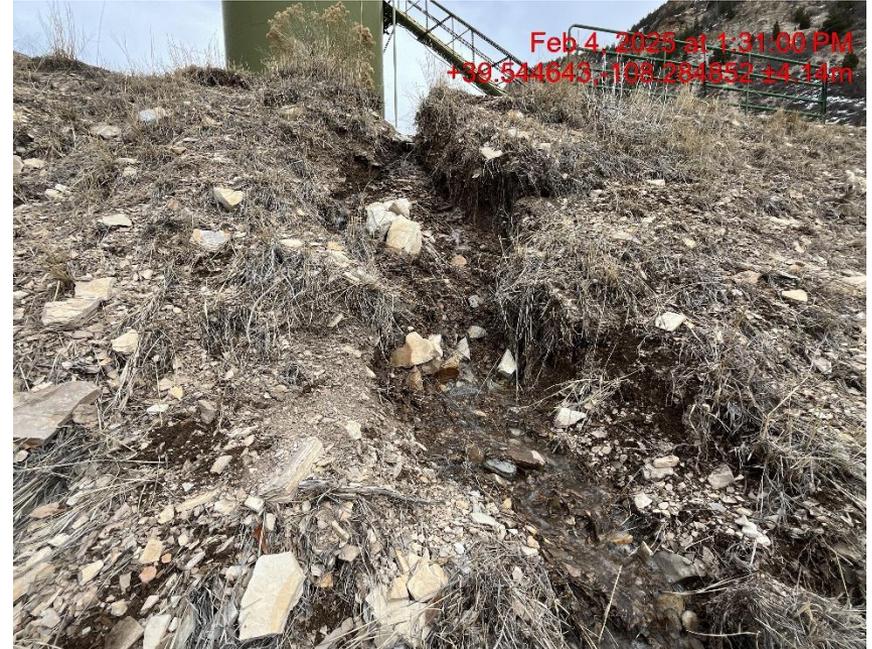
Photo # 4119 Failure to minimize erosion & transport of sediment off location/insufficient BMP's
