## Inspection/Audit Photos

Location: QB ENERGY P6-11-36 (MESA 20 PAD)

Location ID: 418691

Date: 02/5/2025

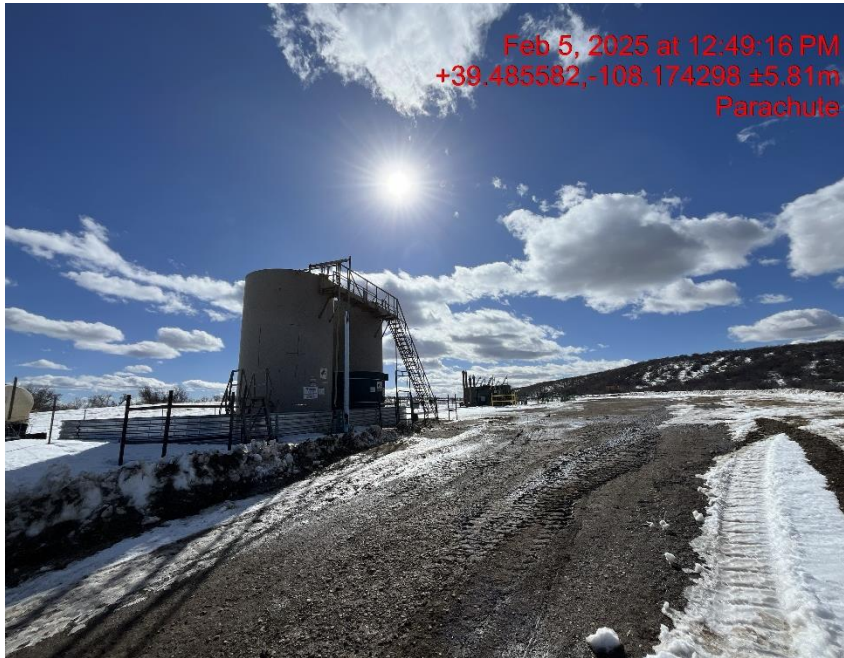
Photo # 4185 Entrance to location

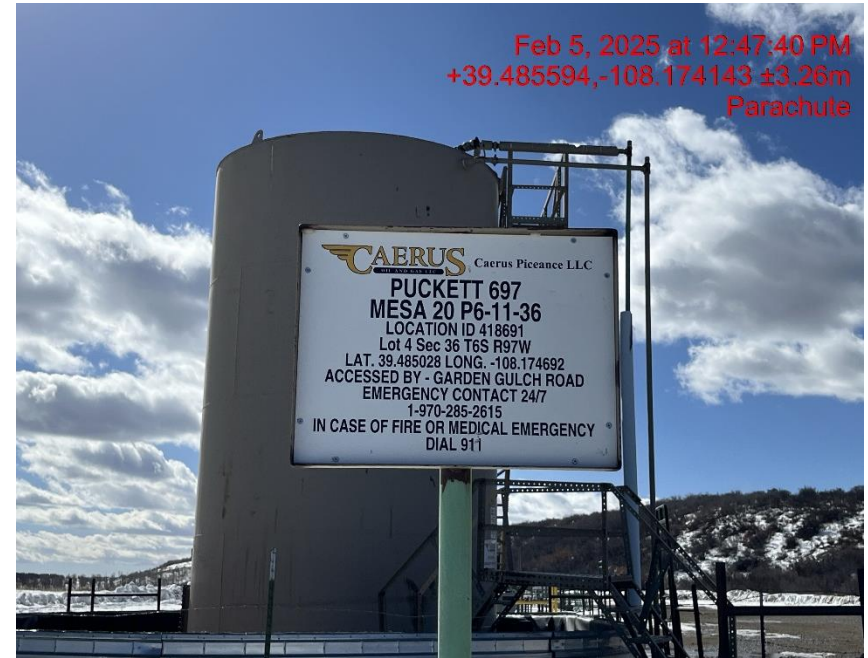
Photo # 4184 Location

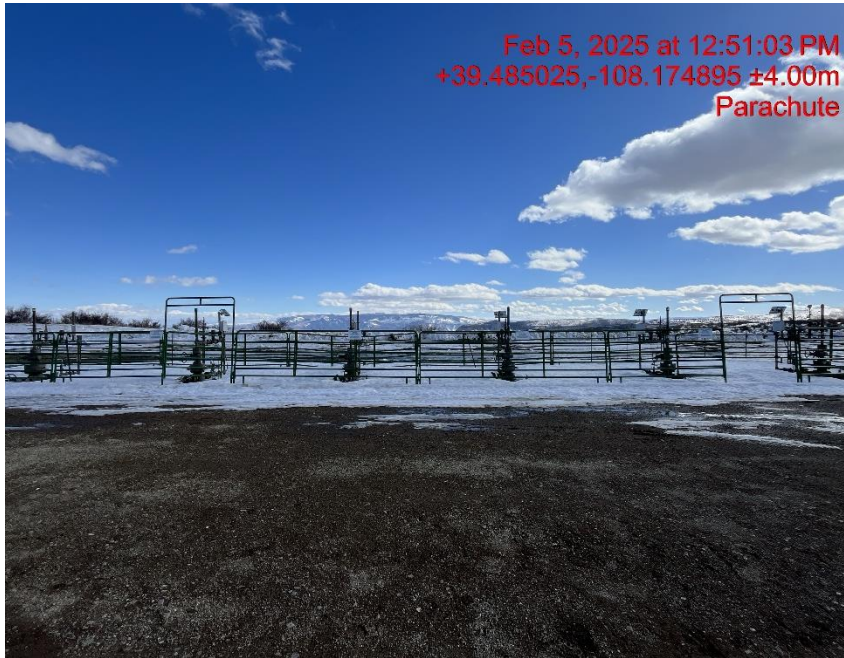
Photo # 4186 Location

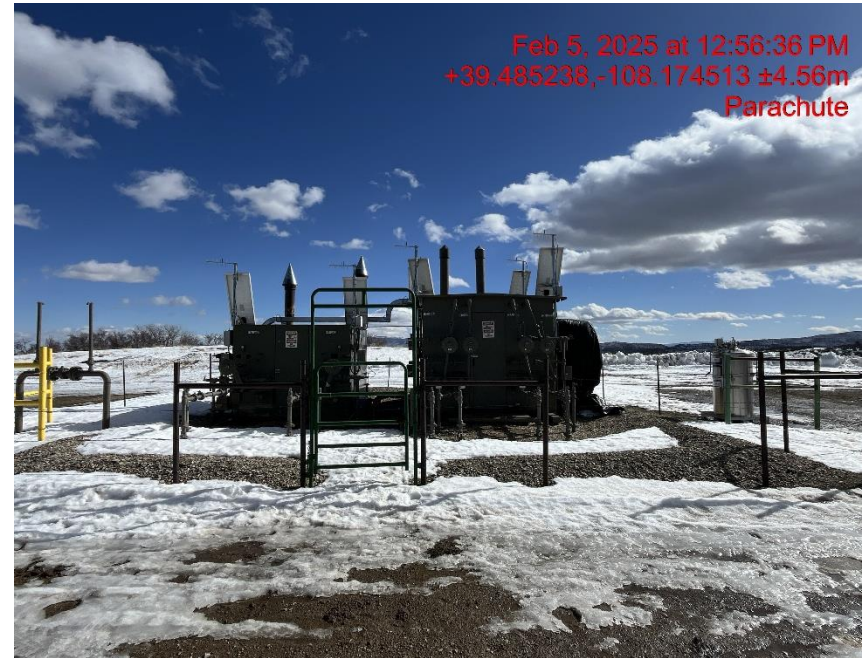
Photo # 4193 Location

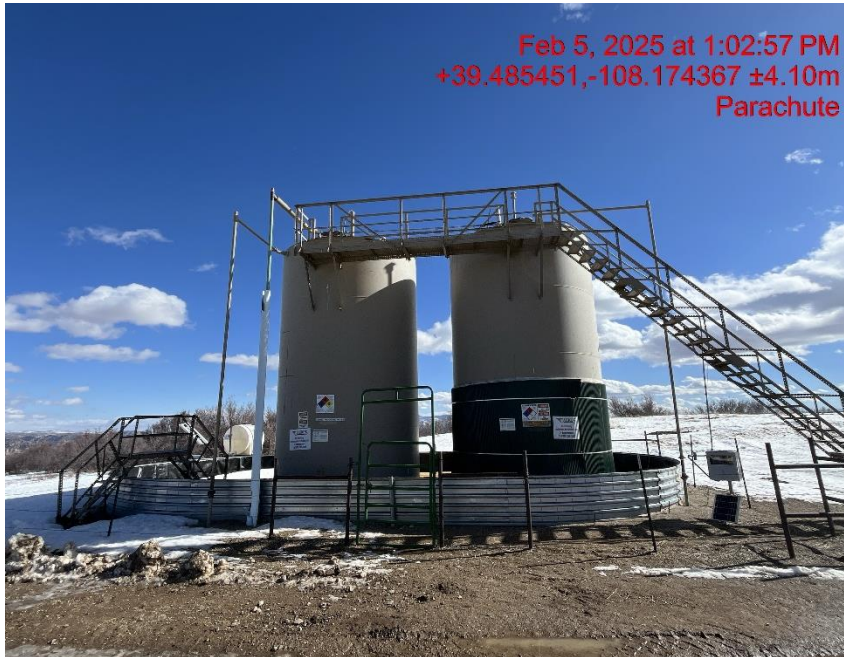
Photo # 4201 No tank battery signage

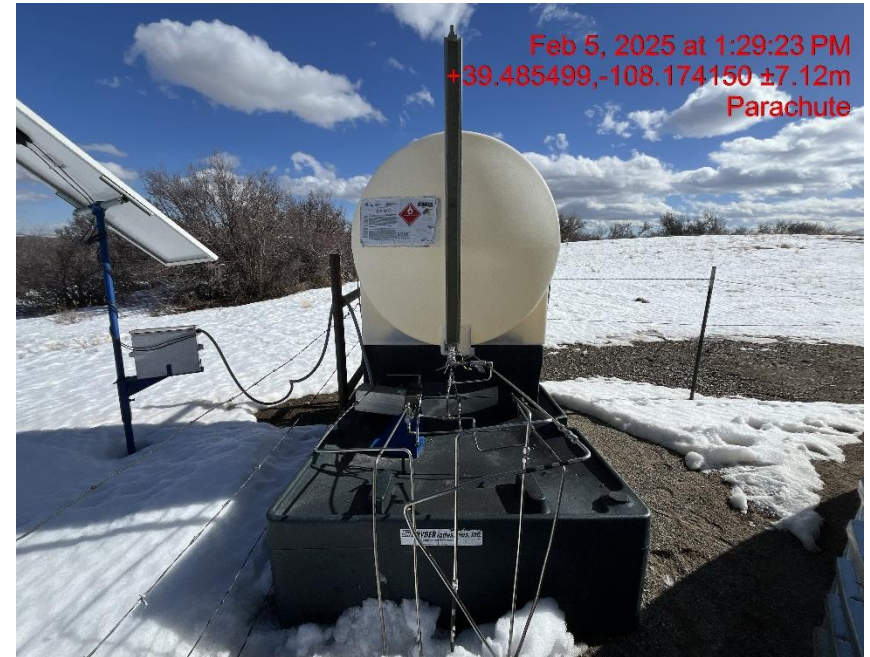
Photo # 4218 Location

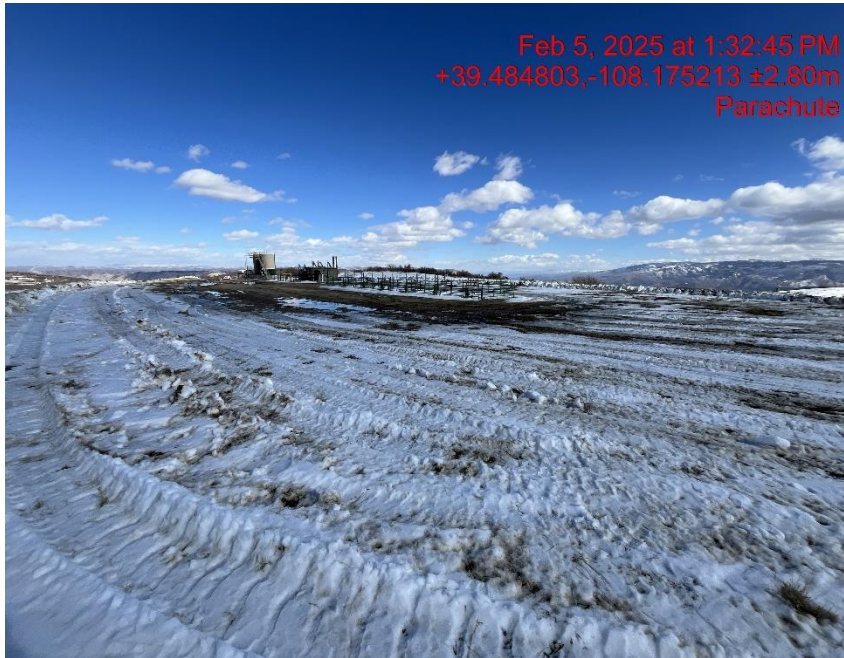
Photo # 4219 NW corner of location

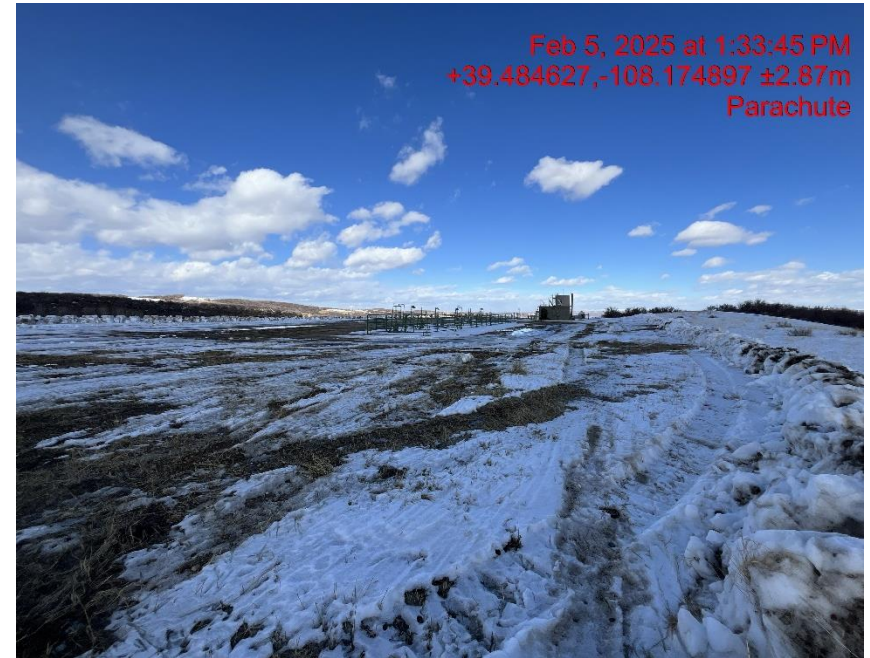
Photo # 4220 SW corner of location

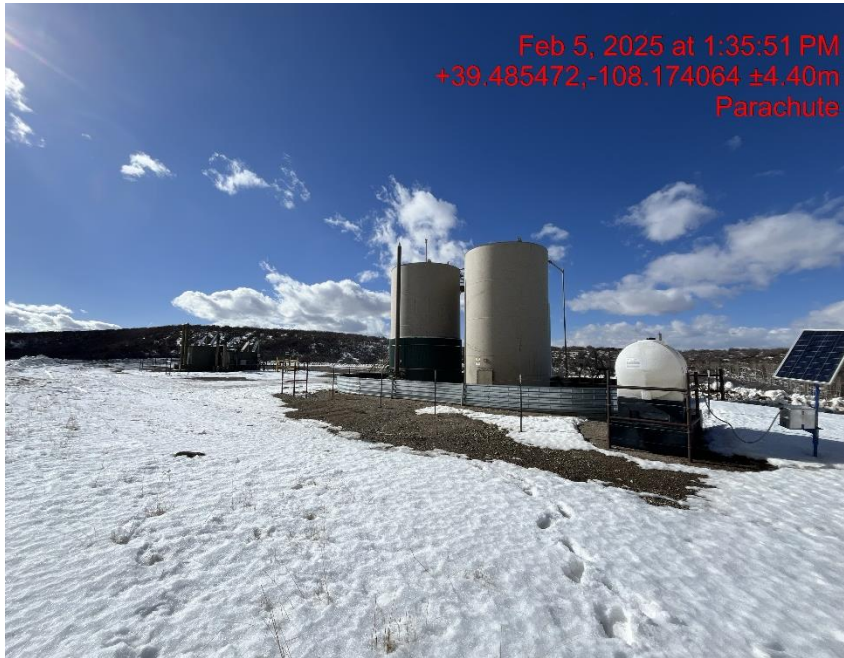
Photo # 4221 SE corner of location

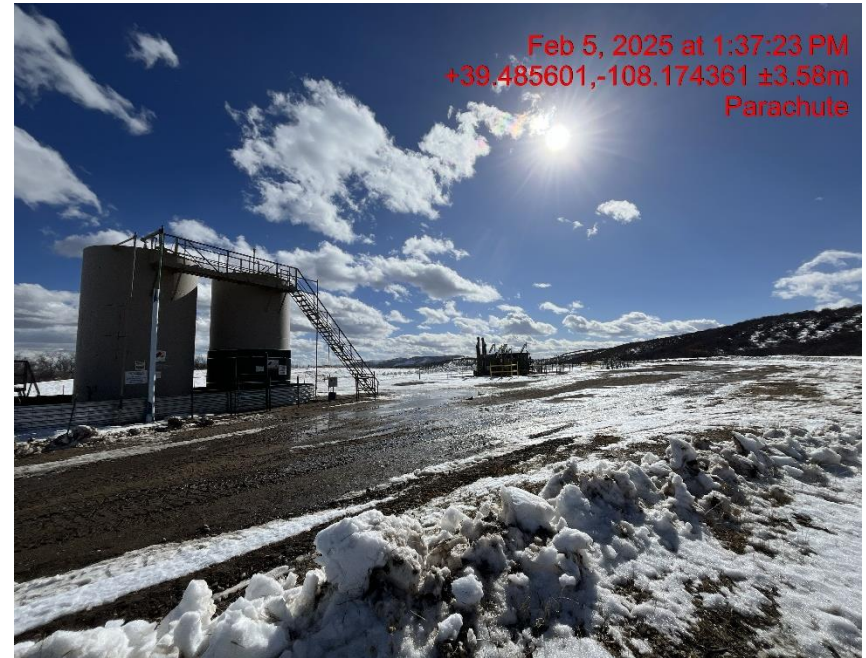
Photo # 4223 NE corner of location

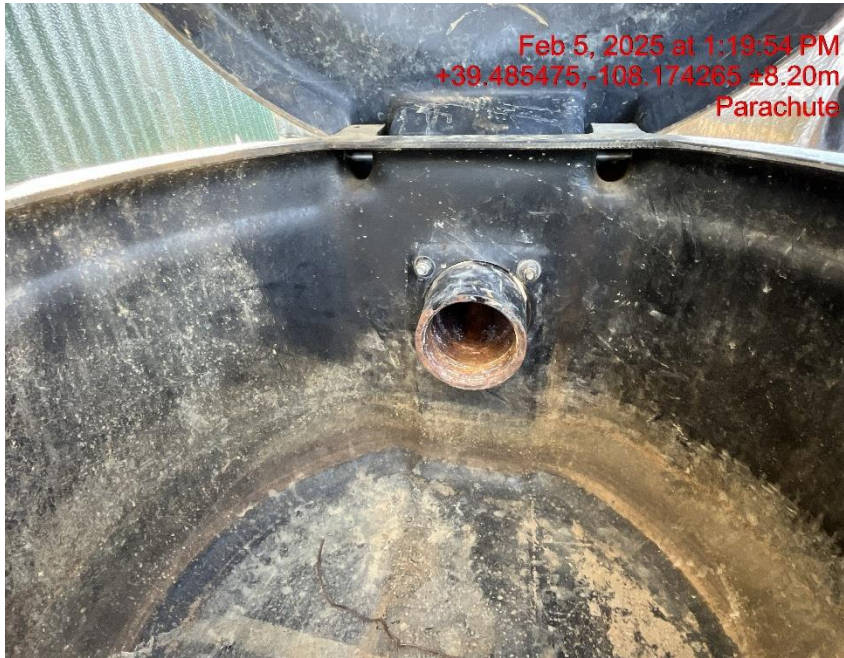
Photo # 4208 Open ended load line

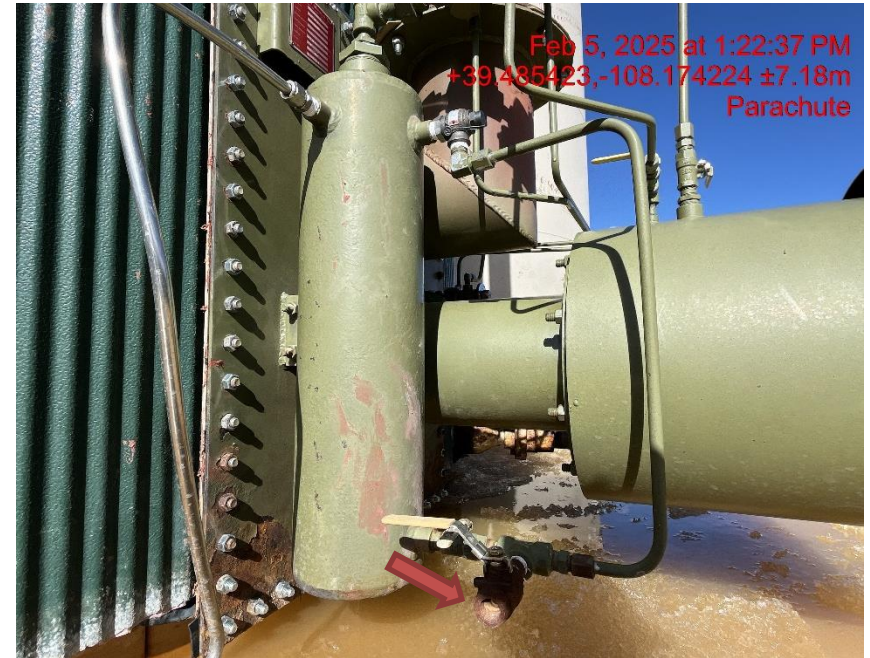
Photo # 4211 PRV vent line on tank heater does not comply with CECMC pressure safety device rules
