Inspection/Audit Photos

Location Name: TEP ROCKY MOUNTAIN LLC SNYDER A Pad

Location ID: 311651

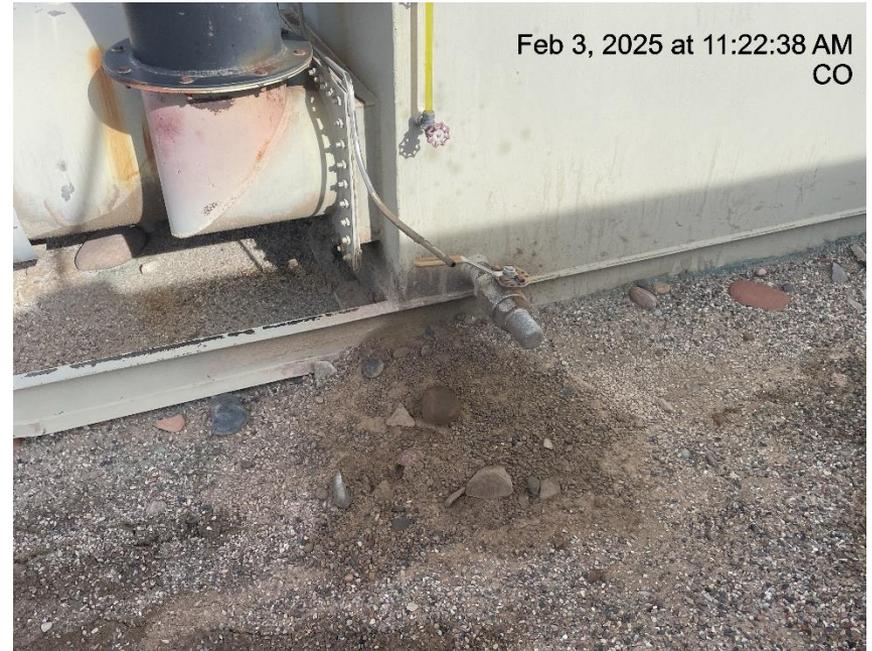
Photo # 3008 Staining near separator

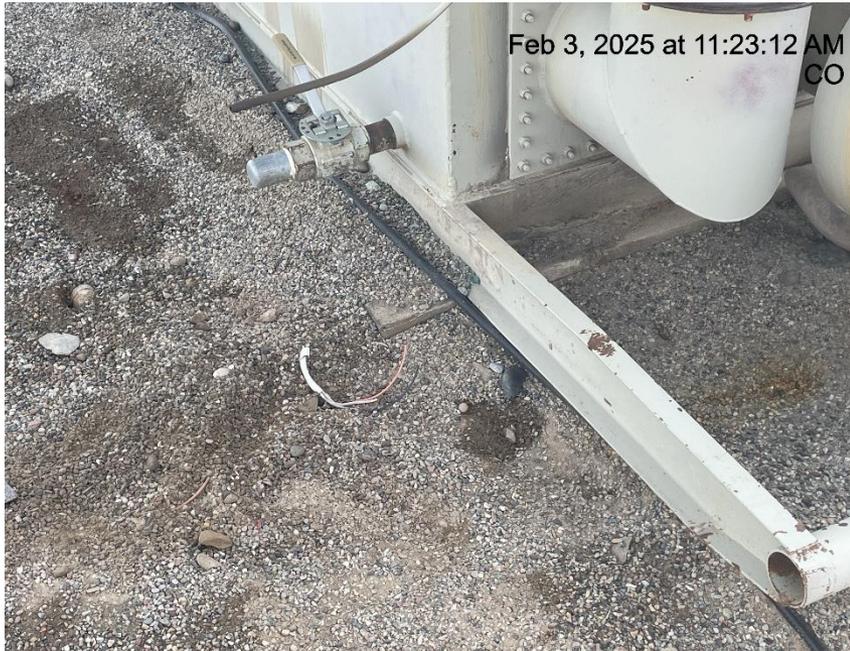
Photo # 3009 Staining near separator

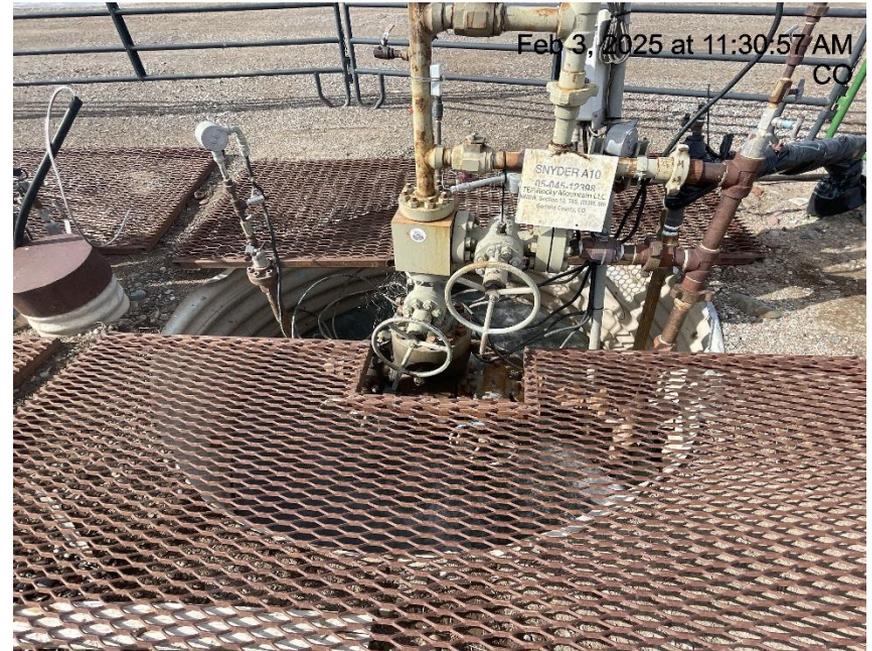
Photo # 3010 SNYDER A10 cellar lacks wildlife egress

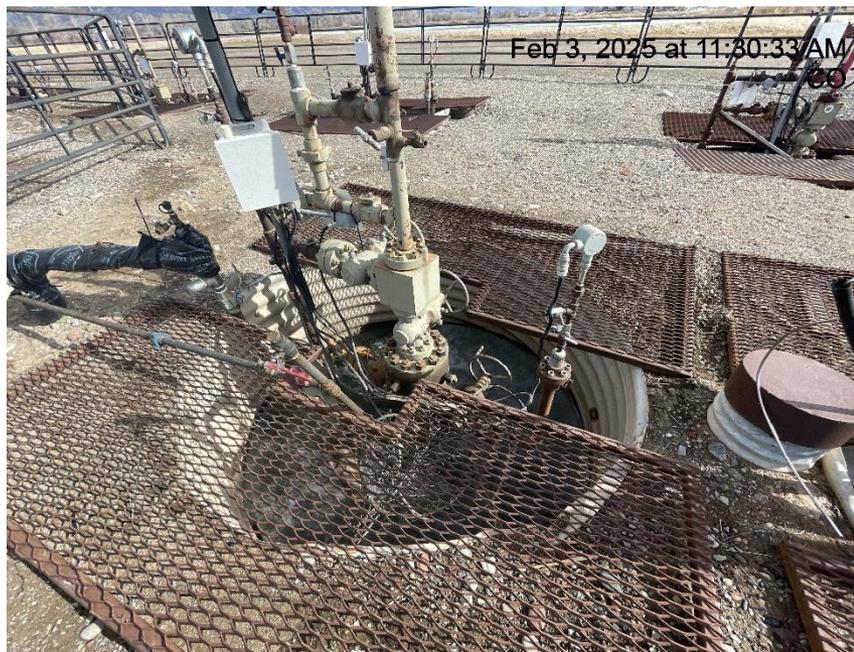
Photo # 3011 SNYDER A10 cellar lacks wildlife egress
