GM 31-17: Rilling at Entrance to Pad Has Been Graded and Bar Ditch Installed on North Side of Entrance

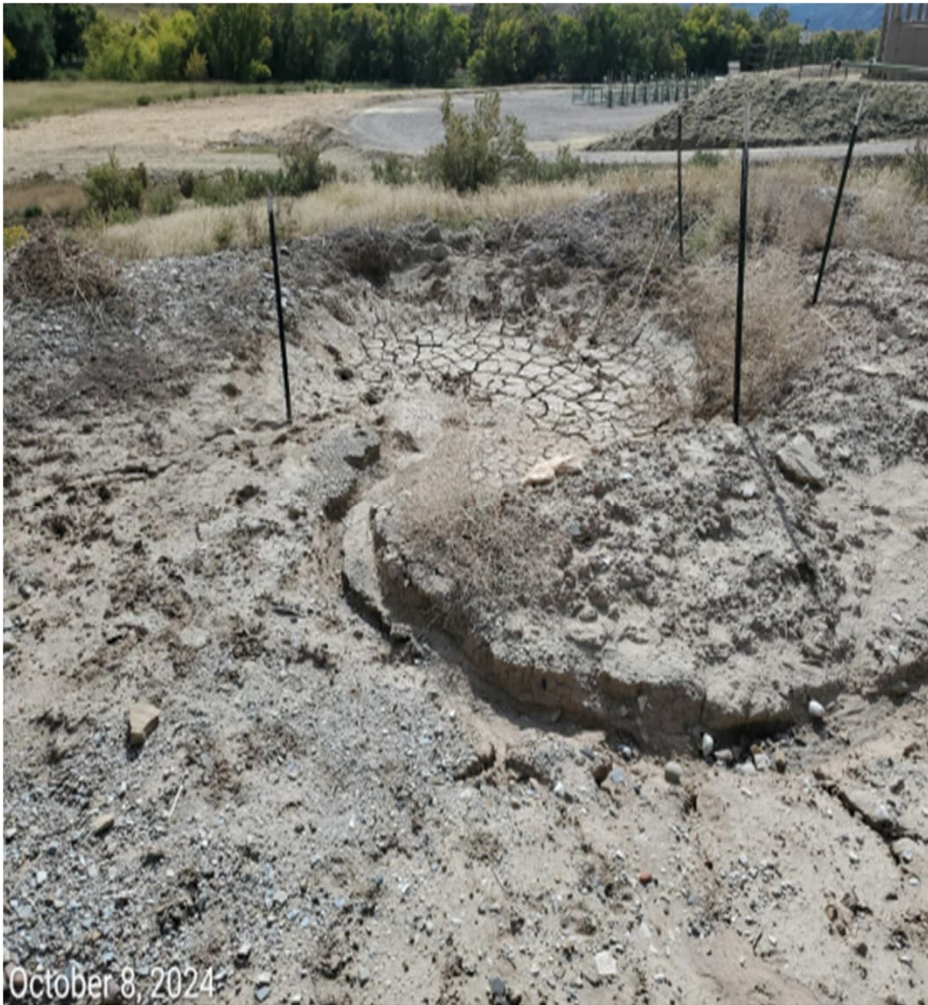
Before

GM 31-17: Sediment Basin on SE Edge of Location Has Been Cleaned Out; Rock Protection Added to All Inlets and Outlets

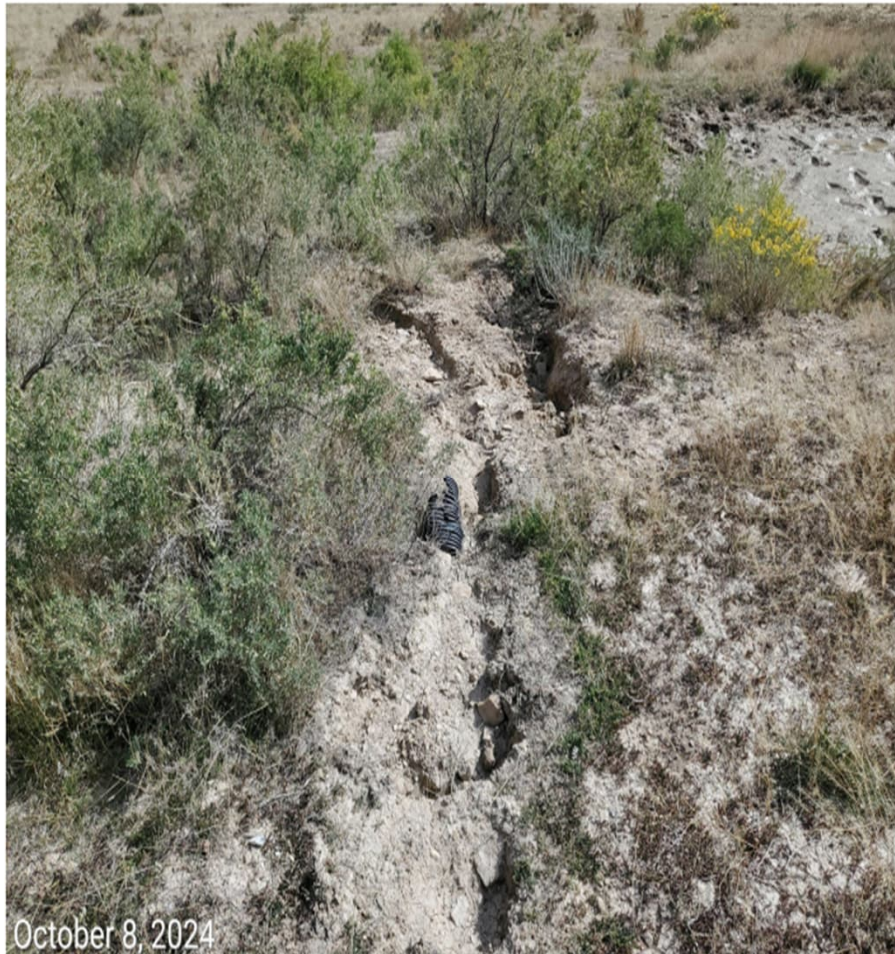
Before

GM 31-17: Rock Protection Added to Rills Below Sediment Basin in SE Corner of Location. Note 3 Additional Sediment Traps Below

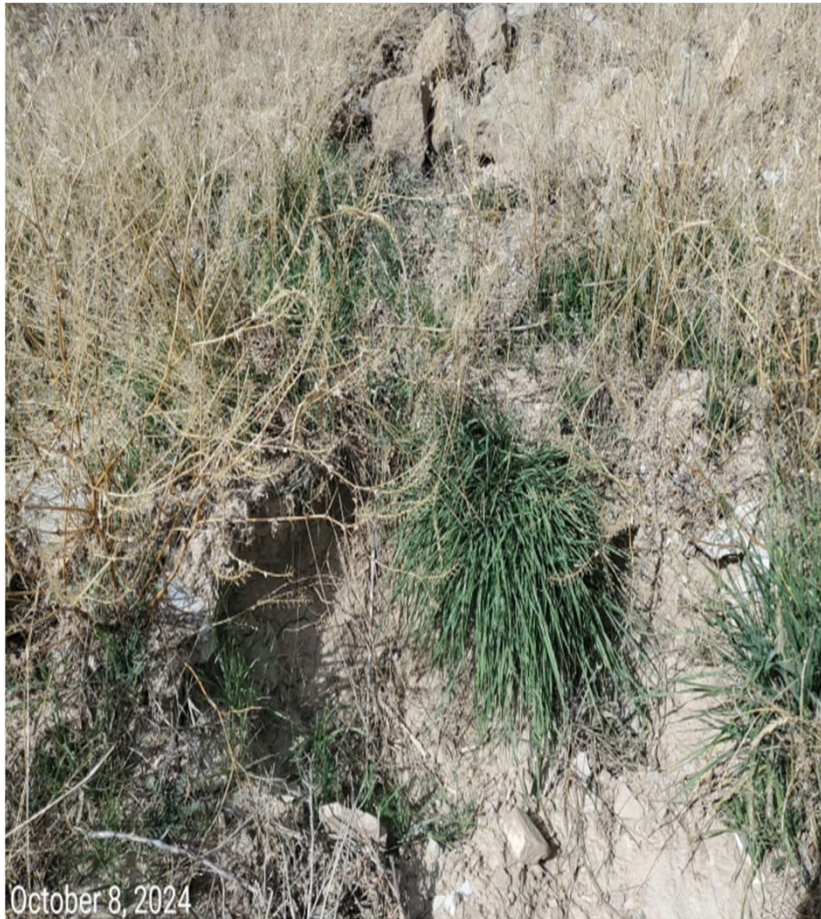
Before

GM 31-17: Outlet of Sediment Trap on SE Edge of Location Has Been Repaired and Protected with Rock Armor

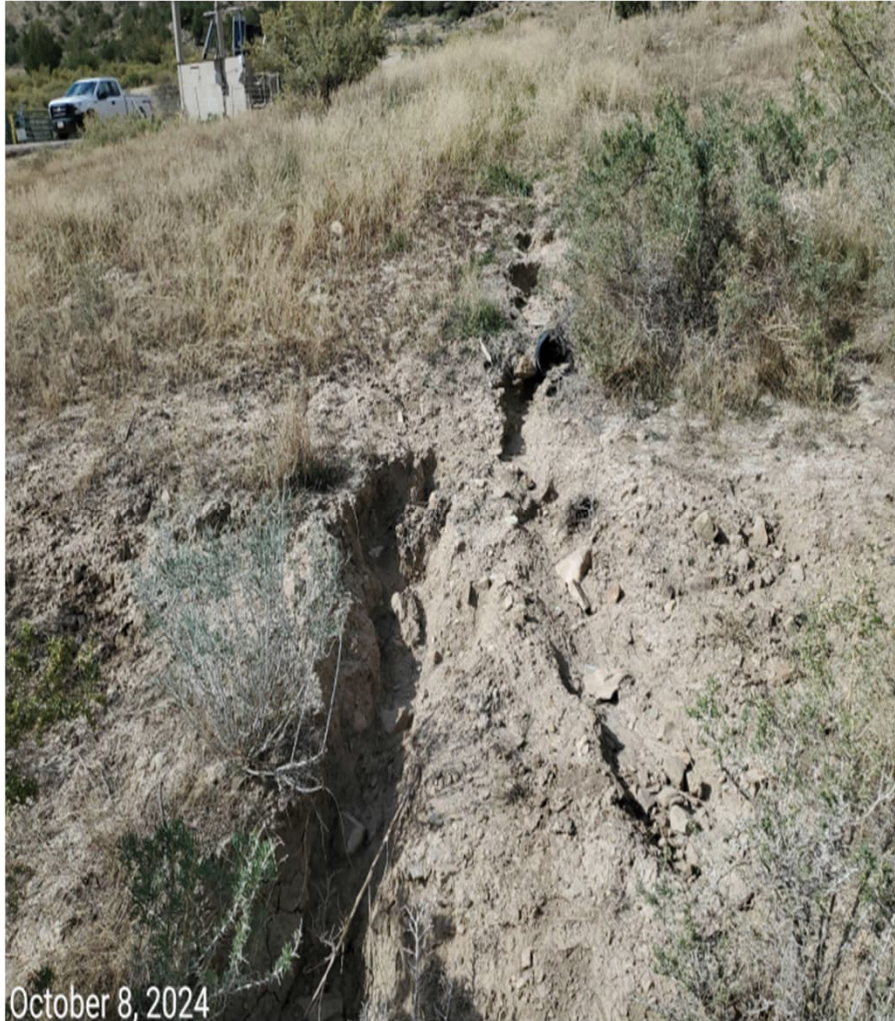
Before

GM 31-17: Rills and Gully Erosion Repaired. Note Series of Rock Check Dams and Rock Outlets Installed Above and Below Sediment Basin

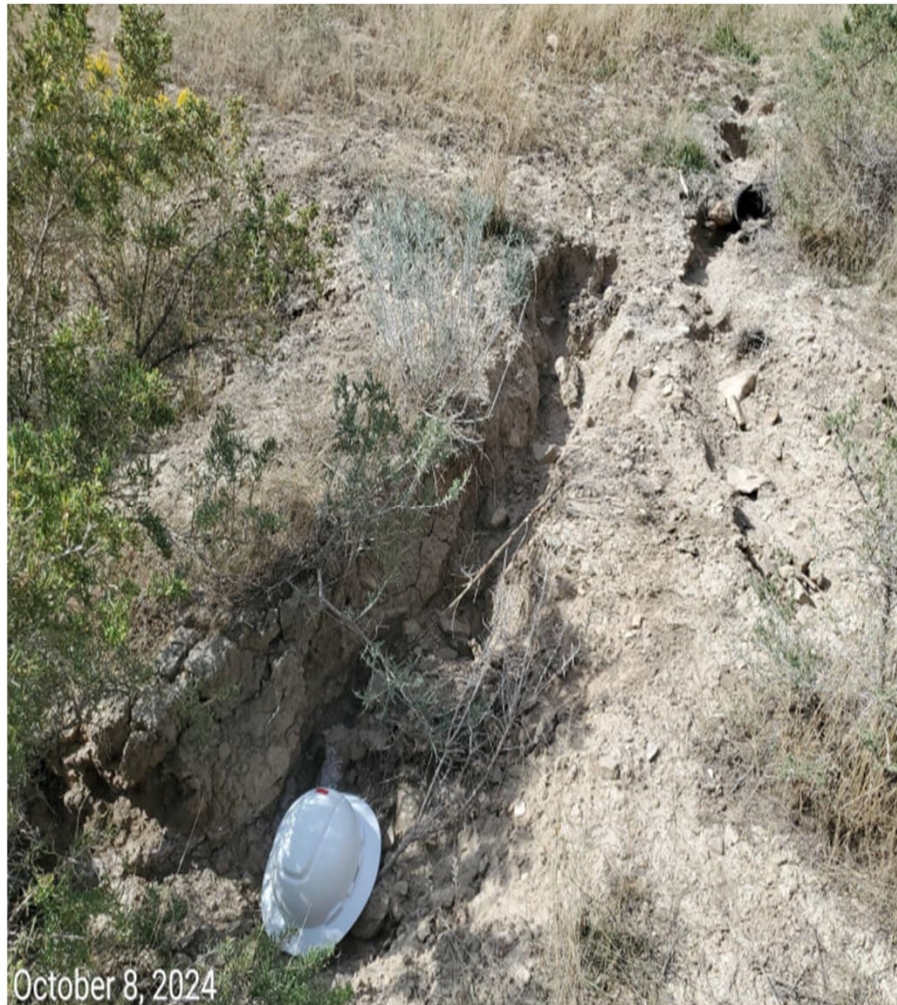
Before

GM 31-17: Rill Erosion on Interim Reclaim Area in SE Portion of Pad Has Been Repaired.

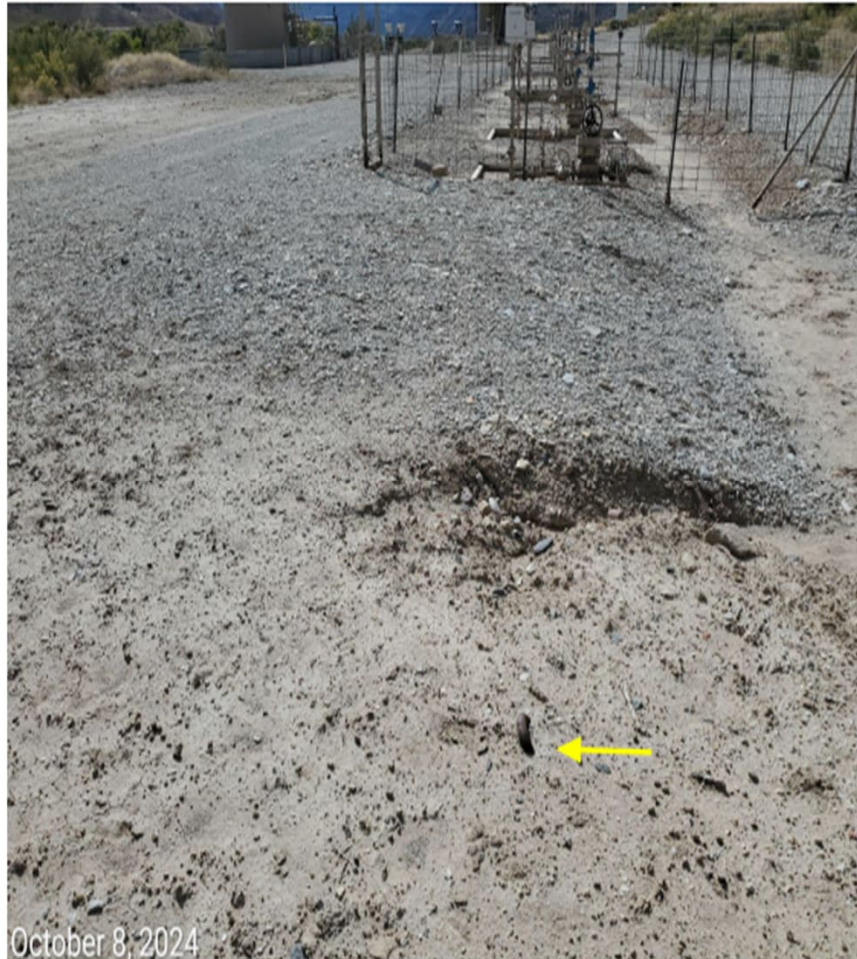
Before

GM 31-17: Unmarked Anchor Has Been Removed

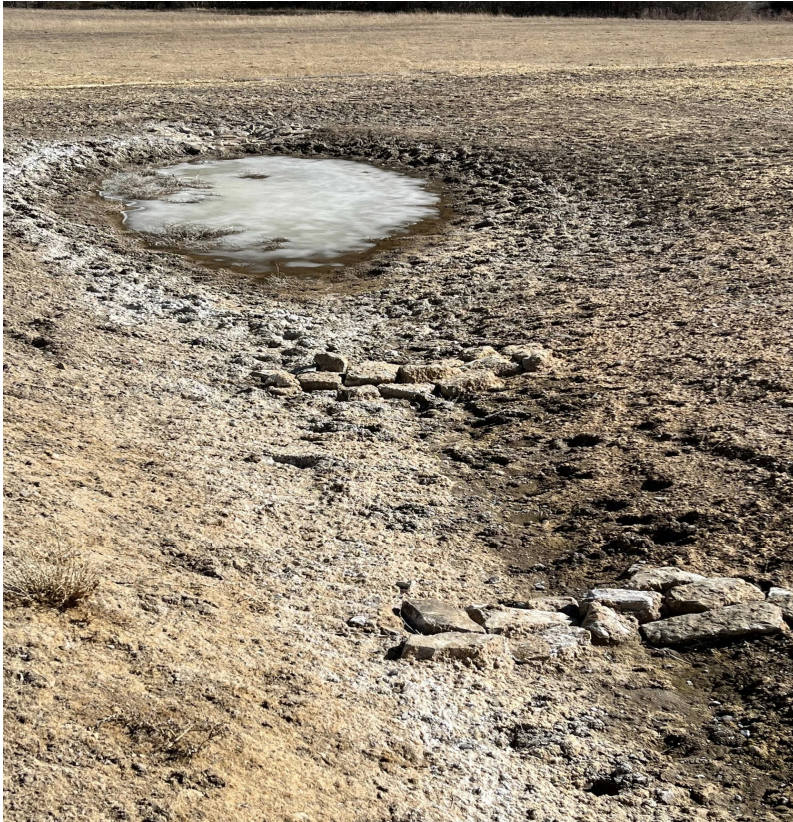
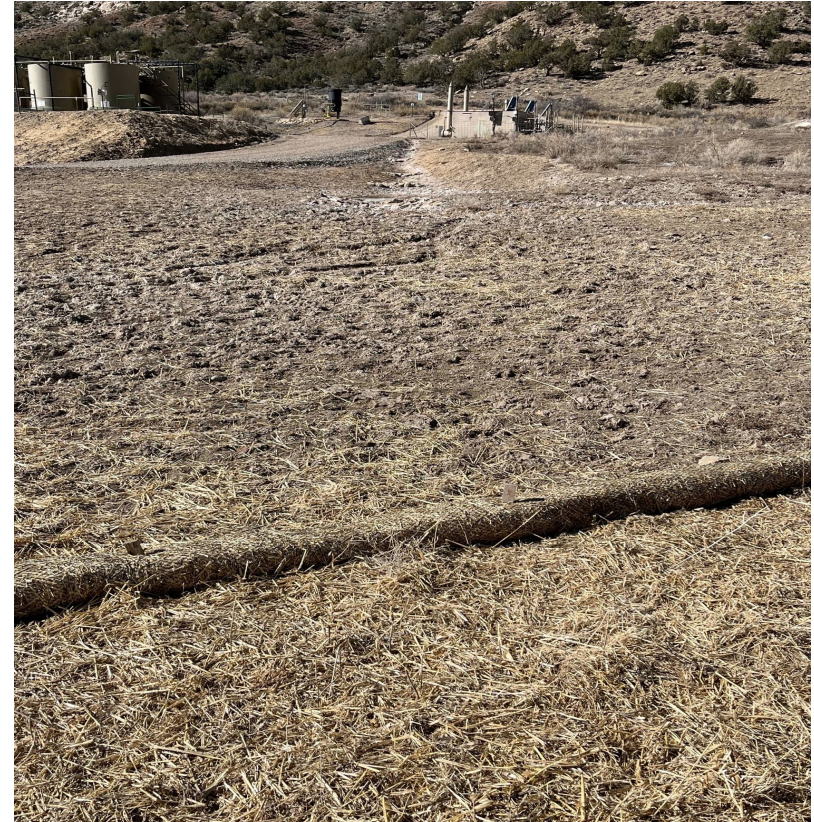
GM 31-17: Multiple Layers of BMPs Below SE Corner of Pad. Rock Check Dams, Hydro Seed & Mulch, Straw Wattles, Multiple Sediment Traps, Rock Protection on Inlets / Outlets, Vegetative Buffer
