# Inspection Photos

Loc: 484357

Operator: DESERT EAGLE OPERATING LLC

Inspection Date: 2/10/2025

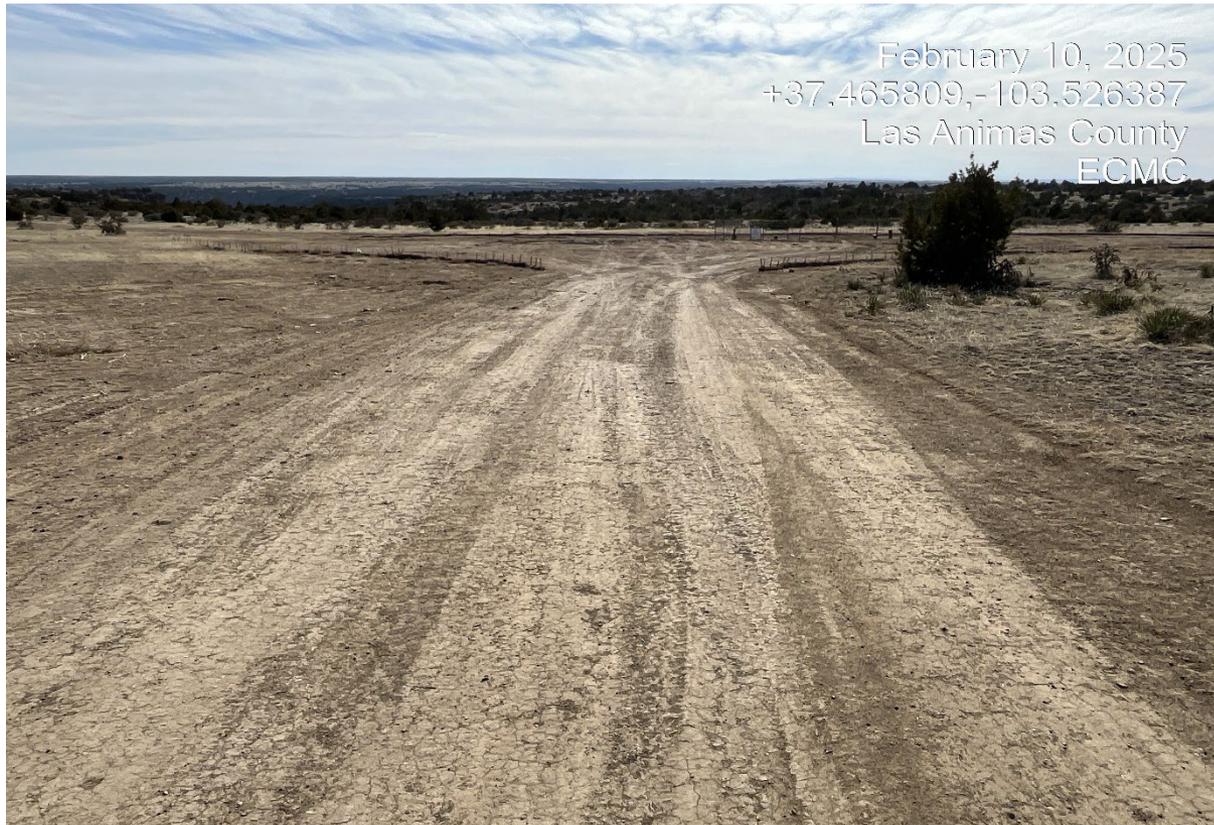
**Photo 1.** Facing south toward the access road and location.

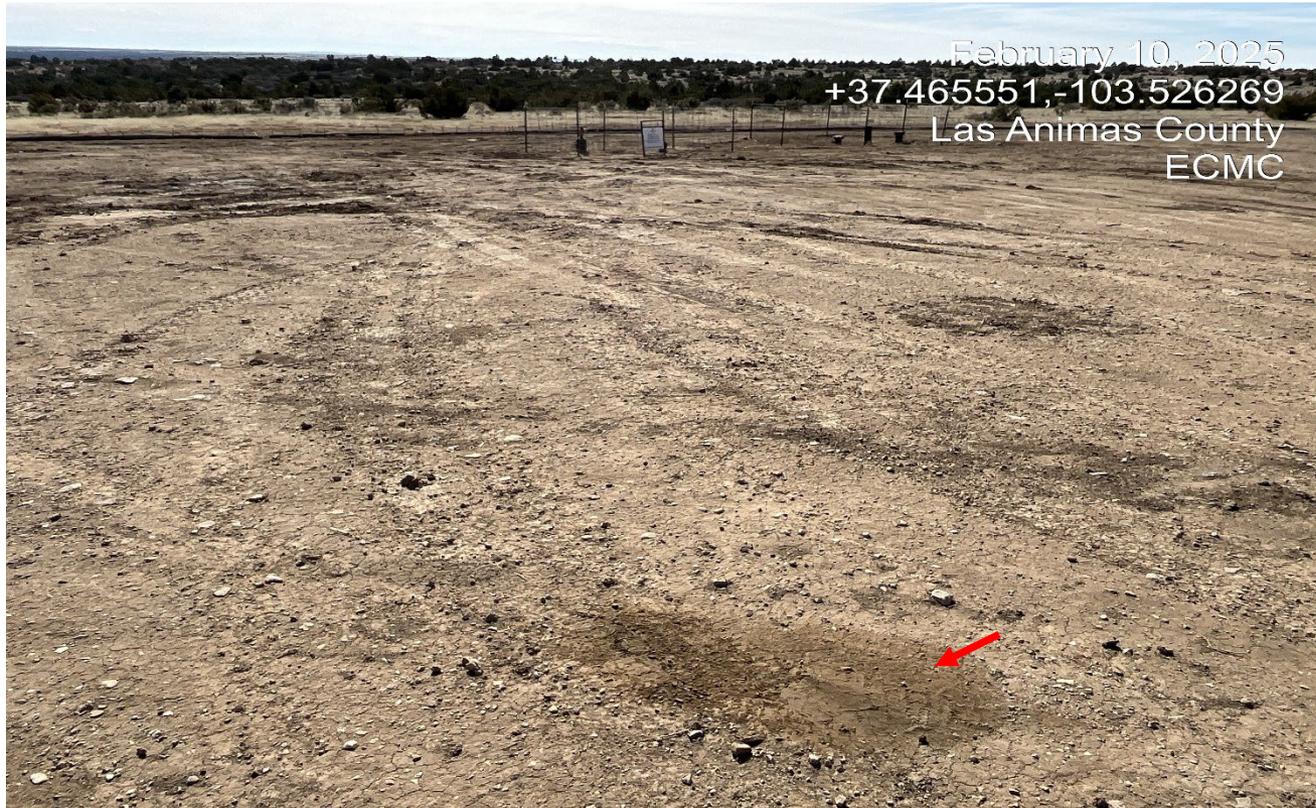
**Photo 2.** Facing southwest toward the wellsite. There is oil stained at red arrow that needs to be cleaned up.

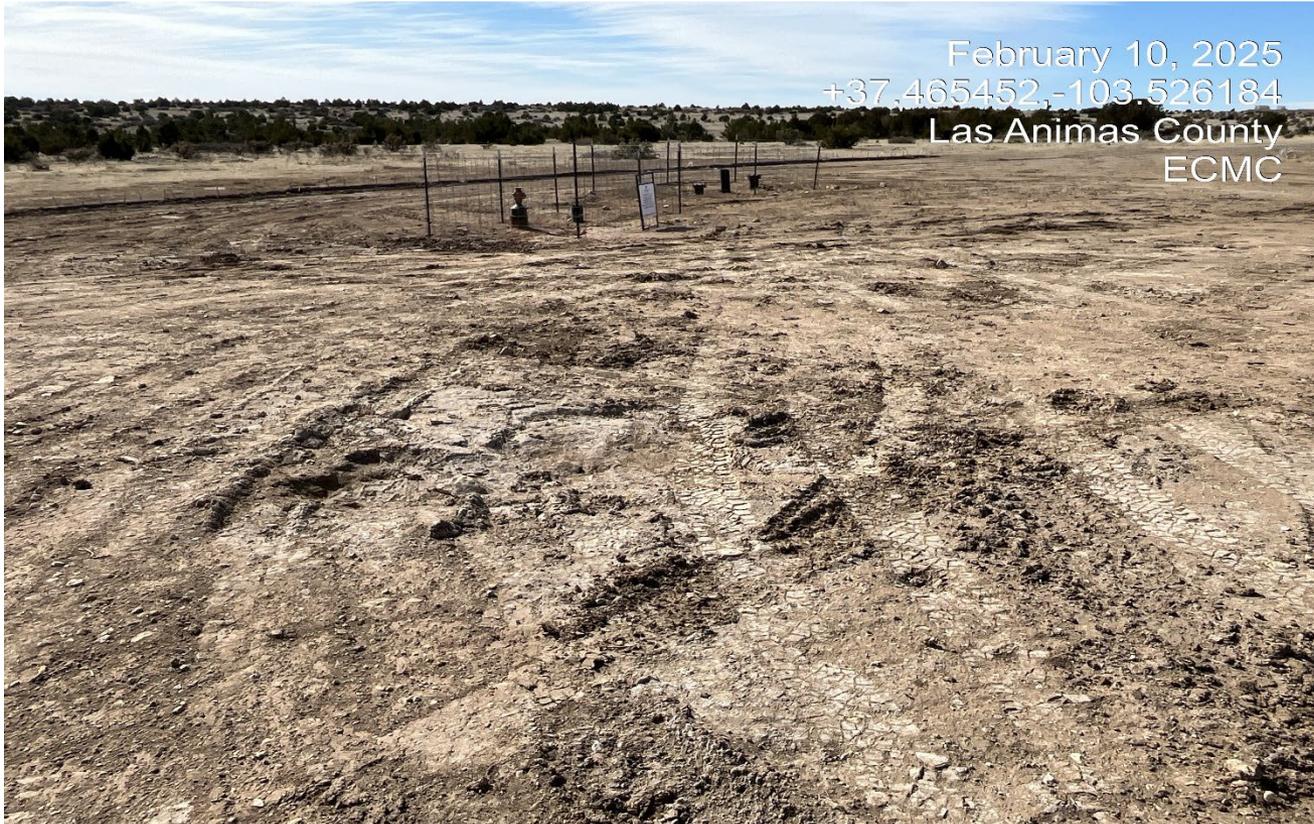
**Photo 3.** Facing southwest closer to the well where drill cuttings were previously spilled. There is still white stains in this area.

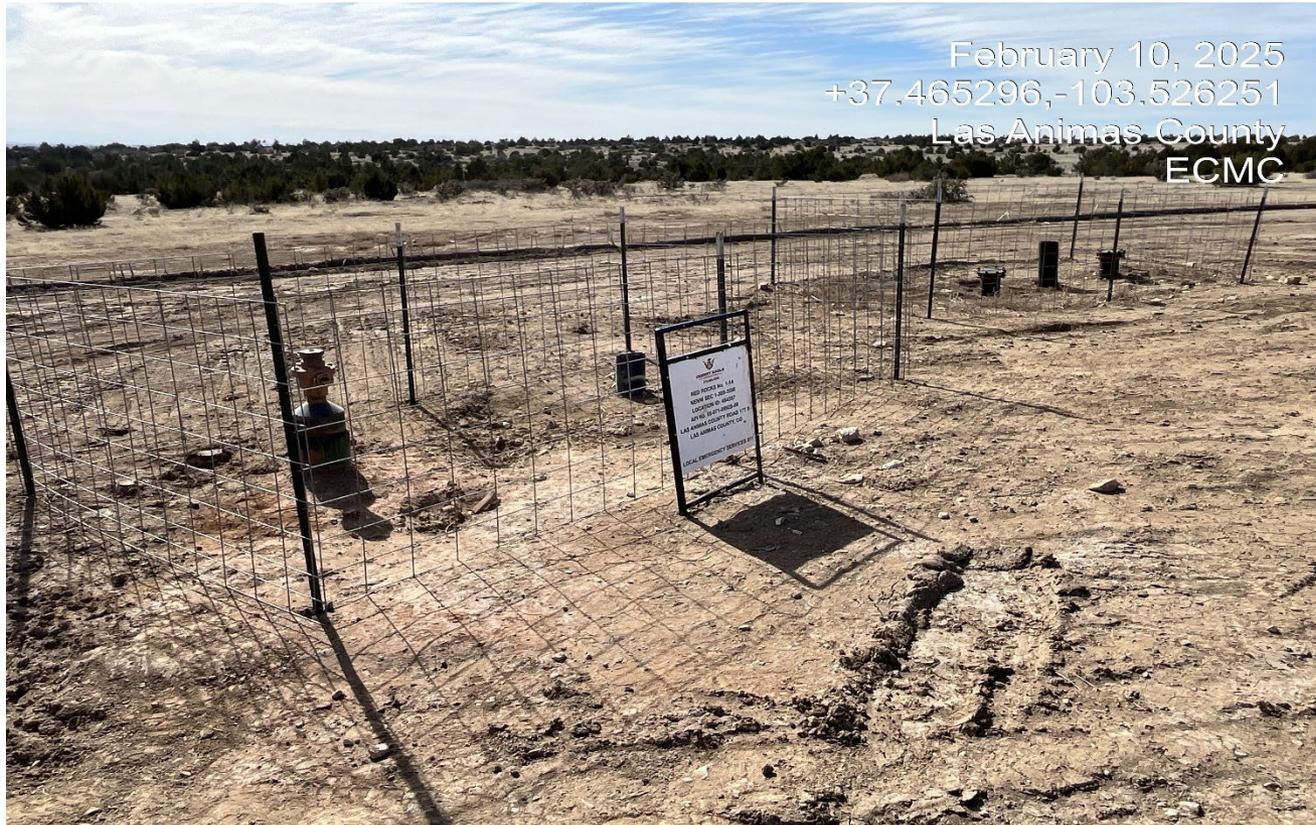
**Photo 4.** Facing at the wellhead. There is red drill cutting still present at the wellhead. Sign and fences have been reinstalled.

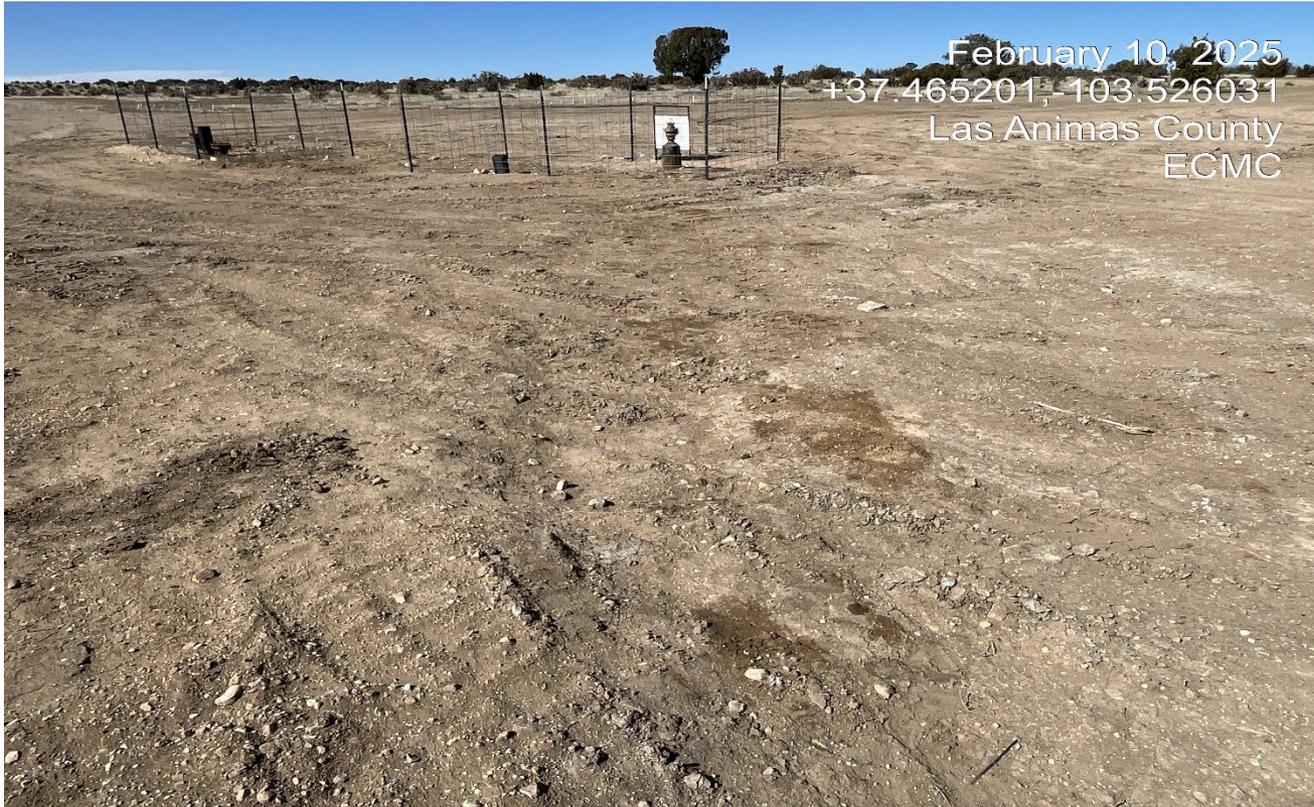
**Photo 5.** Facing northwest at the location. There are stained soils southeast of the wellhead that have not been cleaned up. Previous CA was not completed.

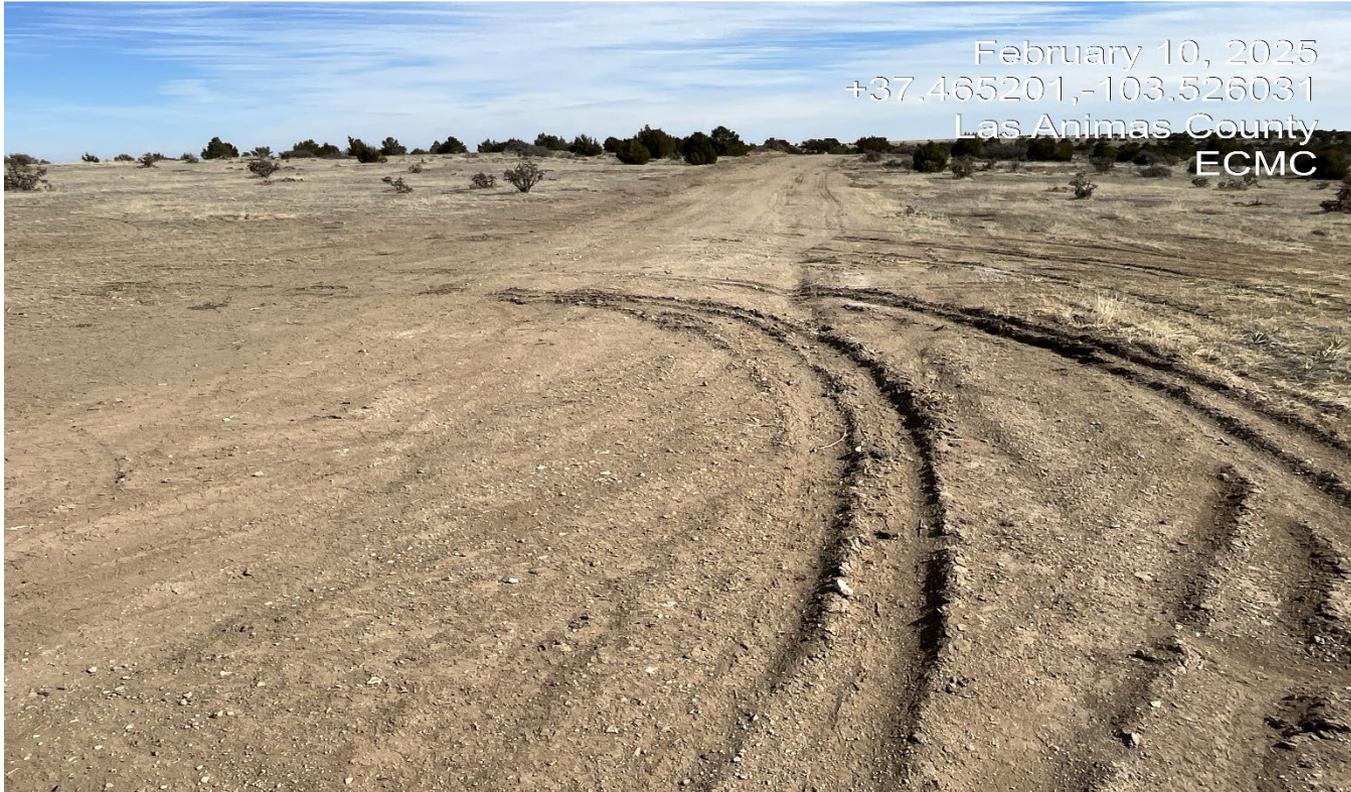
**Photo 6.** Facing east toward the flowline disturbance. The vegetation is not establishing along the flowline and there are vehicle tracks which a causing unnecessary disturbance. The flowline must be reclaimed and stabilized.

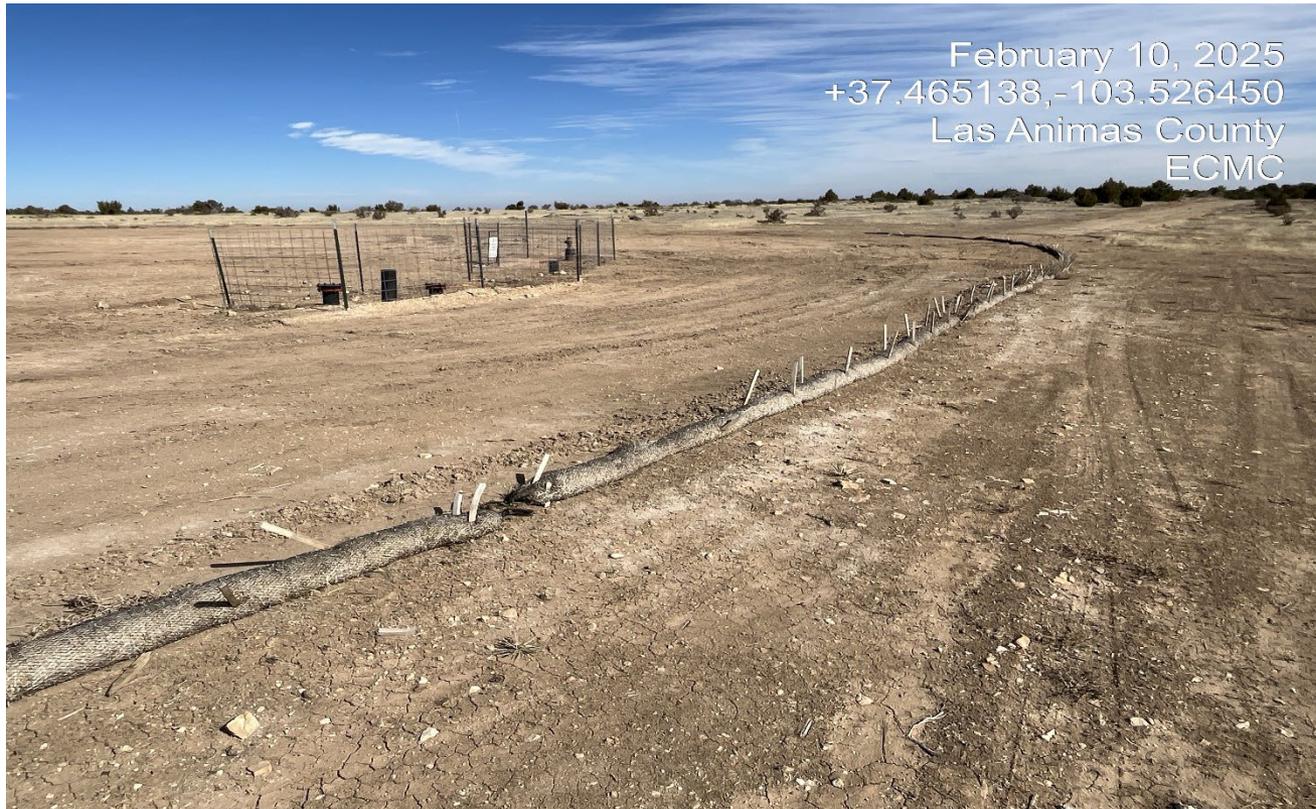
**Photo 7.** Facing northeast at the location. The wattles have been reinstalled at the south side of the location. Disturbed areas will need to be reseeded.

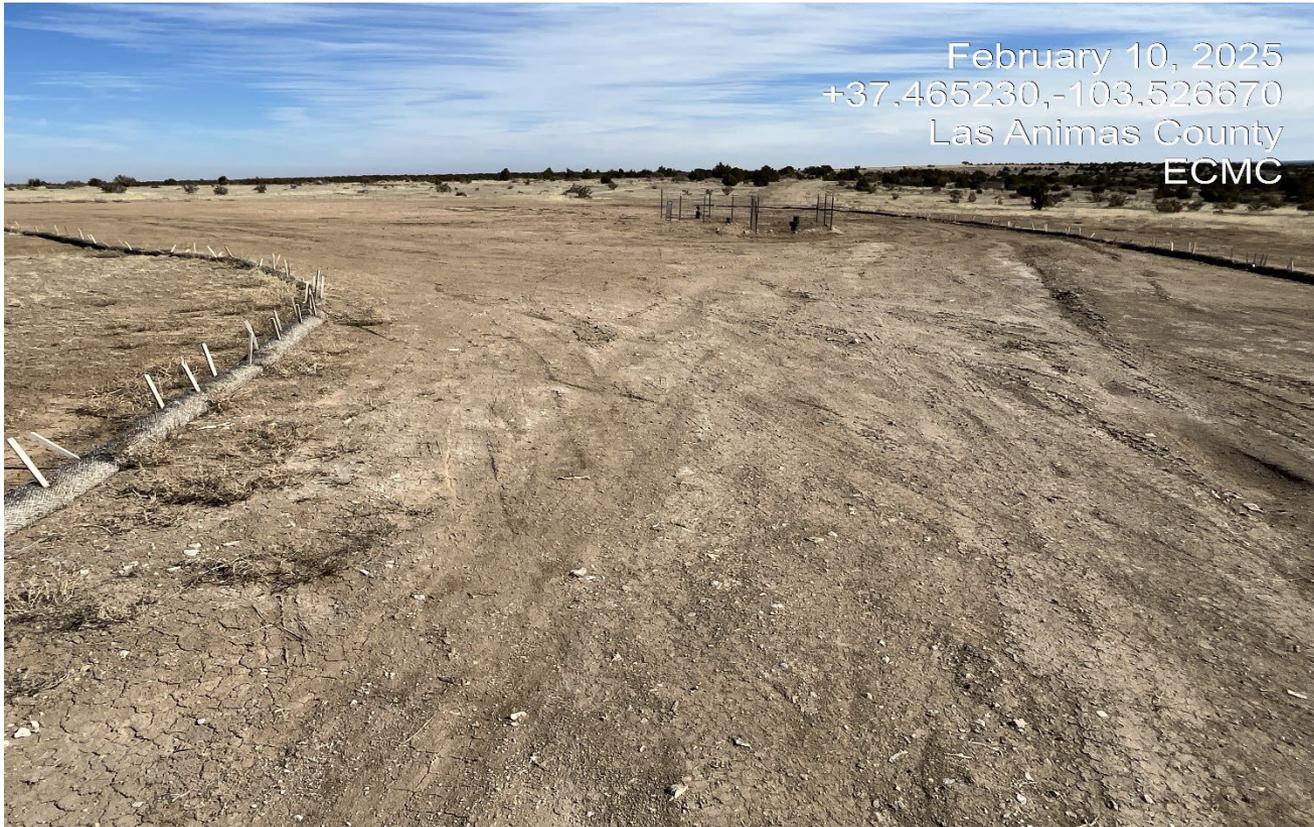
**Photo 8.** Facing northeast at the location. The wattles have been reinstalled at the south side of the location. Disturbed areas will need to be reseeded. Compacted soils must be decompacted by cross ripping to at least 8 inches.

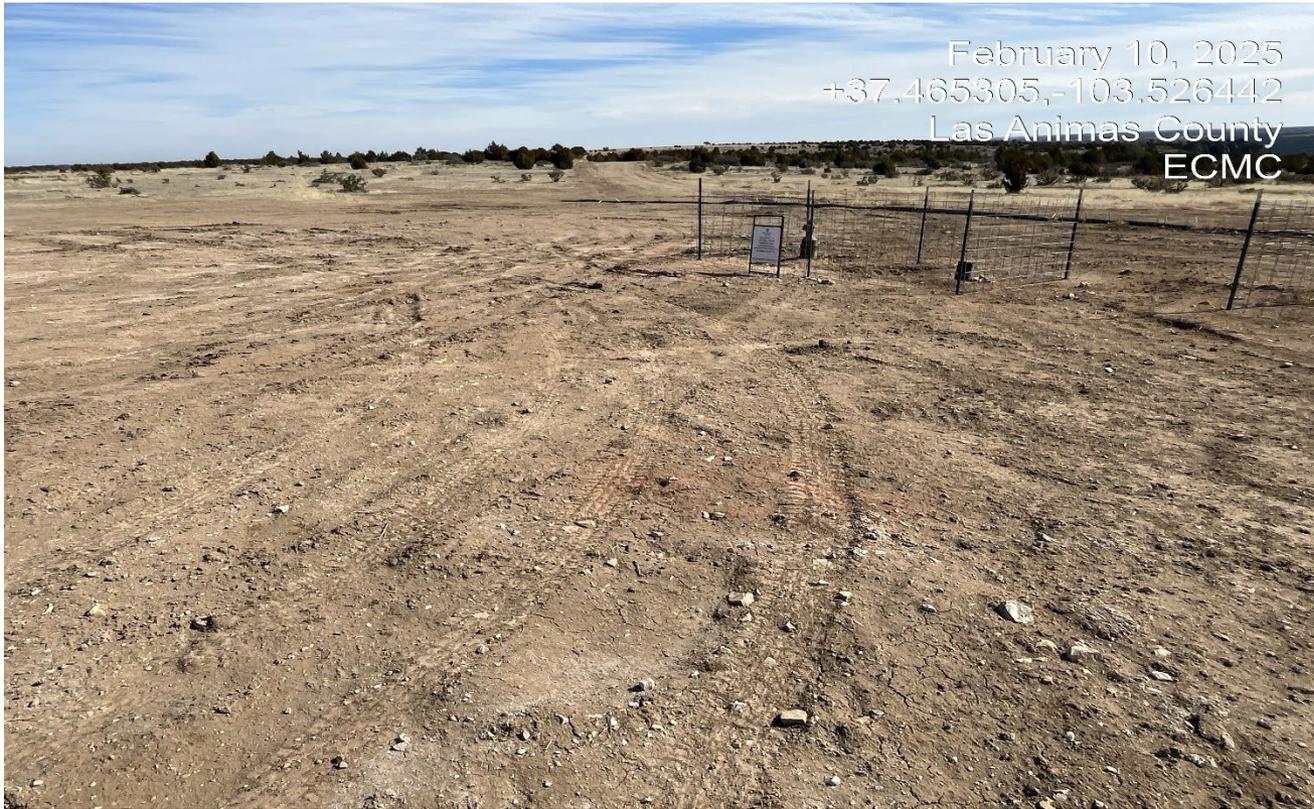
**Photo 9.** Facing east at the wellsite.
