Inspection Photos

Location Name: TEP ROCKY MOUNTAIN LLC, FEDERAL-66S95W/29SWSE

Location ID: 335421

Date: 2/10/2025

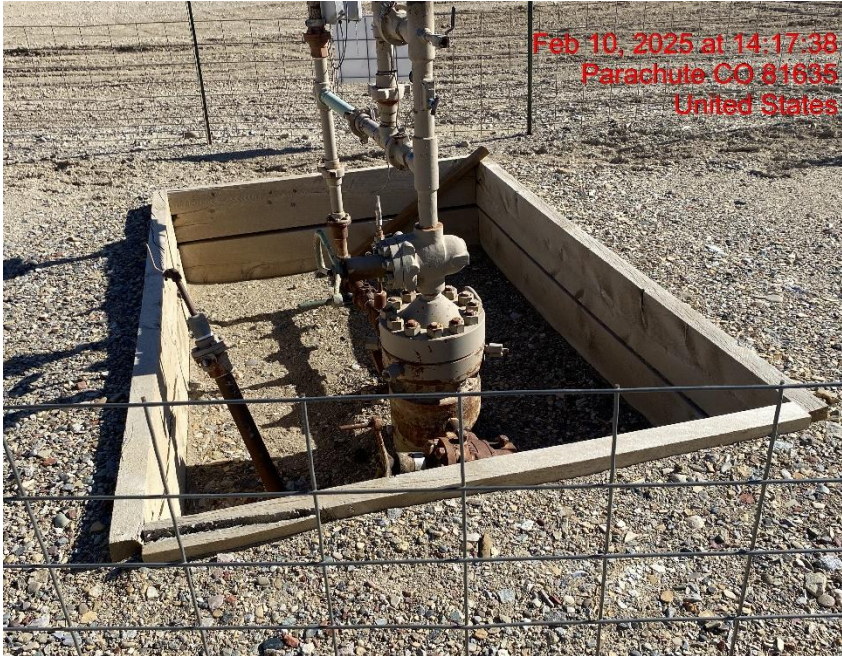
Open Wellhead Cellar – Photo #06553

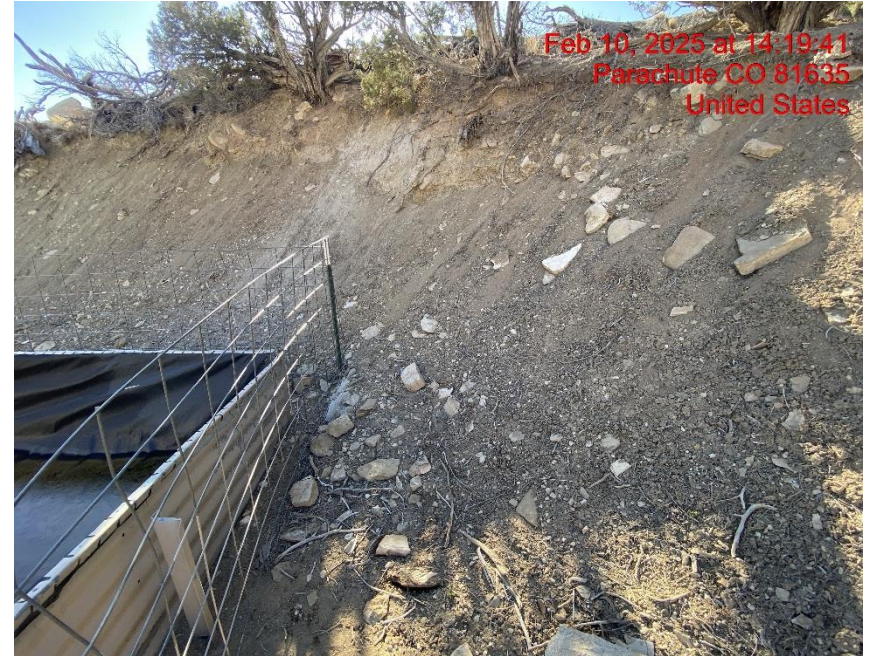
Insufficient Erosion Controls – Photo #06556

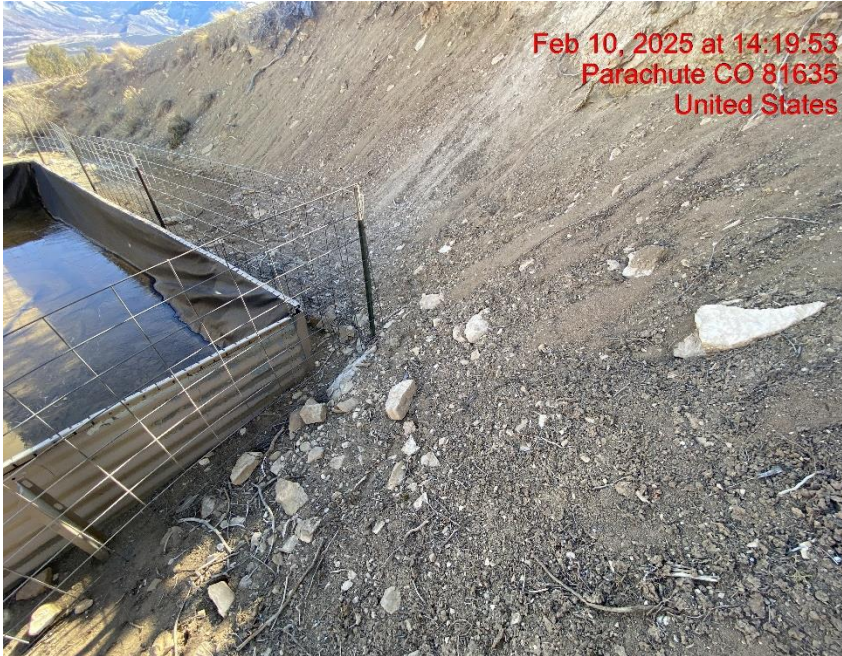
Insufficient Erosion Controls – Photo #06557

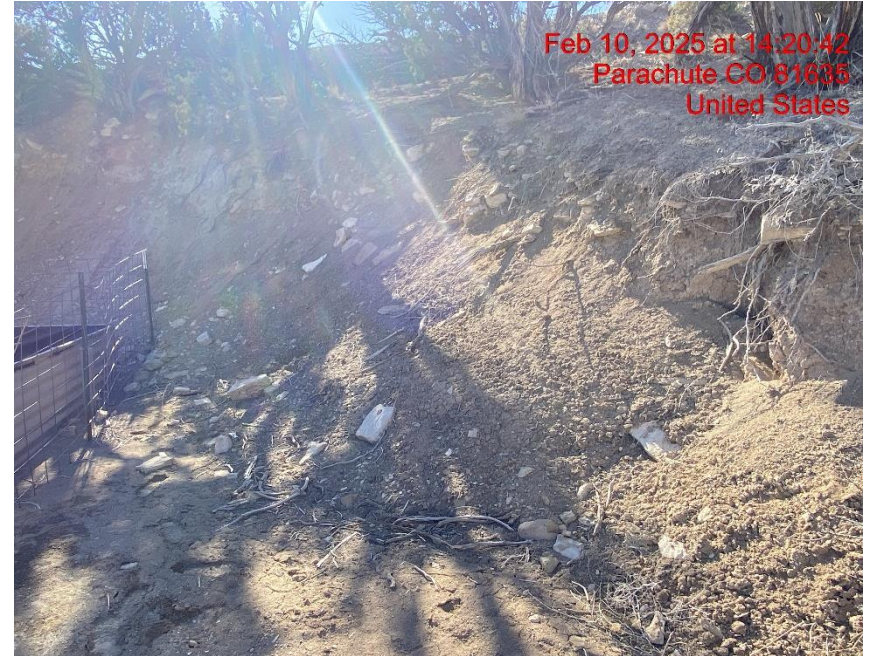
Insufficient Erosion Controls – Photo #06558
