Inspection Photos

Loc #: 481115

Operator: DESERT EAGLE OPERATING

Inspection Date: 2/10/2025

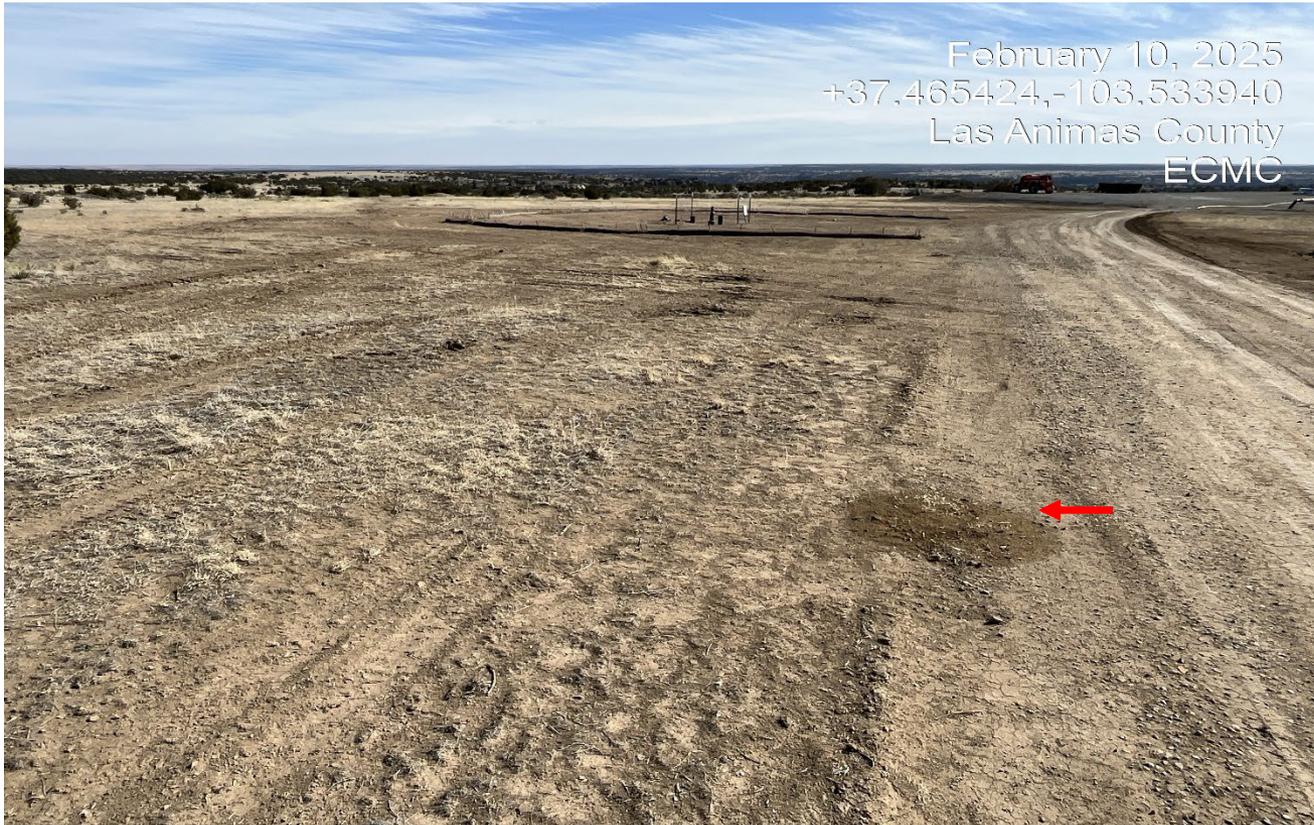
Photo 1. Facing southeast toward the location. There is oil stained soil at red arrow that needs to be cleaned up.

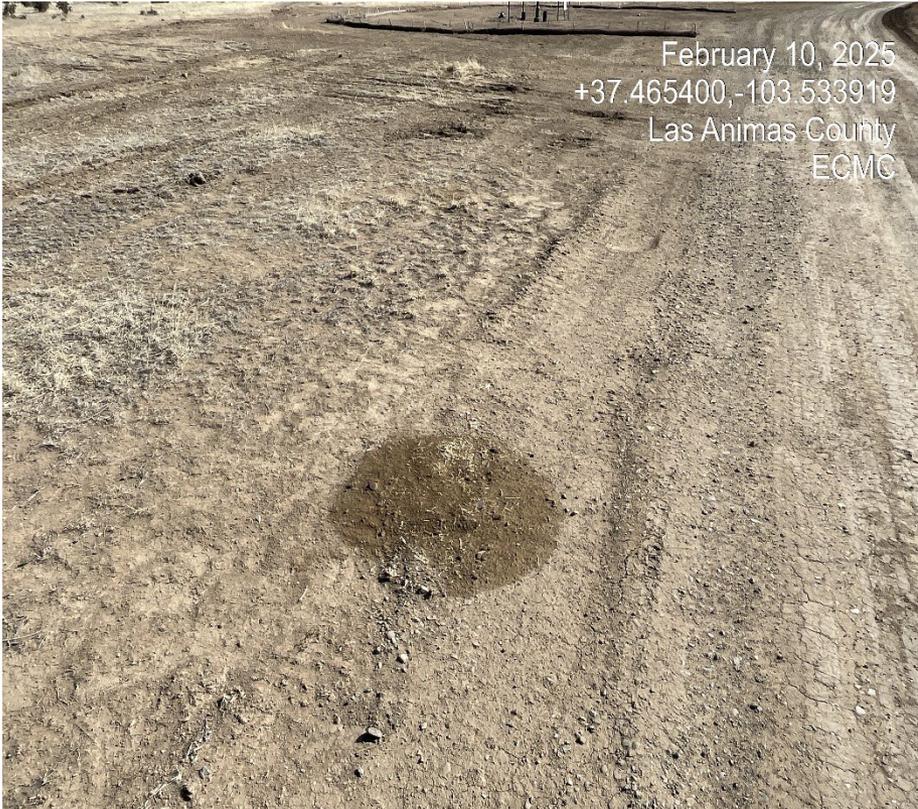
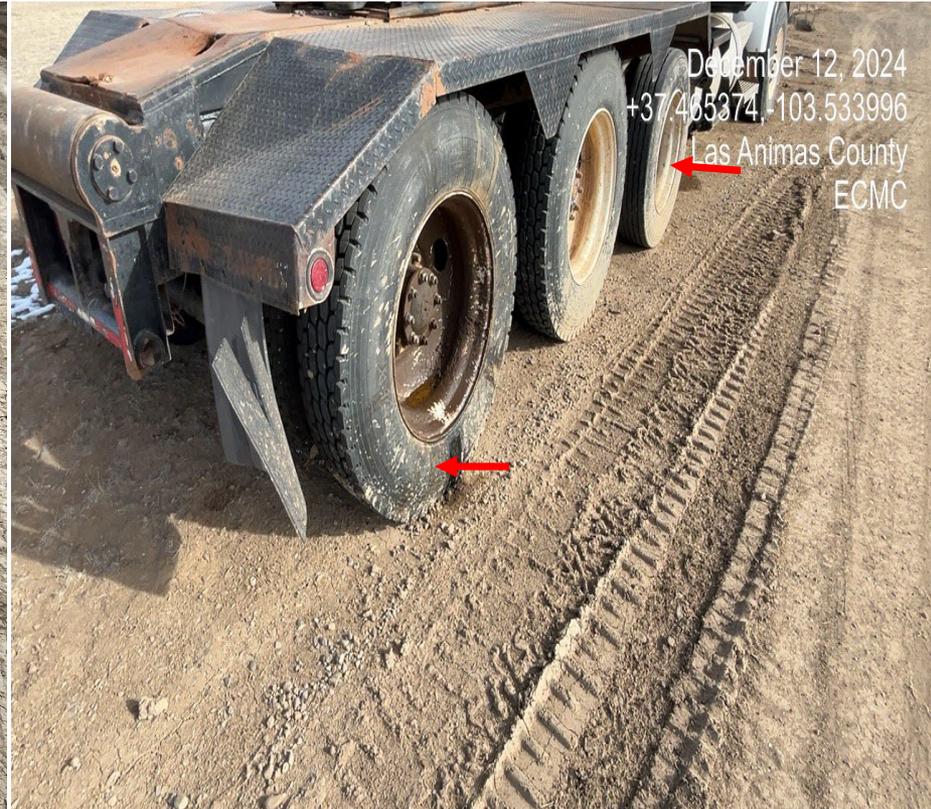
Photo 2. The stained soil is from the leak at the track which was previously identified. Previous CA to clean up was not completed.

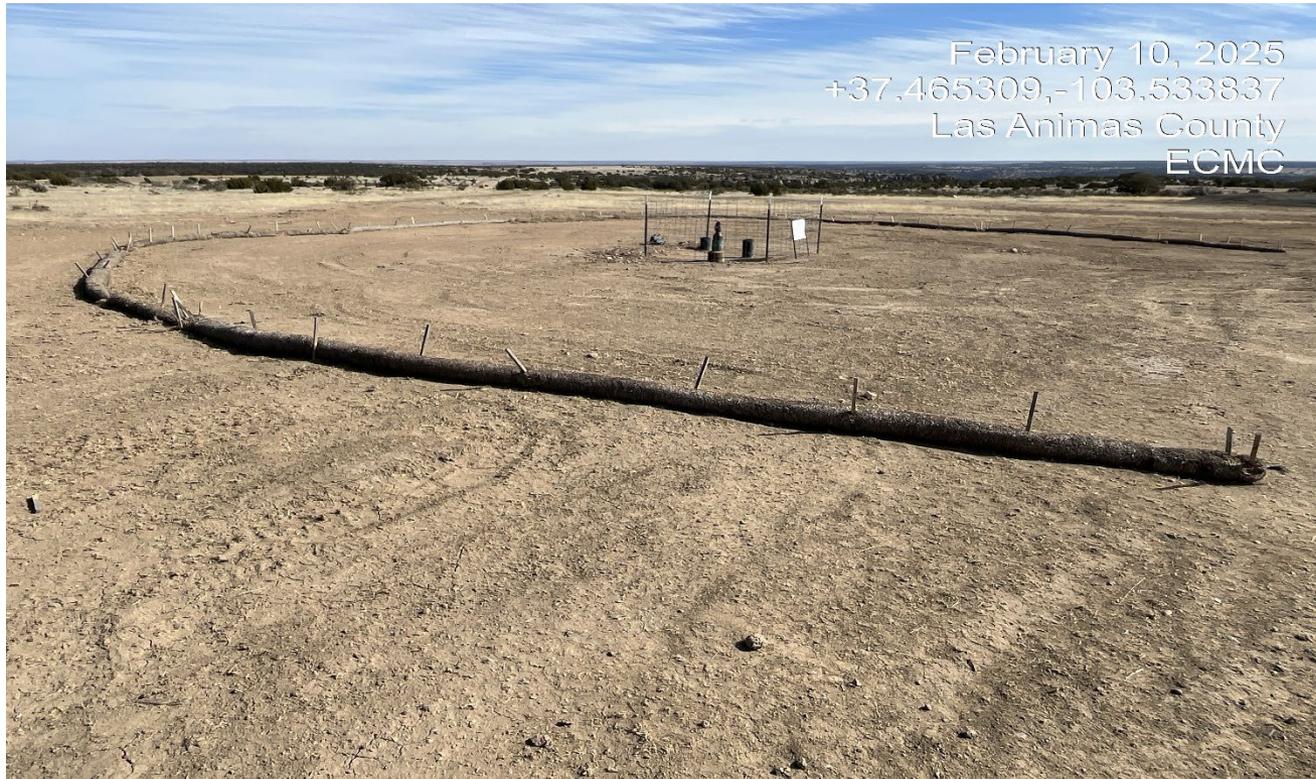
Photo 3. Facing southeast toward the wellsite. The wattles have been replaced.

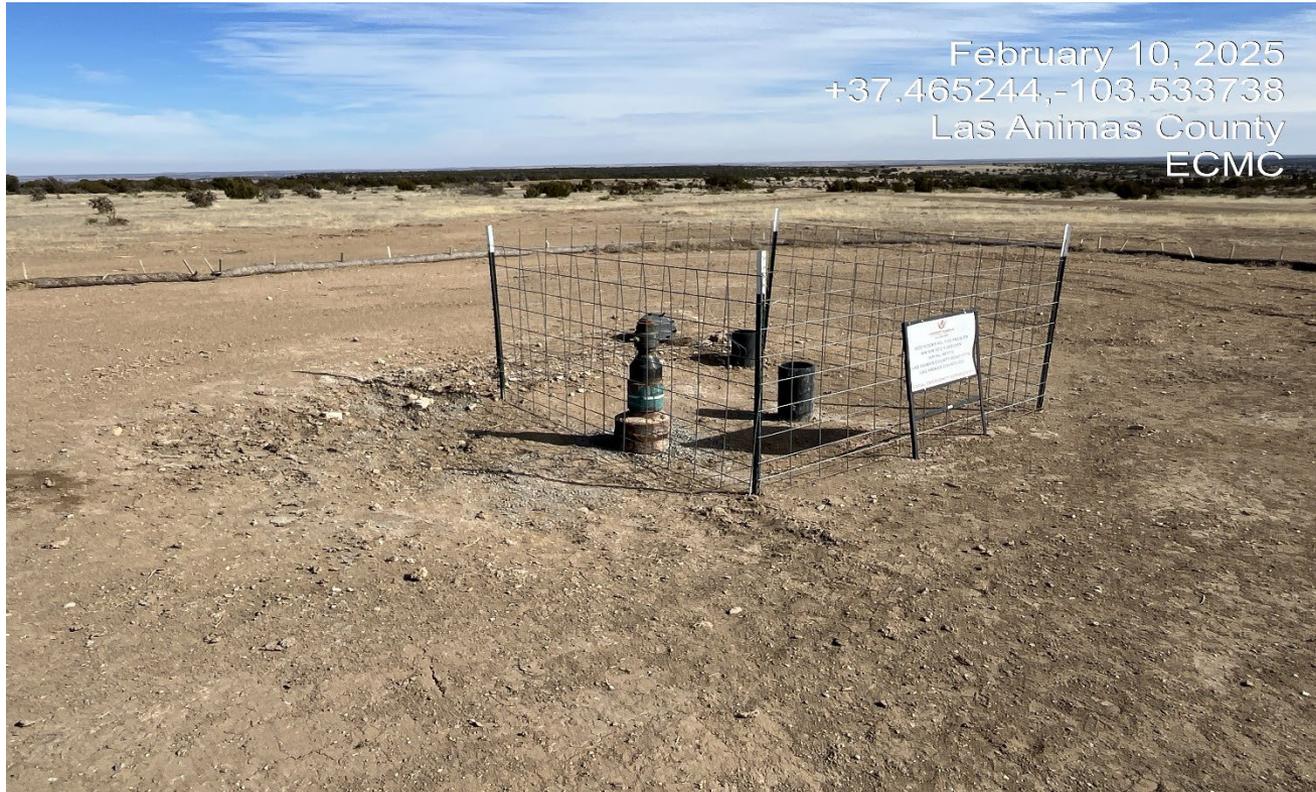
Photo 4. The fence and well sign have been reinstalled.

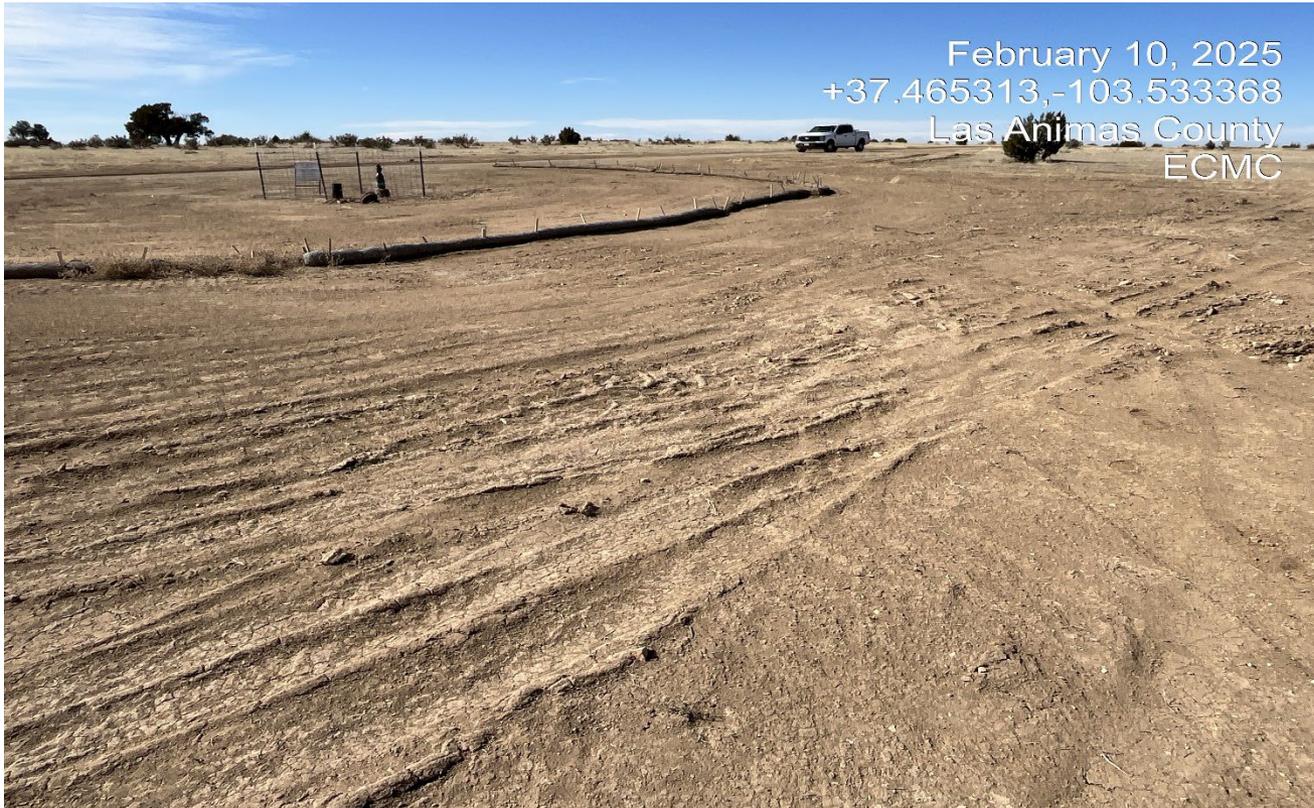
Photo 5. East side of the location facing northwest. Disturbed areas of the location need to be reseeded.

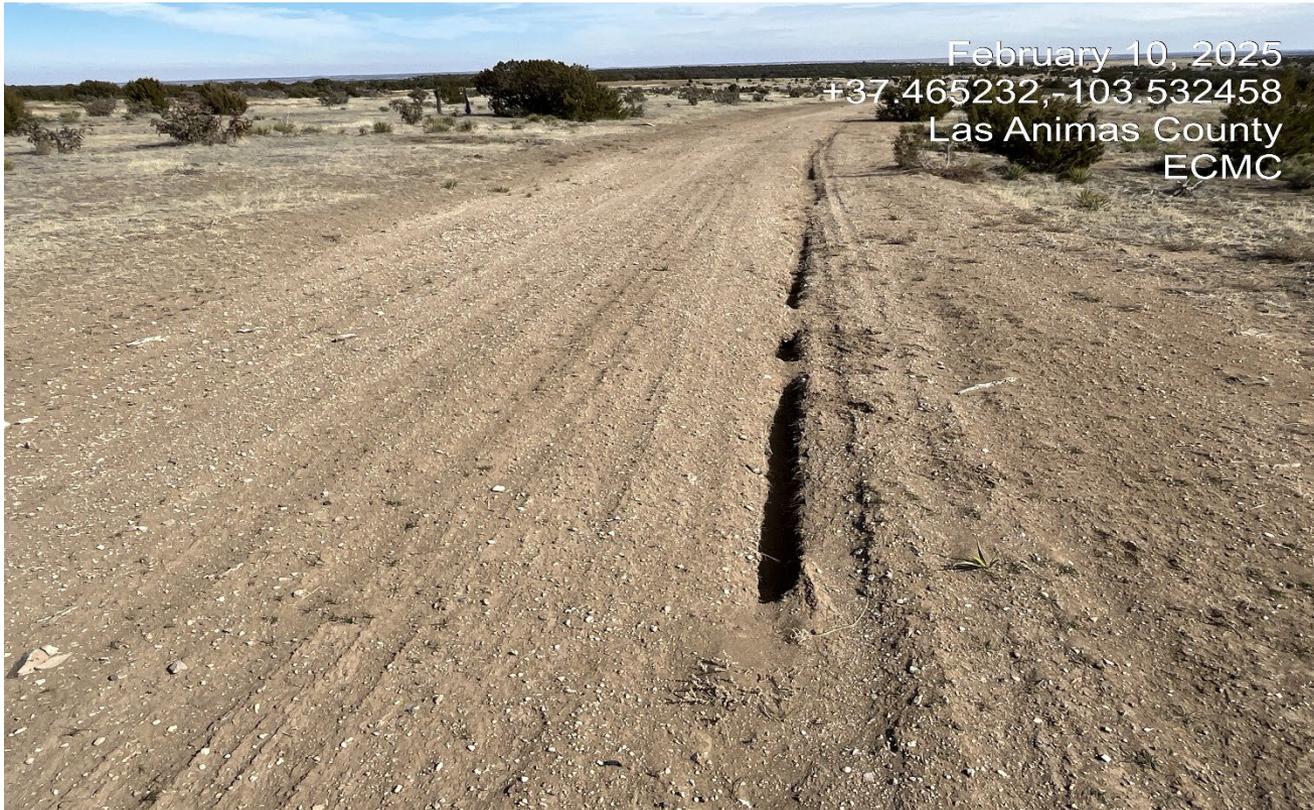
Photo 6. Facing east toward the flowline disturbance. There is subsidence along the flowline that needs to be filled in.
