Inspection/Audit Photos

Location: TEP ROCKY MOUNTAIN LLC KNOX/03-08 PAD

Location ID: 414268

Date: 02/10/2025

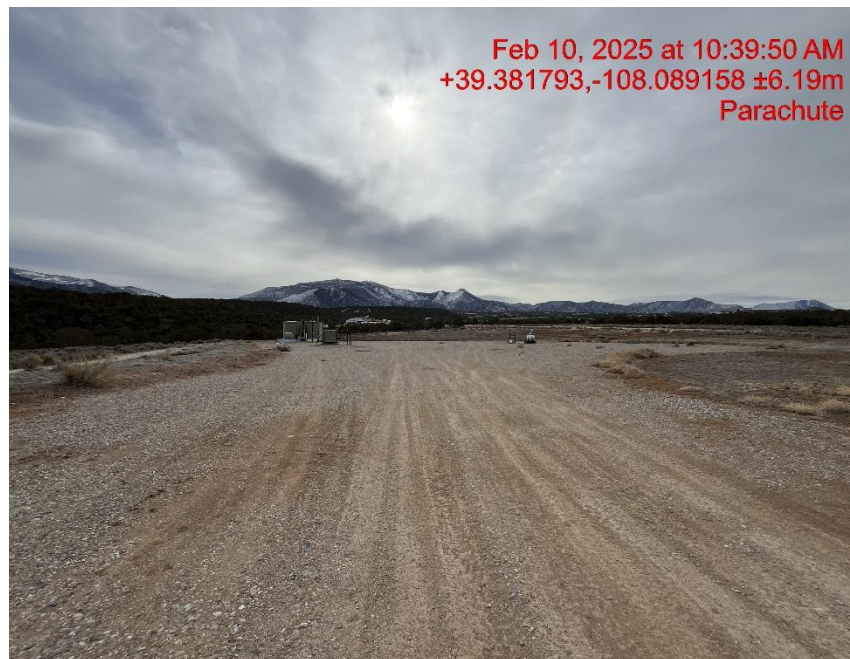
Photo # 4429 Entrance to location

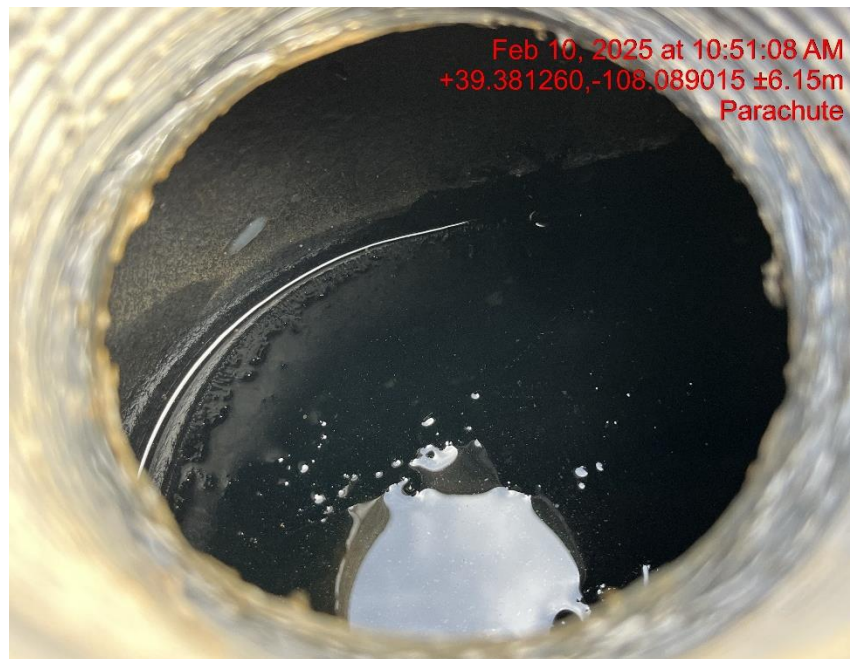
Photo # 4443 Failure to maintain chemical BMP/chemical containment approximately 3/4th full of fluid/not sufficient to contain possible spill

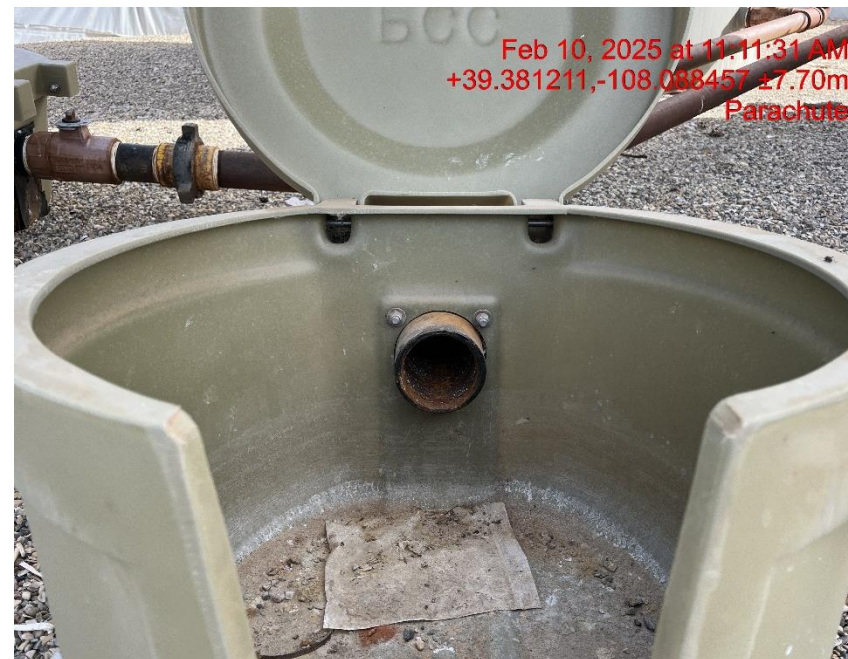
Photo # 4468 Open ended load line

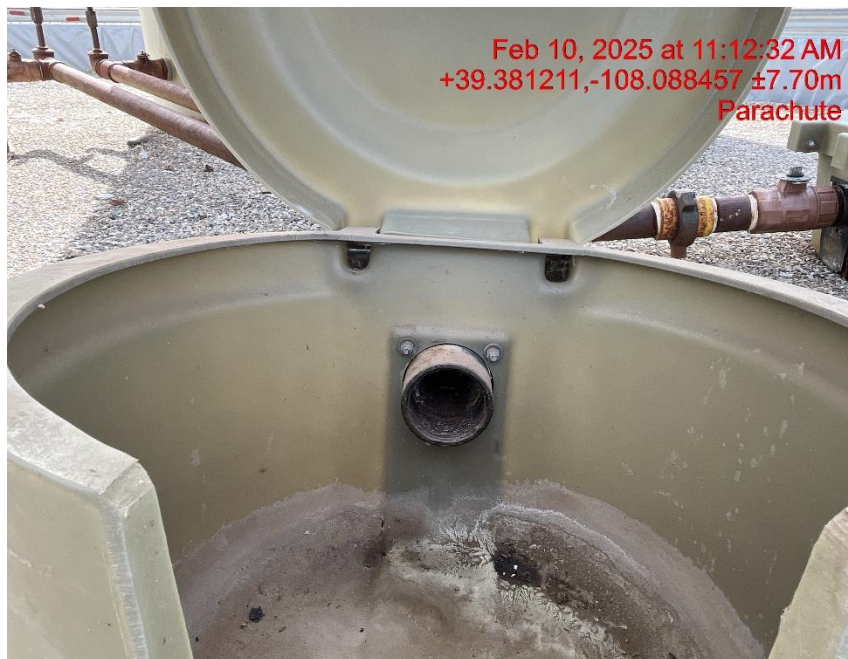
Photo # 4469 Open ended load line

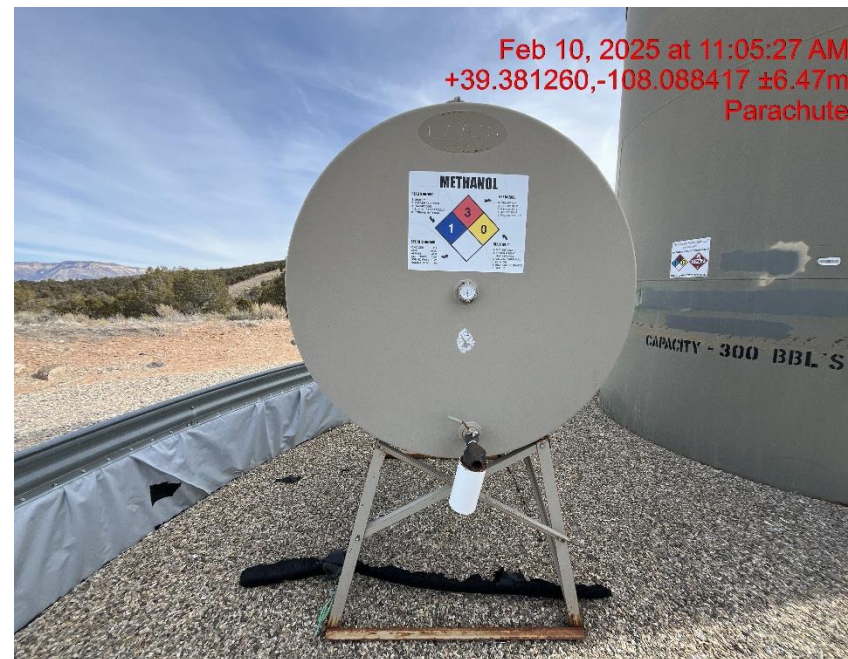
Photo # 4460 Tank lacks required labeling/does not comply with CECMC rules
