Final Reclamation and Stormwater Inspection

Operator: BAYSWATER EXPLORATION &
PRODUCTION LLC - 10261

Location ID: 302324

Inspection Photos
Location Name: Dyer 2-25
Location ID: 302324

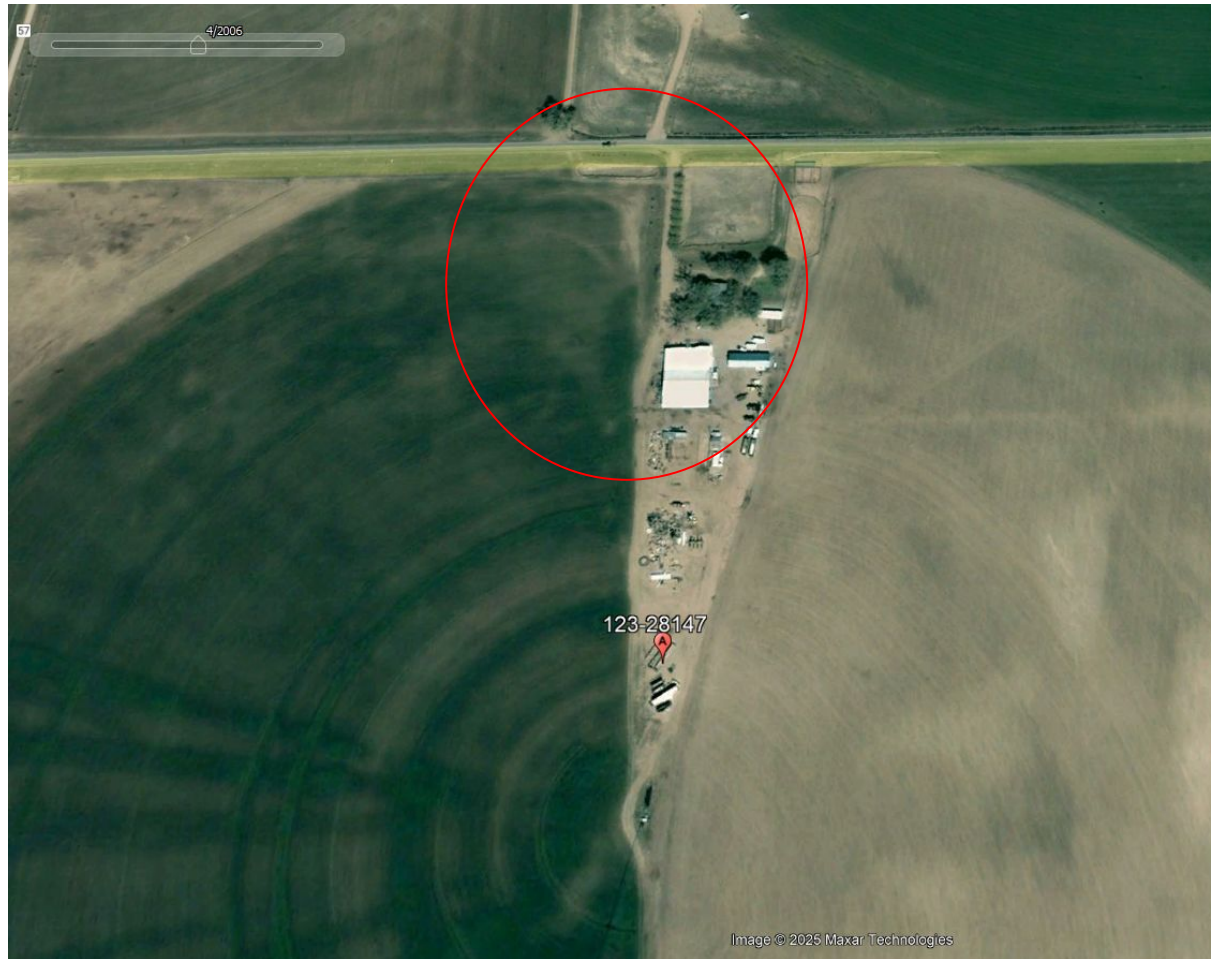
Photo 1. Google Earth aerial imagery (circa 04/2006) illustrating that an access road did not exist prior to the subject Well (API 123-28147) being spud on 10/24/2010.

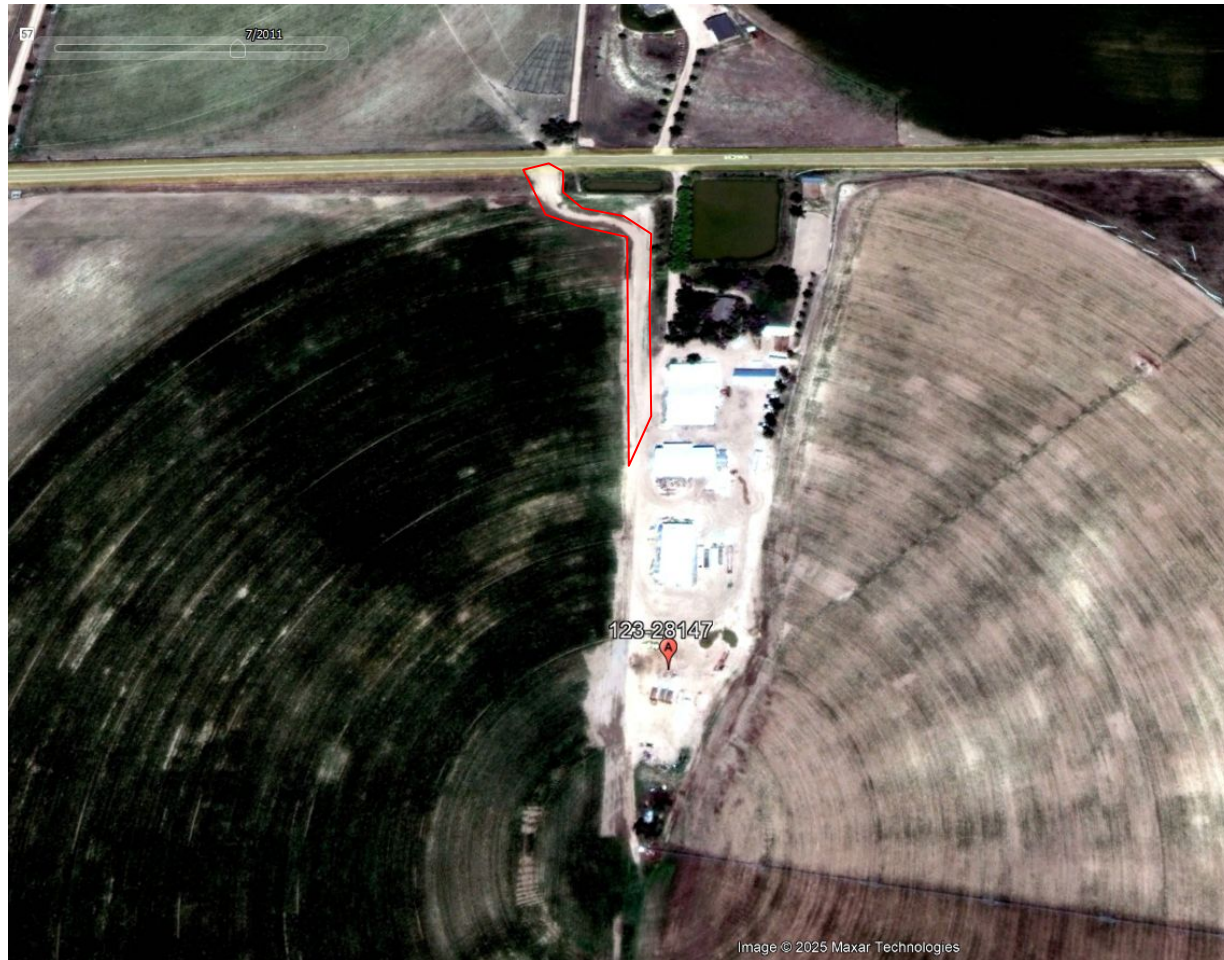
Photo 2. Google Earth aerial imagery (circa 07/2011) illustrating that an access road appears to have been constructed in connection to the subject Well (API 123-28147).

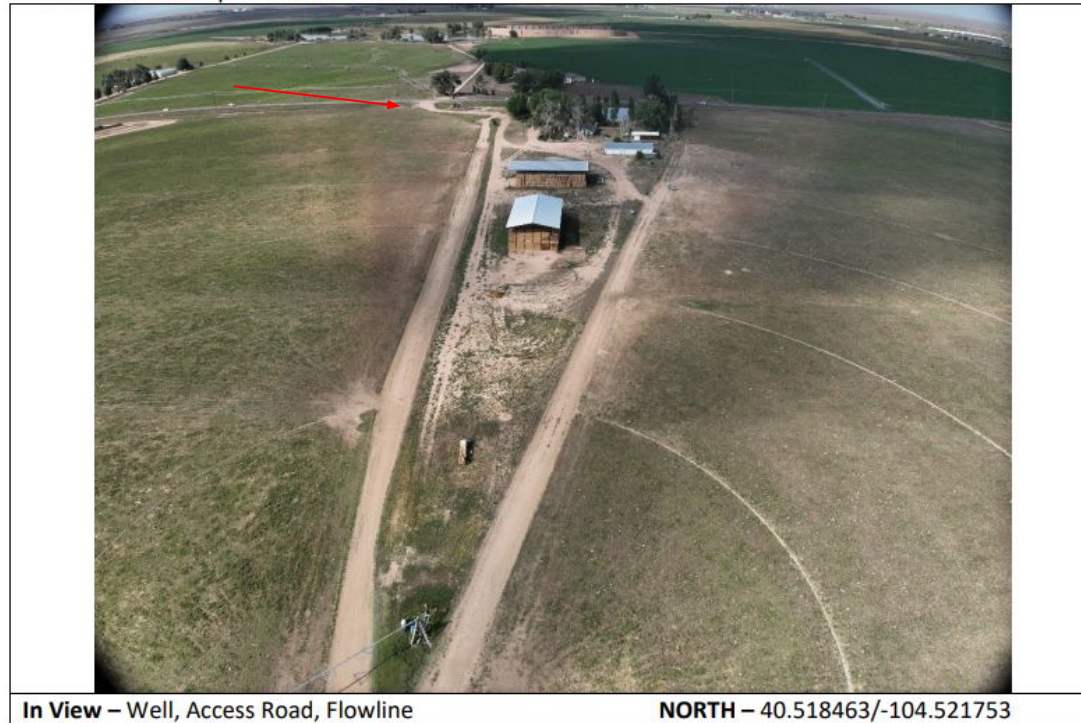
Photo 3. Screenshot from Page 8 of the drone closure report (doc #404067592). No other documentation within the drone closure report illustrates the northern, or start, of the access road, which does not appear to have been reclaimed.

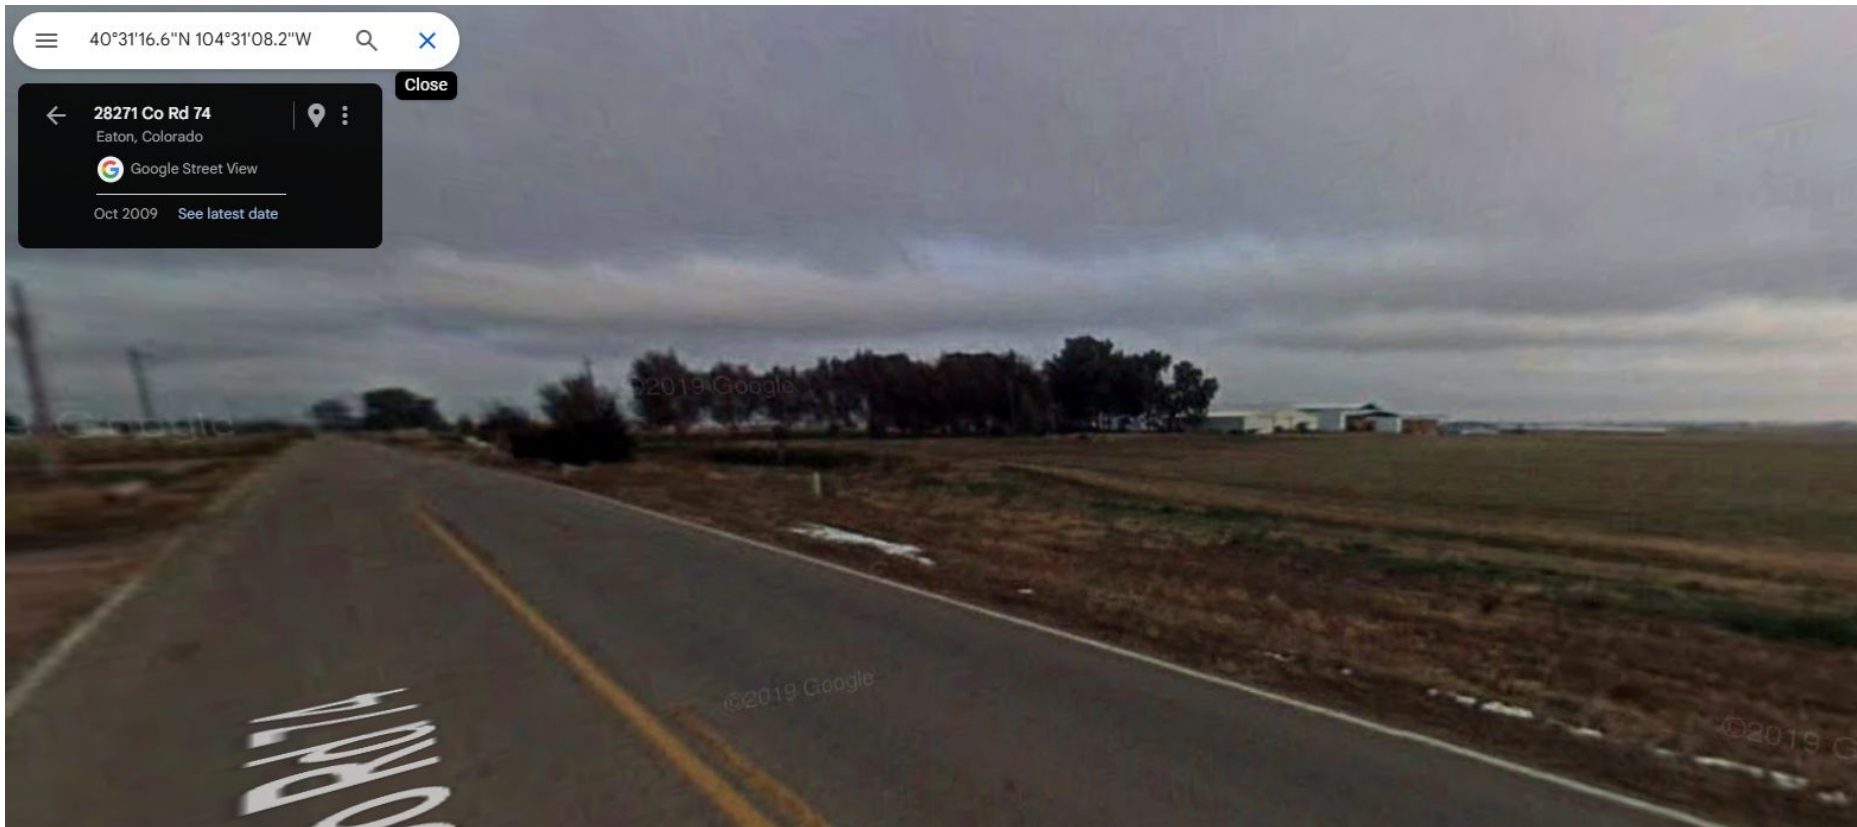
Photo 4. Google Maps imagery (circa 10/2009) illustrating that the access road entrance did not exist prior to oil and gas development.

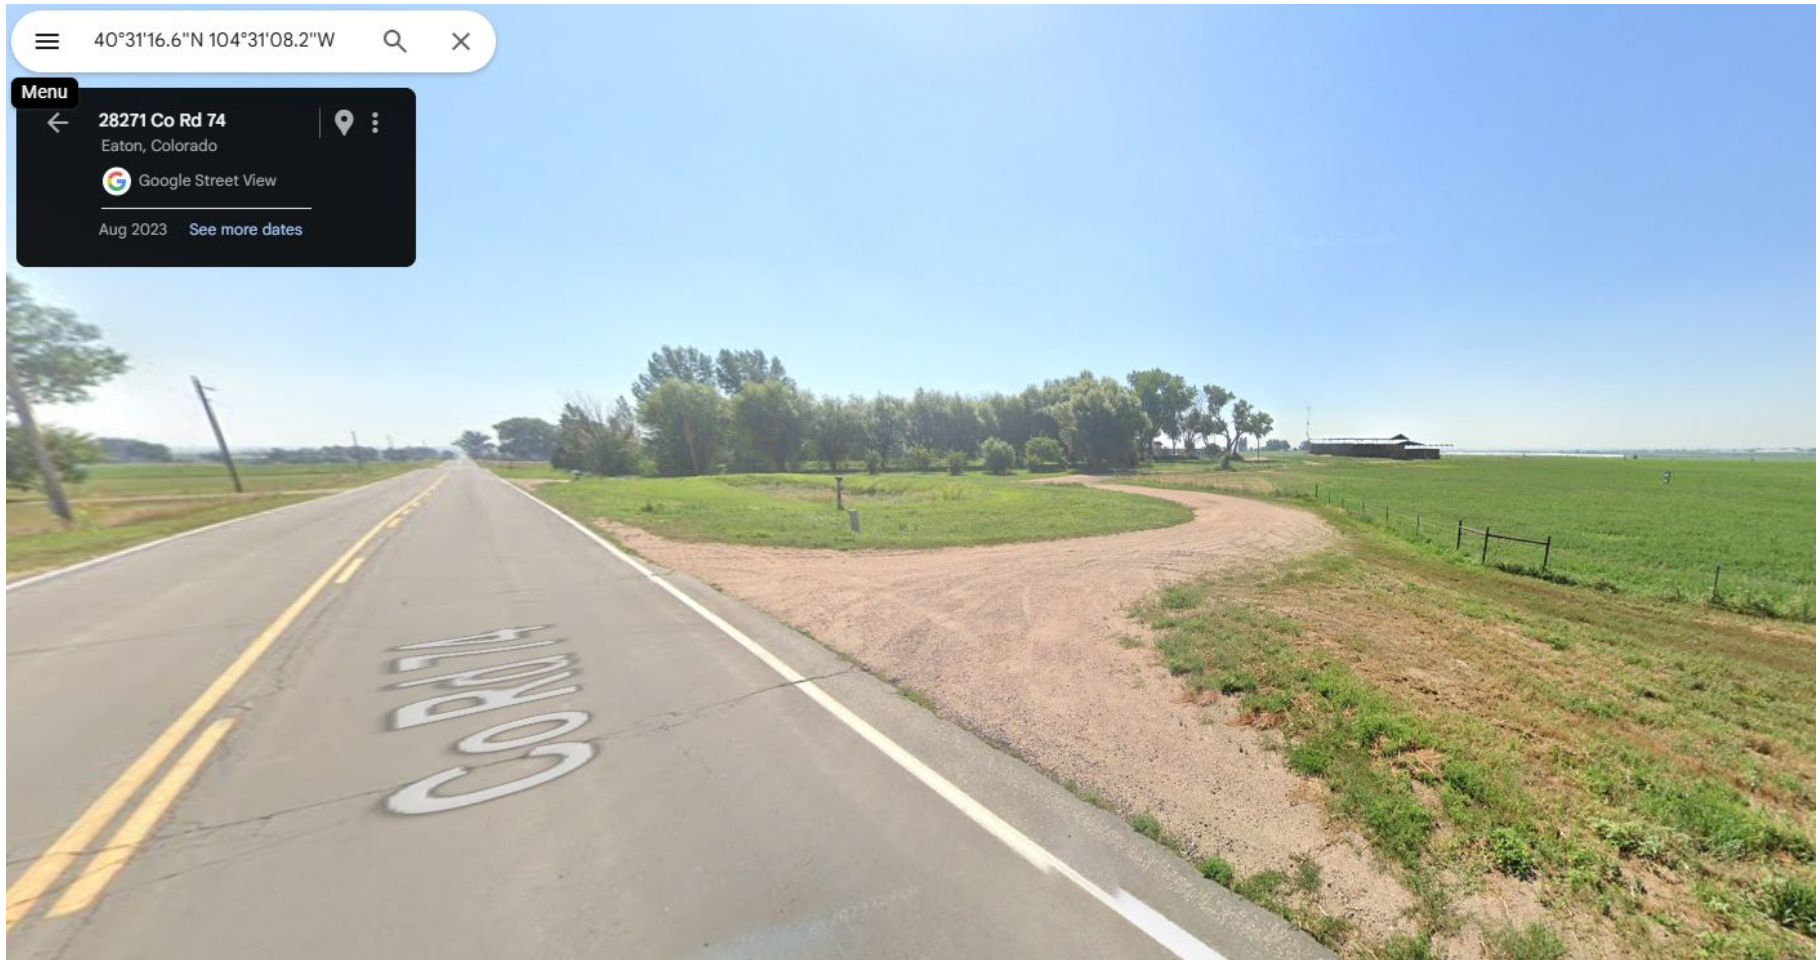
Photo 5. Google Maps imagery (circa 08/2023) illustrating that the access road remains and does not appear to have been reclaimed.
