## Inspection/Audit Photos

Location: TEP ROCKY MOUNTAIN LLC FEDERAL-67S96W/11NWN (GM 31-11 PAD)

Location ID: 334982

Date: 02/11/2025

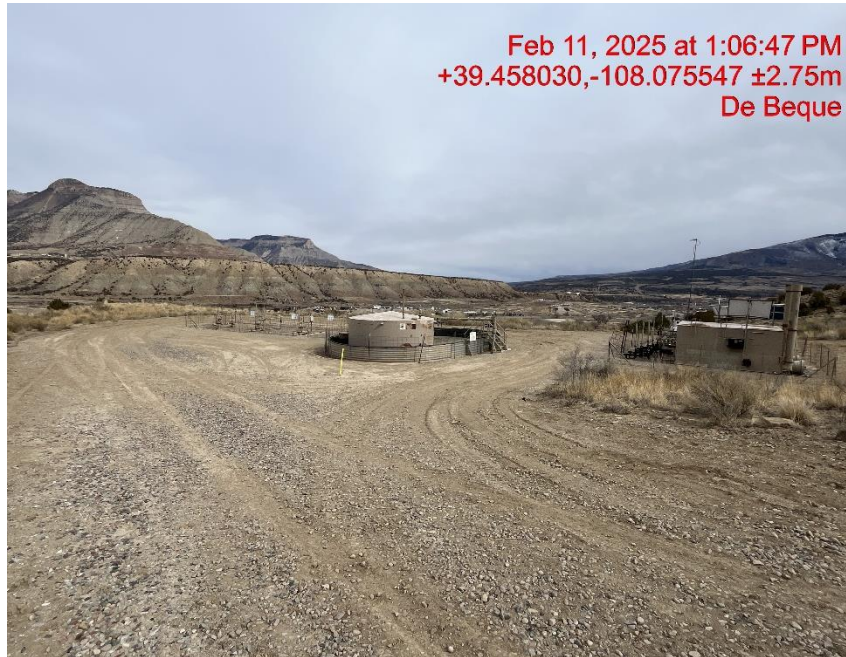
Photo # 4764 Entrance to location

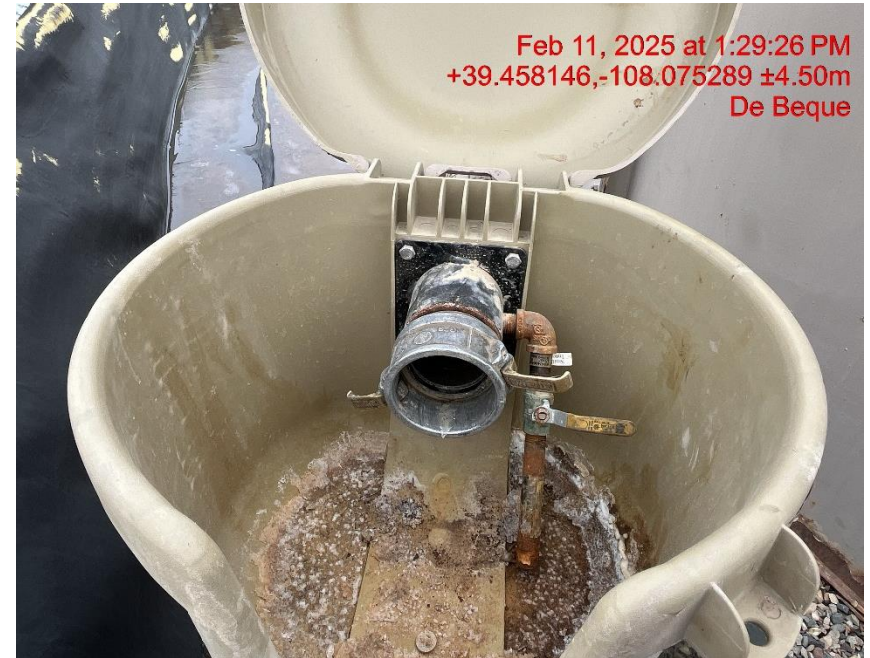
Photo # 4787 Open ended load line

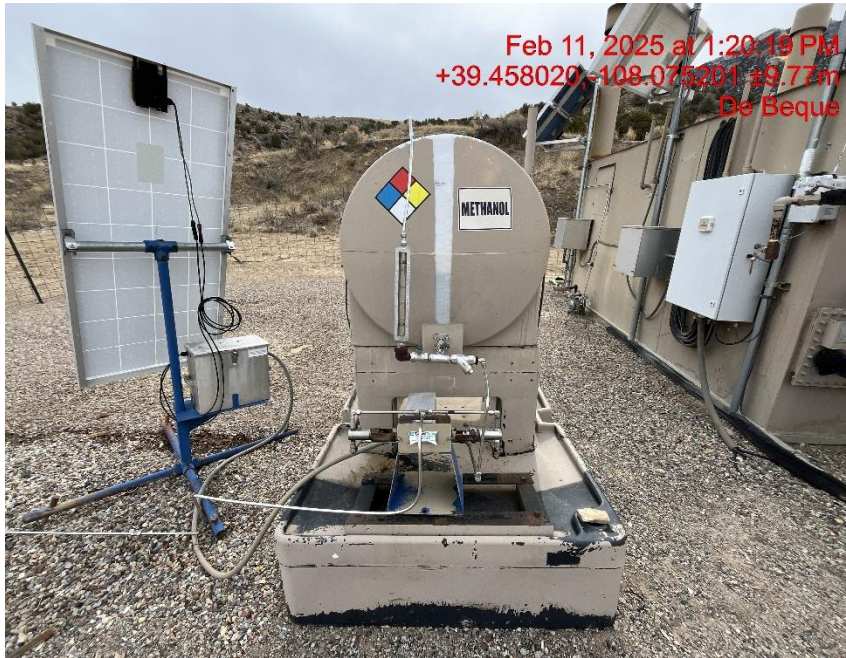
Photo # 4778 Lacks required labeling/does not comply with CECMC rules

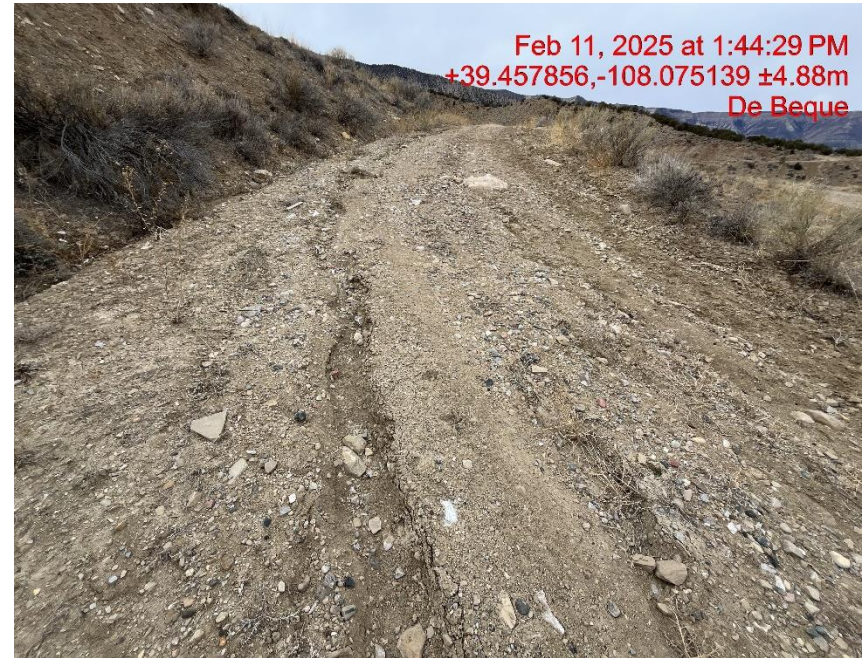
Photo # 4794 Rill erosion on access road, south side of location
