Inspection Photos

Operator: Williford Resources - 96735

Location ID: 325692

Inspection Photos
Location Name: Macey 1
Location ID: 325692

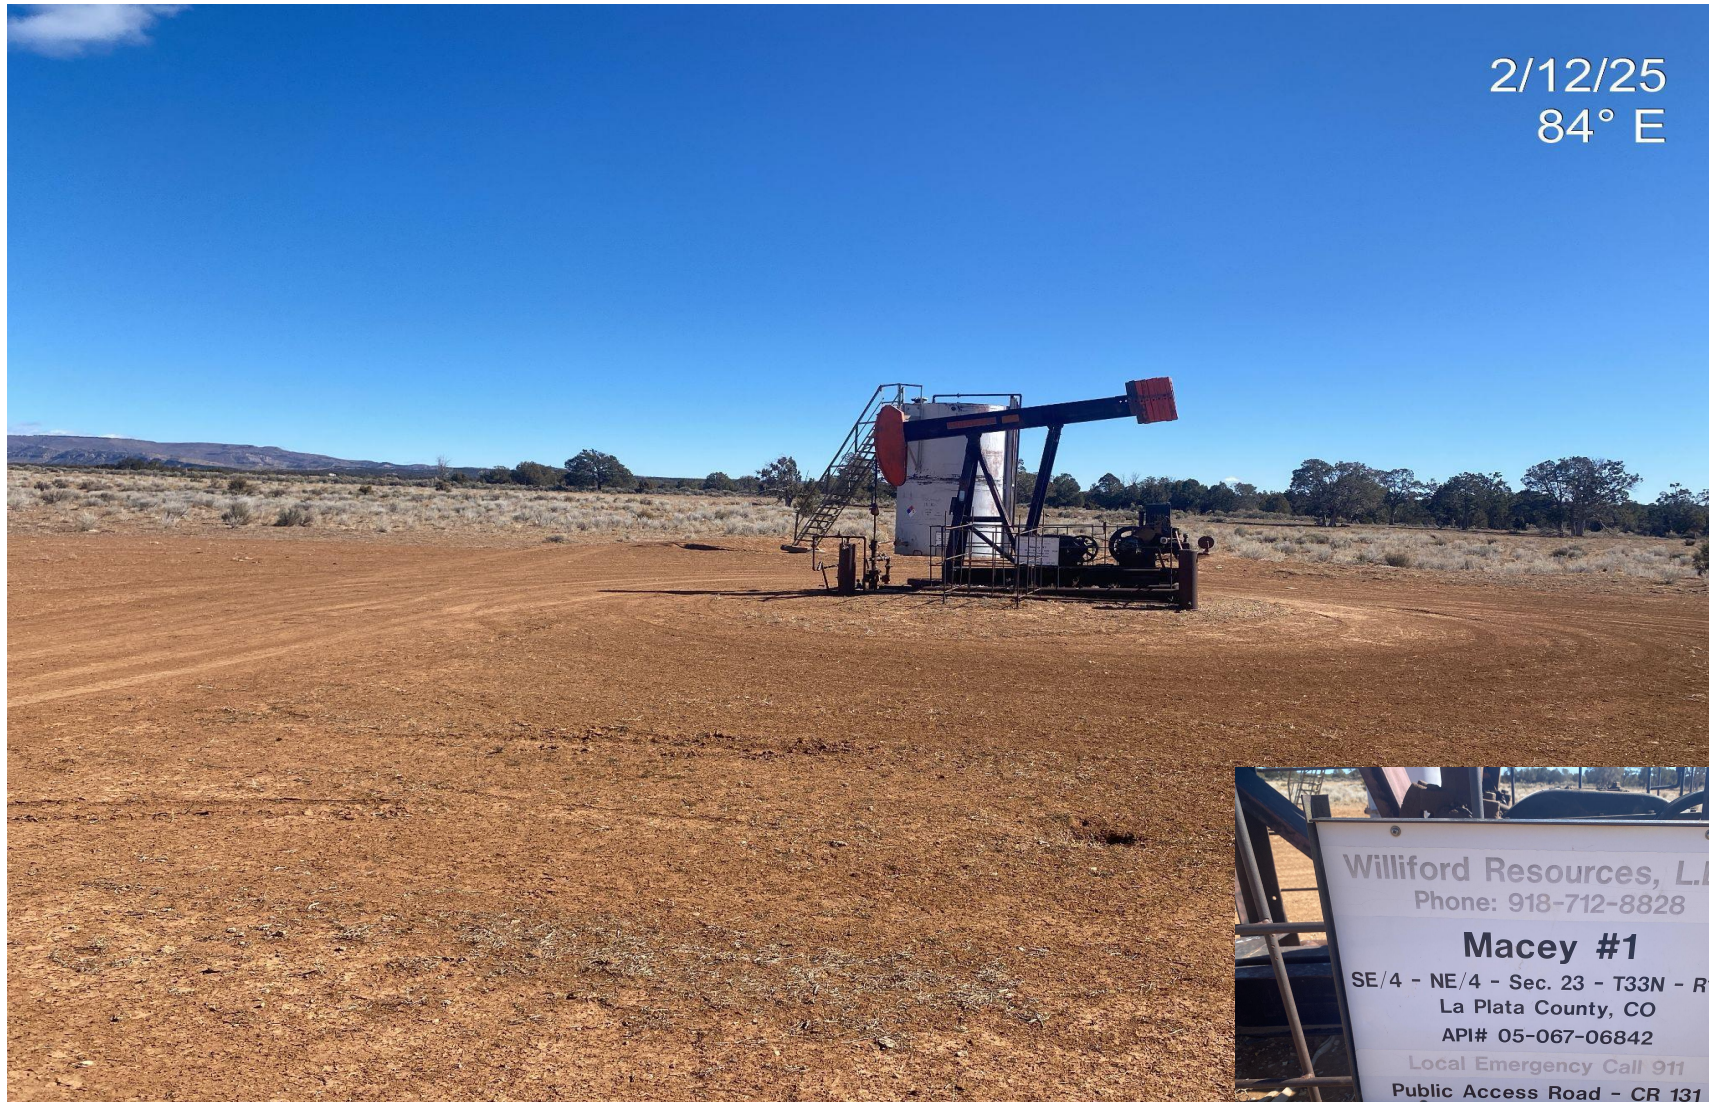
Photo 1. View of the well pad taken from the access point facing center.

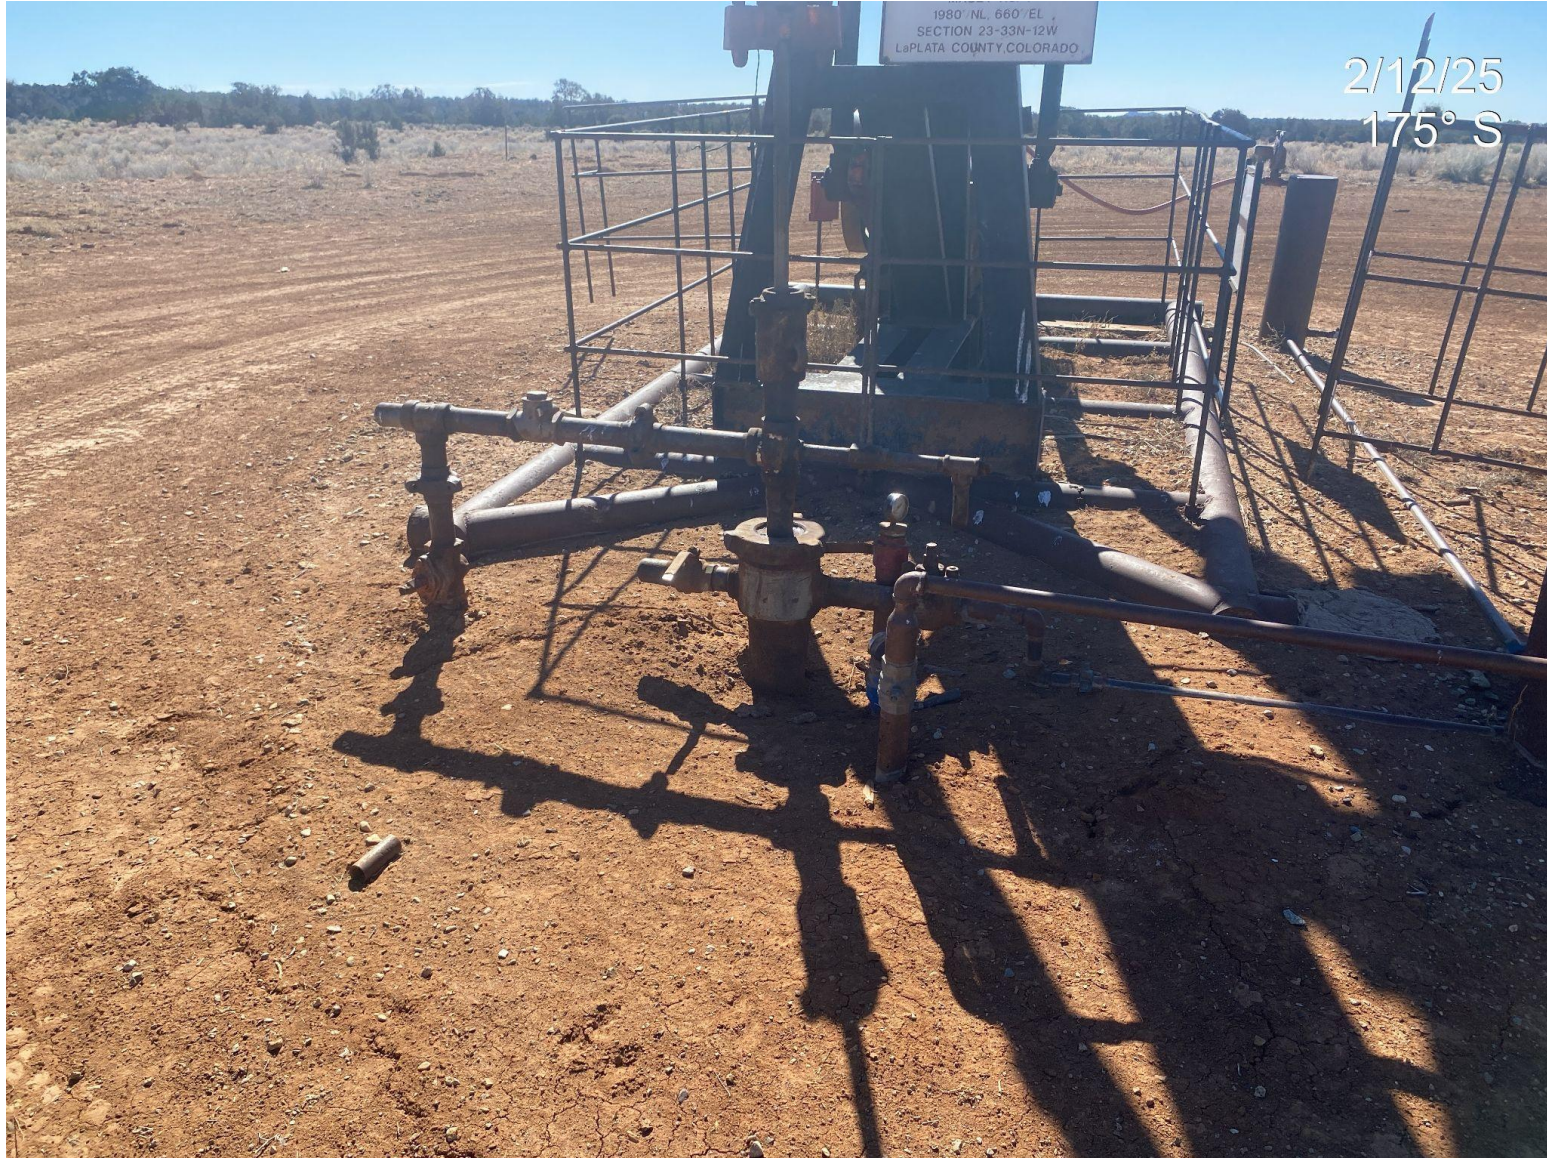
Photo 2. View of wellhead/pump jack, no stained soil was observed.

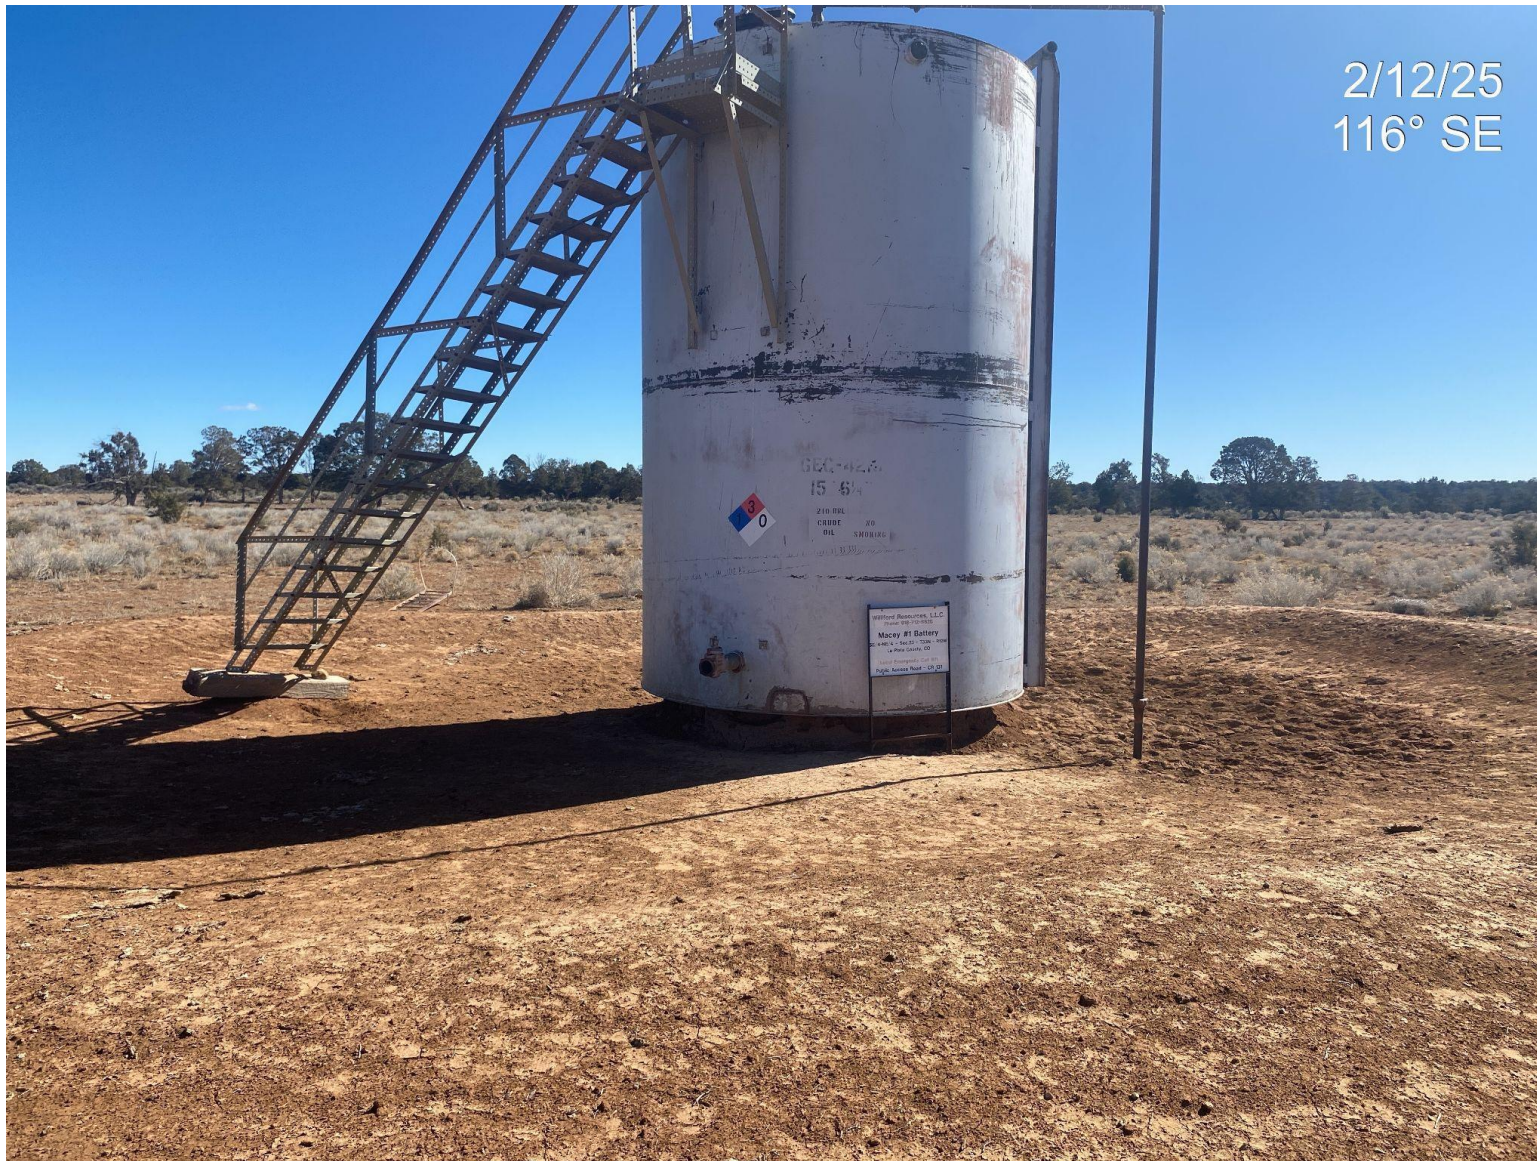
Photo 2. View of tank battery.

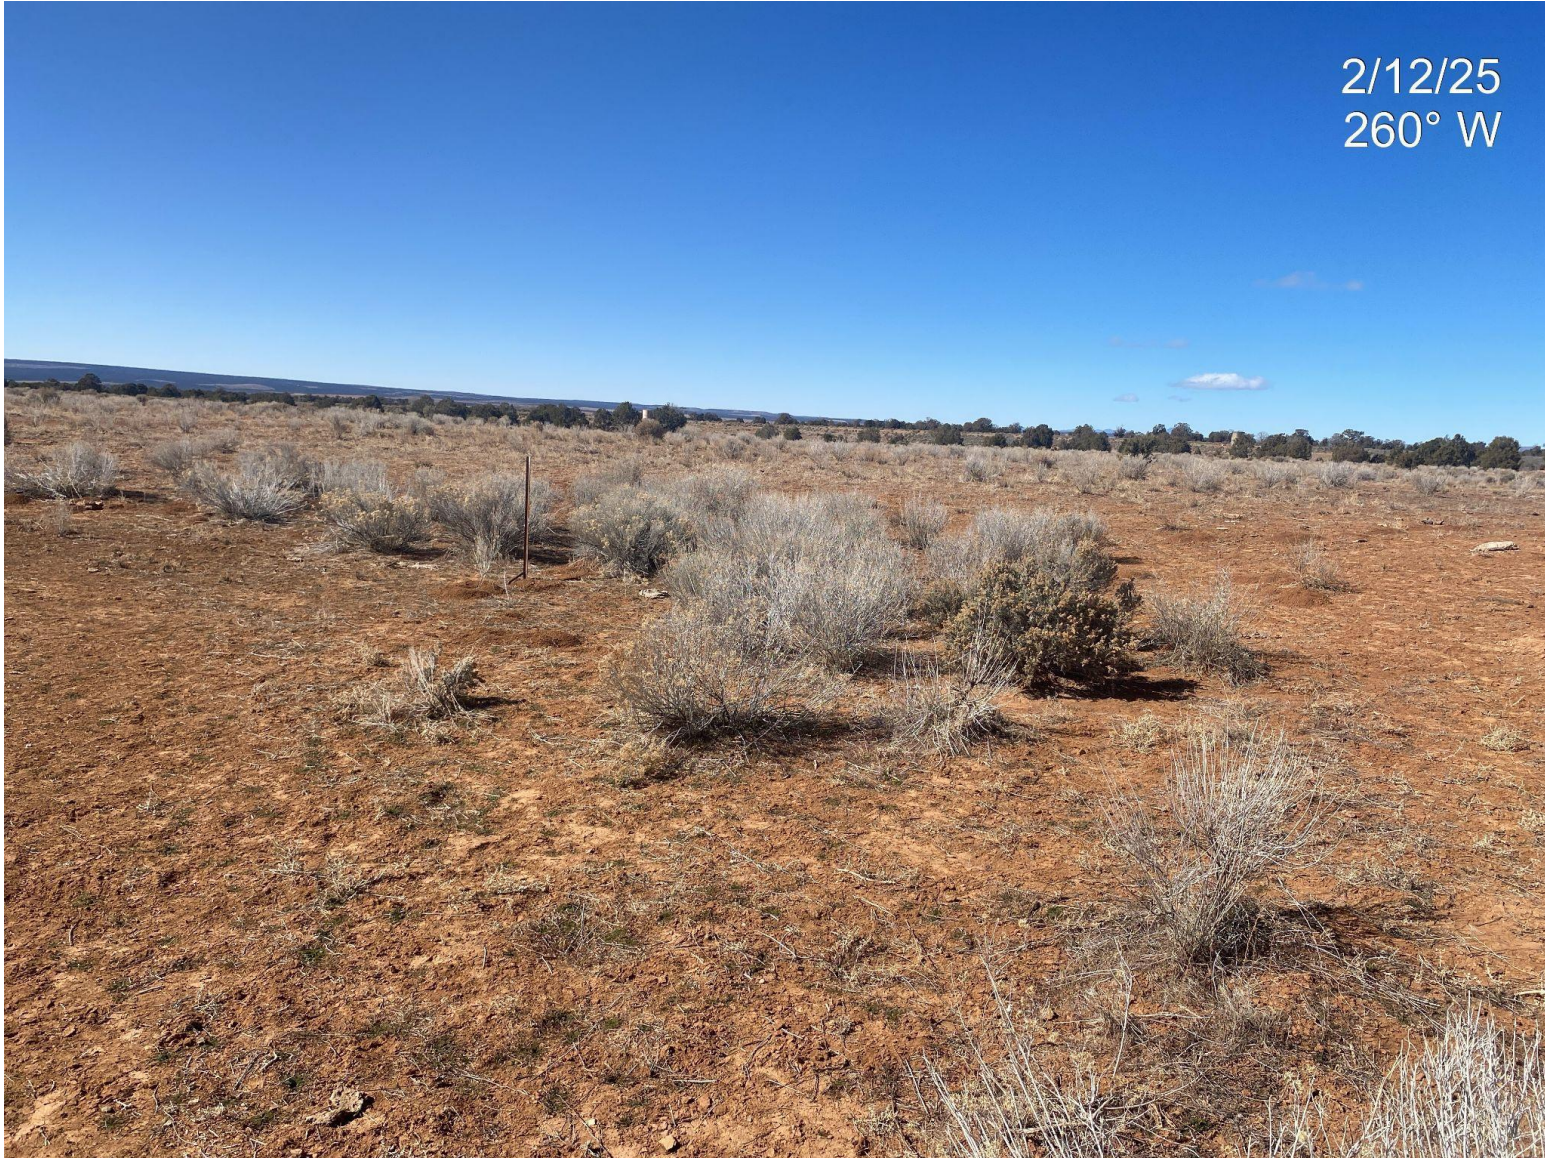
Photo 4. Interim reclamation area composed of Rabbitbrush, Broom Snakeweed and Sagebrush.

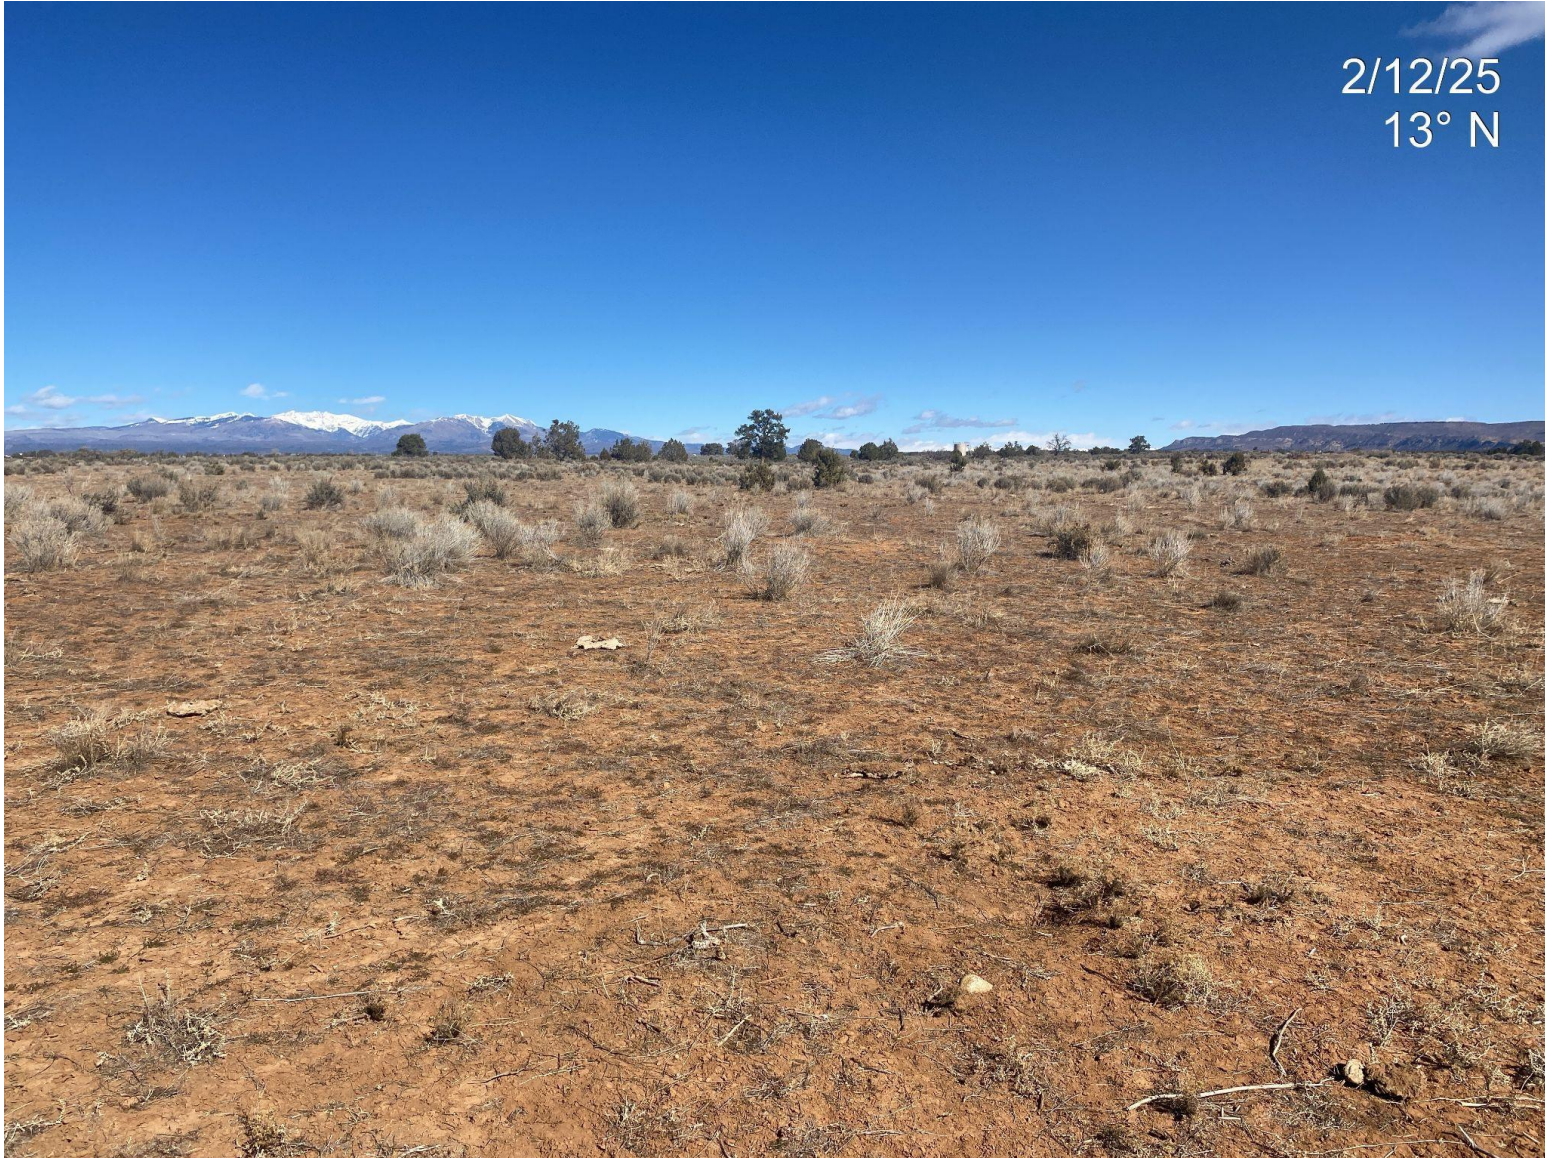
Photo 5. Reference area composed of Rabbitbrush, Broom Snakeweed and James Galleta.
