Inspection/Audit Photos

Location Name: TEP ROCKY MOUNTAIN LLC SNYDER C Pad

Location ID: 336021

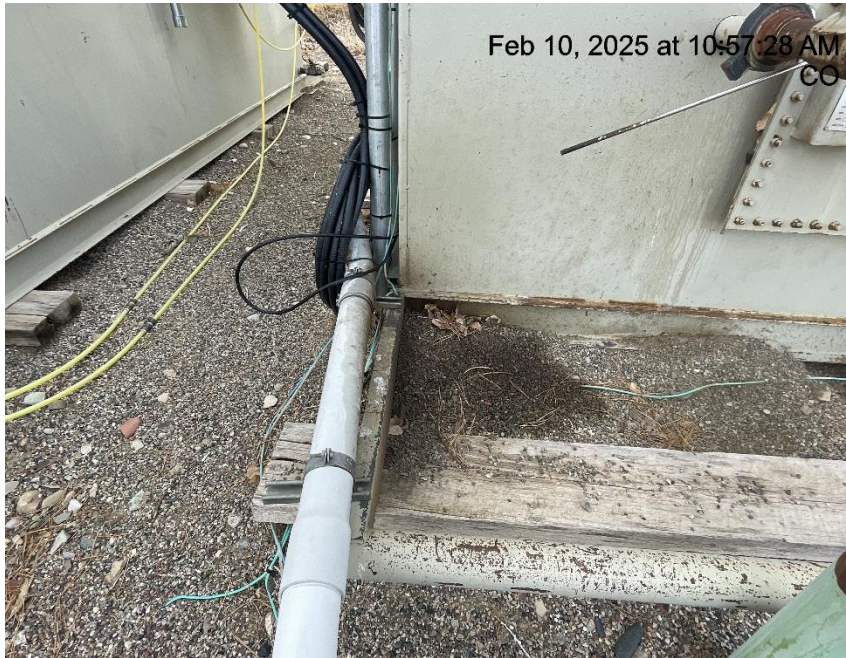
Photo # 4458 Staining near separator

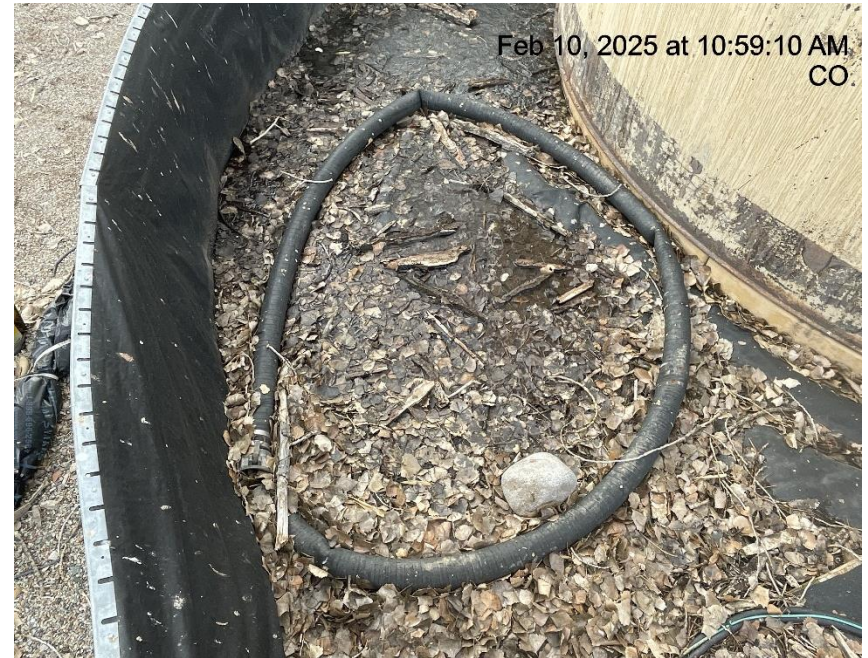
Photo # 4459 Damaged hose/debris

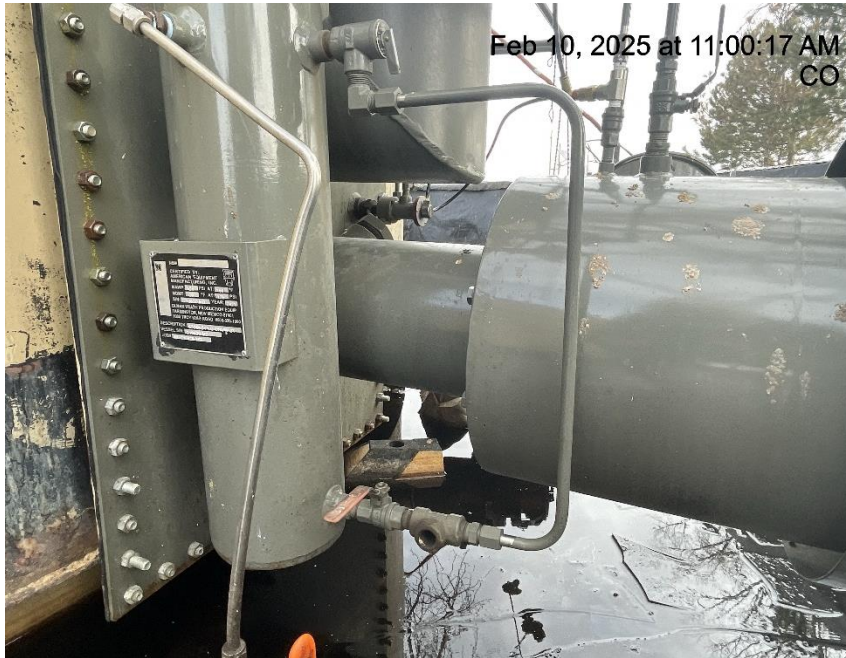
Photo # 4460 PRV vent line does not comply with CECMC pressure safety device rules

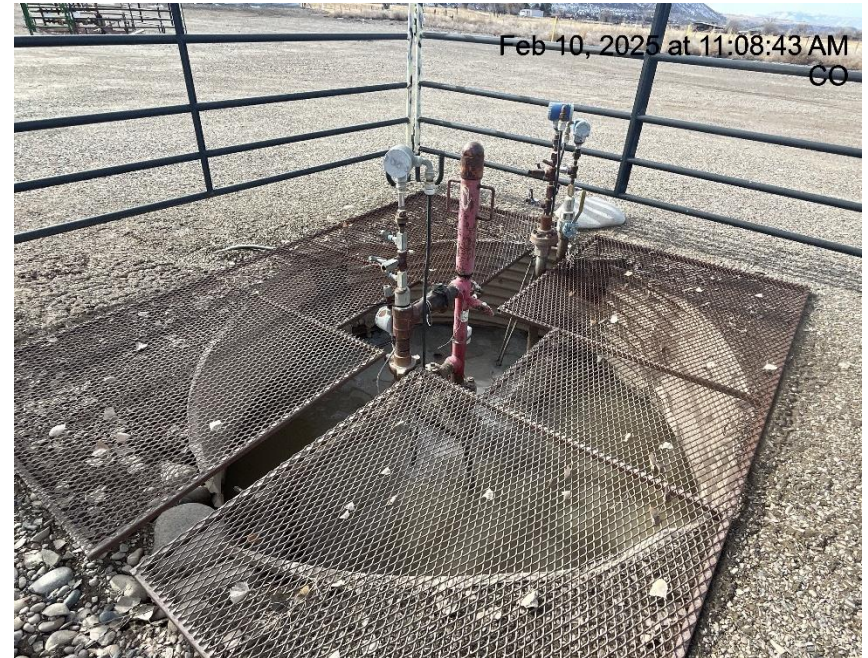
Photo # 4461 Cellar lacks wildlife egress
