Inspection Photos

API: 011-06083

Operator: RENEGADE OIL & GAS COMPANY

Inspection Date: 2/14/2025

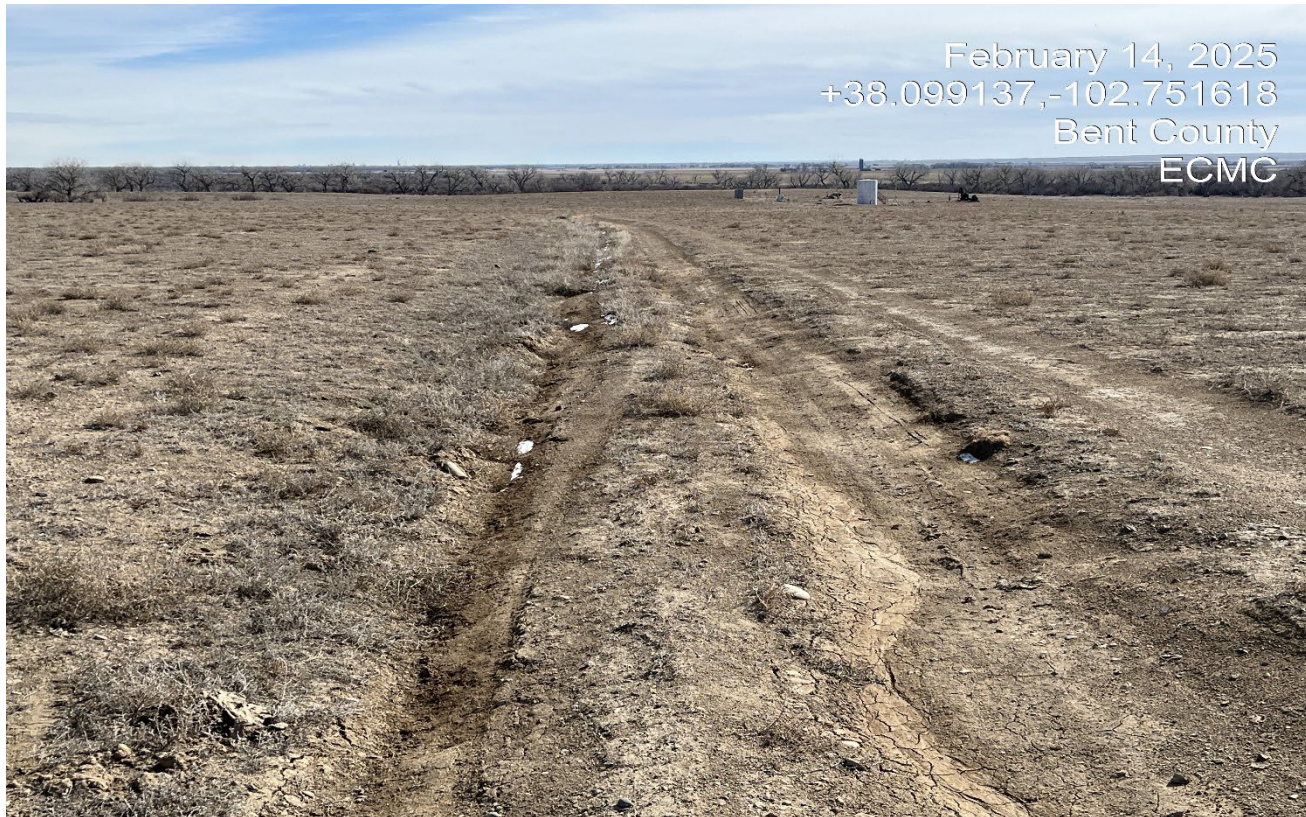
Photo 1. Facing southeast along the access road. There is erosion along the road that must be repaired and stabilized. Vehicles are driving off the original road causing more disturbance.

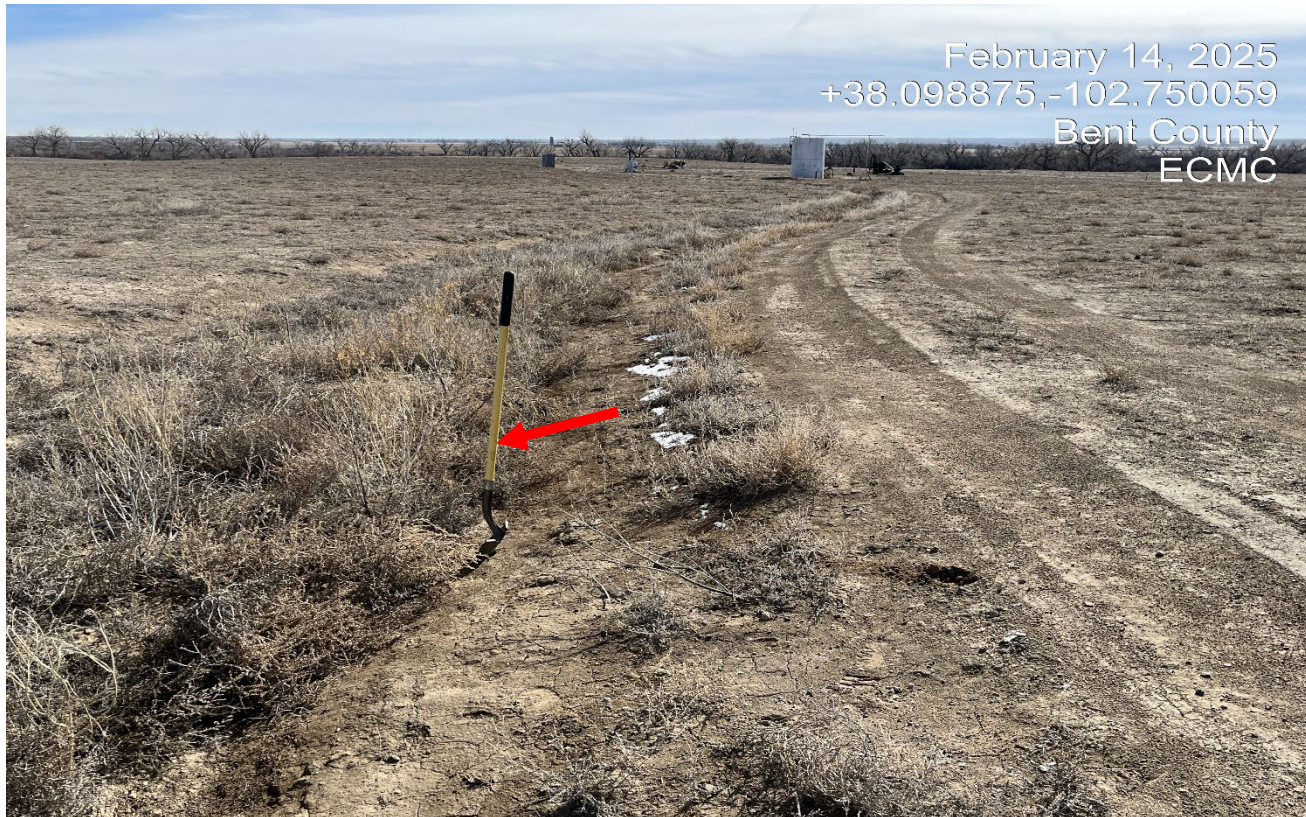
Photo 2. Facing southeast along the access road. There is erosion along the road that must be repaired and stabilized. Red arrow points to 4.5' shovel for scale. Vehicles are driving outside of the original access road to avoid the eroded road.

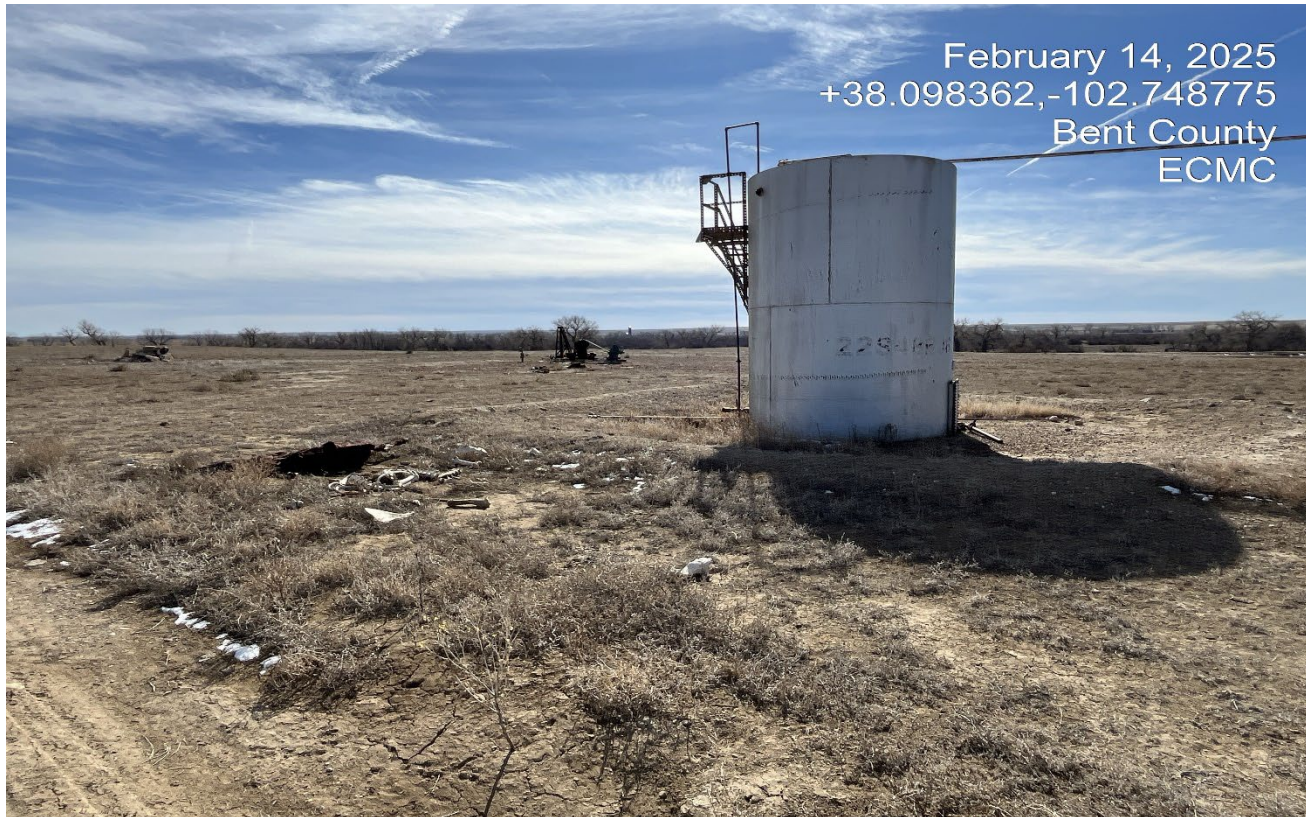
Photo 3. Facing southeast toward the wellsite and tank battery.

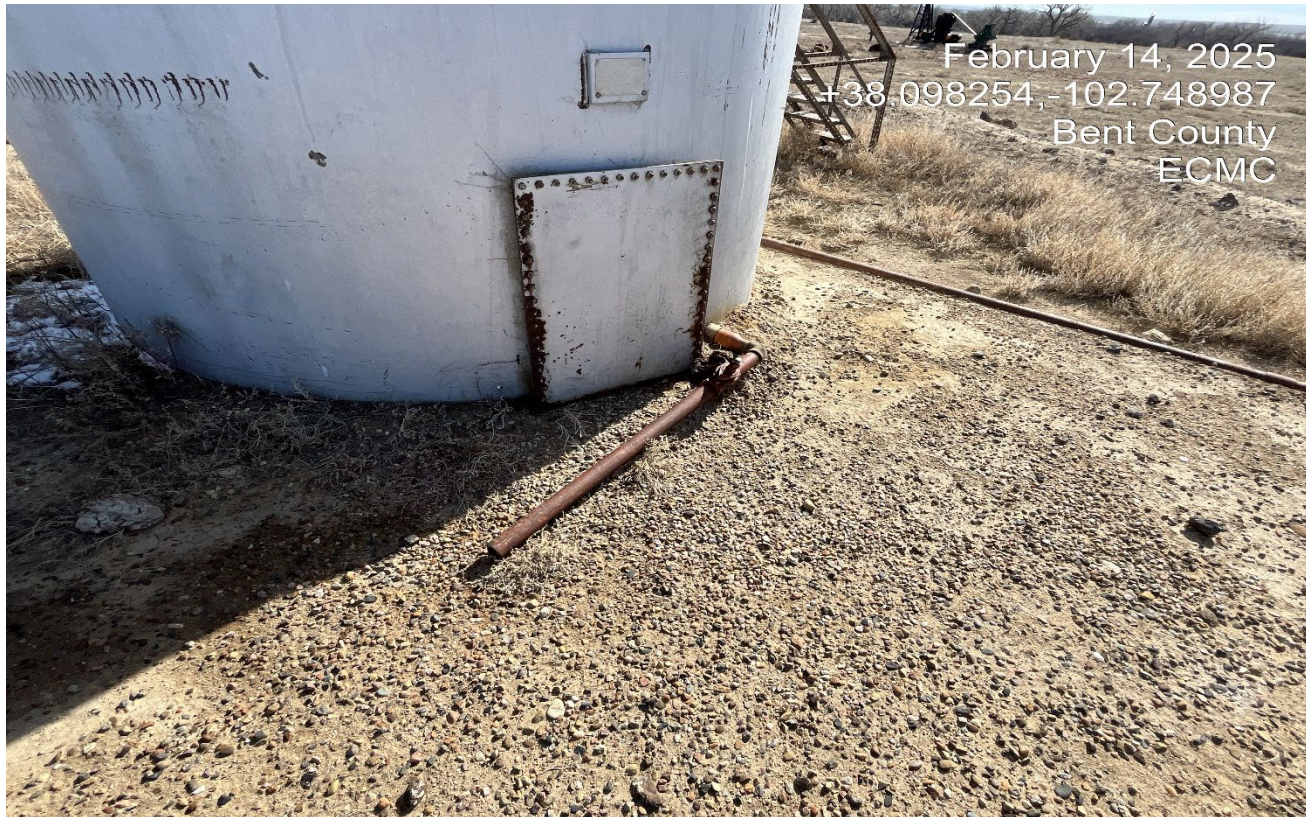
Photo 4. Stained soil have faded but still remain at the base of the tank.

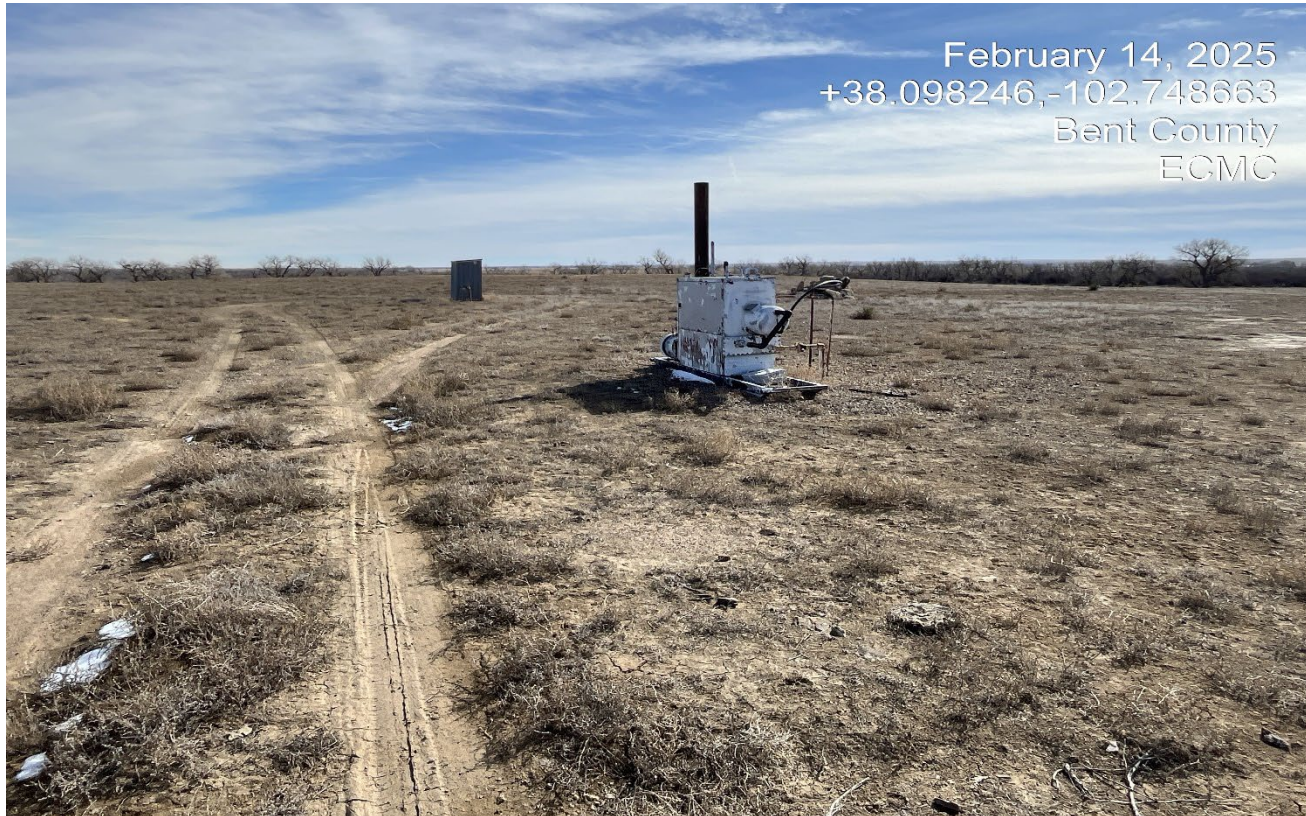
Photo 5. Facing east at the location.

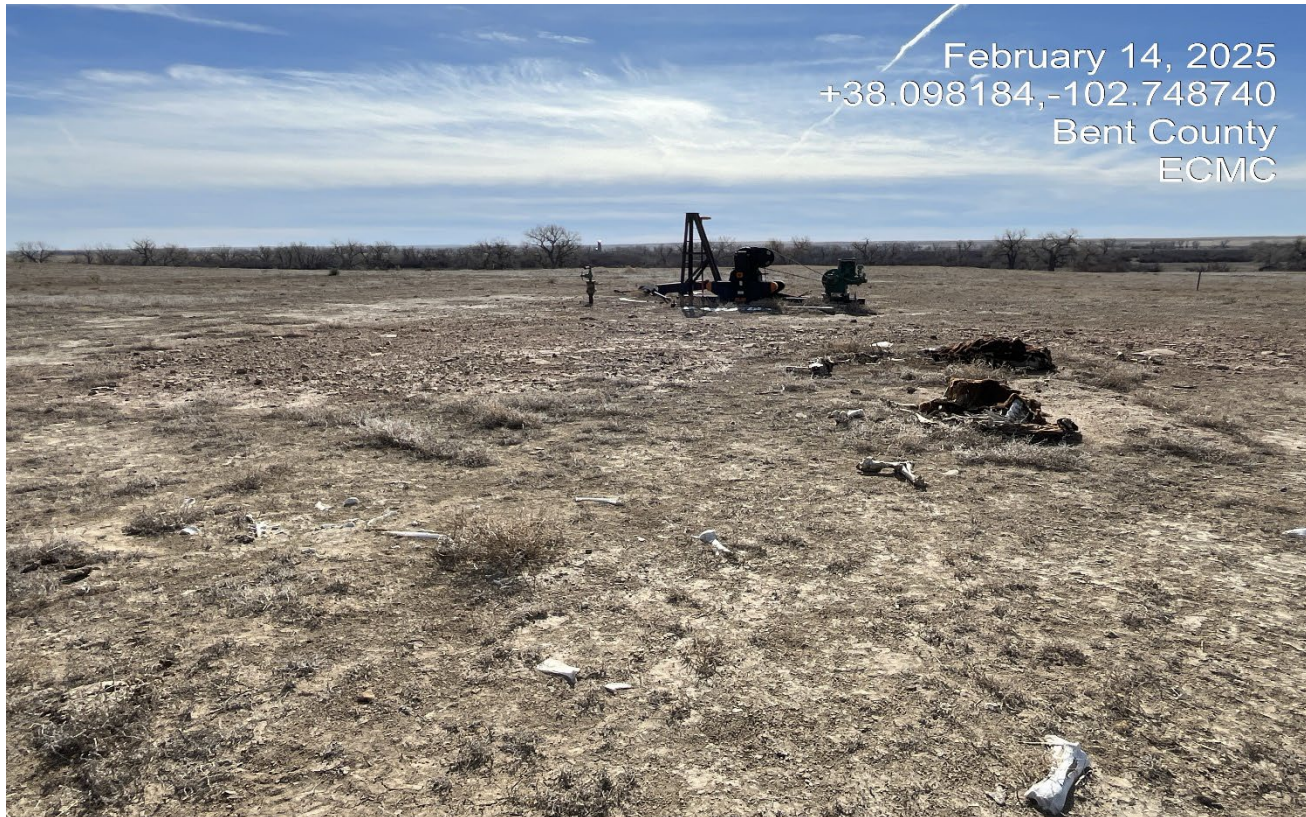
Photo 6. Facing north toward the well which is temporarily abandoned. Unused equipment needs to be removed.

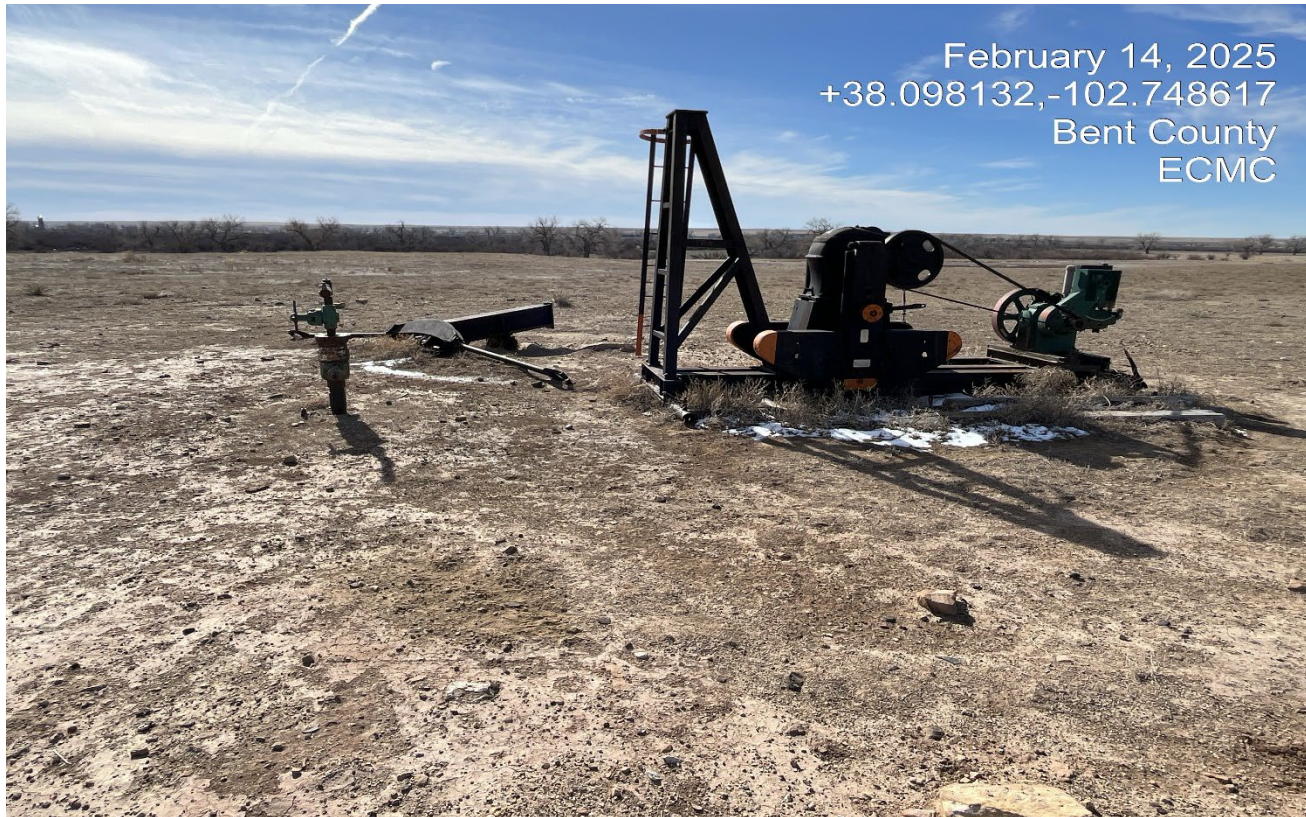
Photo 7. Facing north toward the TA'd well. The pumpjack and parts are unused equipment that need to be removed.

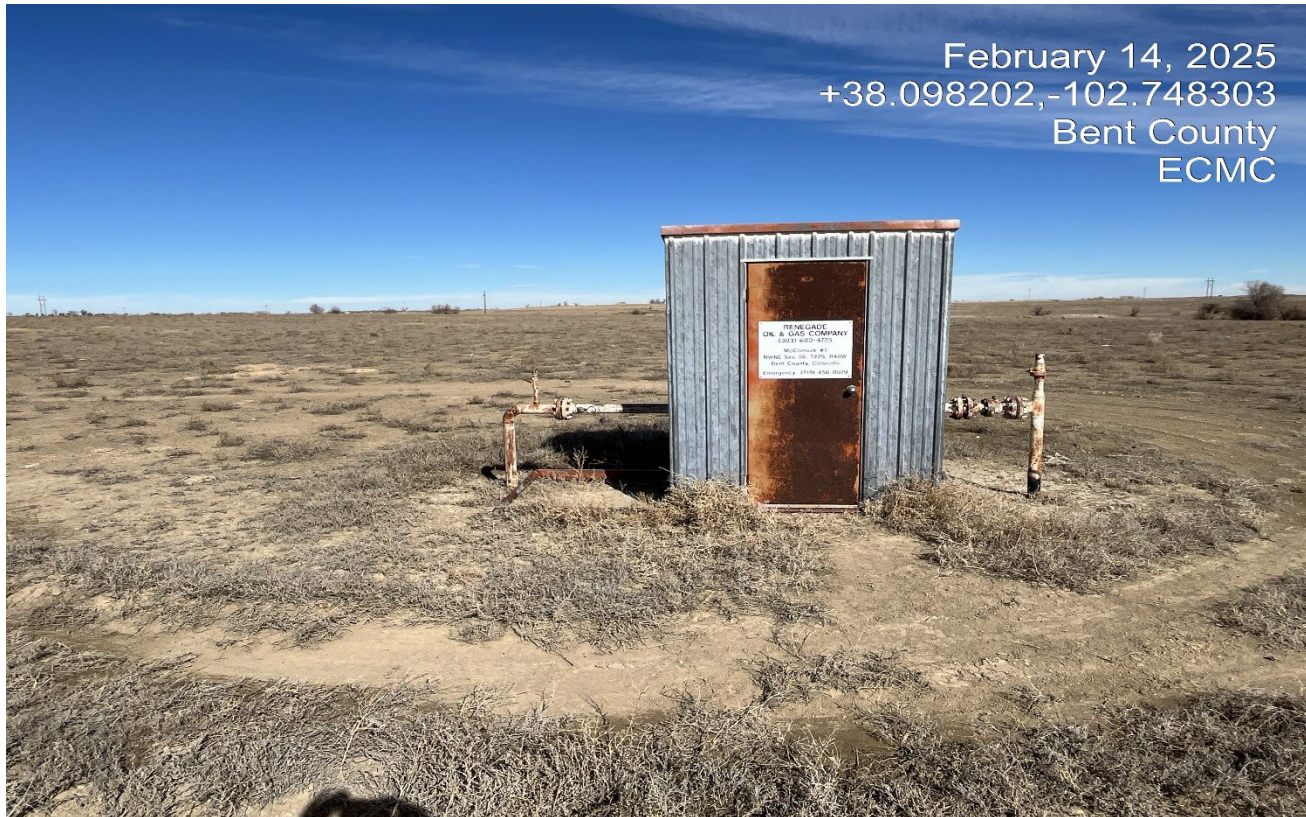
Photo 8. Well sign is posted at the meter shed. Emergency number is disconnected.
