# Inspection Photos

Operator: Simcoe LLC - 10749

Location ID: 325385

Inspection Photos  
Location Name: Smith 01-20 1  
Location ID: 325385

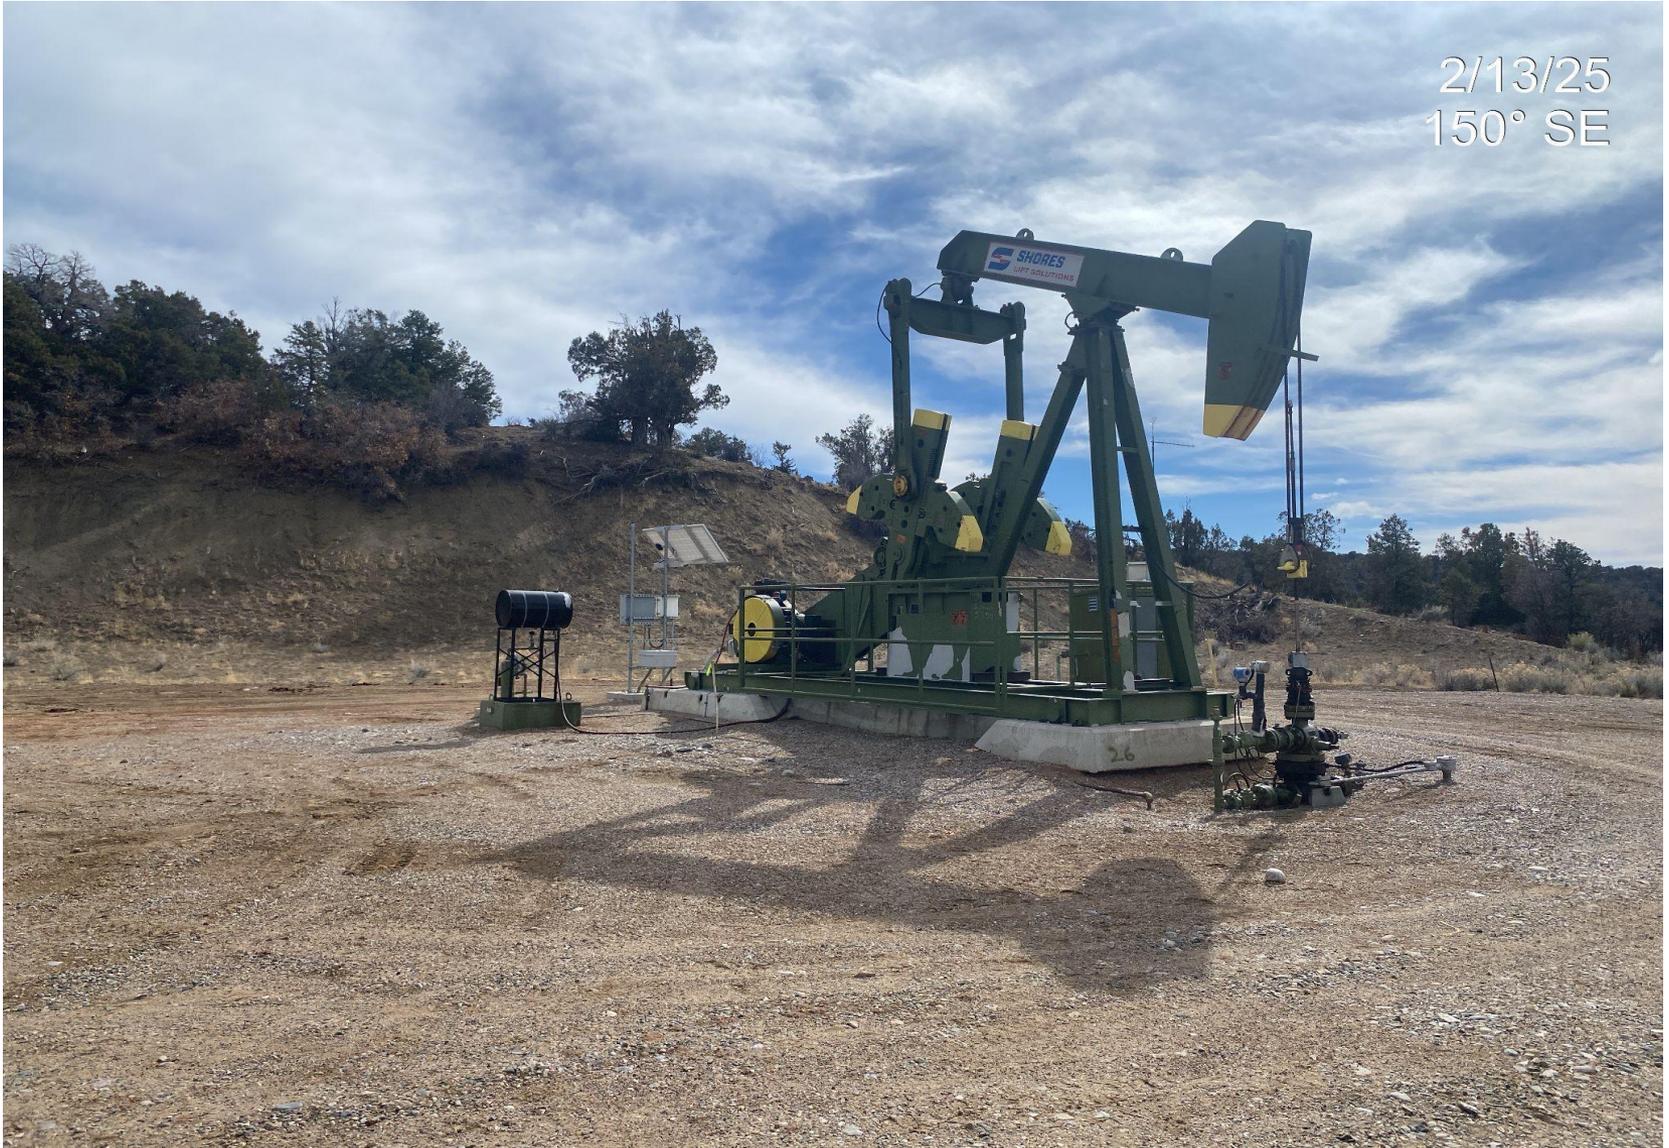
**Photo 1.** View of the well pad taken from the access point facing center.

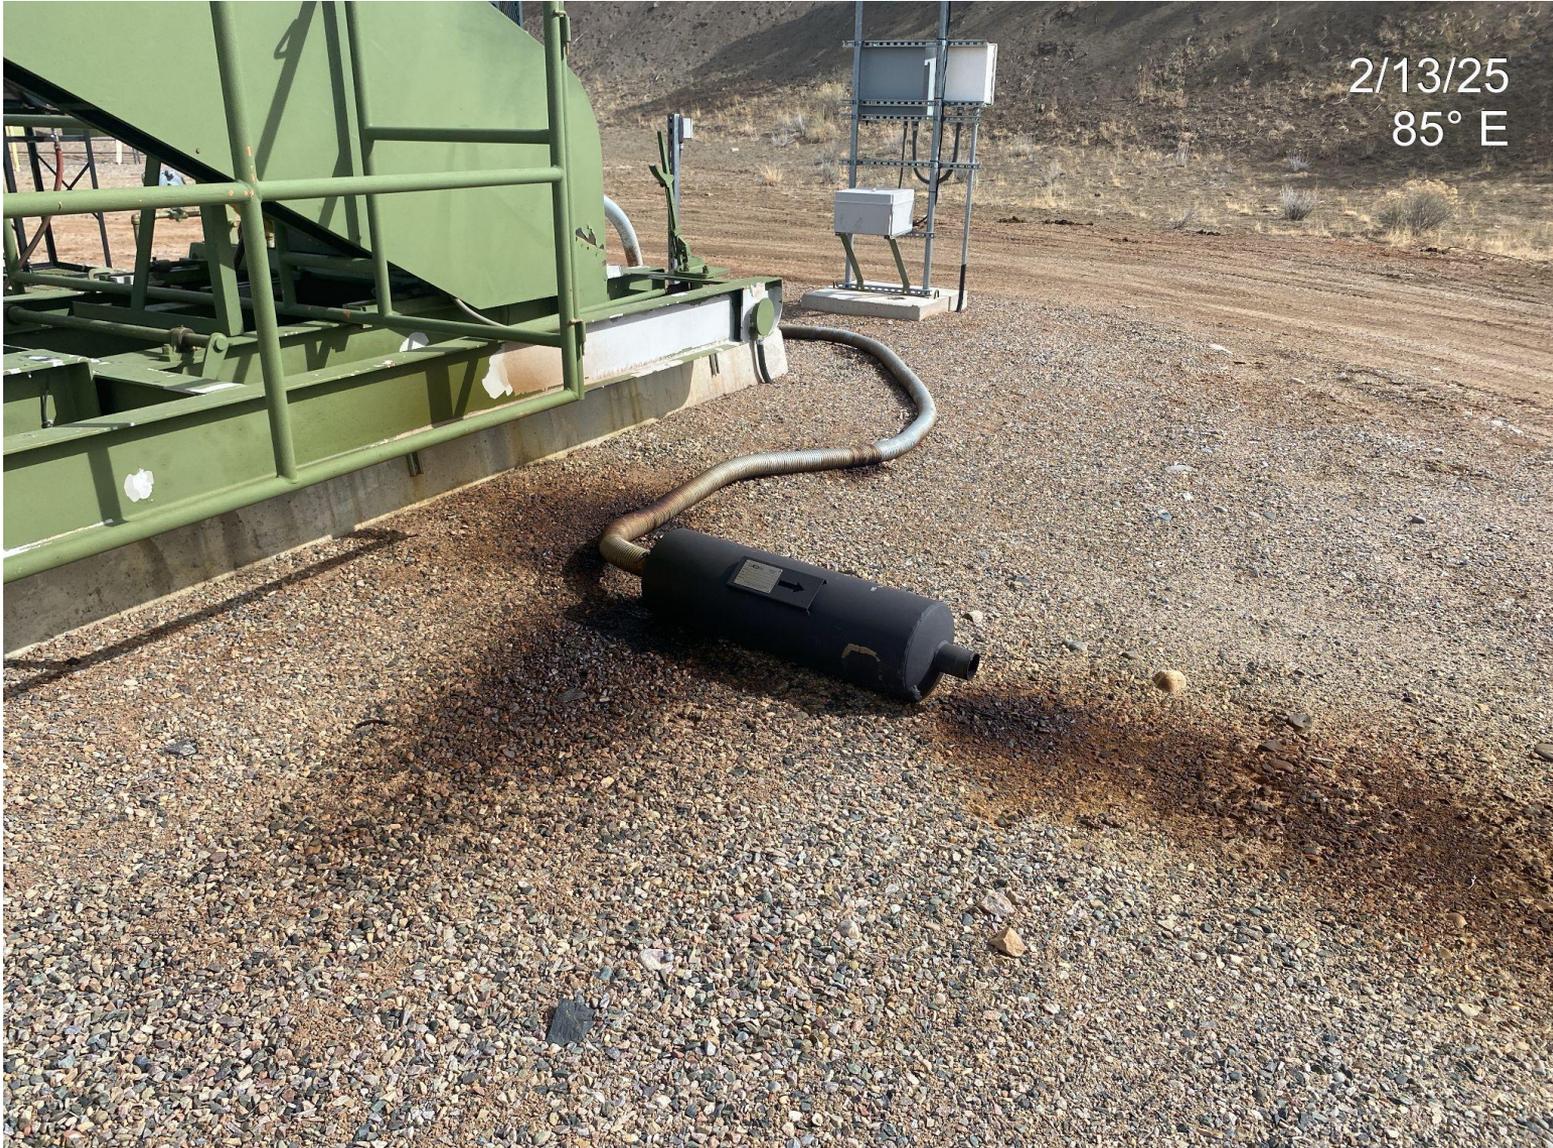
**Photo 2.** Stained soils at pump jack muffler.

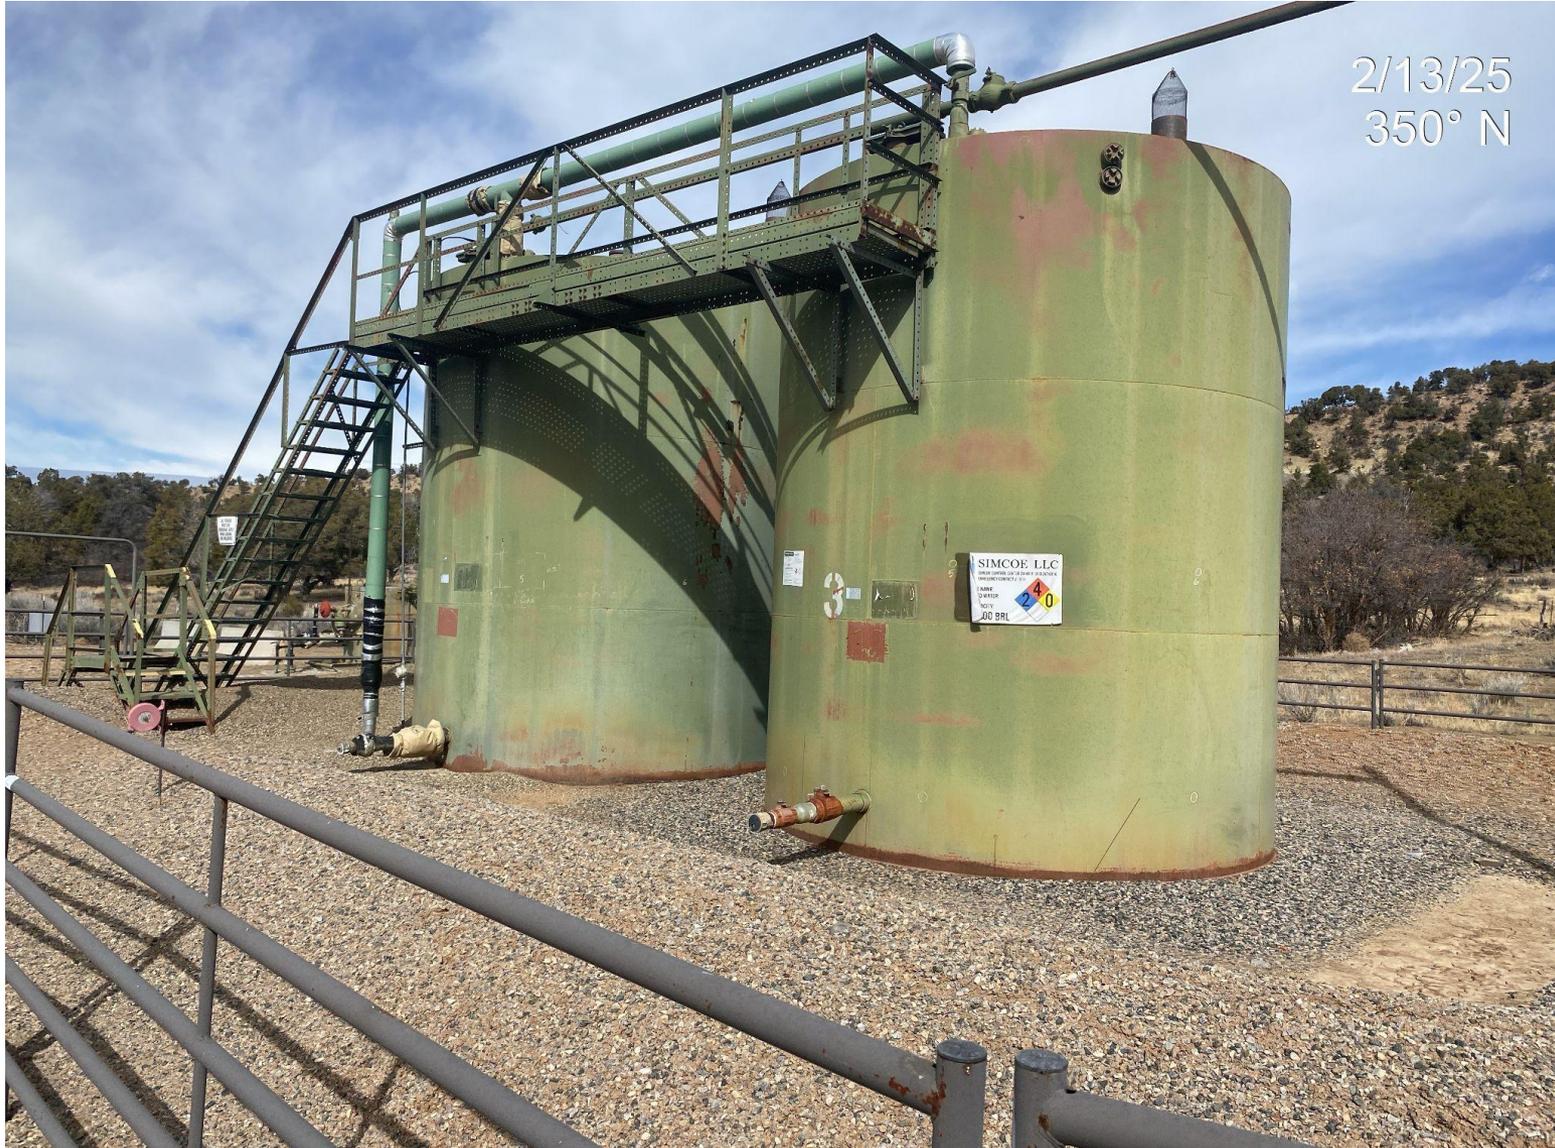
**Photo 3.** Labels at produced water tanks are starting to deteriorate, future maintenance is advised.

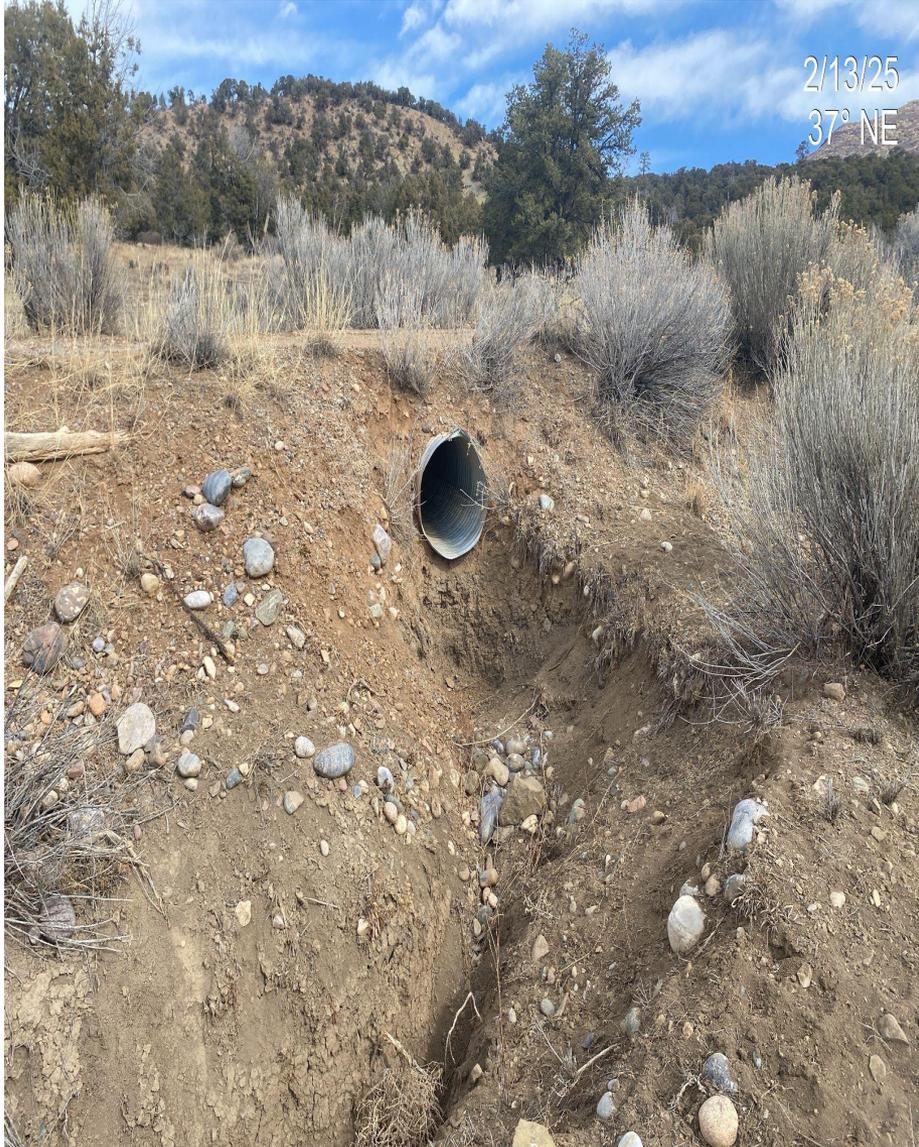
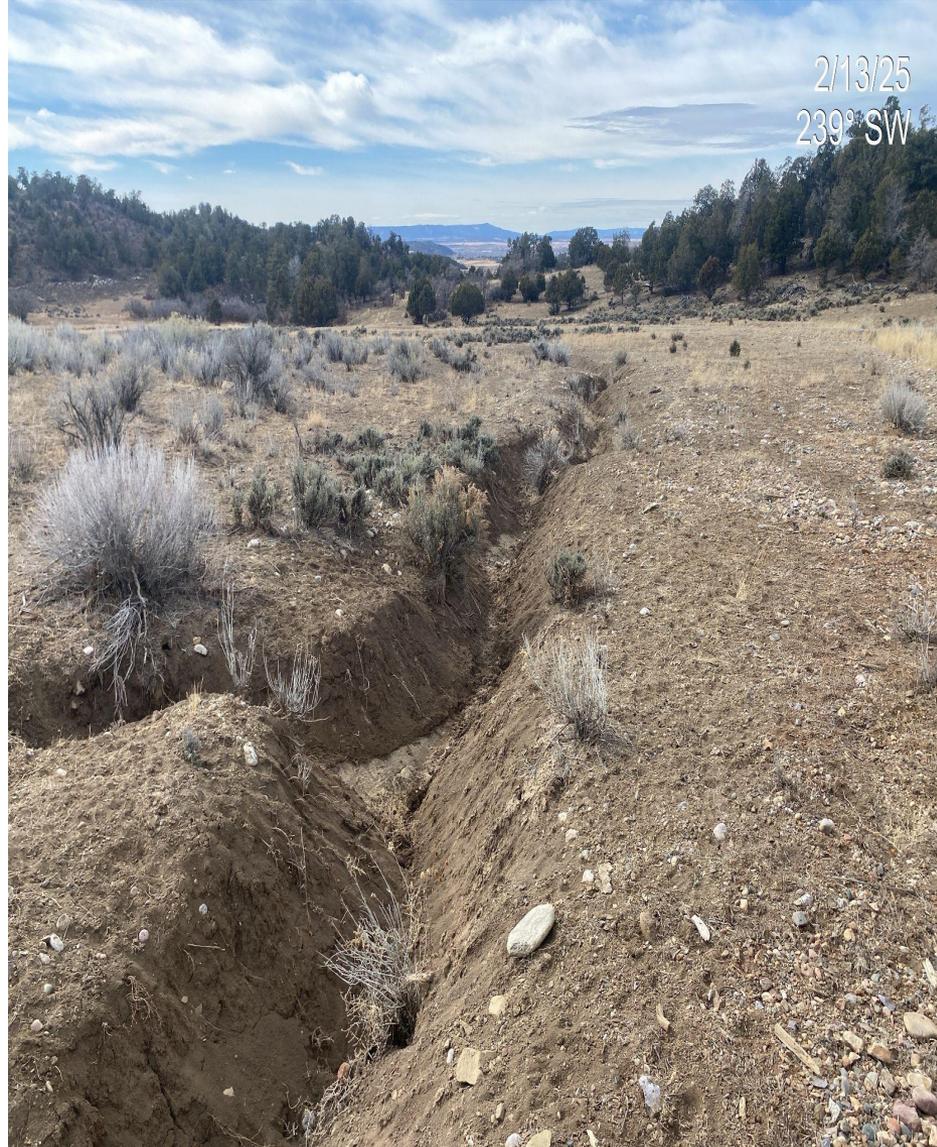
**Photo 4.** View of stormwater issues at access point culvert. Width of gully erosion has increased since previous inspection, head cut forming at culvert entrance. Additional stabilization measures/stormwater BMPs are needed.

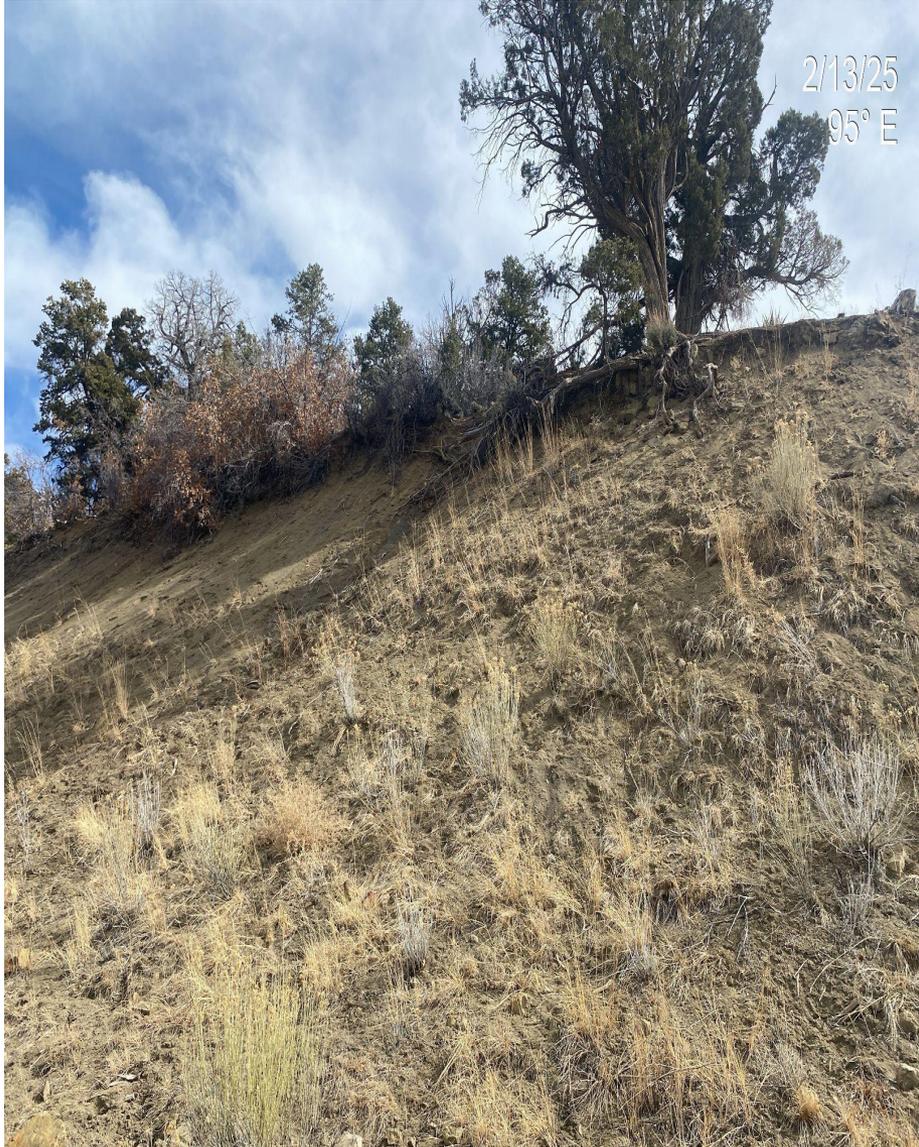
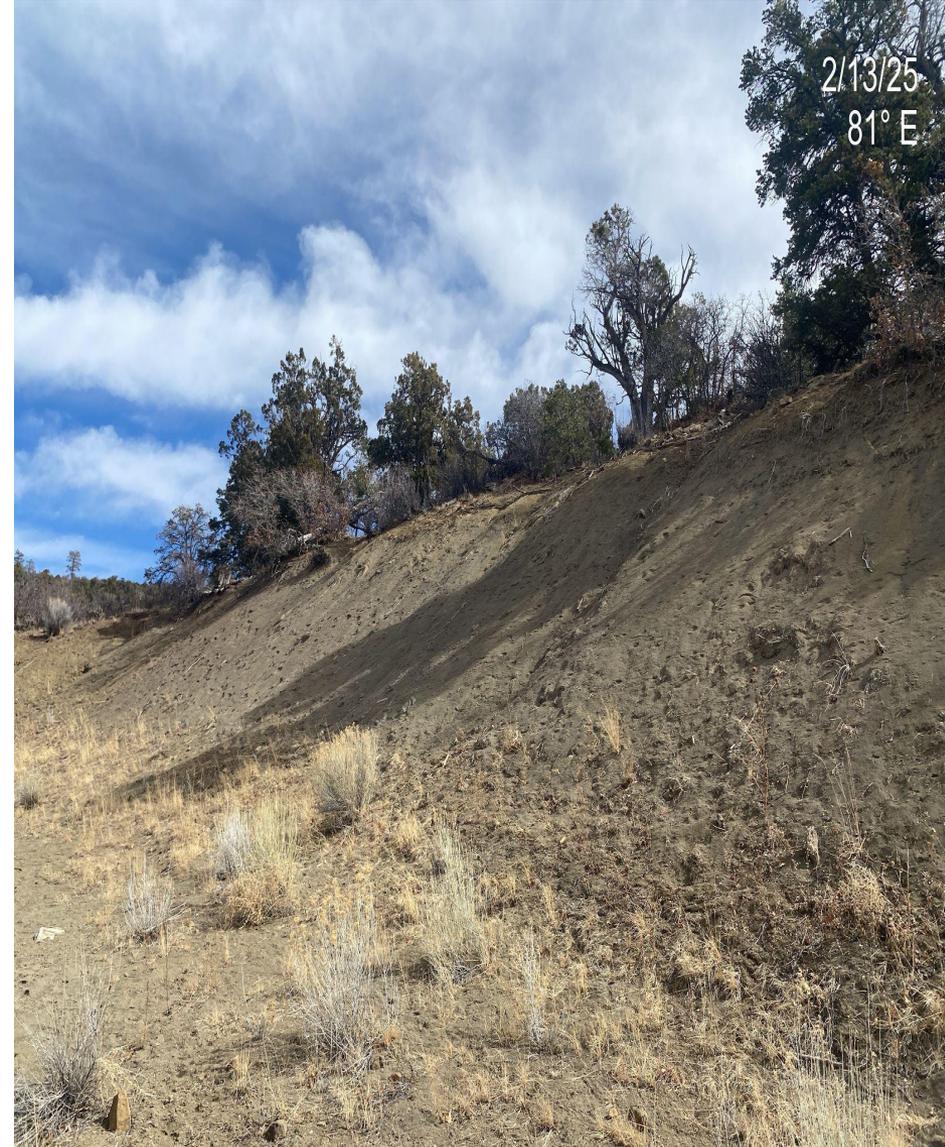
**Photo 5.** Portions of the cut slope and seeding efforts appear successful, portion of the cutslope remains with bare soils.

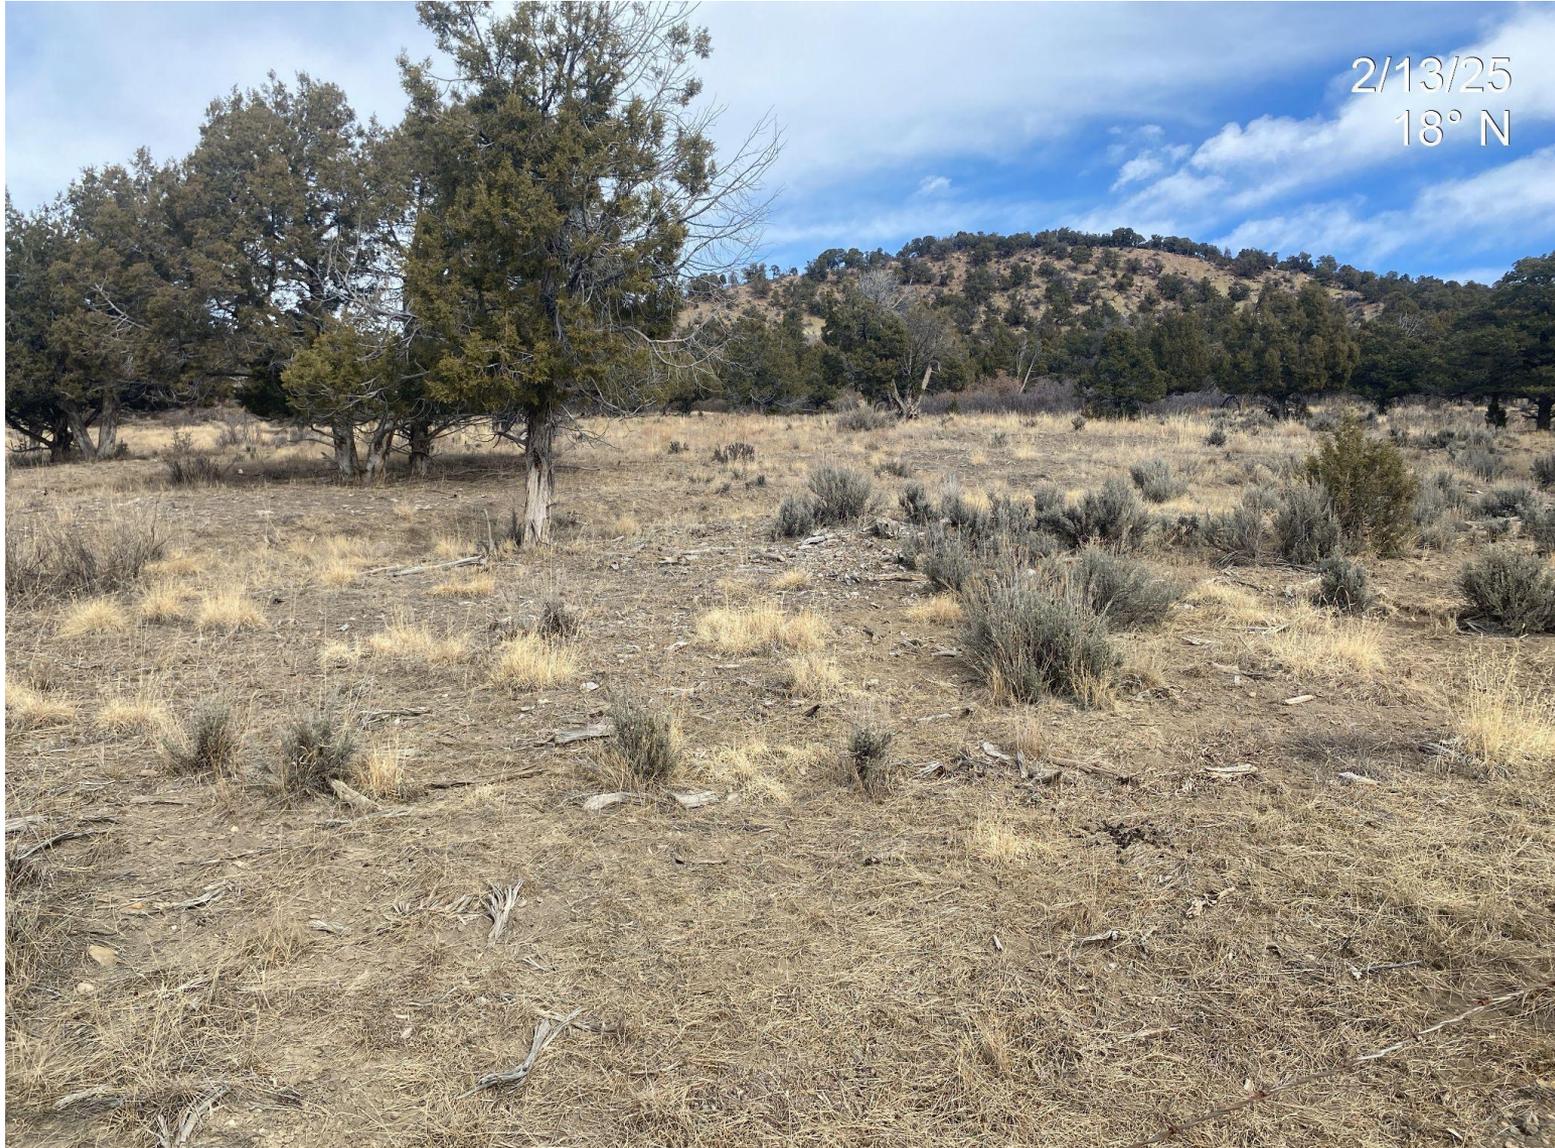
**Photo 6.** Reference area composed of Juniper, Sagebrush and Grama.
