Inspection Photos  
Location Name: Carl A Miller B #13  
Location ID: 318668

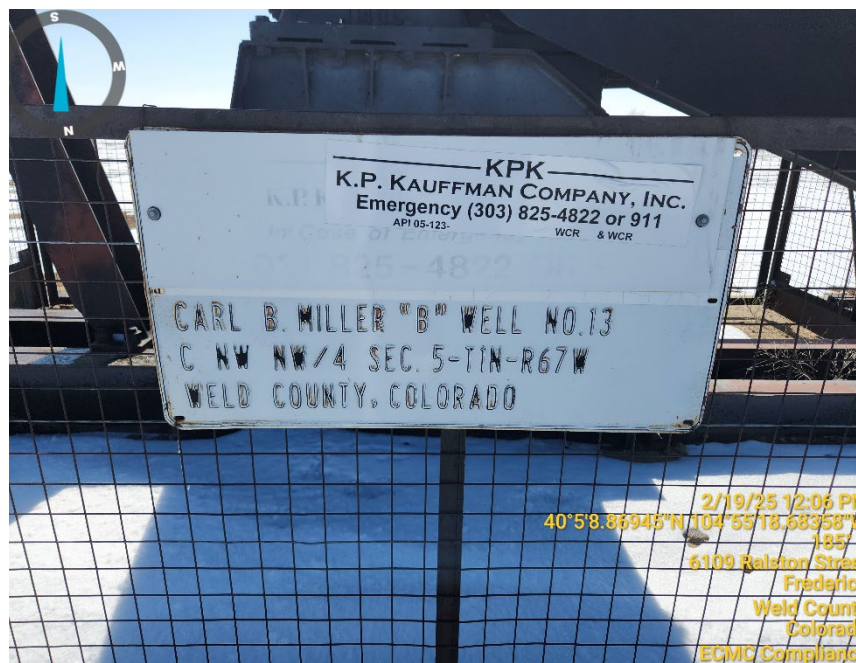
Photo 1: Wellhead Sign

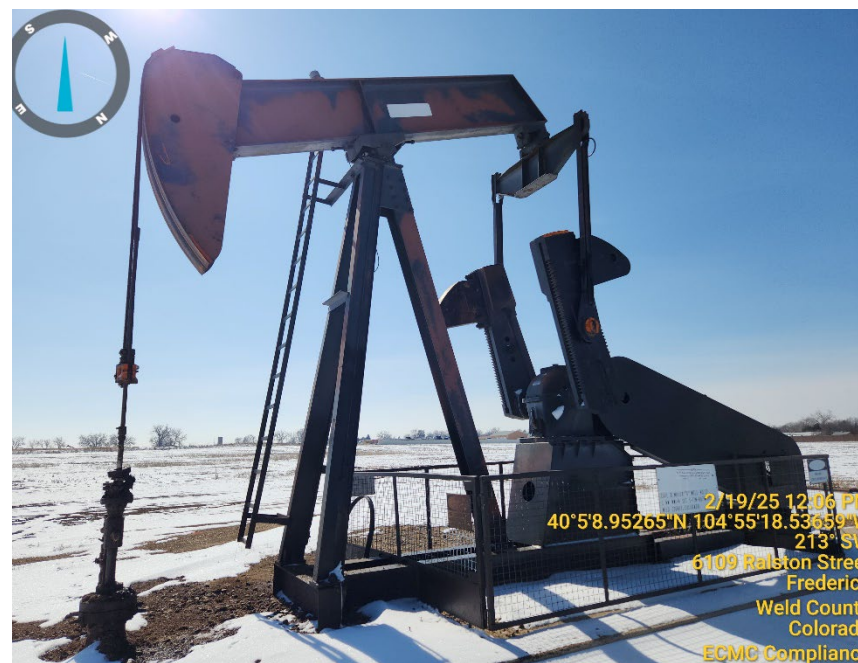
Photo 2: SI pumpjack

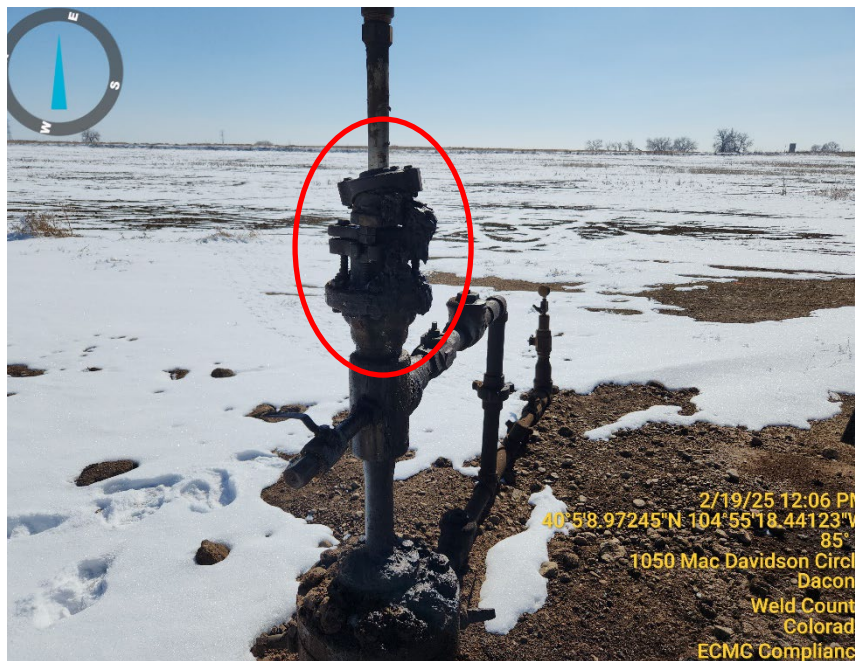
Photo 3: Possible leak, mechanical issue

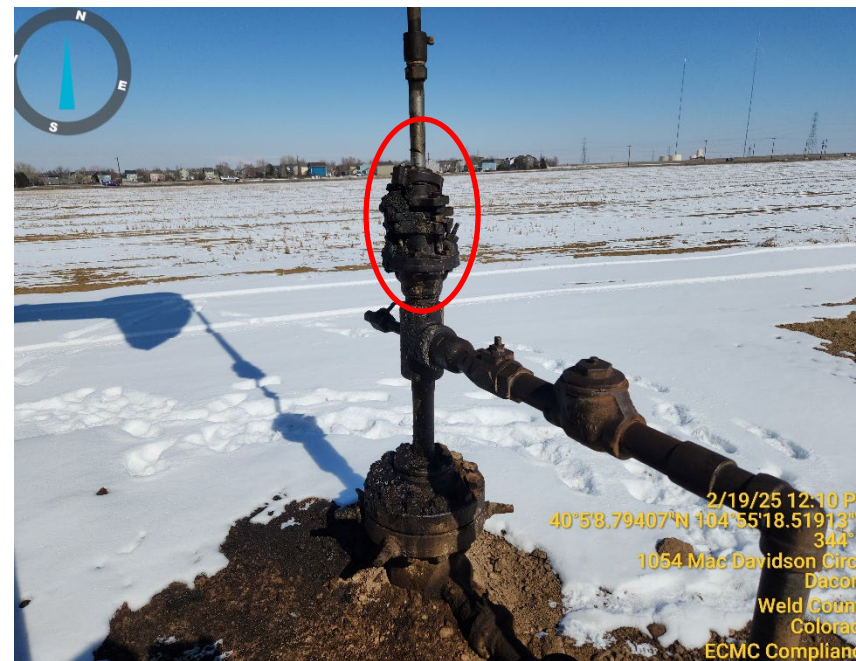
Photo 4: Possible leak, mechanical issue

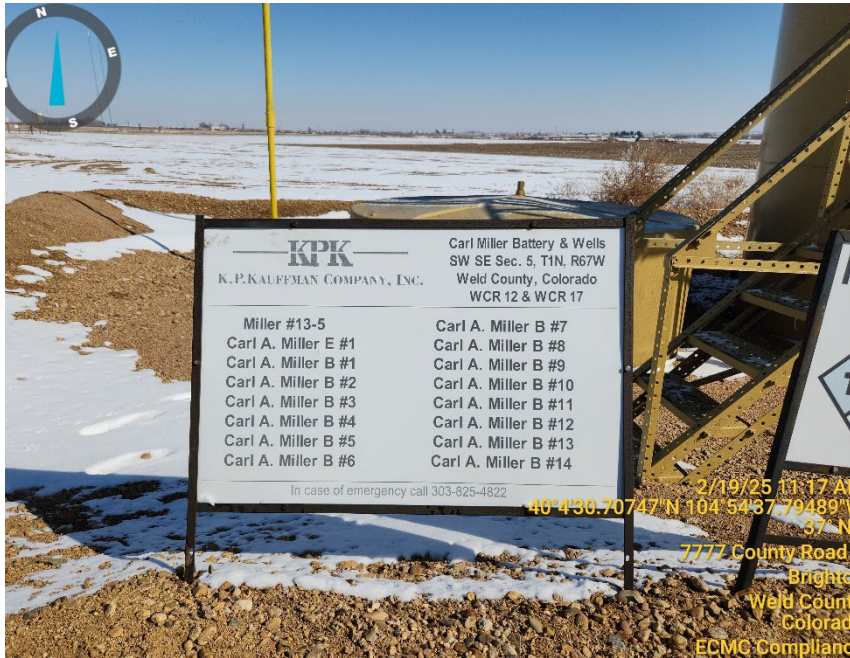
Photo 5: Tank Battery Sign

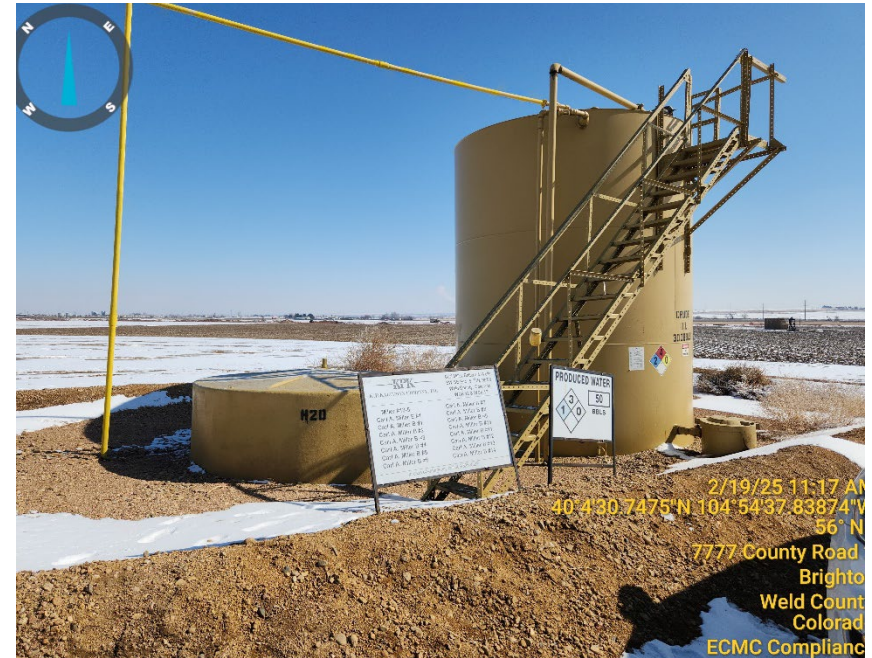
Photo 6: Centralized tank battery
