RMV 32-21: Condition of access road and pad surface. Pad is sufficiently stable for routine oil and gas operations. When ruts occur, they are routinely bladed out and rock (gravel) is added to the pad surface and access roads as needed. Driving a vehicle on a soft pad is unavoidable and it will leave minor tracks. However, minor tracking on the pad surface does not mean that the pad was improperly constructed, nor does it mean that the pad is unstable. TEP implements a robust storm water management and BMP repair program. We inspect, repair, and maintain our BMPs according to the schedule and frequency that is required by the rules, or as may be required by weather conditions.

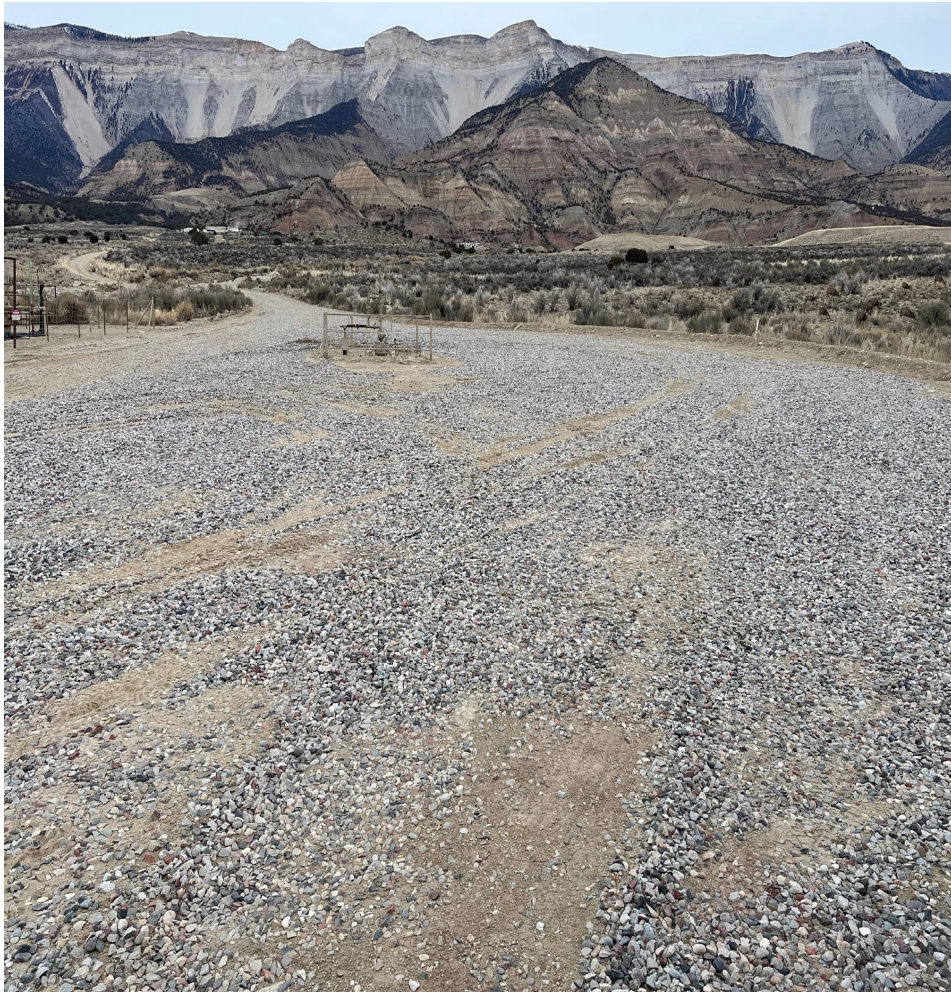
After

RMV 32-21: Pad has a good gravel surface. Note substantial earthen berm surrounds perimeter of the pad which minimizes amount of off-site sediment migration. Perimeter berms are an example of good engineering practices that effectively stabilize and protect the well location. An extensive vegetative buffer also exists beyond the berms which filter, trap, and slow the migration of any sediment from the pad.

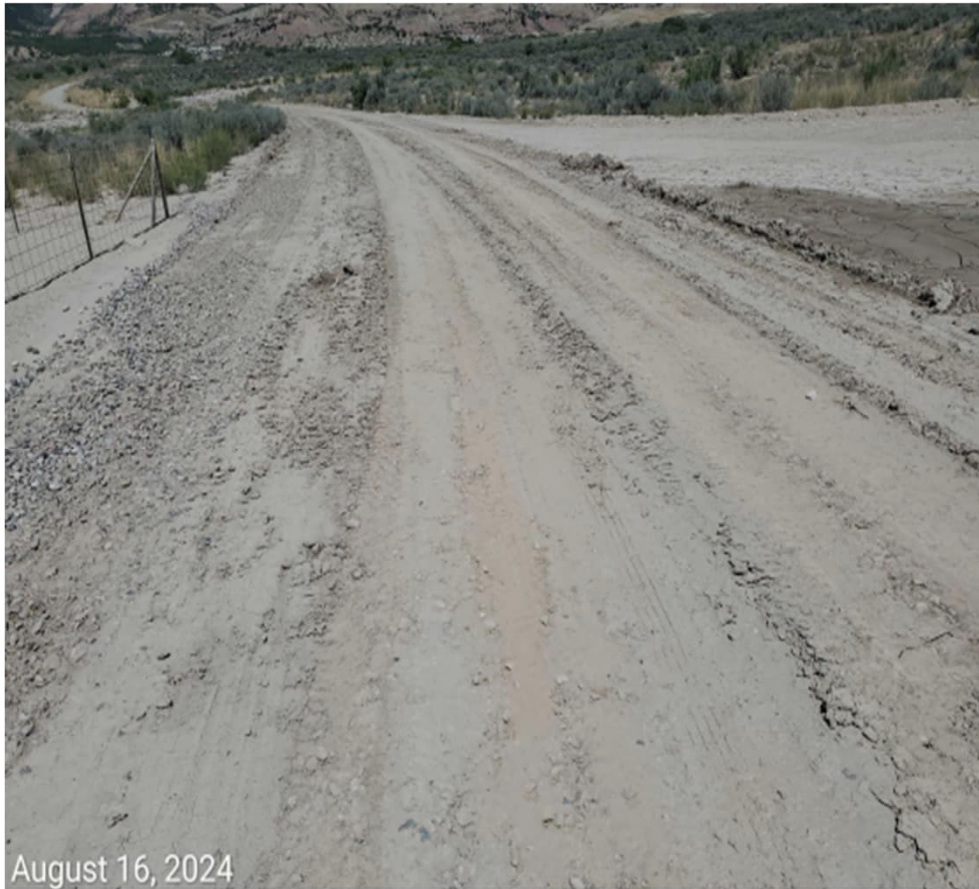
Before

RMV 32-21: The pad has a good gravel surface. This pad and access road have been safe and functional for many years despite the claims of the inspector. TEP continuously removes any sediment that is washed onto our pads and roads from off-site areas, and we inspect and repair our BMPs as needed to maintain access to our locations.

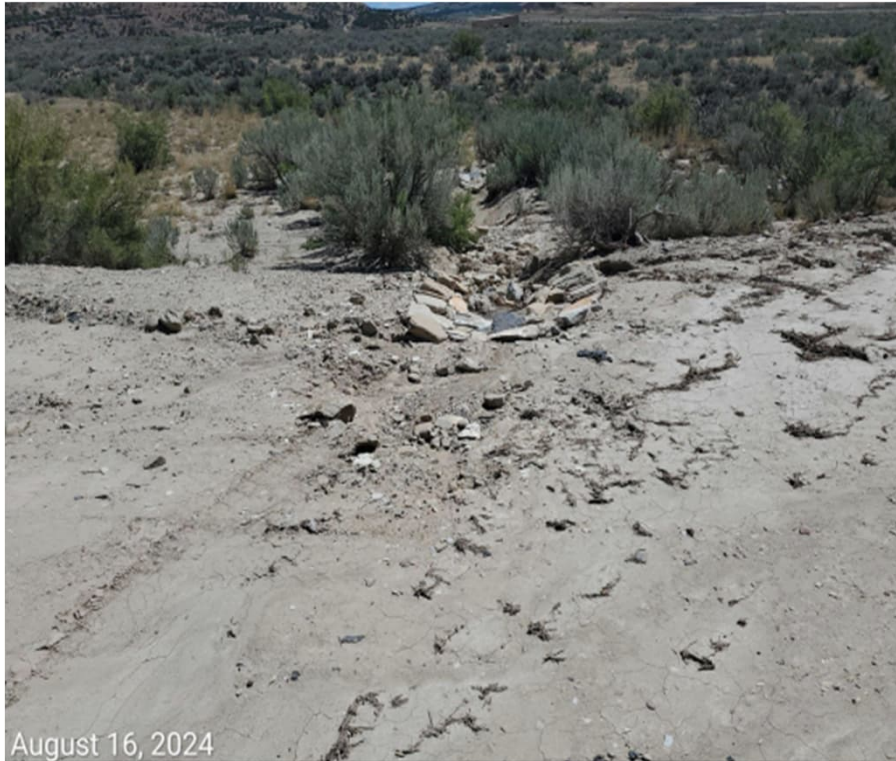
Before

RMV 32-21: Sediment trap on east end of pad has been maintained / repaired after heavy spring runoff conditions. Rilling has been repaired. Note: BMPs are designed to minimize and control runoff / sediment; they are not intended to prevent and eliminate sediment.

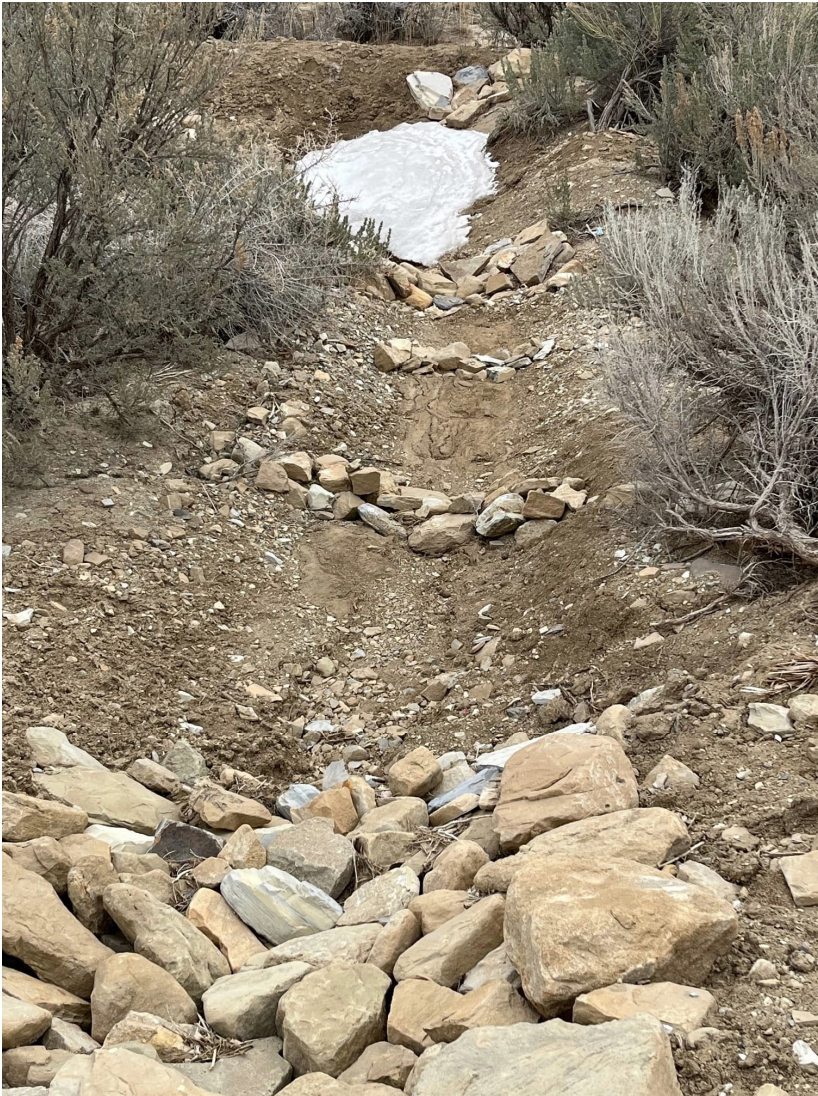
After

RMV 32-21: Rock Check Dams and Rock Outlets Added to Sediment Basin in Southeast Corner of Location.

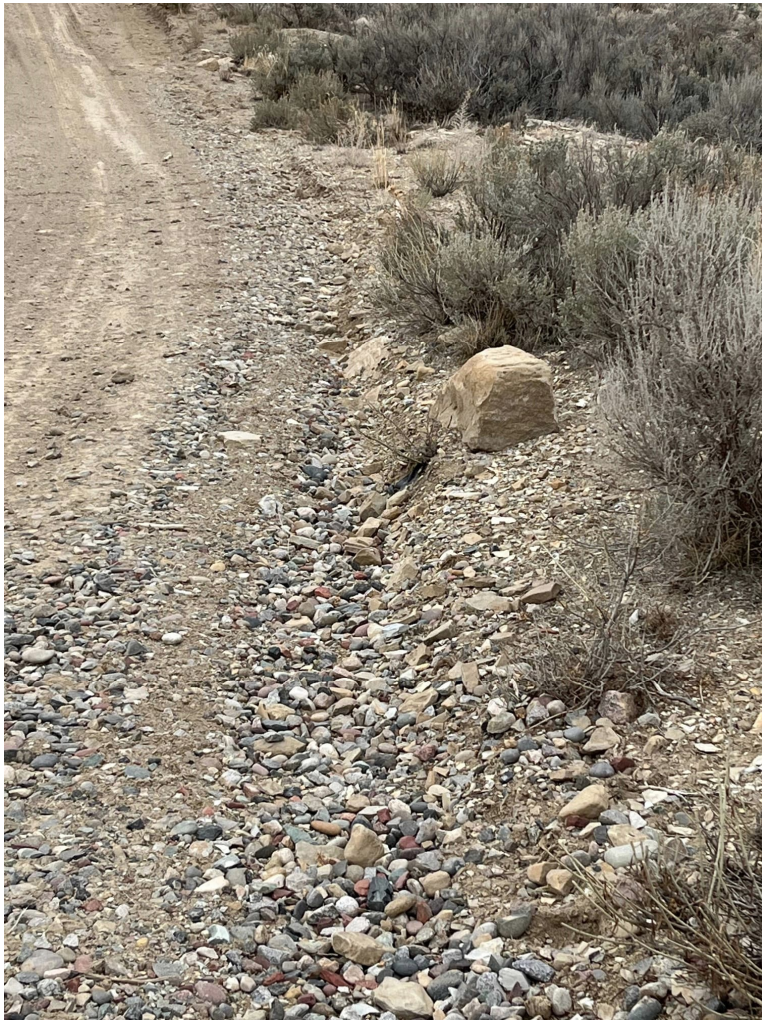
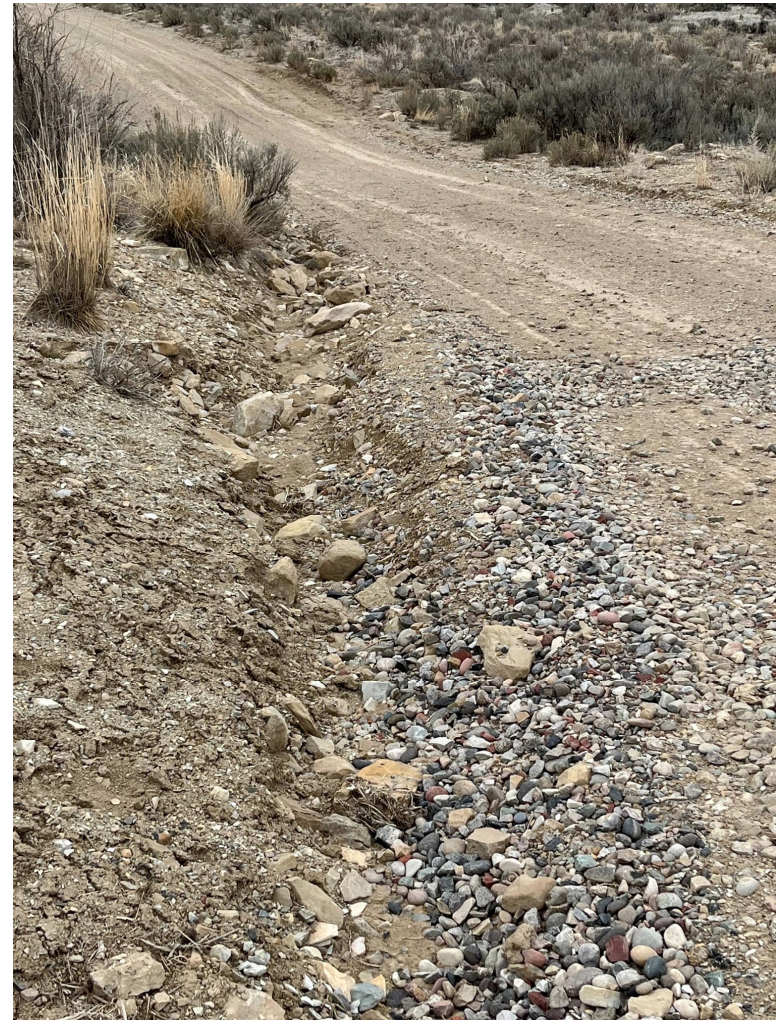
RMV 31-17: Good rock armoring of bar ditches along access road. This is an effective BMP that helps to minimize and control storm water runoff and sediment. The bar ditches and rock construction are evidence of good engineering practices and proper road construction techniques.

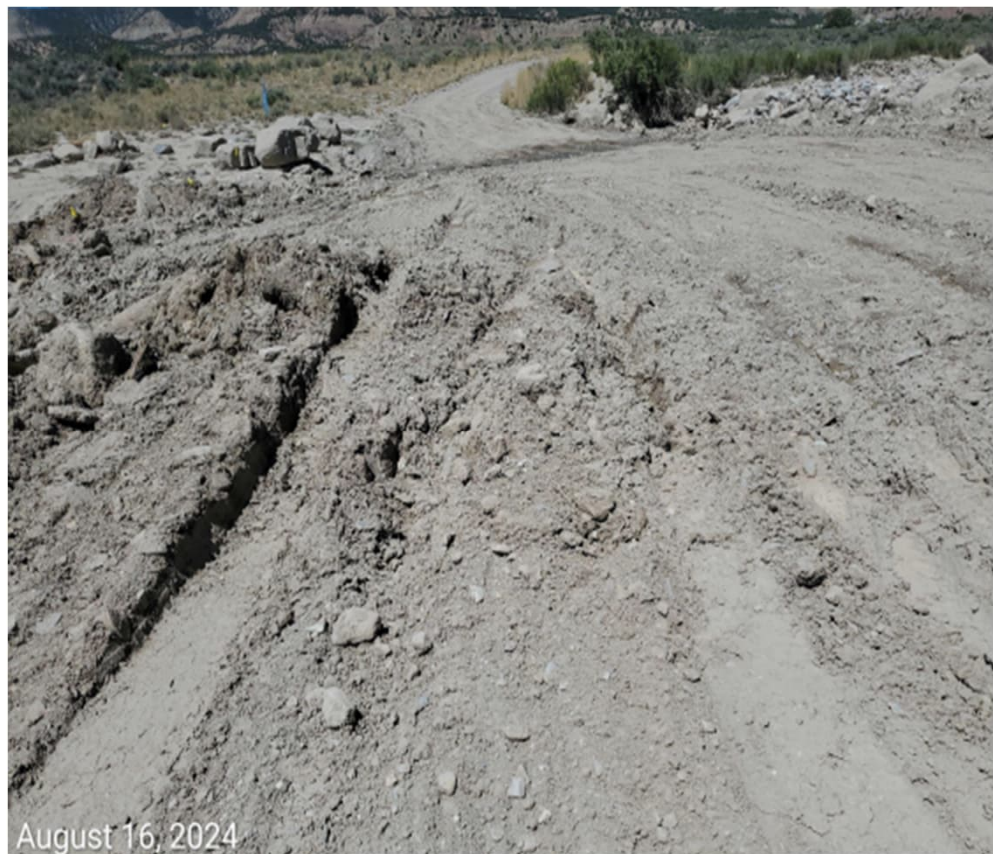
Before

Low Water Crossing Above the RMV 32-21 Pad: Rills and gully erosion have been repaired. Note that the low water crossing is approximately 7 feet higher in elevation than the RMV 32-21 well pad. The water crossing is located outside the actual well pad boundary. It is critical to our operations to maintain these crossings in a safe and functional condition.

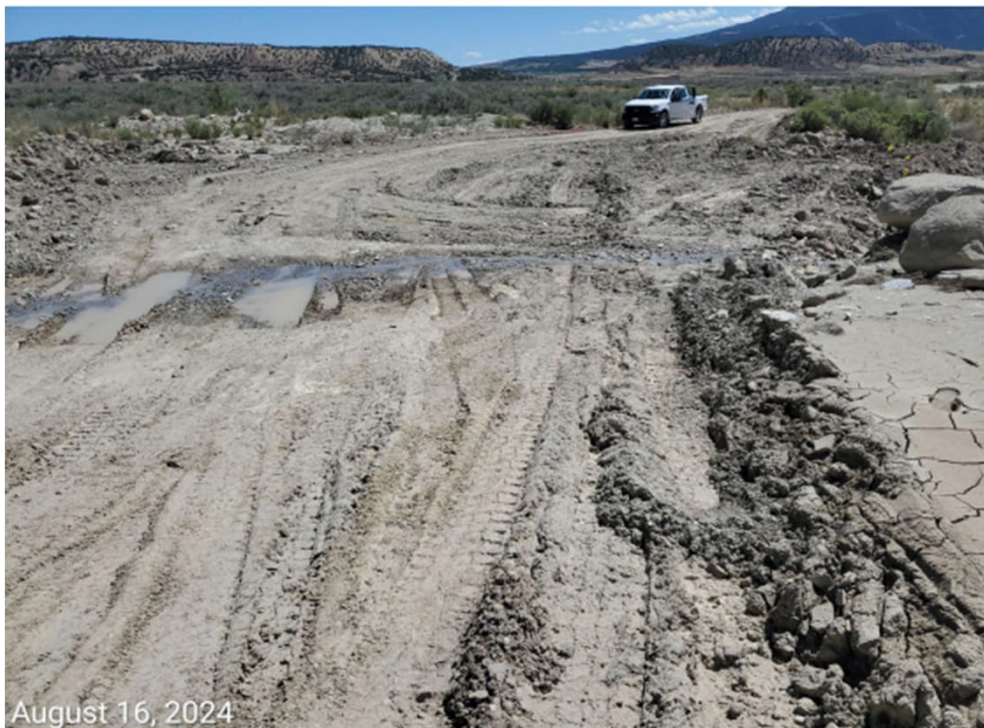
Before

Low Water Crossing Above the RMV 32-21 Well Pad: Rill erosion along edges of crossing has been repaired. Rock and sediment transported from upstream by snow melt and storm events have been removed and graded to allow for the safe passage of vehicles. This crossing has been used in this manner without any safety incidents or environmental impacts for at least 25 years. The U.S. Army Corps of Engineers has recently reviewed this specific crossing and has determined that the maintenance activities that periodically occur at this location do not need a permit, and that there is no adverse impact to water quality.
