Inspection Photos

Location Name: COCKROFT USX A-66N64W/11NWNE

Location #: 306461

Cockroft USX A 11-2 (123-24709) Wellsite

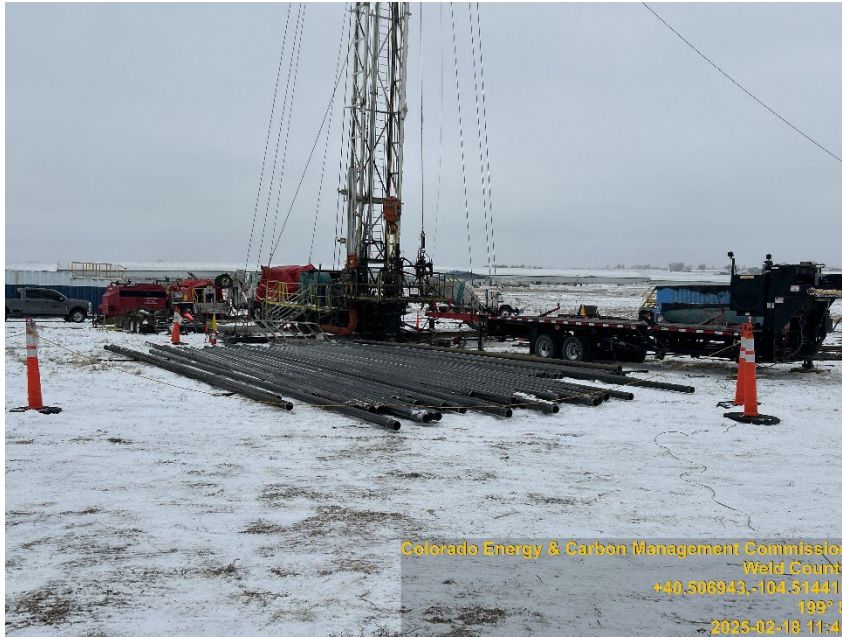
Photo #1

Plugged & Abandoned | PA

Plugging Ops; Cementing: cmt-surf

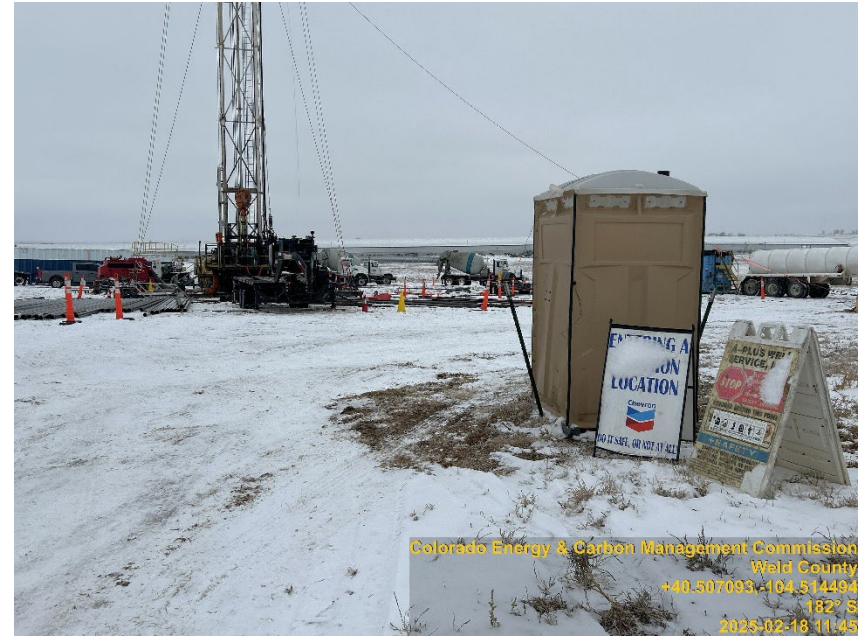
Photo #2

Cockroft USX A 11-2 Wellsite

Plugged & Abandoned | PA

Plugging Ops; Cementing: cmt-surf

Site safety signage

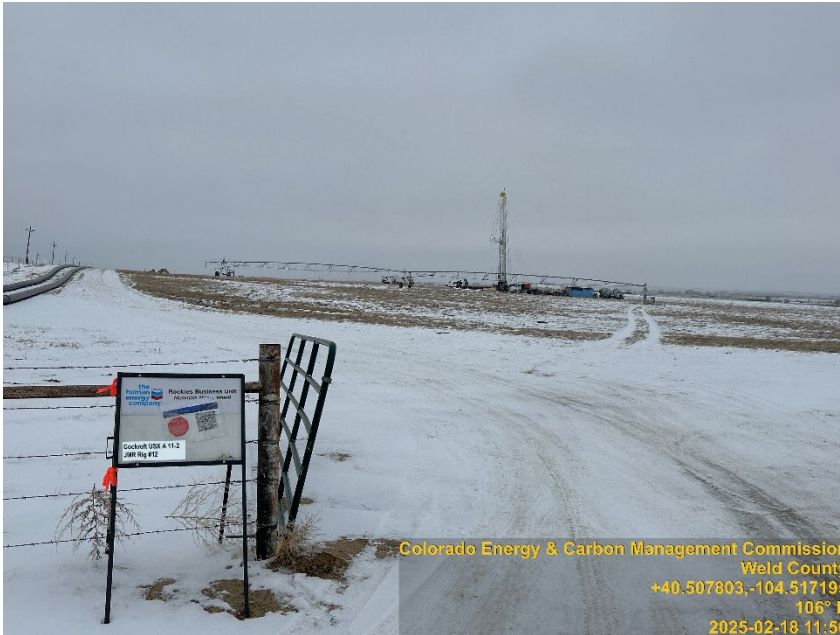
Photo #3
Cockroft USX A 11-2 Wellsite
Plugged & Abandoned | PA
Plugging Ops; Cementing: cmt-surf
Wellsite entrance

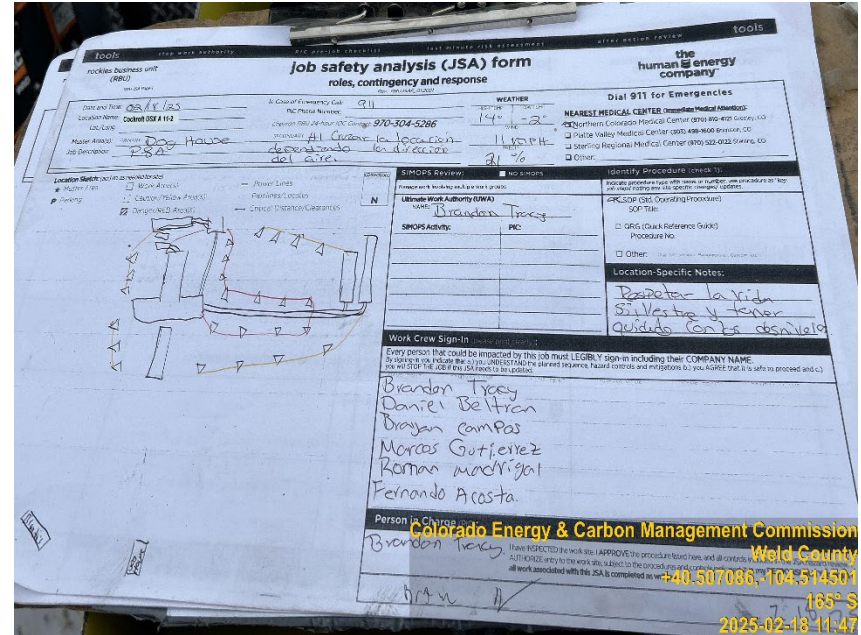
Photo #4
Cockroft USX A 11-2 Wellsite
Plugged & Abandoned | PA
Plugging Ops; Cementing: cmt-surf
JSA: 2025-02-18
