**Antler Energy LLC
Baggs Land & Cattle 1
Location ID: 312868**

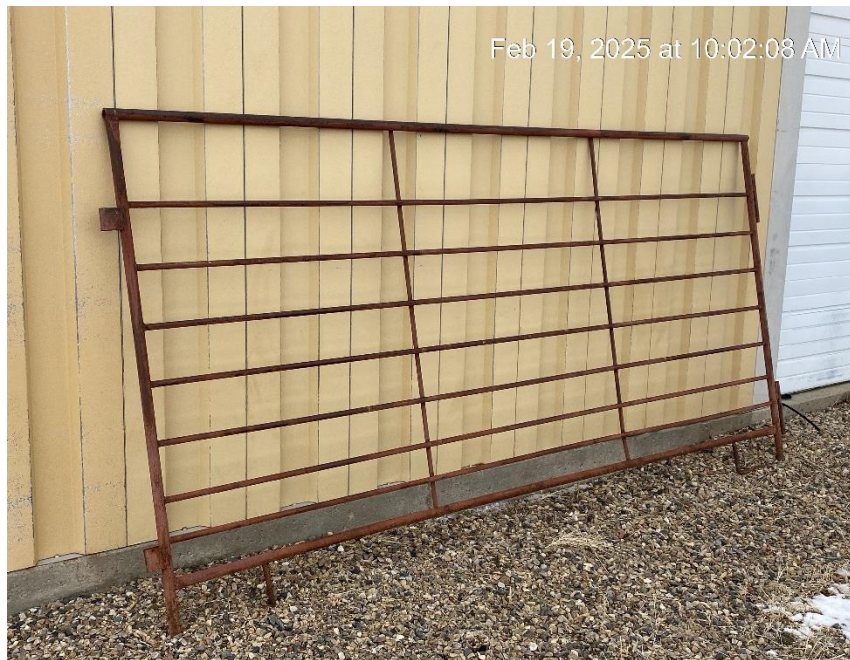
Debris

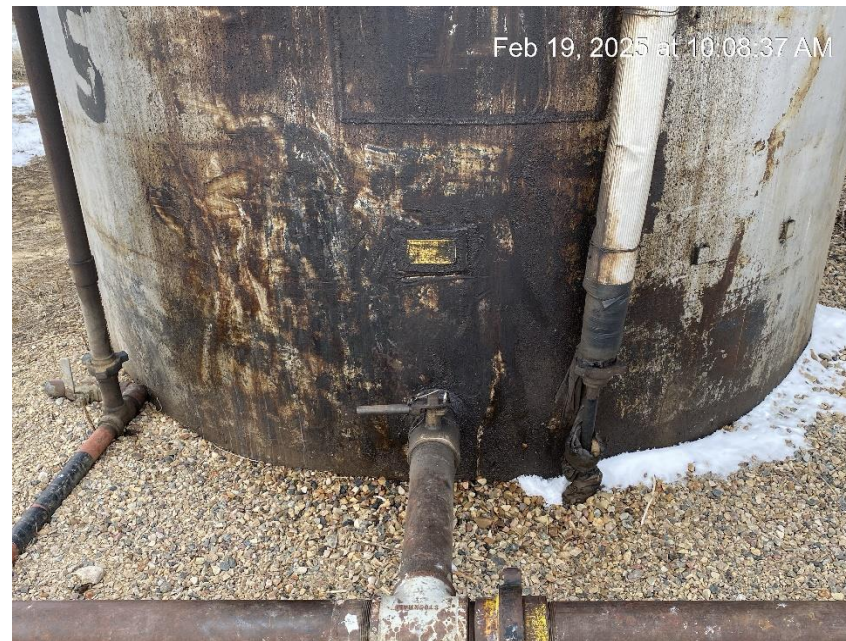
Oily waste and staining around tanks

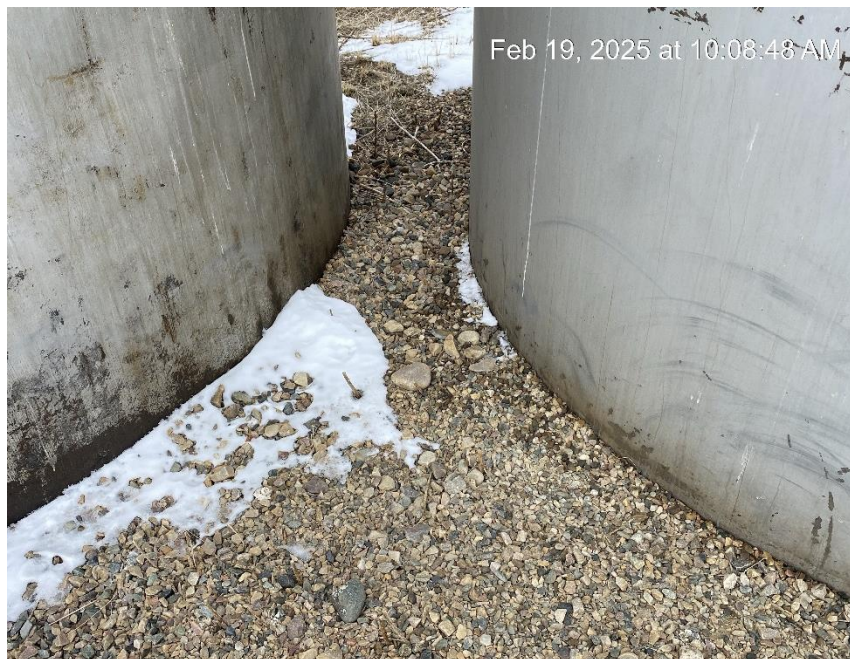
Staining around tanks

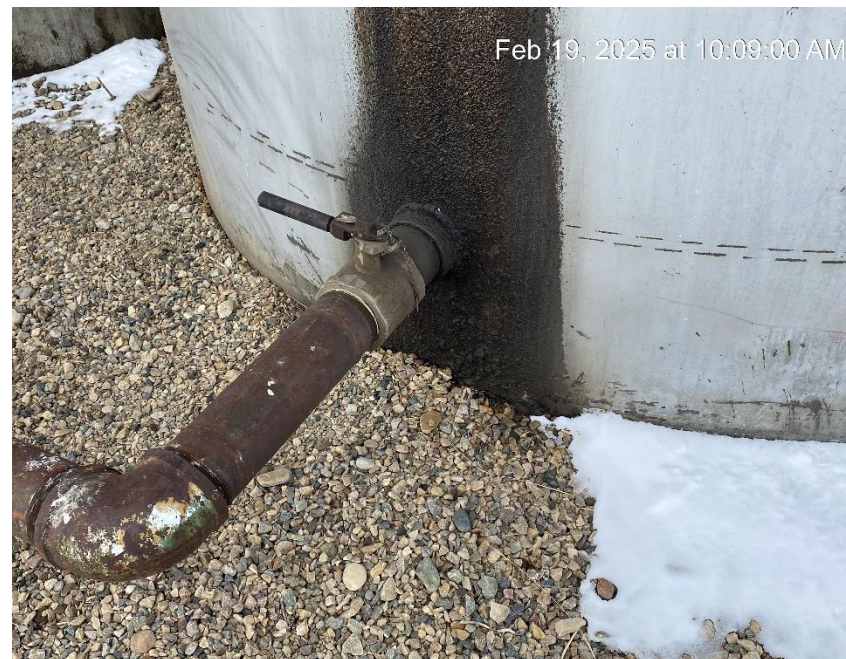
Staining around tanks

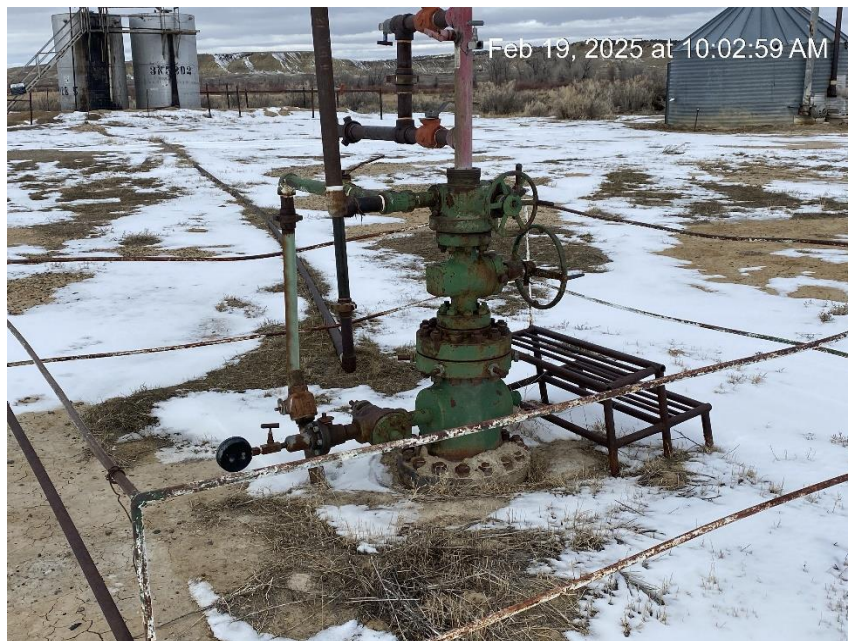
Blow down line to tank missing back pressure valve

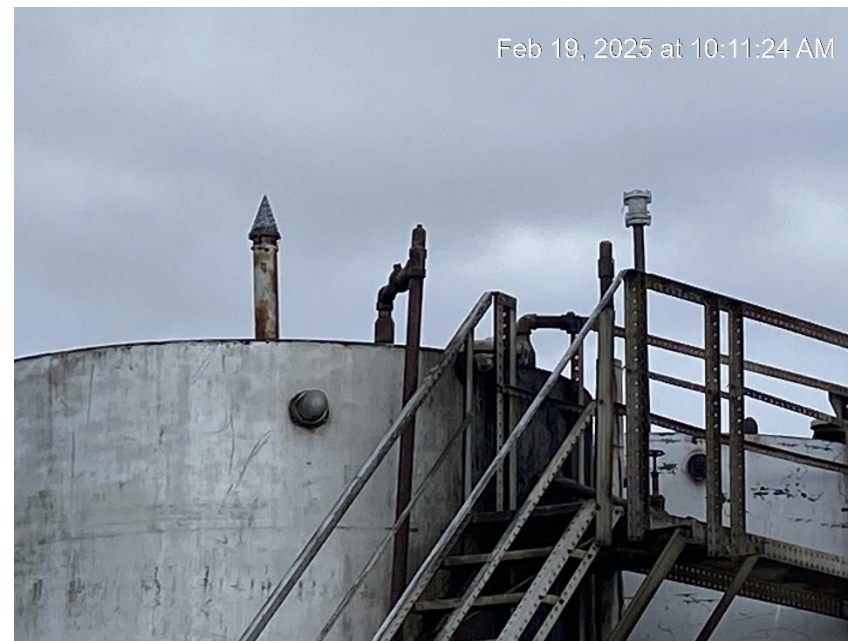
Tank venting to atmosphere

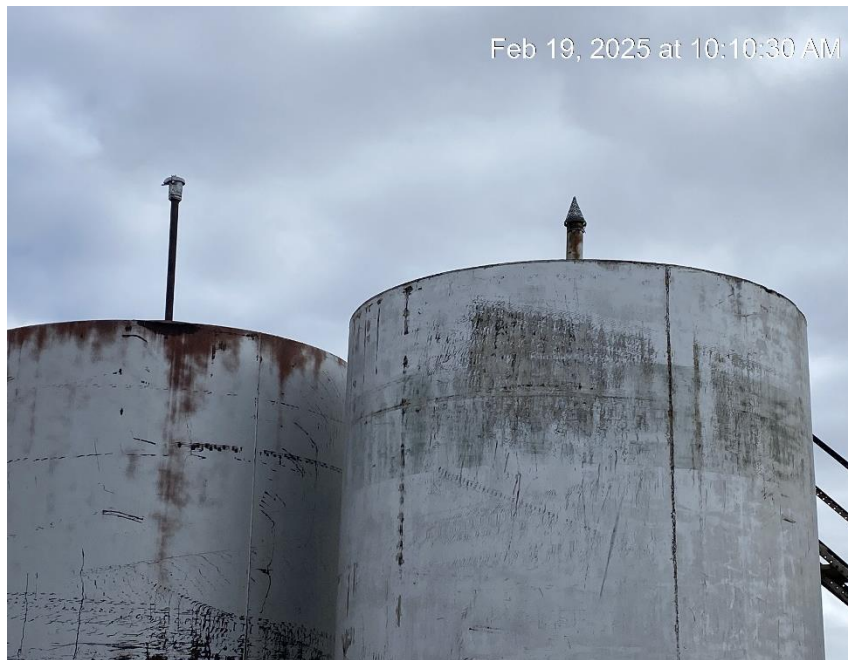
Tank missing pressure relief valve
