Final Reclamation Complete Notice – Cropland Drone Imagery

PERMIT CLOSURE REPORT – CROPLAND

Location ID 305240

Location Name Park/33-4 Pad

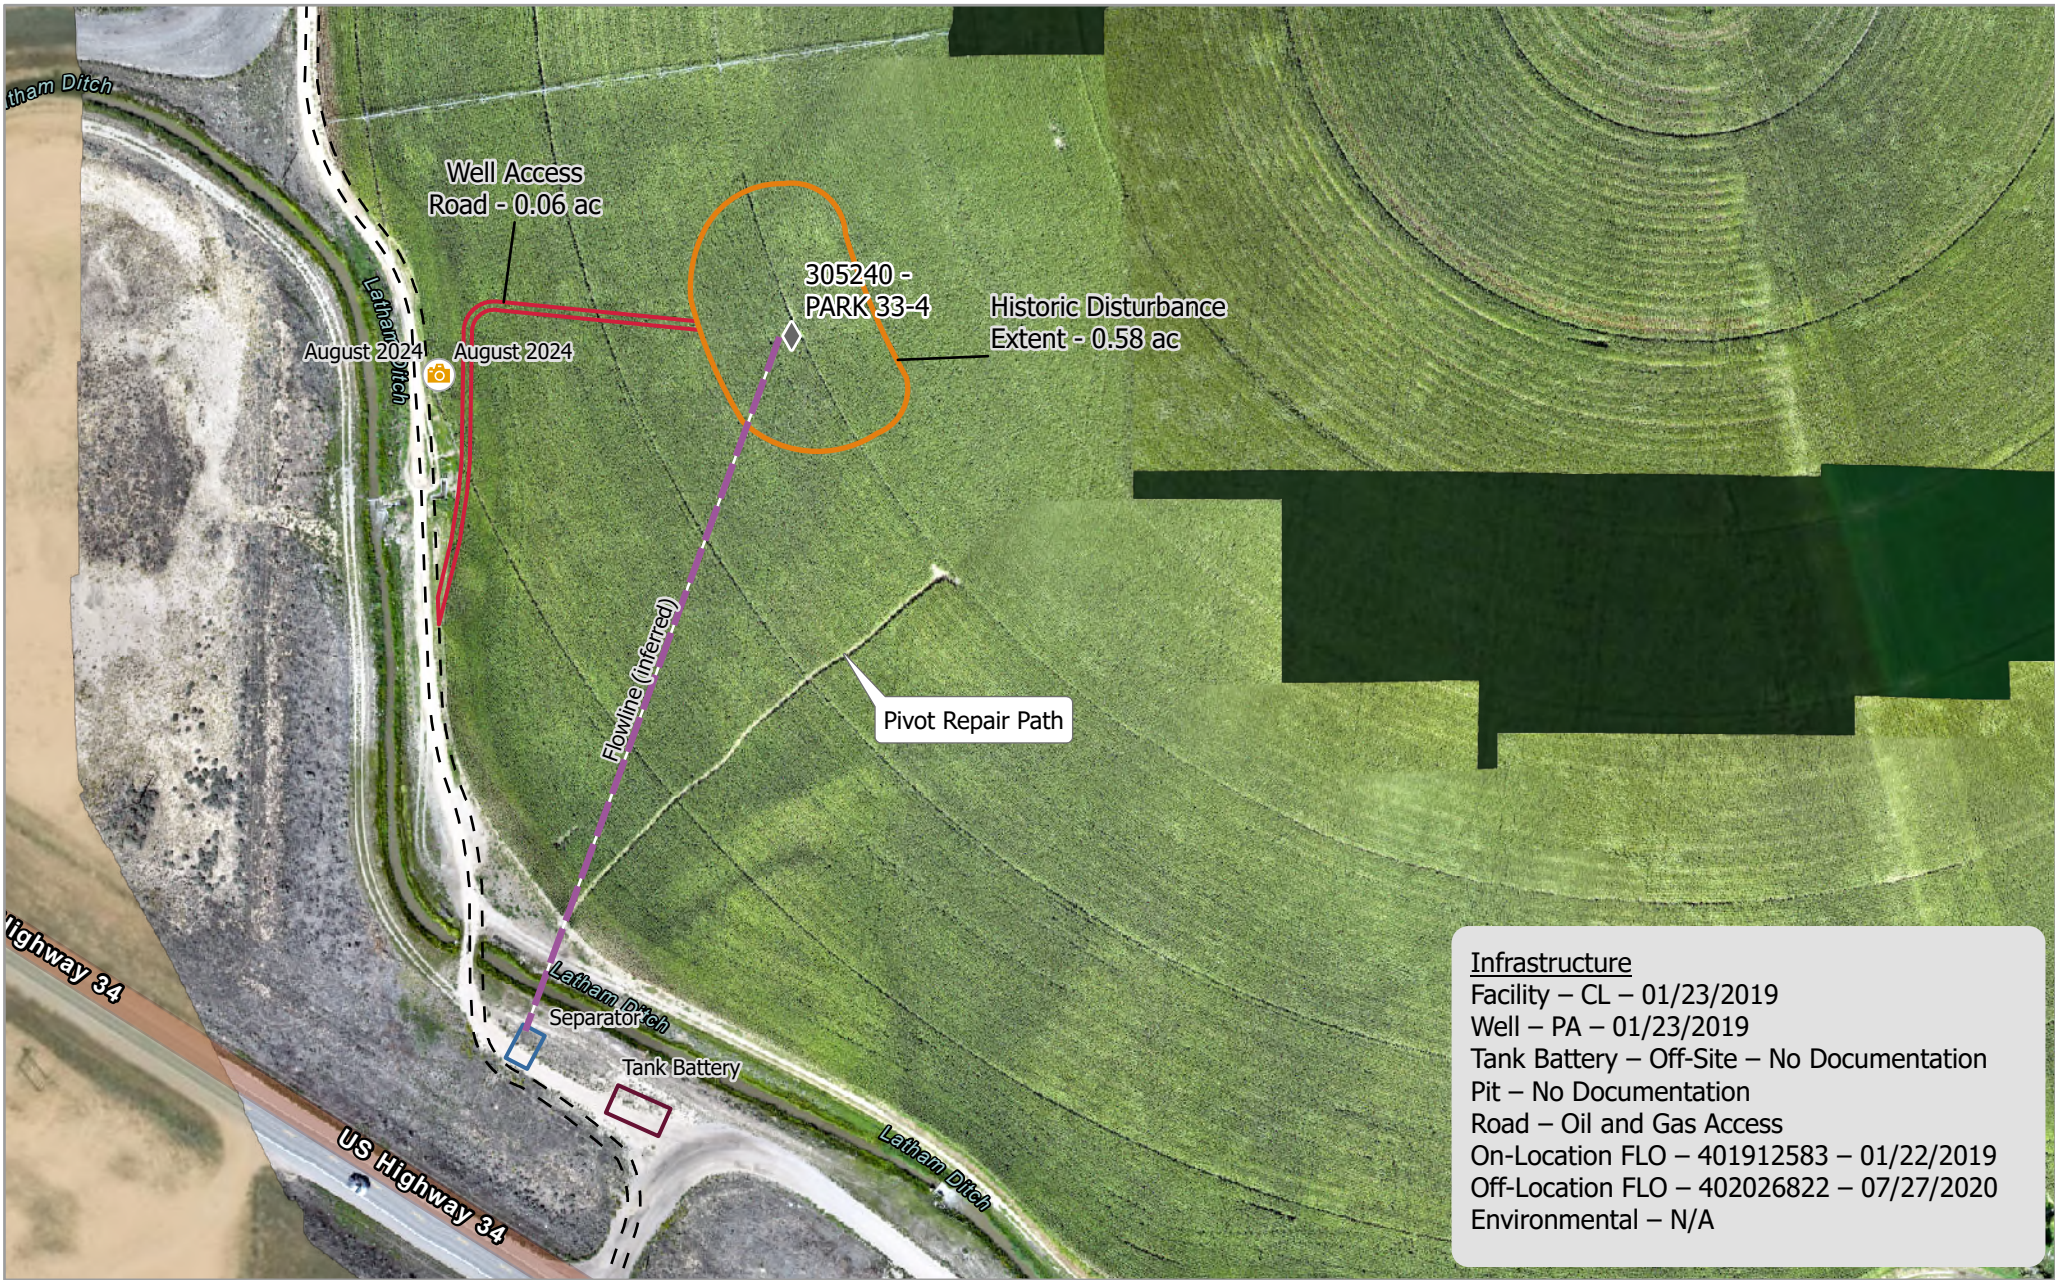
**CIV - 305240- Park 33-4
 Map Extent - Post-Plugging Overview**

PARK #33-4 well (API # [05-123-22696](#)) was plugged and abandoned on January 23rd, 2019. The access road was reclaimed at this time. The related Off-Site Production Facility, Location ID [463360](#), was closed and reclaimed at the same time. At some point in 2024, it appears the farmer needed to access his pivot for repairs, creating a small path through the crop just south of the PARK #33-4 well. This pivot repair path is not related to this Location, refer to Post-Plugging Overview Map and August 2024 Drone Cardinal Photos on Page 14 of this report.

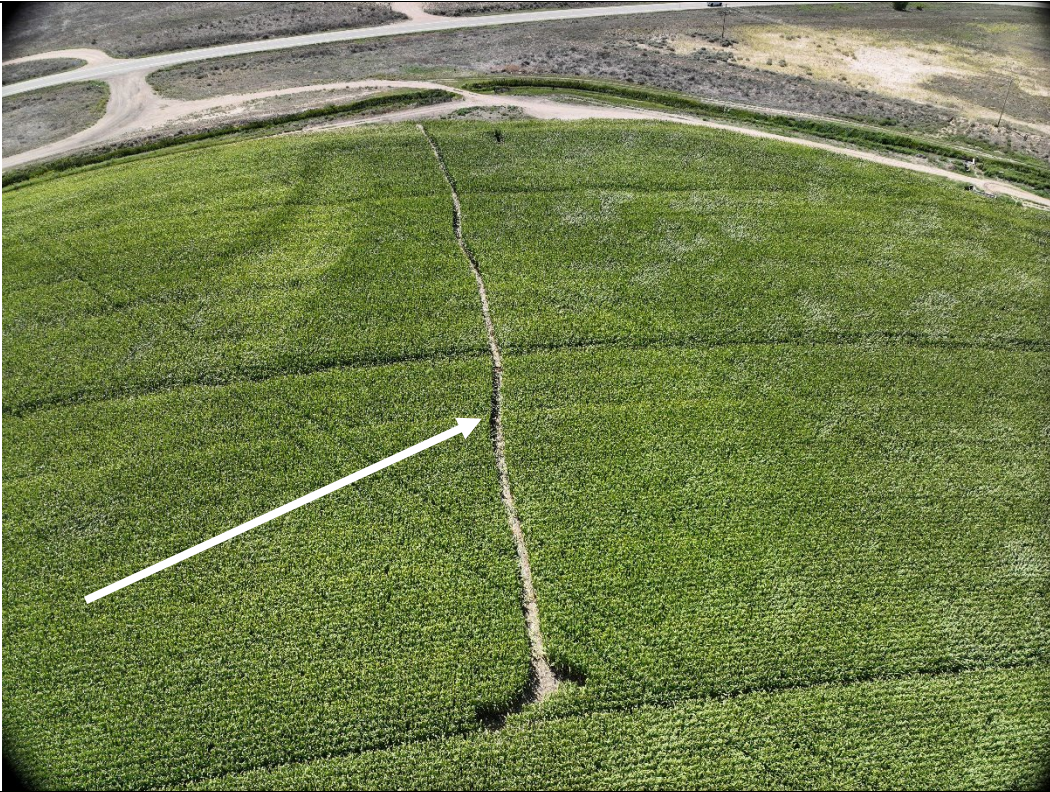
In View – Arrow Indicating Farmer Path for Pivot Repairs – Not Oil and Gas Related **SOUTHWEST** – 40.339387 / -104.439214
