Inspection Photos
Location Name: Carl A Miller B #13
Location ID: 318668

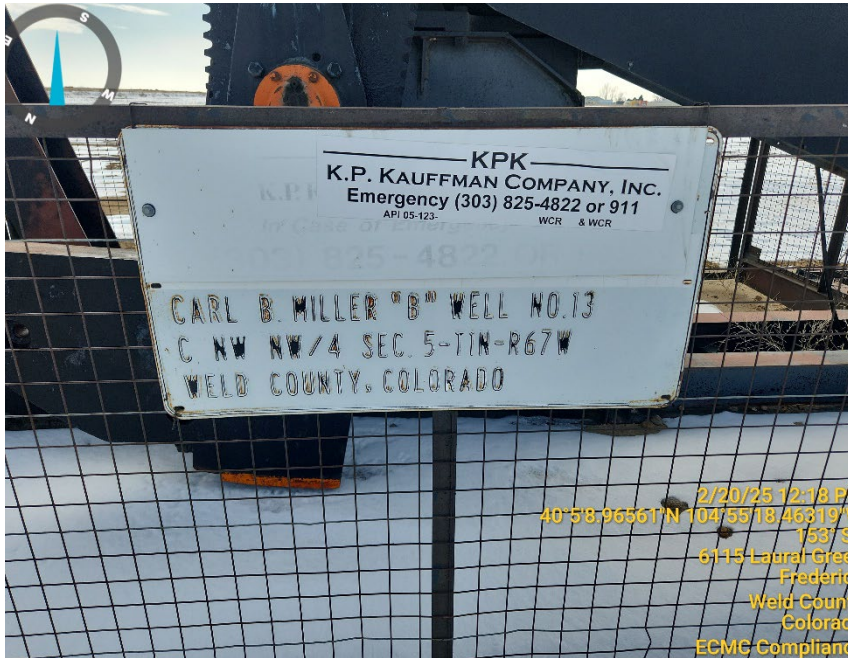
Photo 1: Wellhead Sign

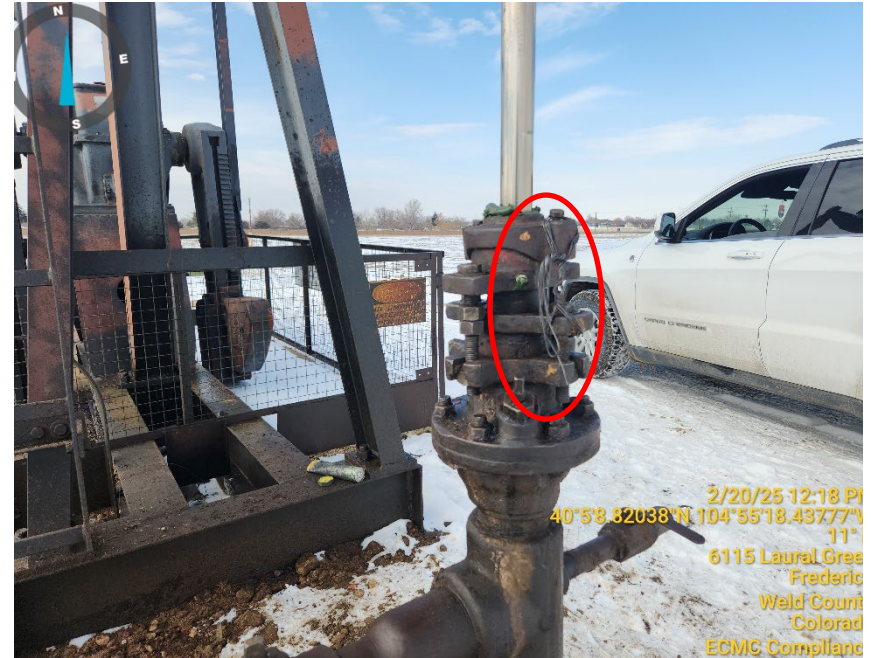
Photo 2: Repair

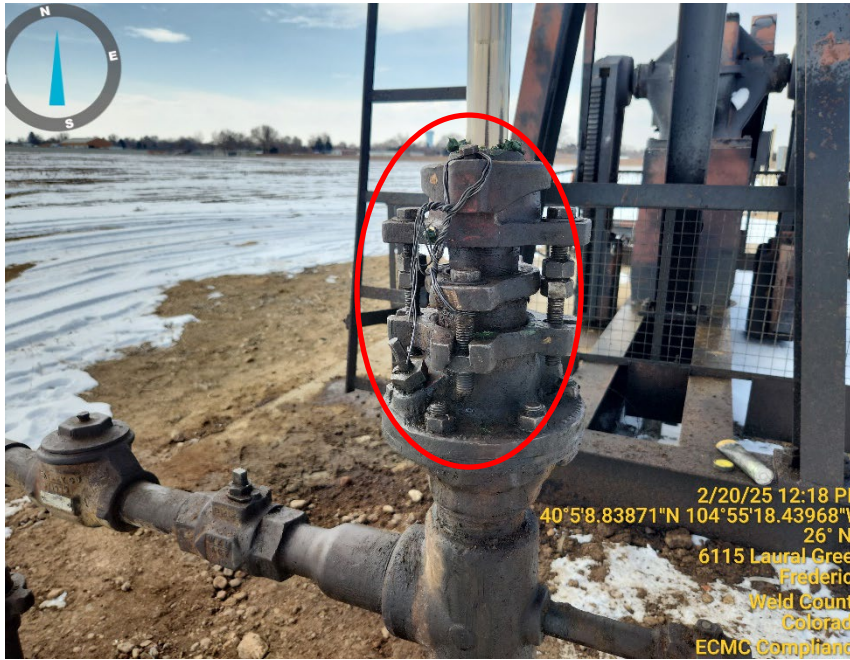
Photo 3: Repair

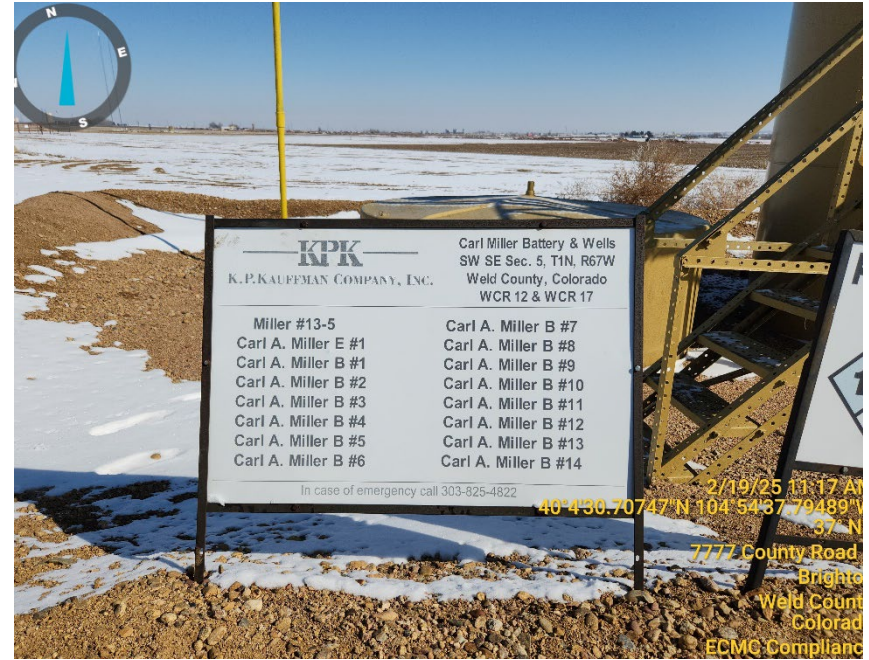
Photo 4: Tank Battery sign

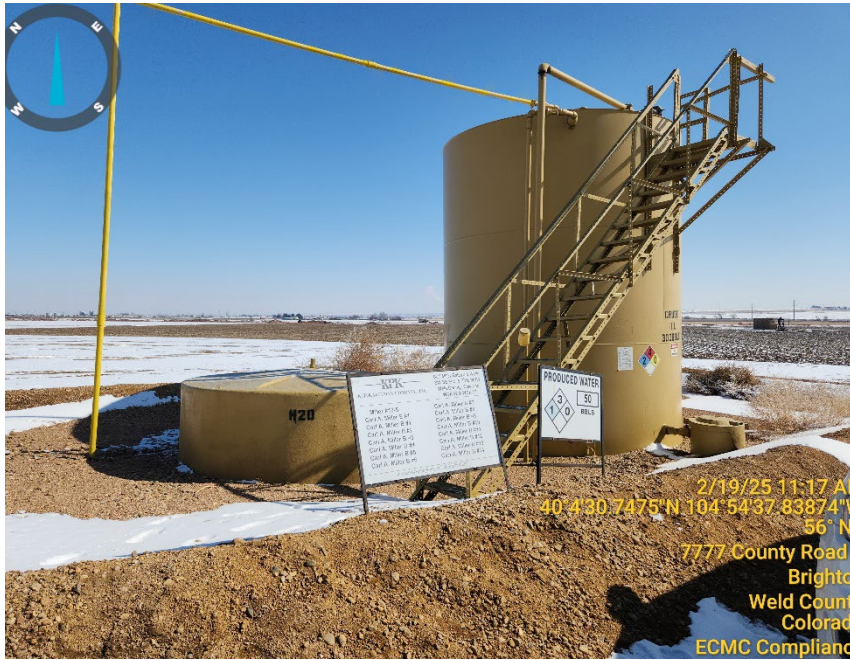
Photo 5: Centralized tank battery
