Inspection/Audit Photos

Location: QB ENERGY KNOX-68S96W/11NWNW (OD11 Pad)

Location ID: 334064

Date: 02/19/2025

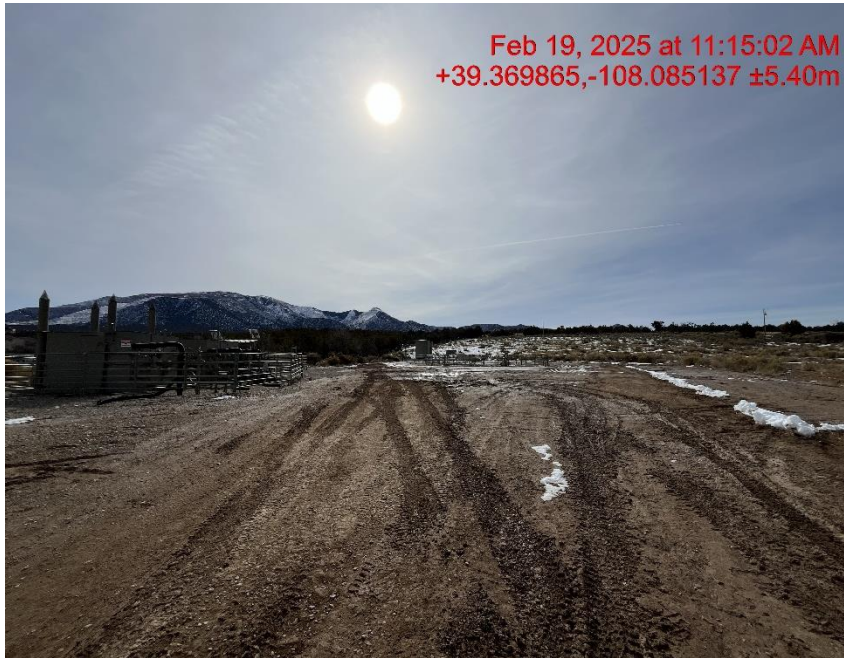
Photo # 5320 Entrance to location

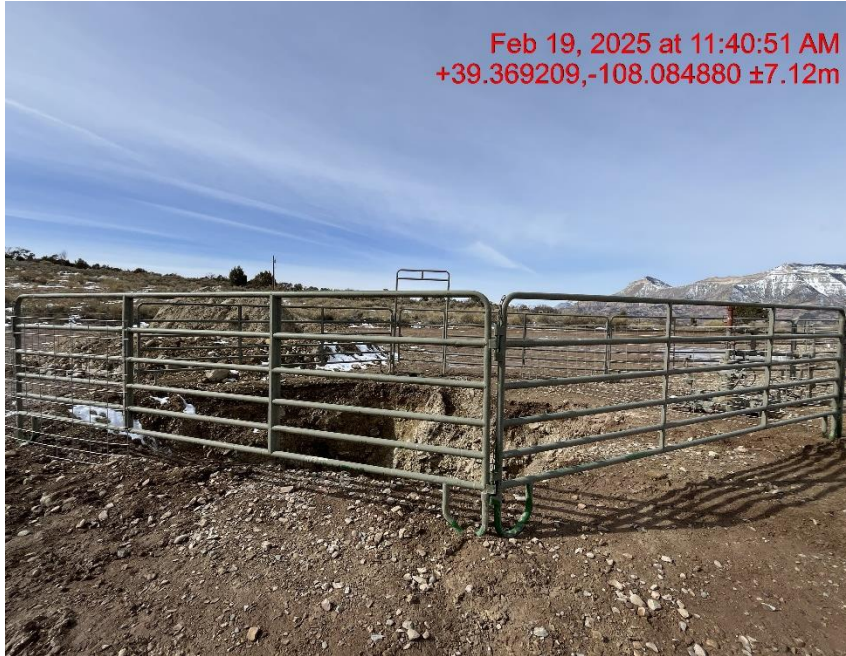
Photo # 5331 Open hole with no wildlife egress/wildlife hazard

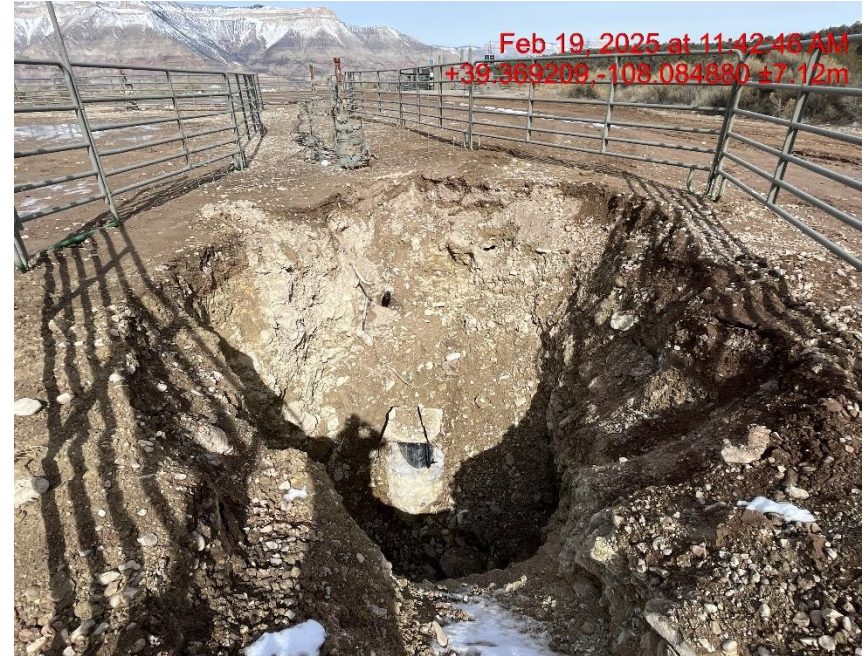
Photo # 5333 Open hole with no wildlife egress/wildlife hazard

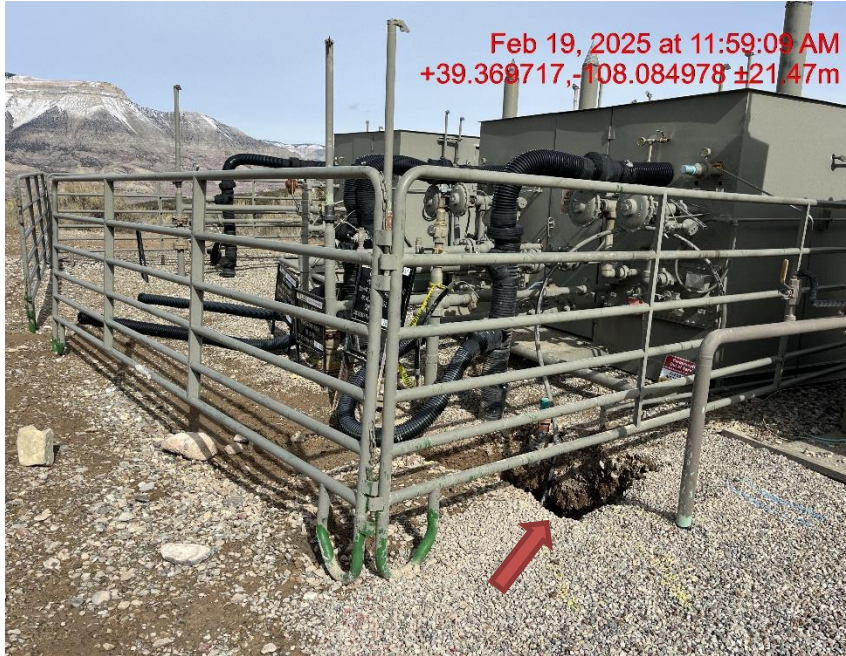
Photo # 5343 Open hole with no wildlife egress/wildlife hazard

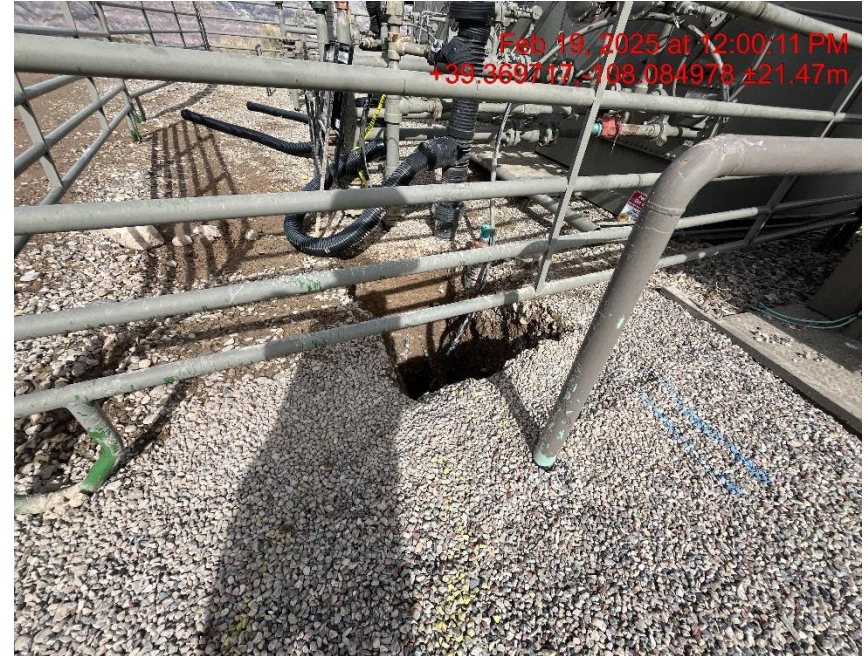
Photo # 5345 Open hole with no wildlife egress/wildlife hazard

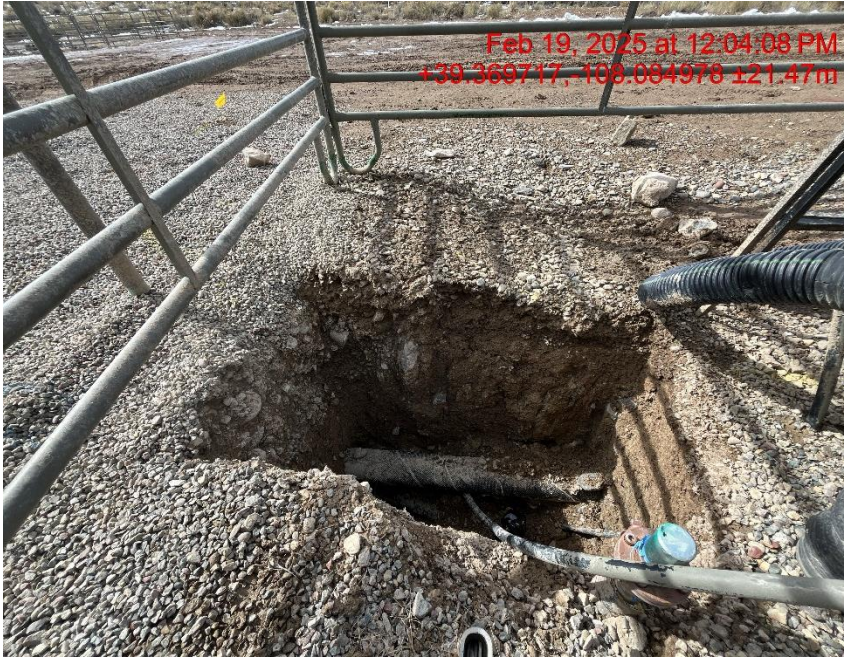
Photo # 5349 Open hole with no wildlife egress/wildlife hazard

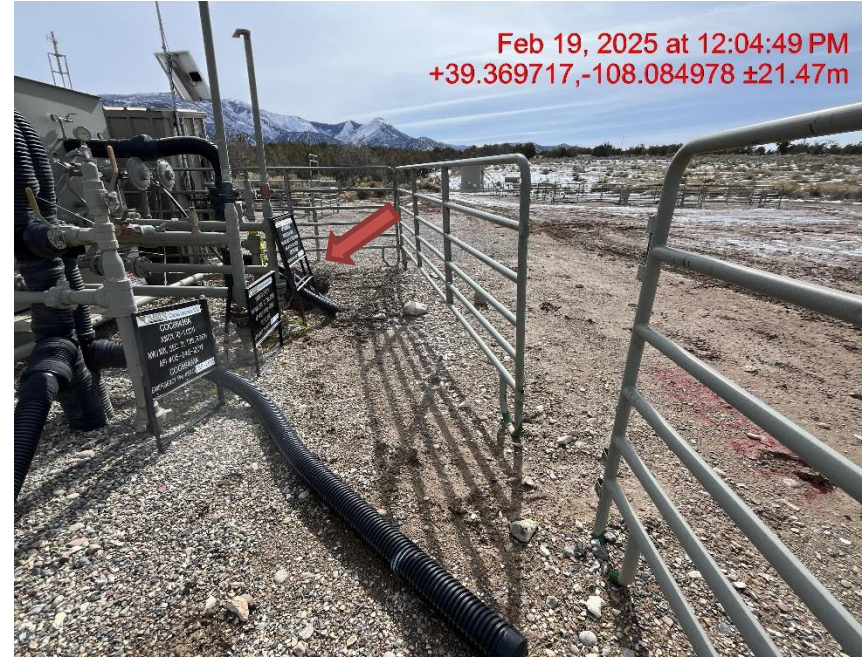
Photo # 5352 Open hole with no wildlife egress/wildlife hazard/open fence

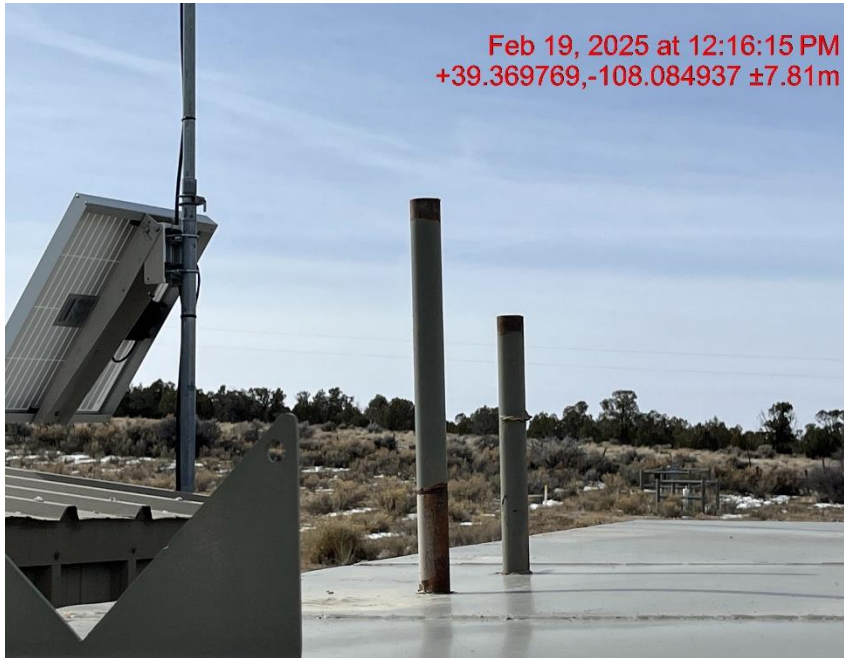
Photo # 5363 PRV vent line & rupture disc vent line does not comply with CECMC pressure safety device rules

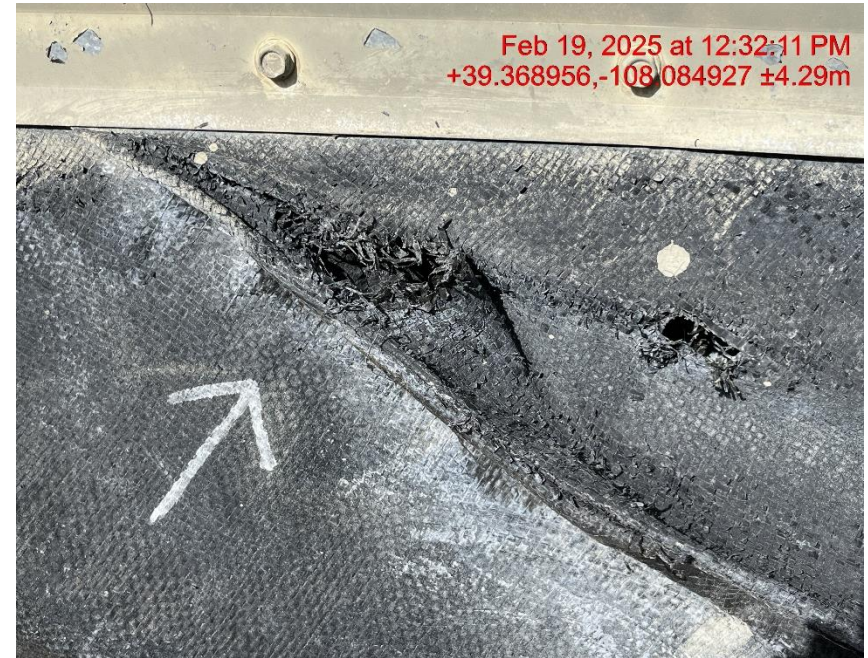
Photo # 5380 Holes in secondary containment liner/liner needs maintenance

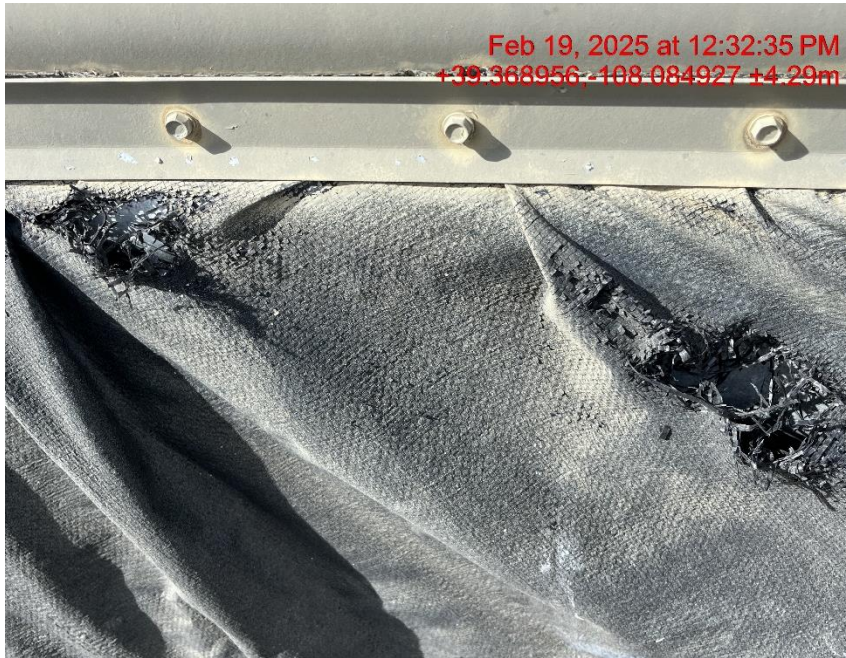
Photo # 5382 Holes in secondary containment liner/liner needs maintenance

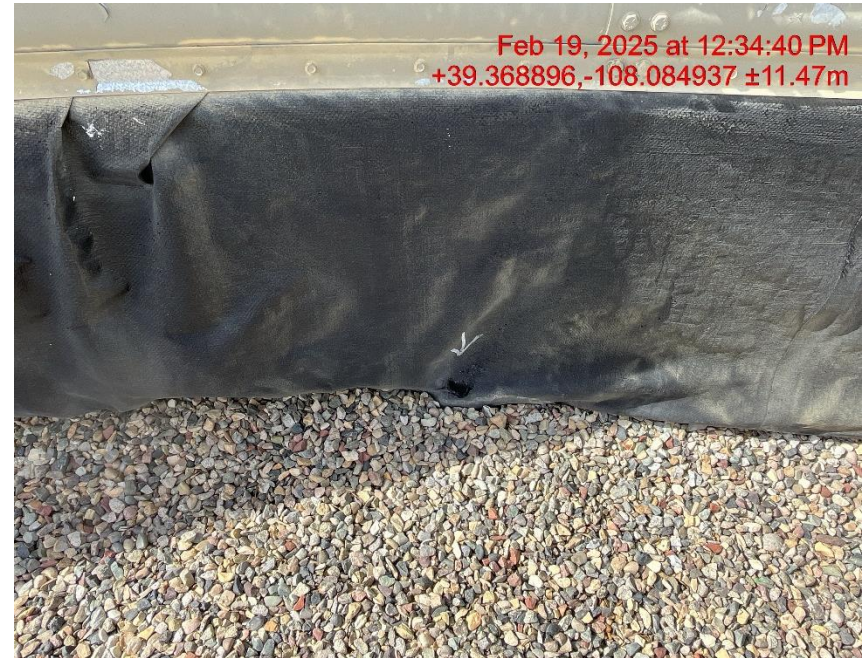
Photo # 5385 Holes in secondary containment liner/liner needs maintenance

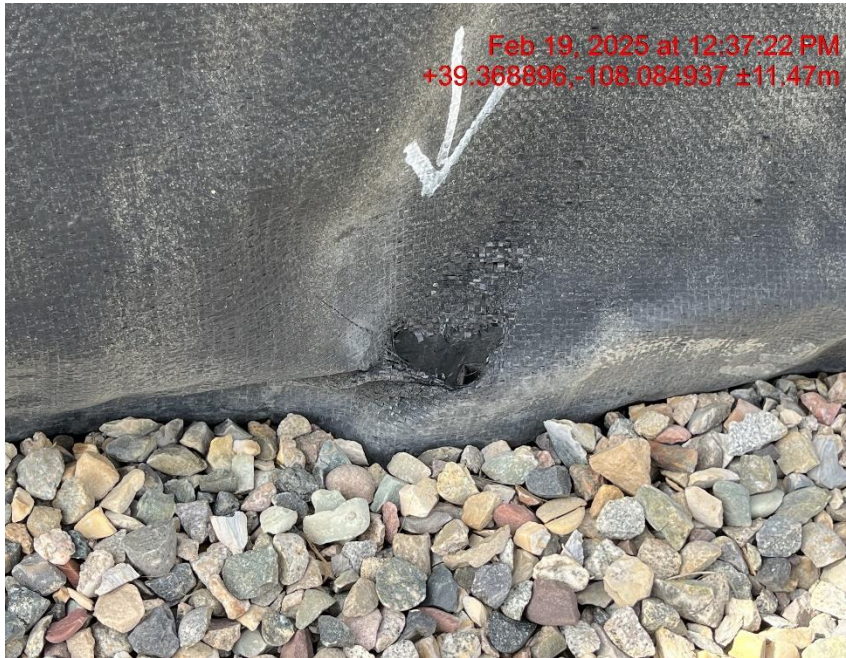
Photo # 5389 Holes in secondary containment liner/liner needs maintenance

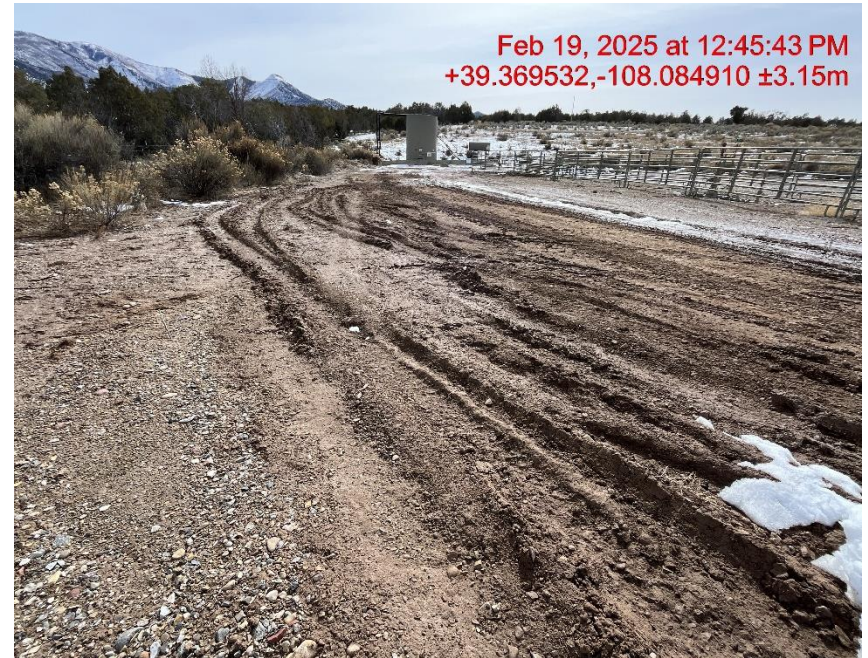
Photo # 5394 Lack of stabilization/compaction on location/insufficient tracking BMP's

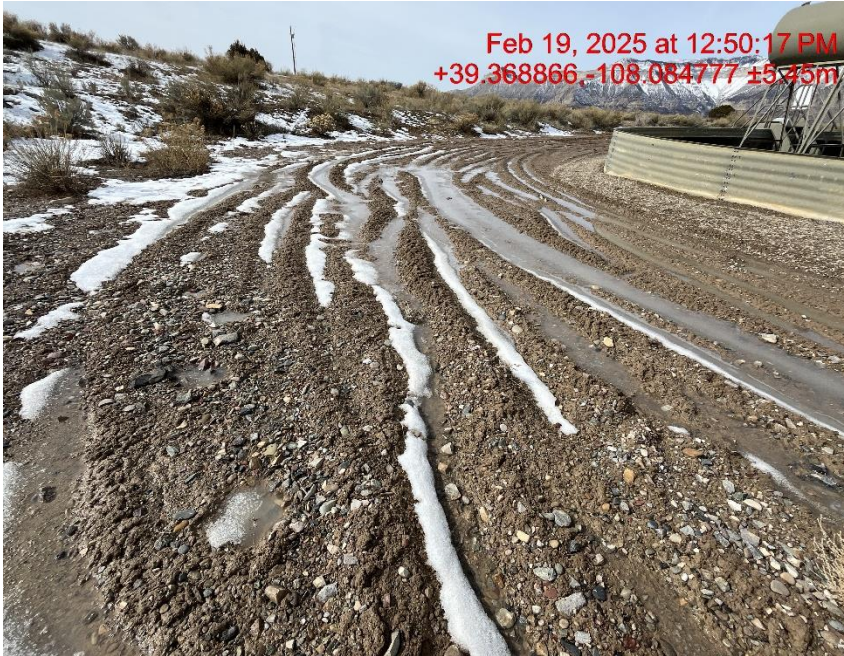
Photo # 5399 Lack of stabilization/compaction on location/insufficient tracking BMP's

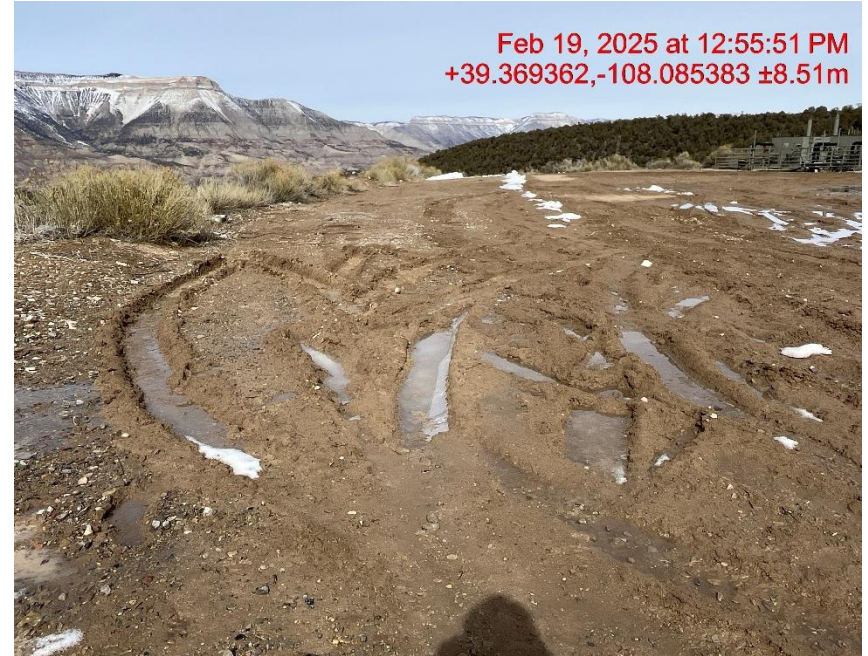
Photo # 5408 Lack of stabilization/compaction on location/insufficient tracking BMP's

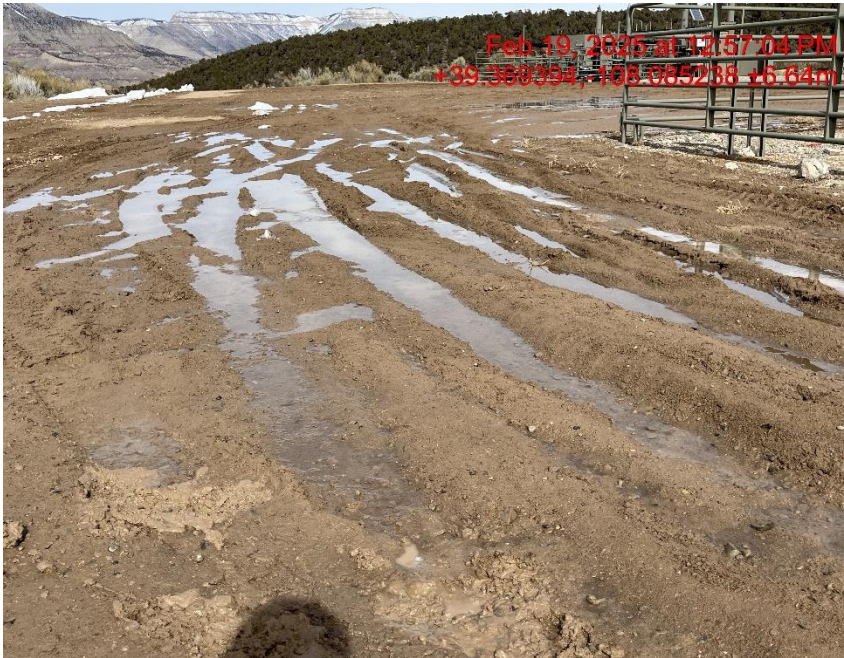
Photo # 5411 Lack of stabilization/compaction on location/insufficient tracking BMP's

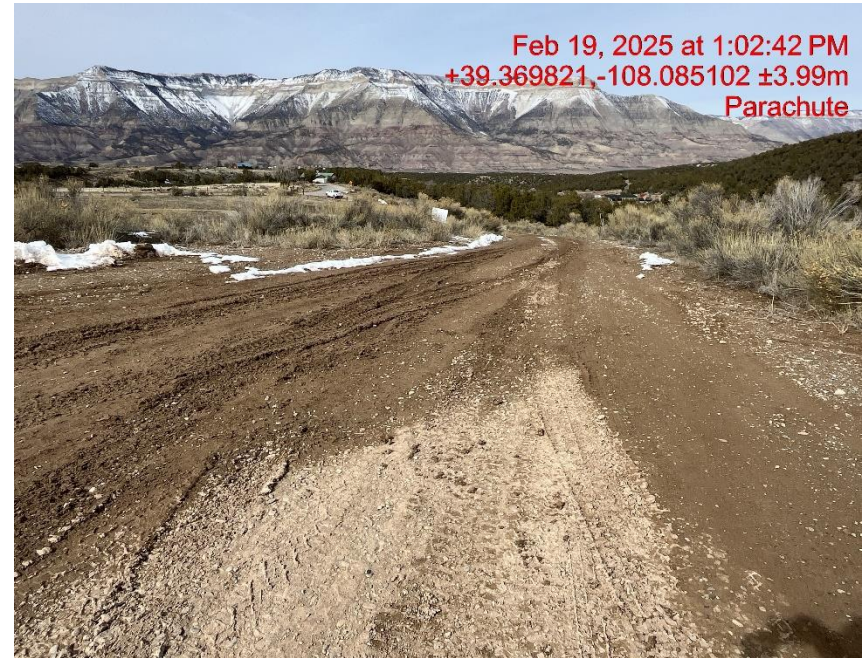
Photo # 5417 Tracking onto lease road/Insufficient tracking BMP's

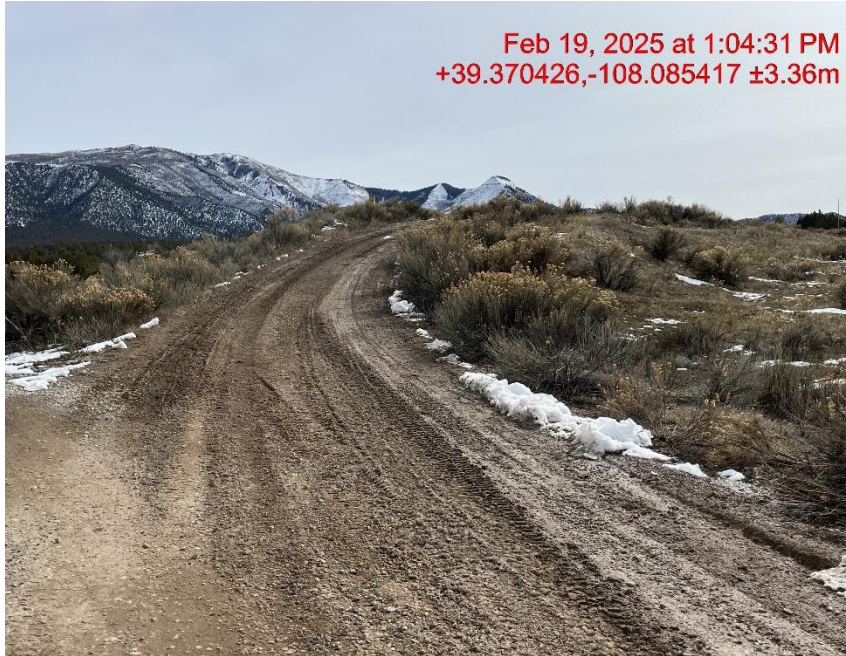
Photo # 5419 Tracking onto lease road/Insufficient tracking BMP's

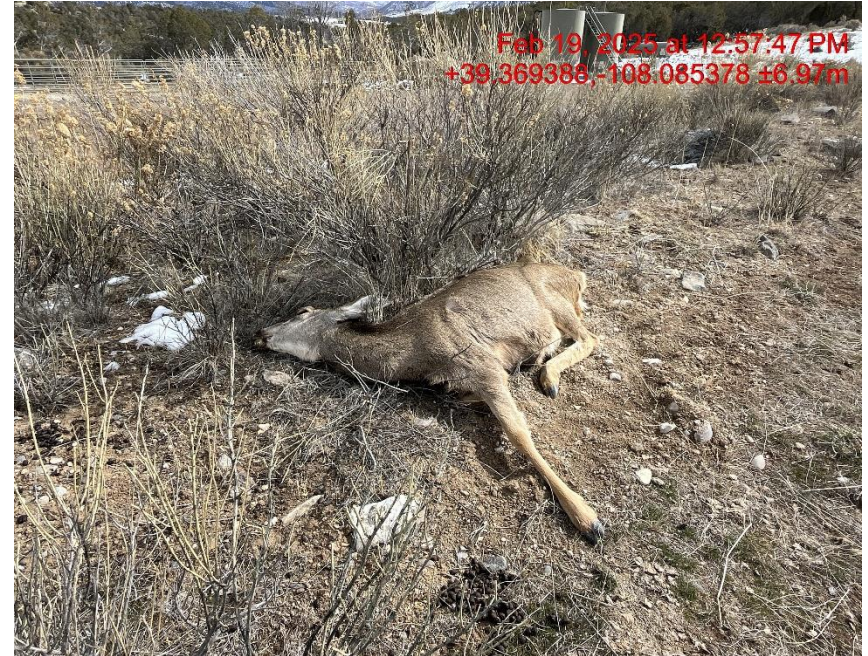
Photo # 5412 Dead Deer on west side of location

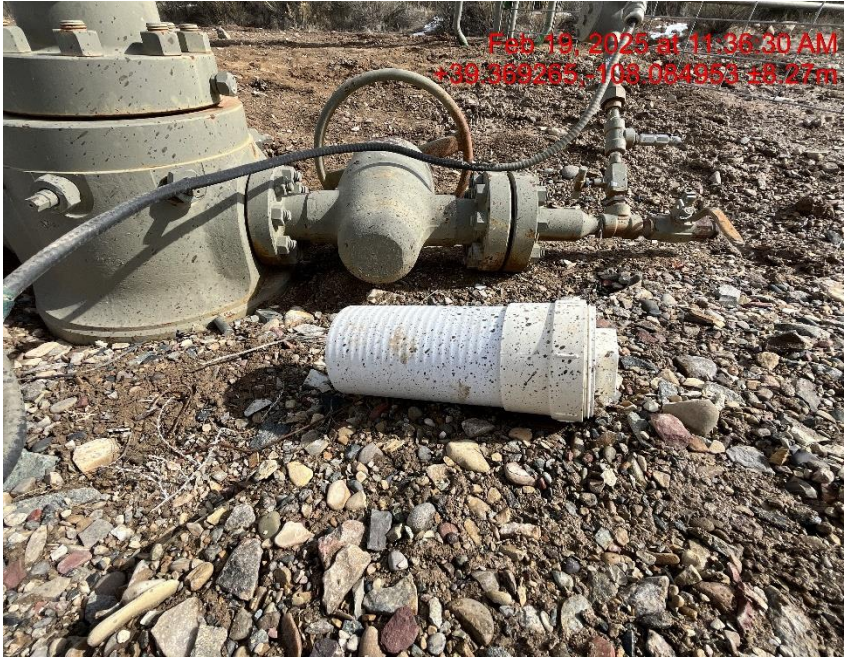
Photo # 5326 Debris

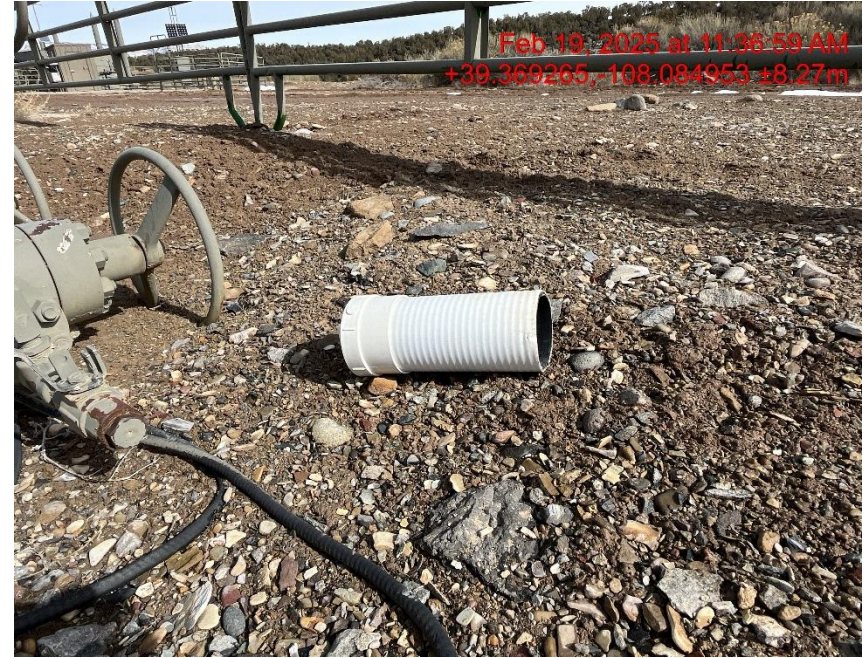
Photo # 5327 Debris
