Inspection/Audit Photos

Location Name: TEP ROCKY MOUNTAIN LLC CIRCLE B LAND 21A-35-692 Pad

Location ID: 334703

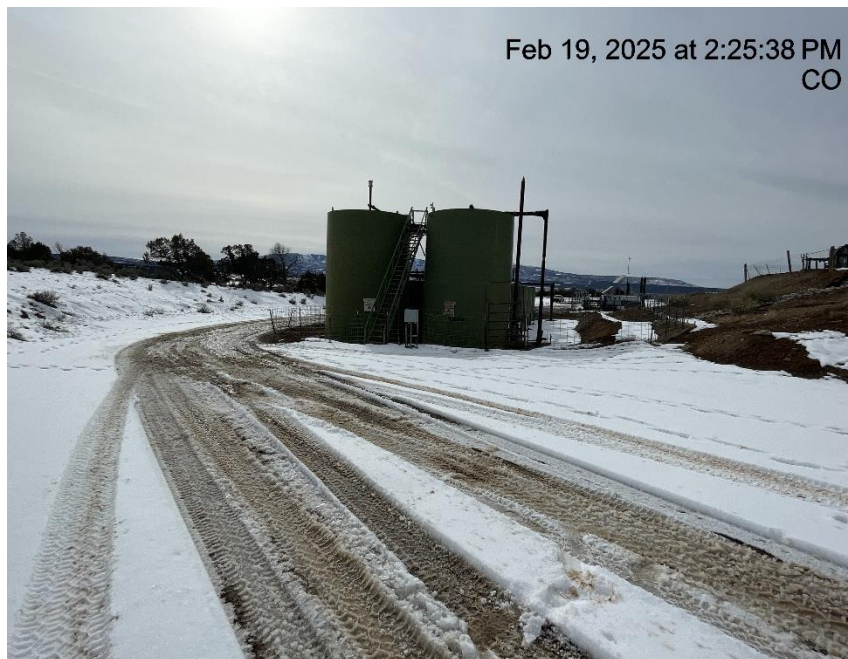
Photo # 7525 From entrance to location

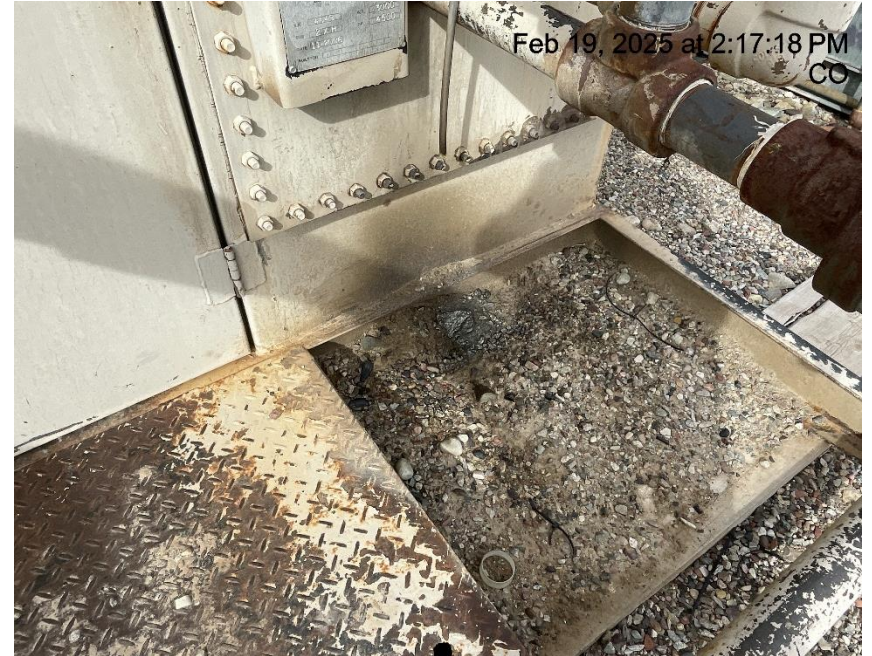
Photo # 7534 Staining near separator

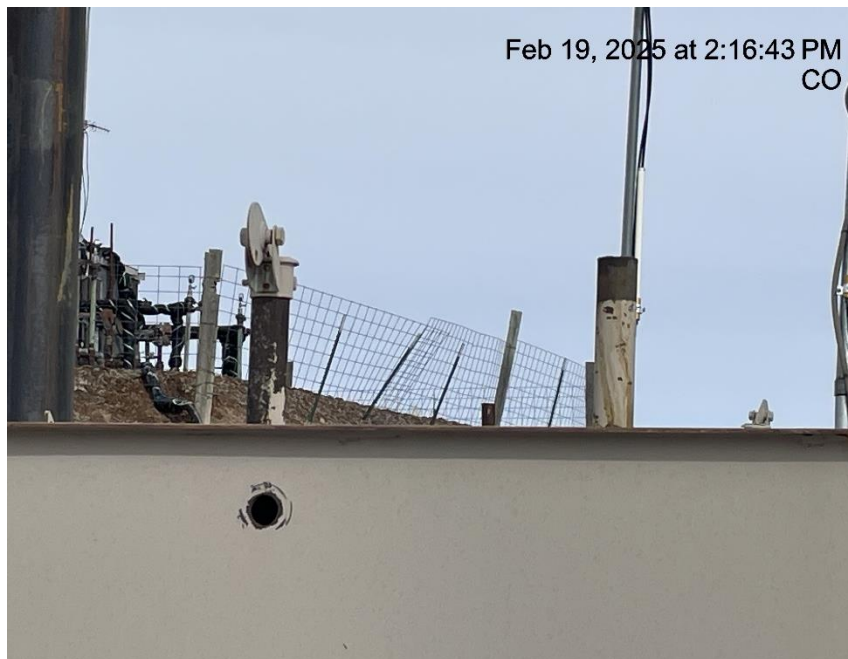
Photo # 7535 Rupture disc vent line does not comply with CECMC pressure safety device rules

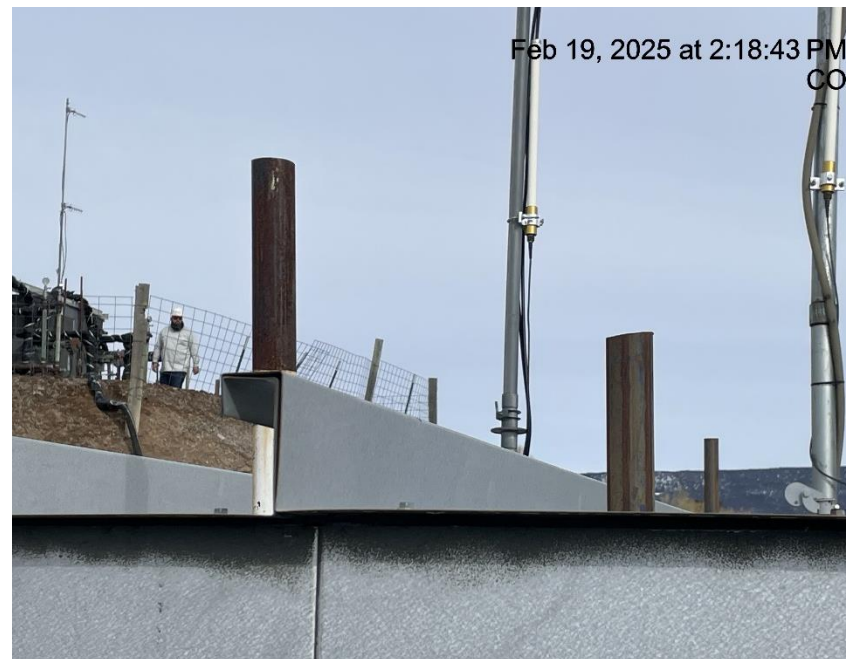
Photo # 7536 Rupture disc & PRV vent lines do not comply with CECMC pressure safety device rules

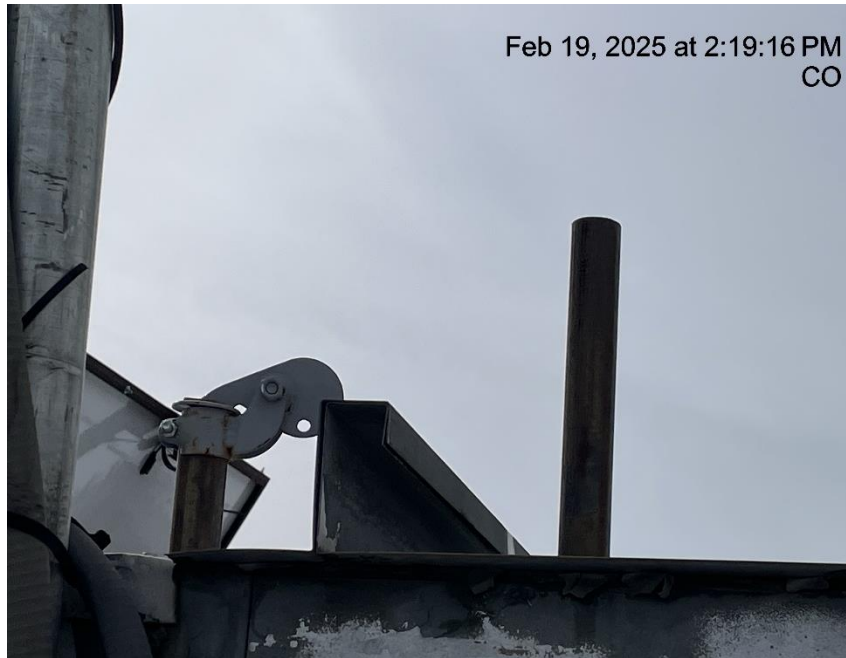
Photo # 7537 Rupture disc vent line does not comply with CECMC pressure safety device rules

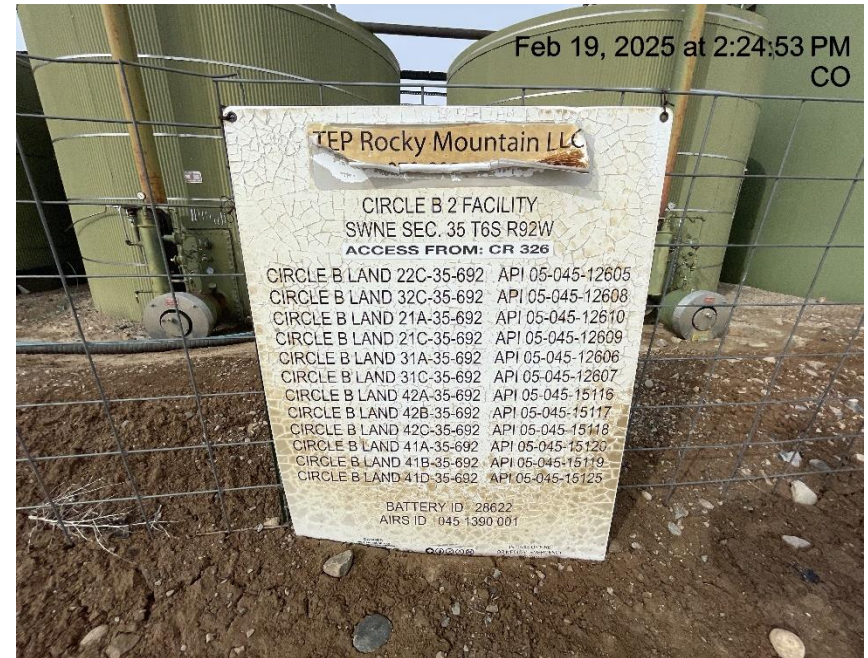
Photo # 7538 Battery sign lacks required information

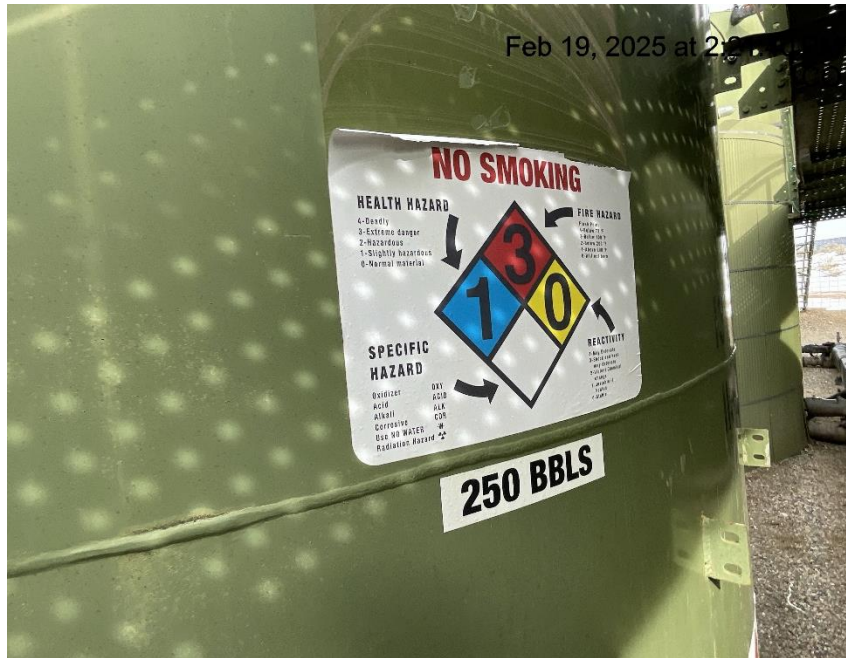
Photo # 7539 Tank label missing required information

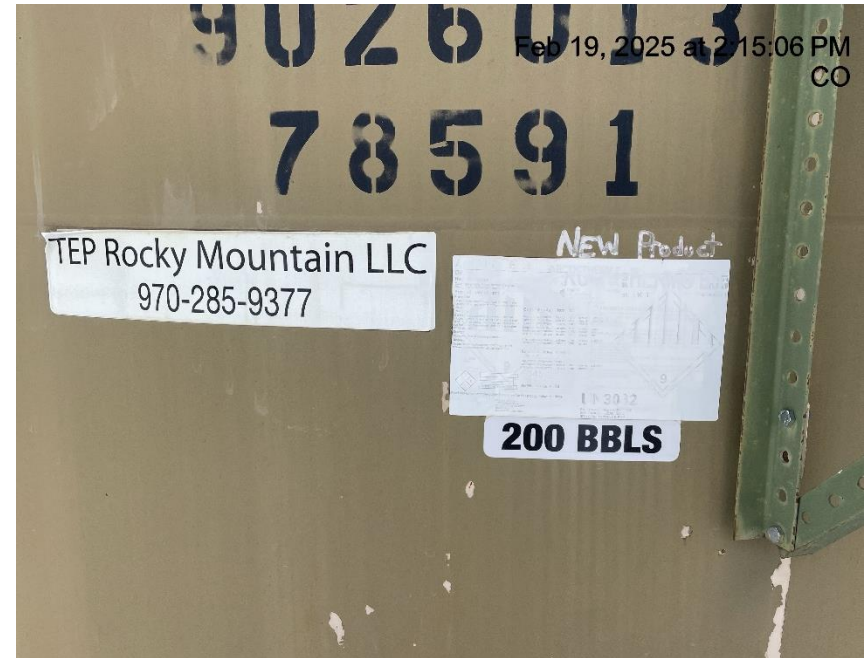
Photo # 7540 Tank label faded & some required information is illegible

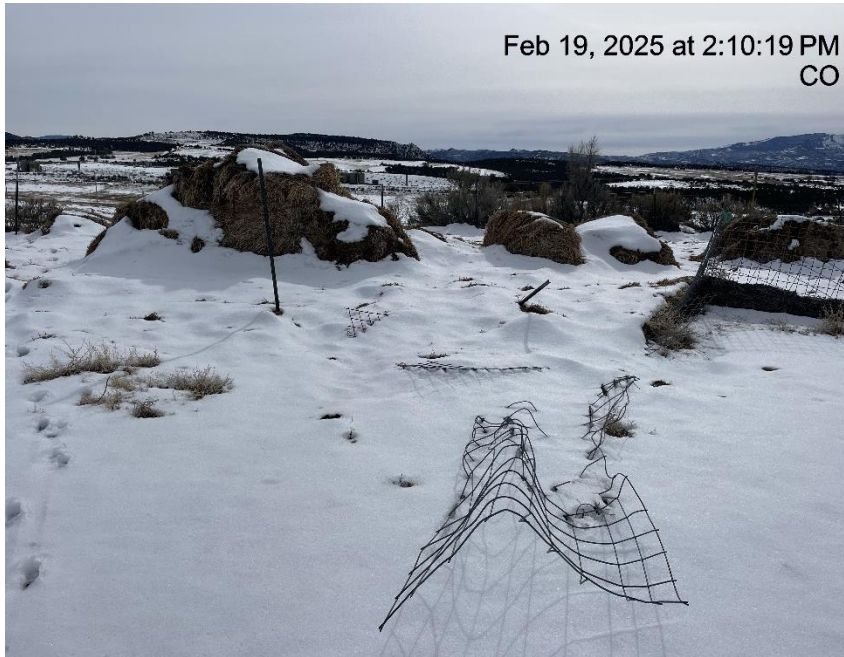
Photo # 7541 Debris/wildlife hazard

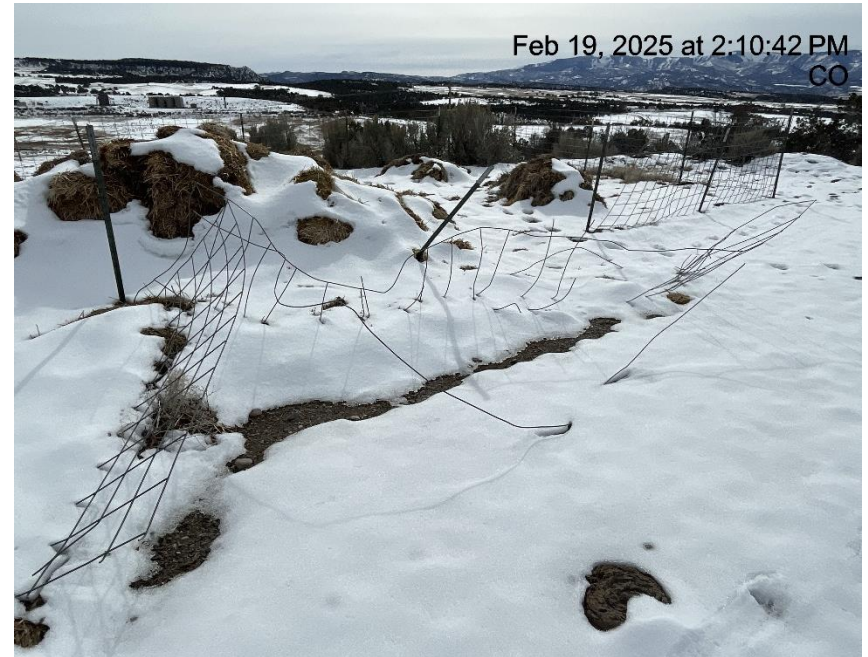
Photo # 7542 Debris/wildlife hazard
