Inspection/Audit Photos

Location Name: TEP ROCKY MOUNTAIN LLC CIRCLE B LAND 23B-35-692 Pad

Location ID: 334629

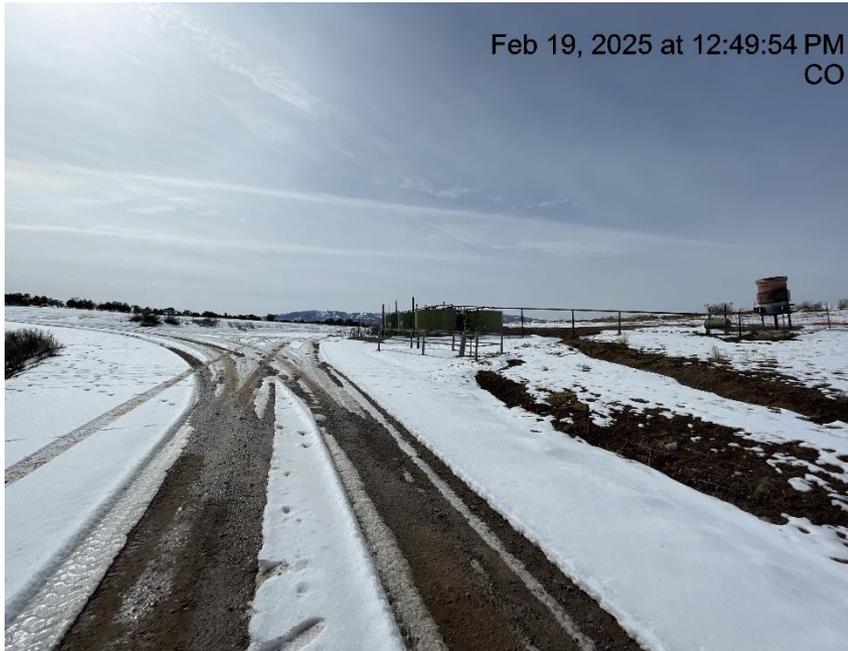
Photo # 7191 From entrance to location

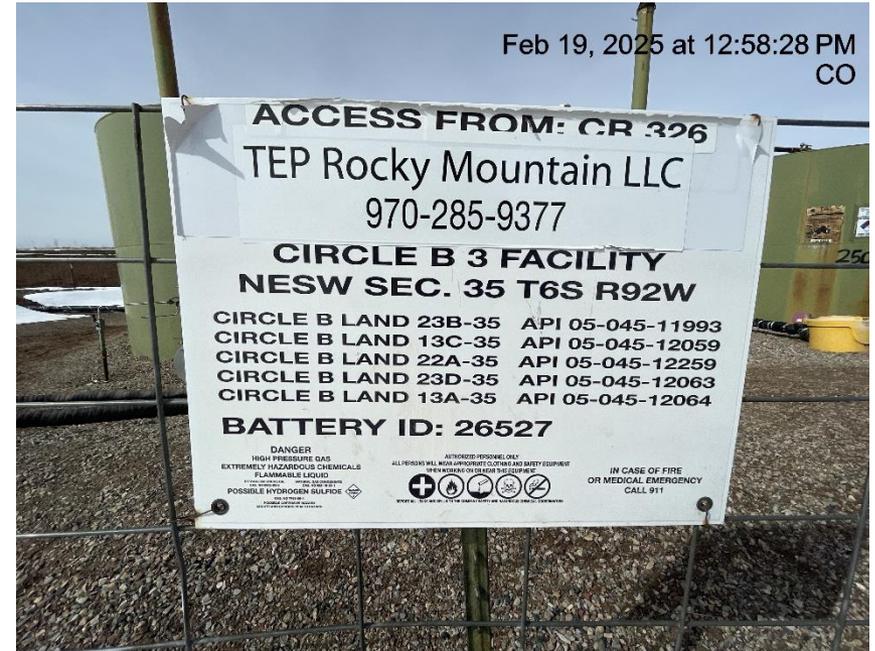
Photo # 7192 Location

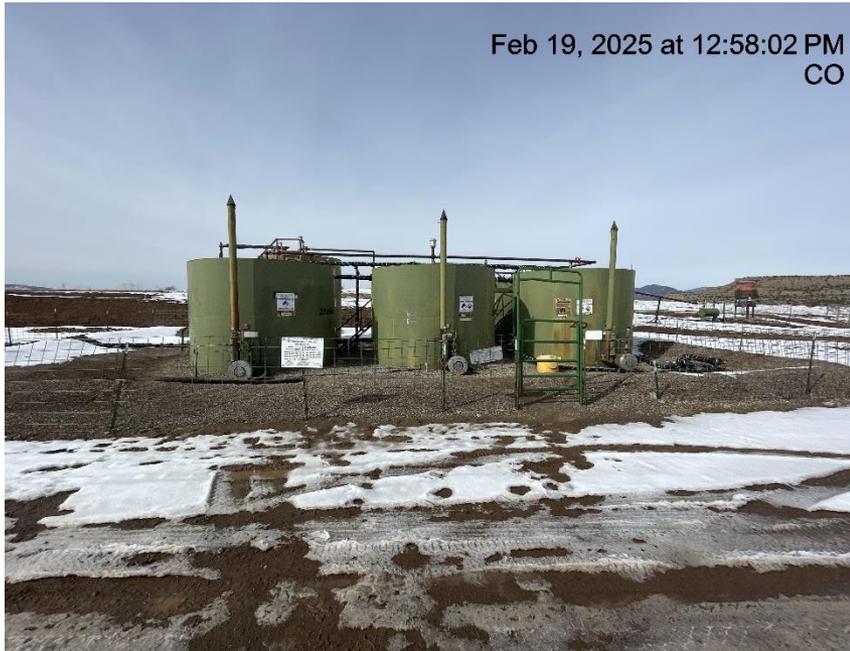
Photo # 7193 Location

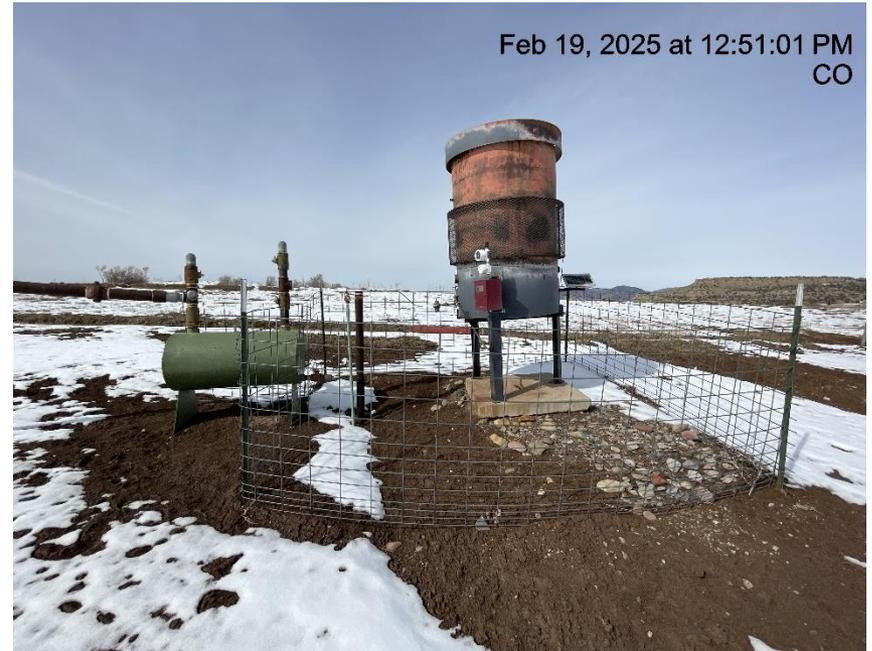
Photo # 7194 Location

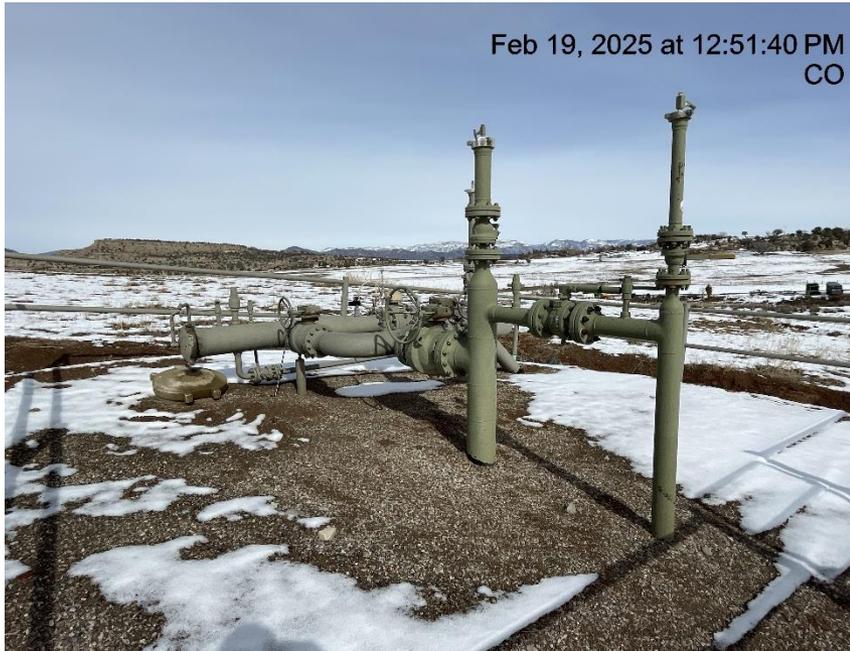
Photo # 7195 Location

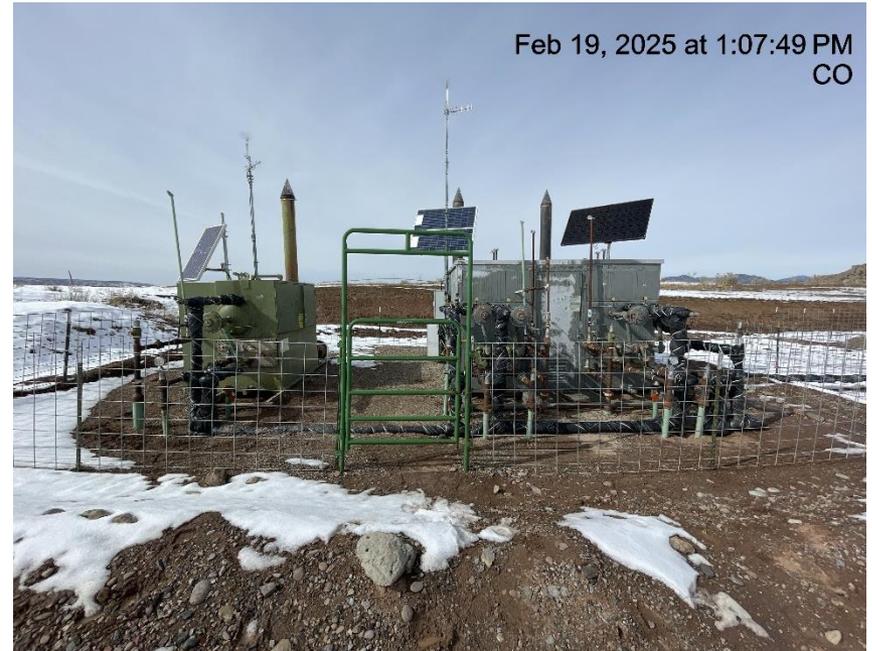
Photo # 7196 Location

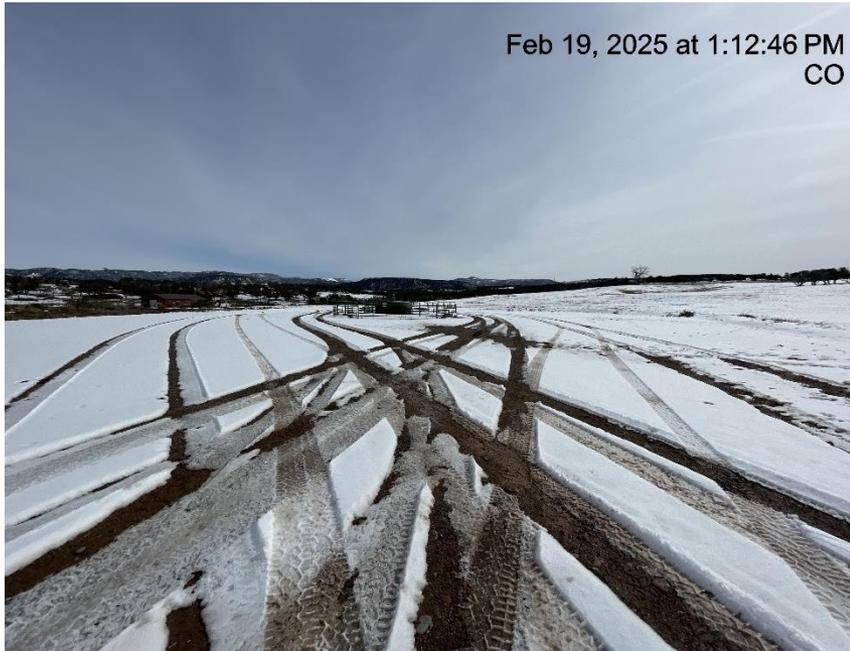
Photo # 7197 Location

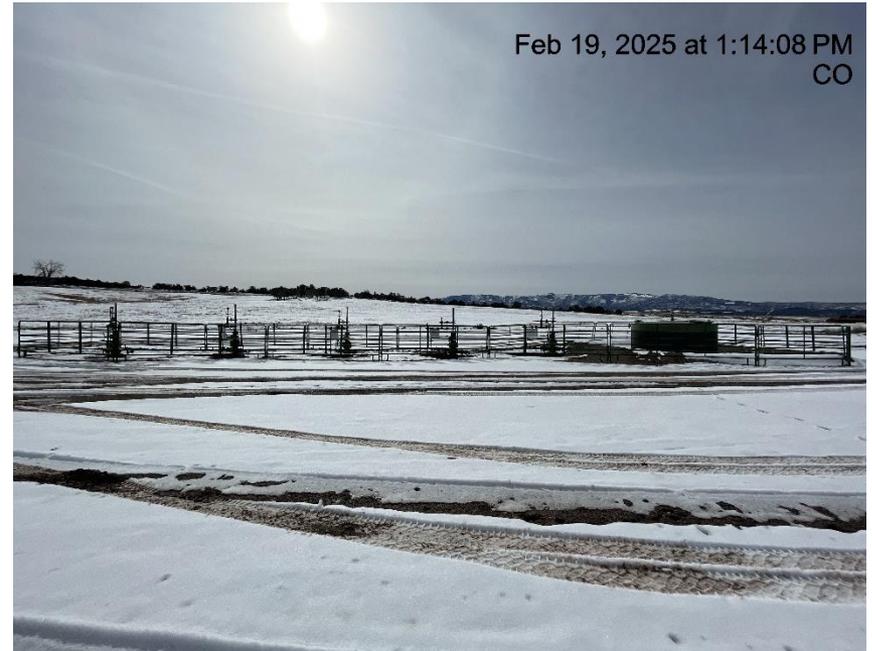
Photo # 7198 Location

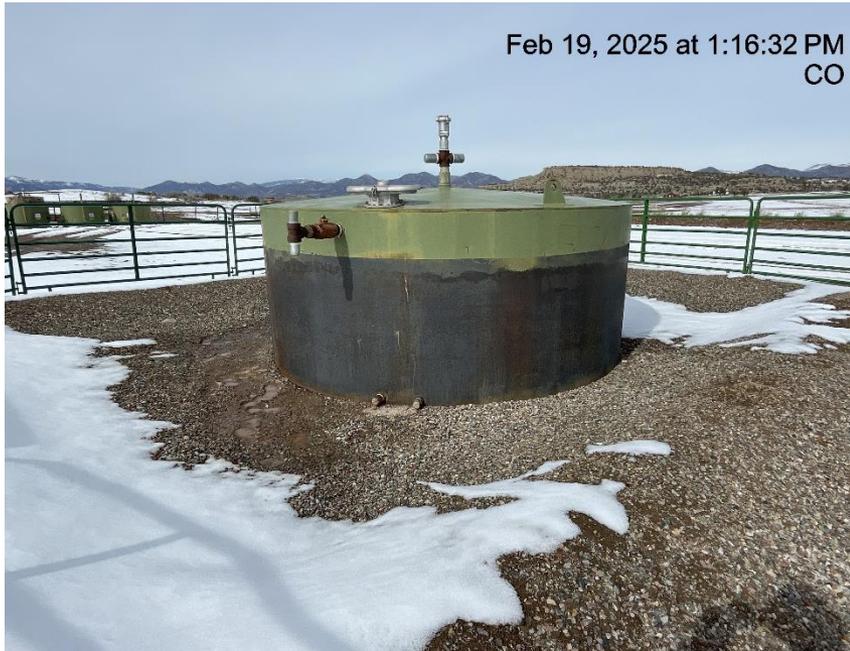
Photo # 7199 Unused equipment

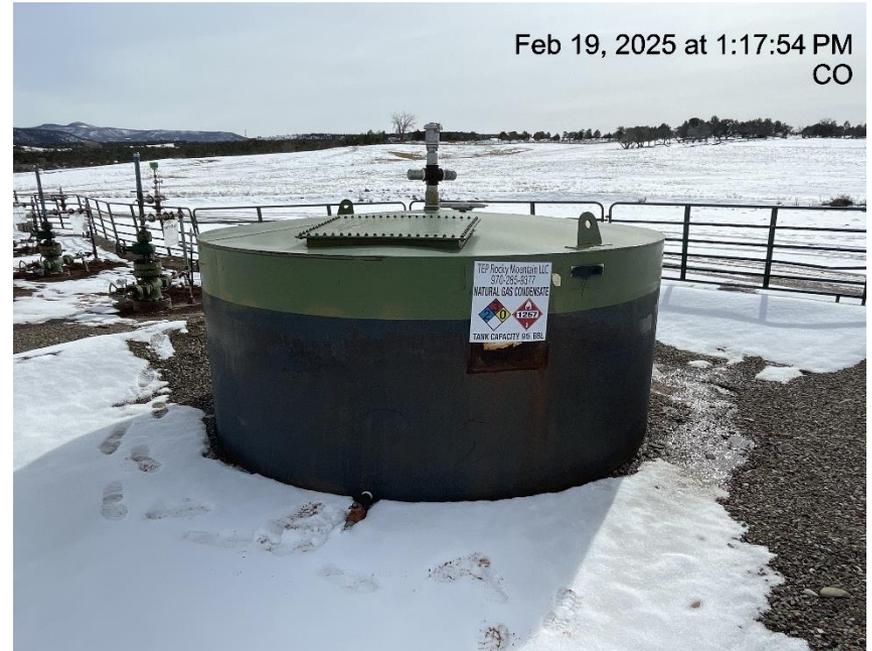
Photo # 7200 Unused equipment

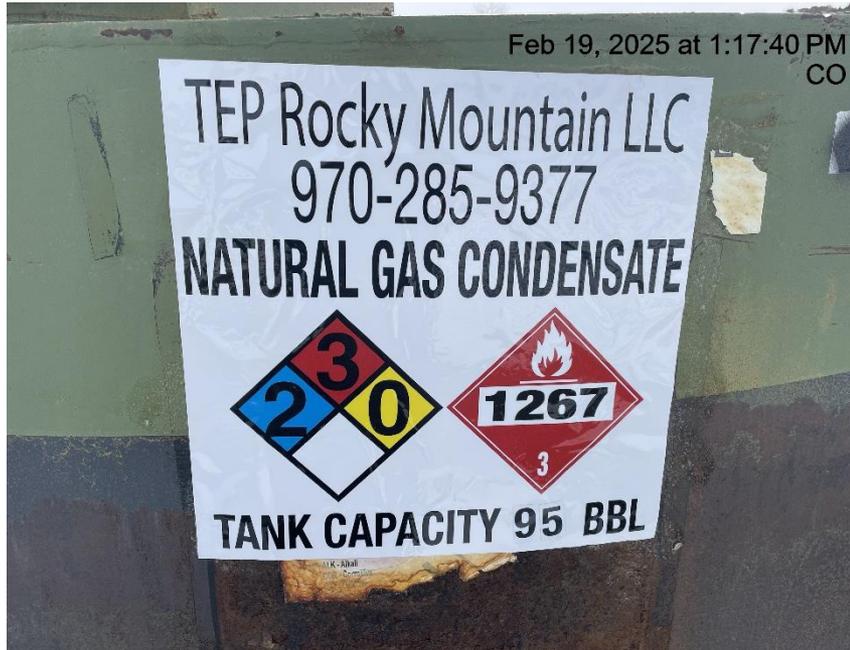
Photo # 7201 Tank capacity incorrect

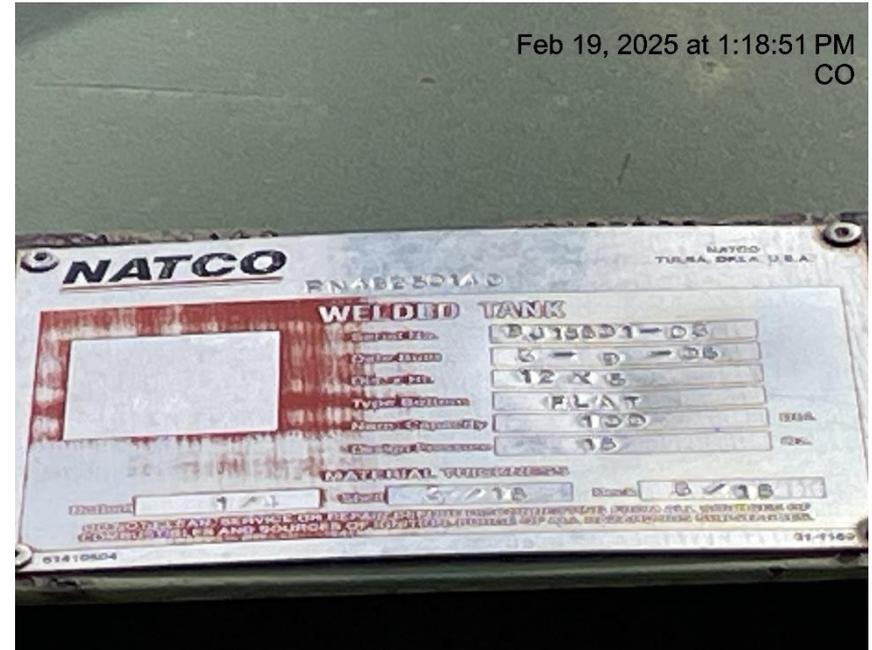
Photo # 7202 Tank capacity

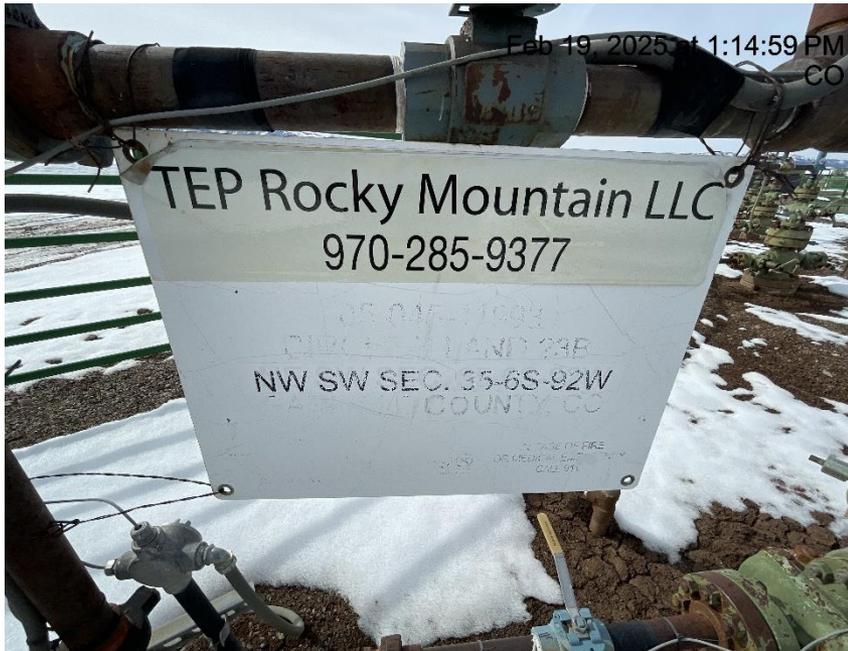
Photo # 7203 Wellhead sign weathered/faded & required info is becoming illegible

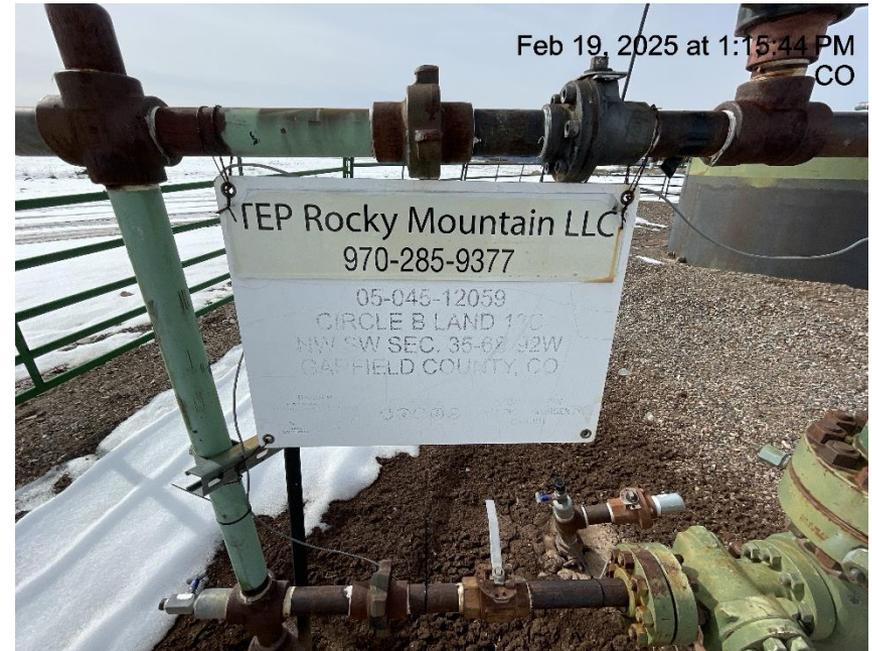
Photo # 7204 Wellhead sign weathered/faded & required info is becoming illegible

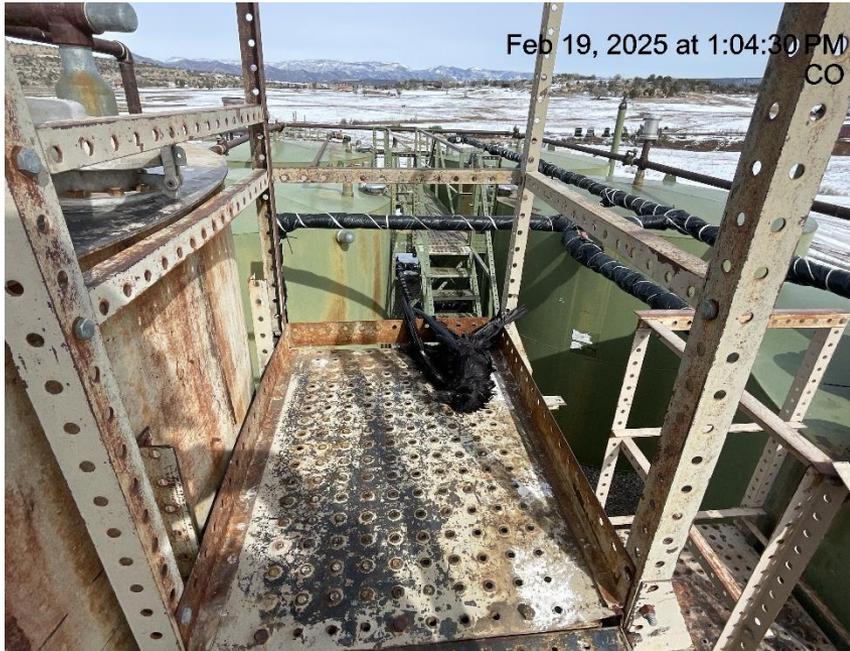
Photo # 7205 Dead bird observed in tank battery

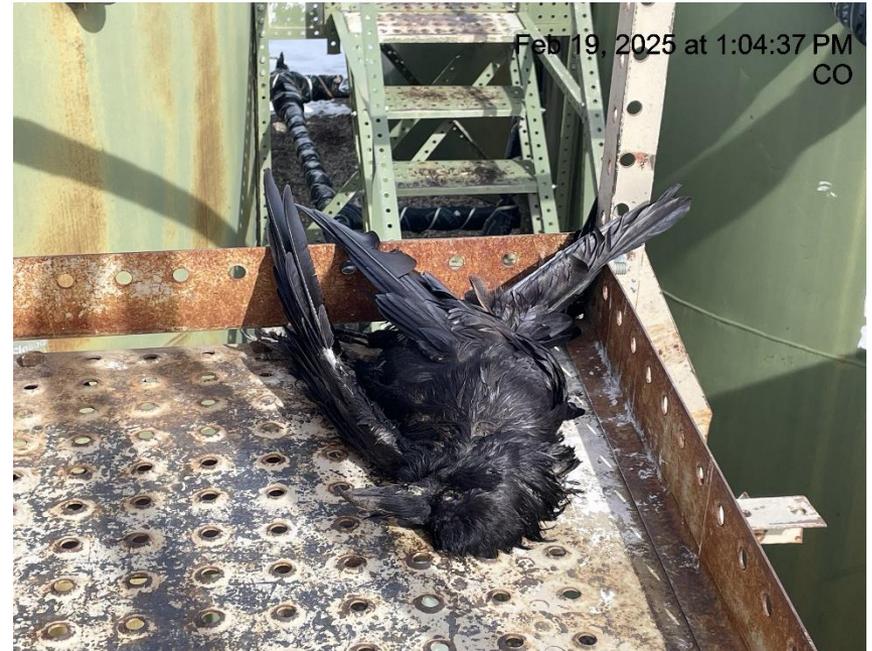
Photo # 7206 Dead bird observed in tank battery

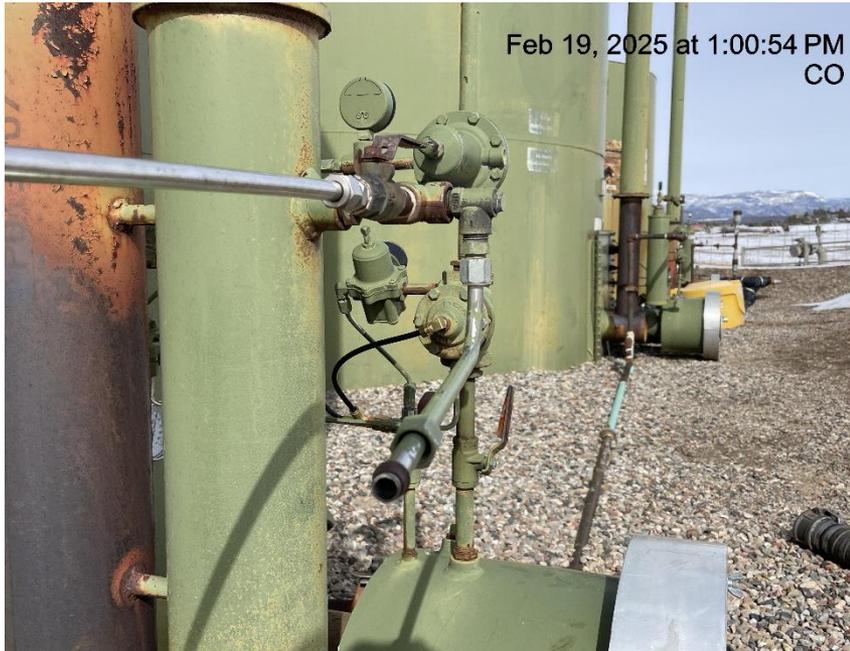
Photo # 7207 PRV vent line does not comply with CECMC pressure safety device rules & general safety rules

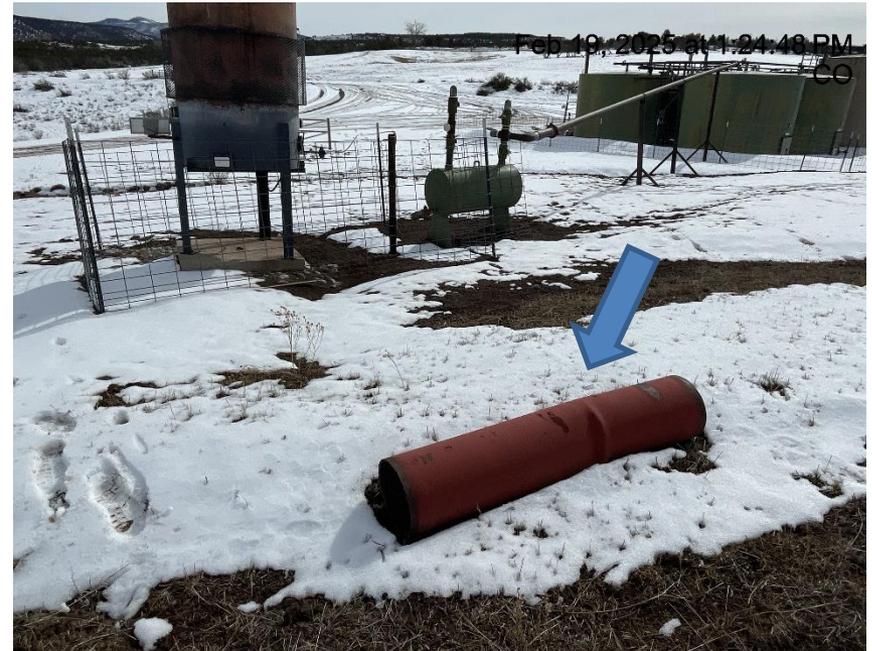
Photo # 7208 Debris
