Inspection/Audit Photos

Location: QB Energy HYRUP-68S96W/2NWSE (PAD-2 J)

Location ID: 334158

Date: 2/18/2025

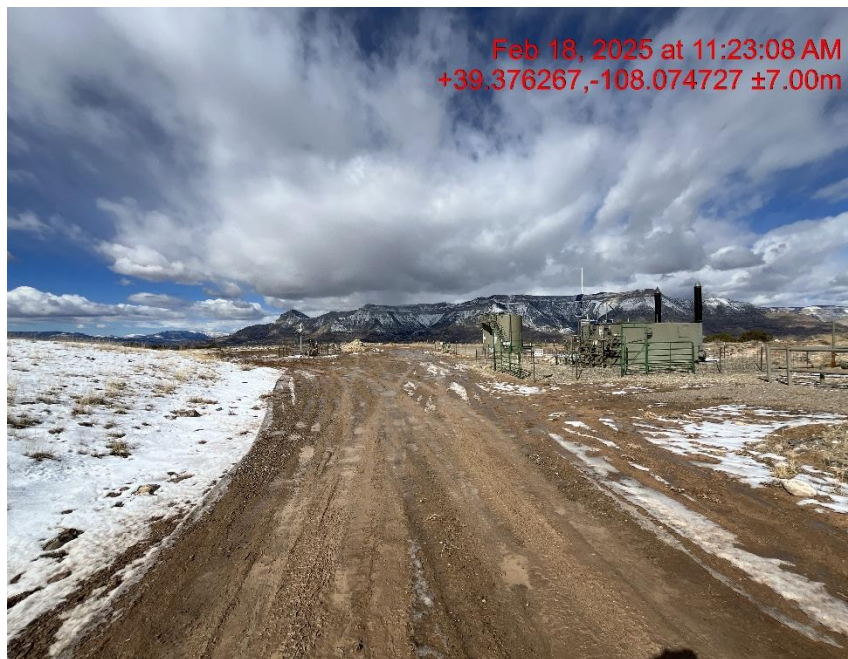
Photo # 5152 Entrance to location

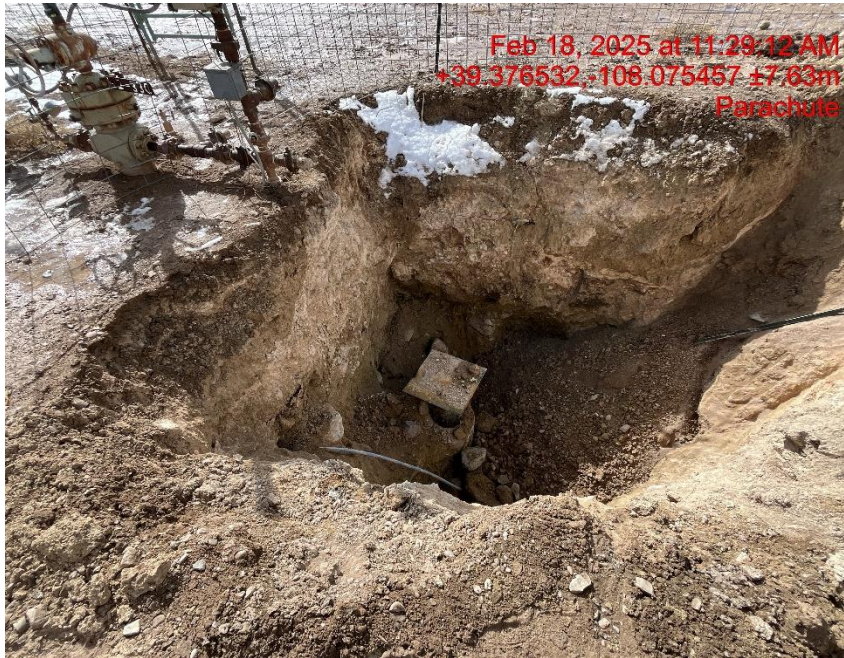
Photo # 5156 Open hole with no wildlife egress/wildlife hazard

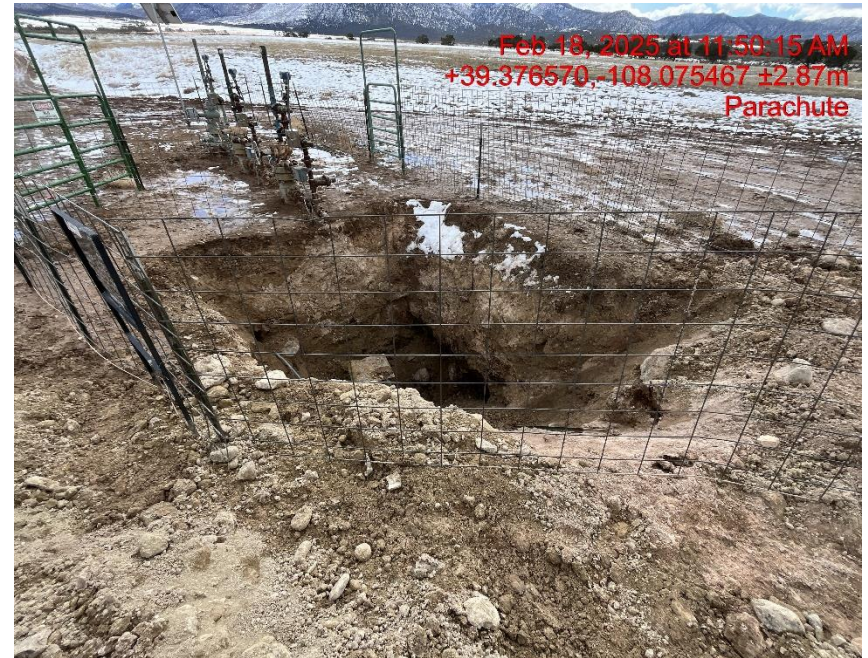
Photo # 5169 Open hole with no wildlife egress/wildlife hazard

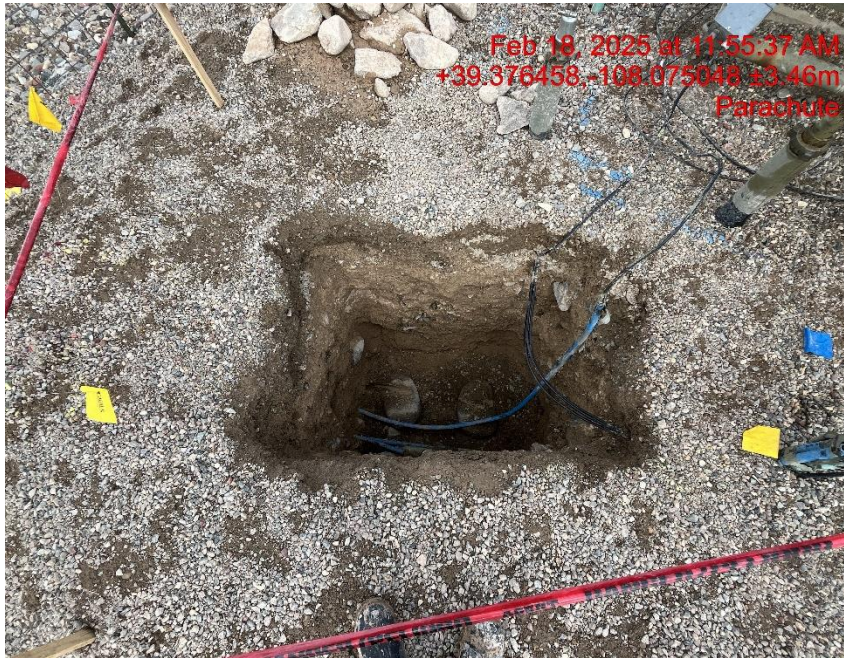
Photo # 5176 Open hole with no wildlife egress/wildlife hazard

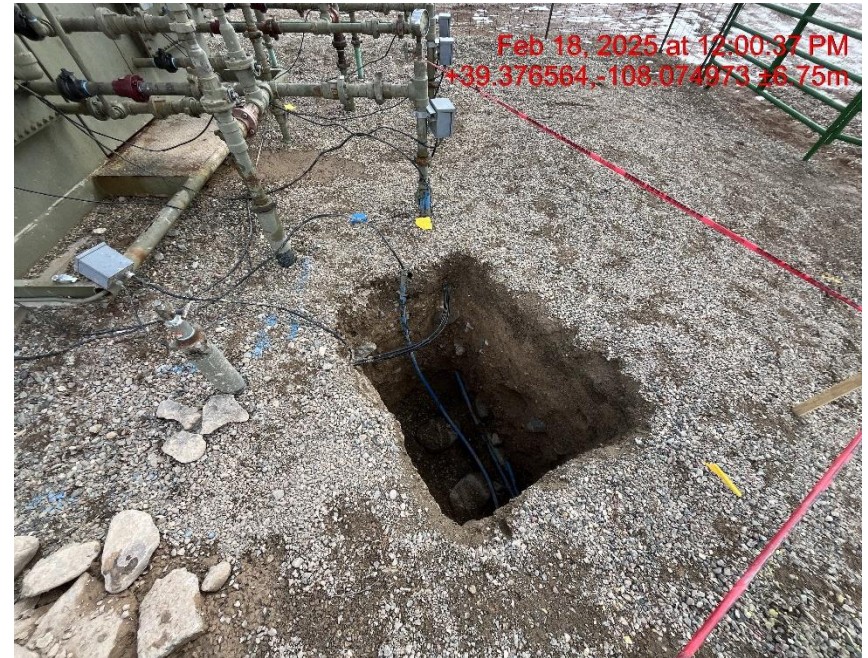
Photo # 5181 Open hole with no wildlife egress/wildlife hazard

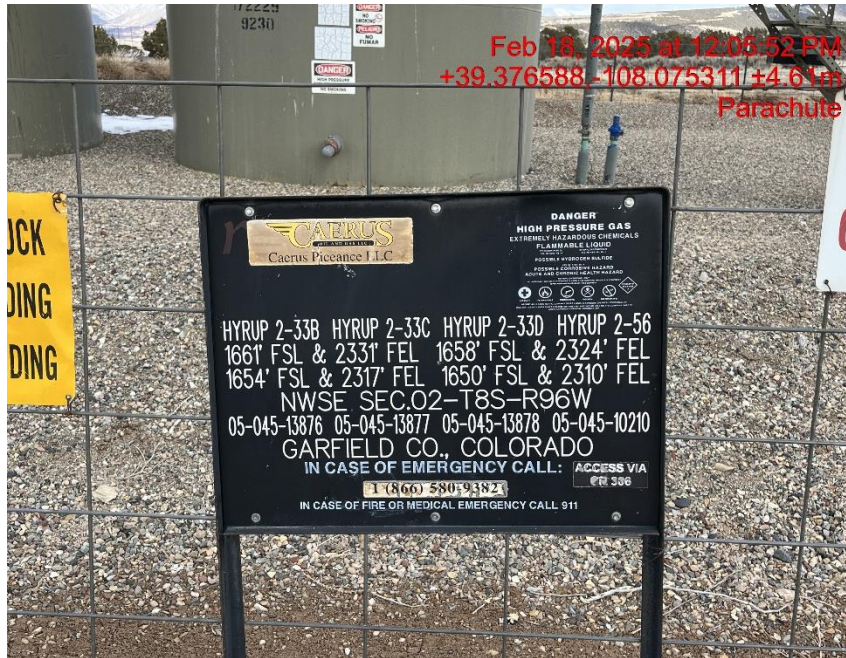
Photo # 5188 Some info is starting to become illegible

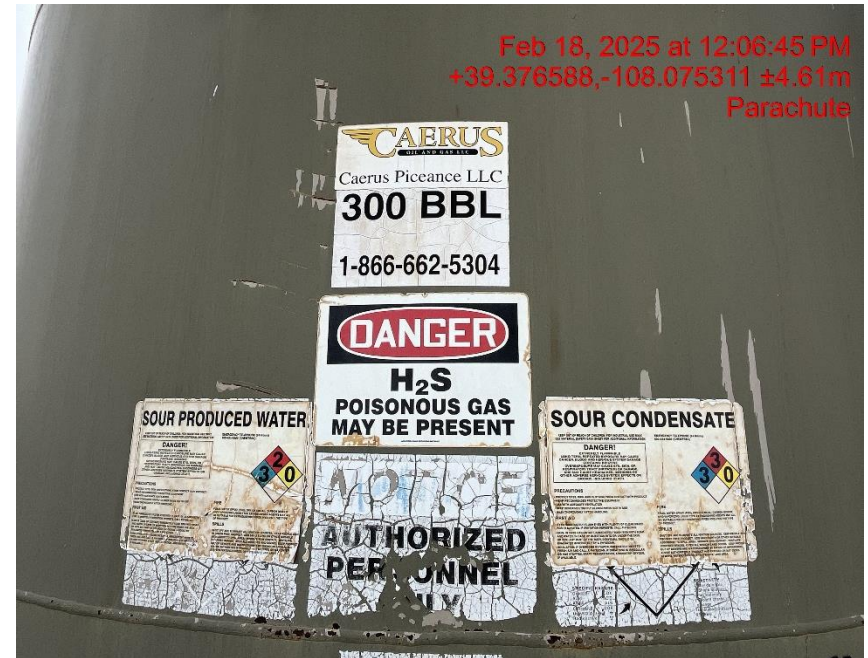
Photo # 5189 Tank labels contain inaccurate contact info and some info is starting to become illegible/not in compliance with CECMC rules

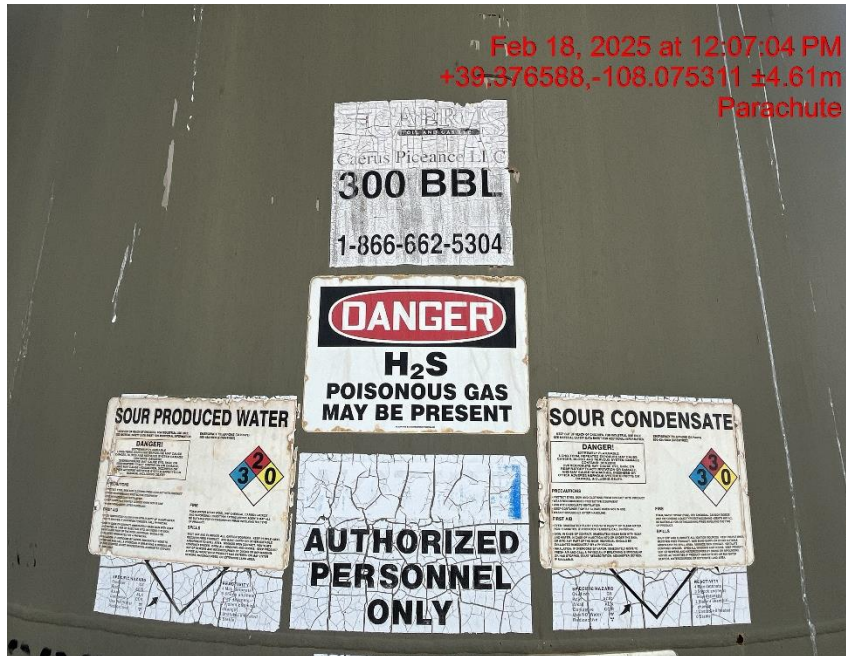
Photo # 5190 Tank labels contain inaccurate contact info and some info is starting to become illegible/not in compliance with CECMC rules

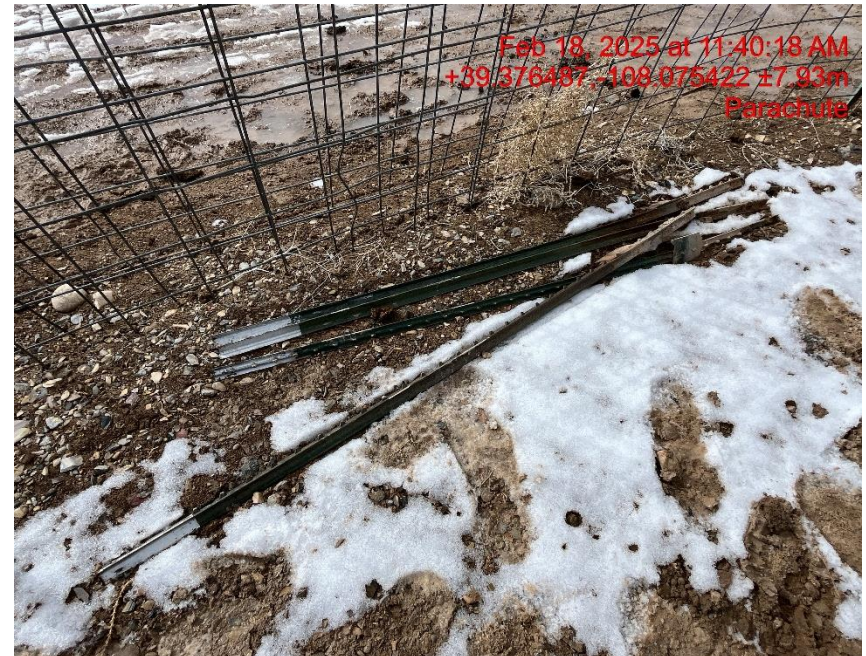
Photo # 5168 Debris
