Inspection Photos  
Location: PCW 41-33  
Location ID: 307307  
API # 05-071-06204

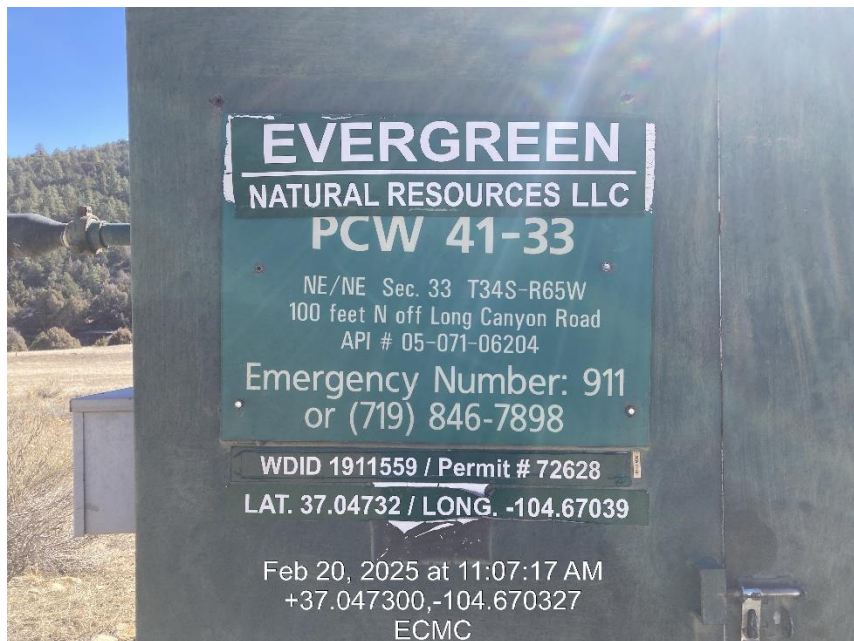
Photo 1 –Well placard

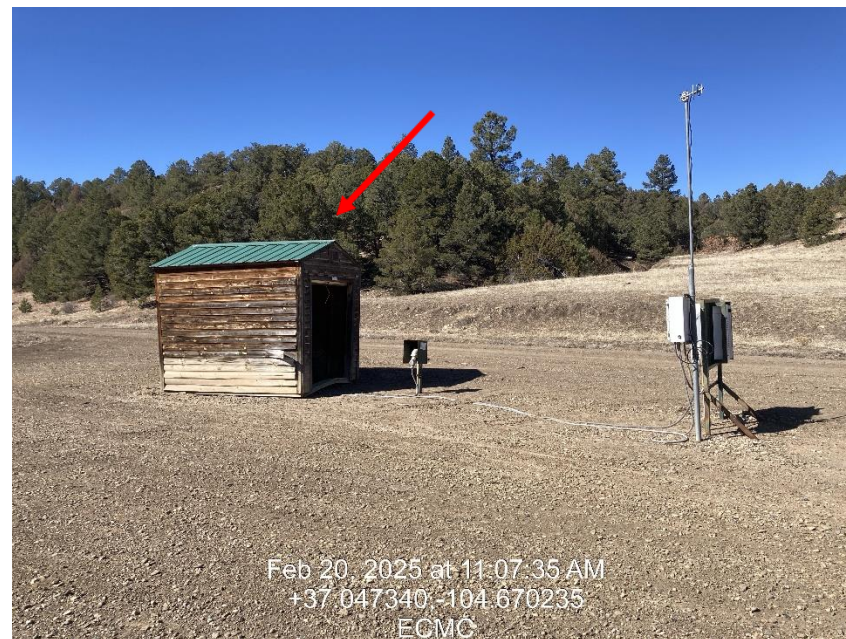
Photo 2 – Wellhead

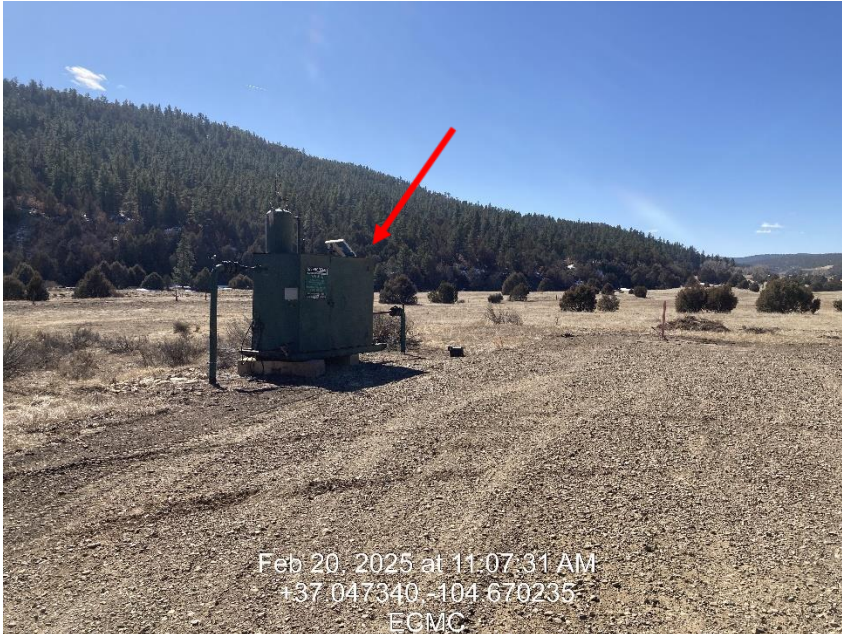
**Photo 3 – Meter House**

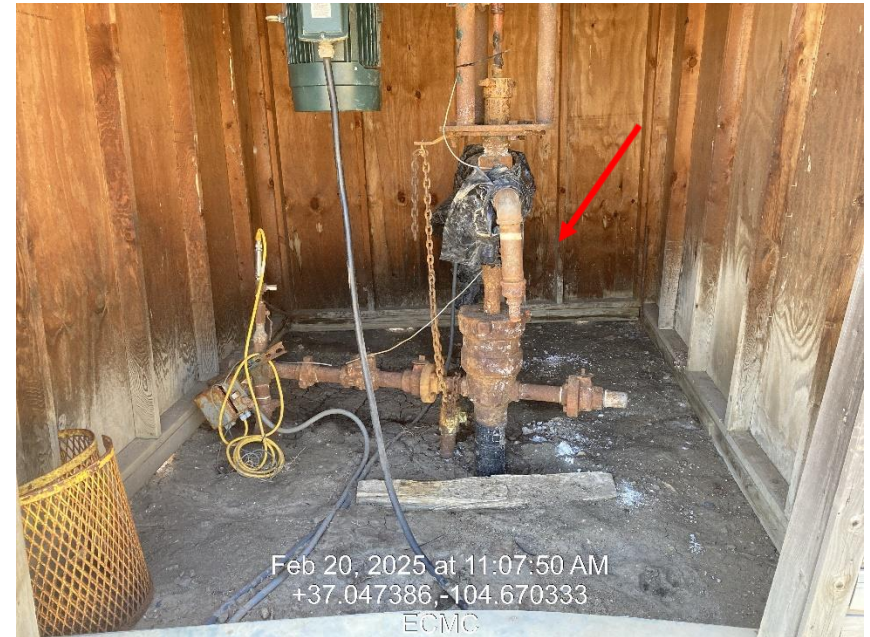
**Photo 4 – Wellhead, white stained  
soils are present.**

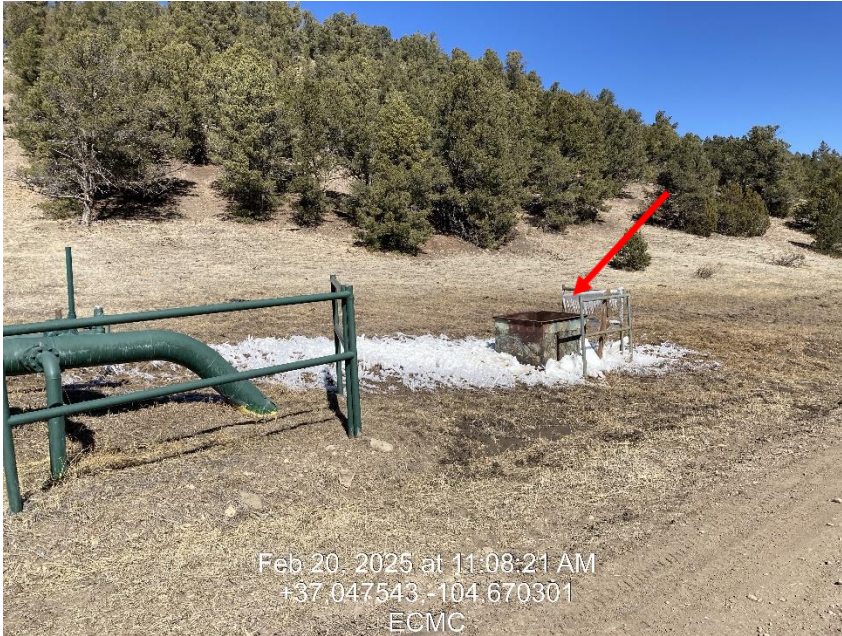
**Photo 5 – Source area, area impacted by spill**

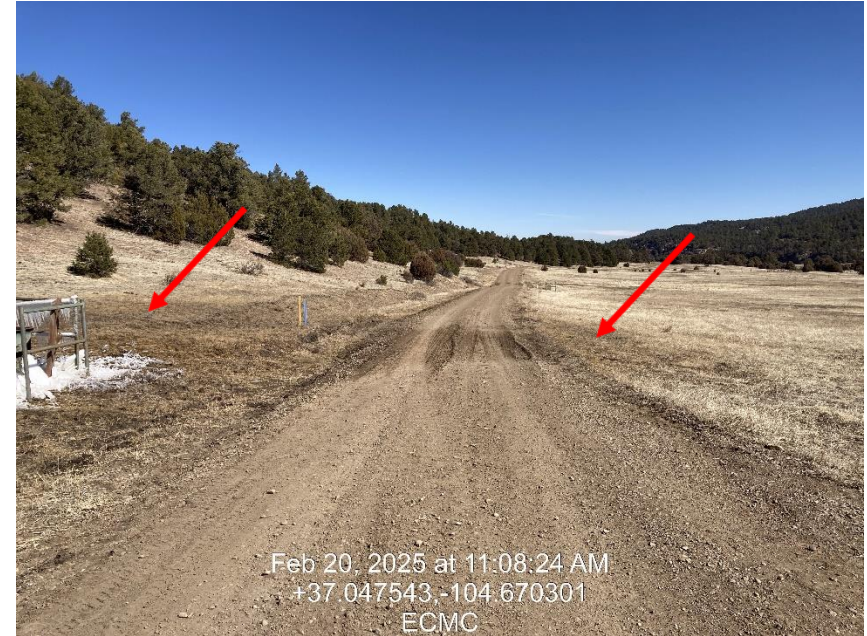
**Photo 6 – Area impacted by spill**

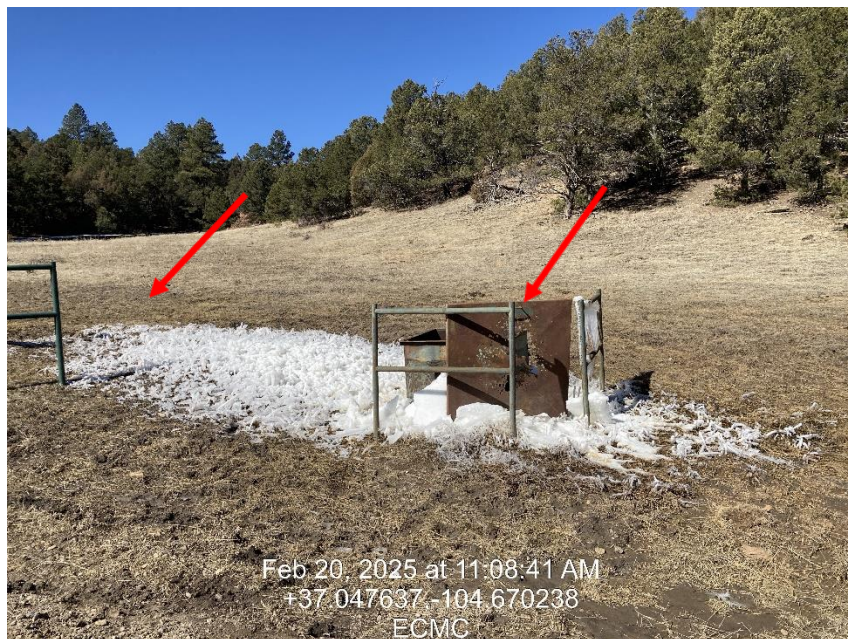
**Photo 7 – Source area**

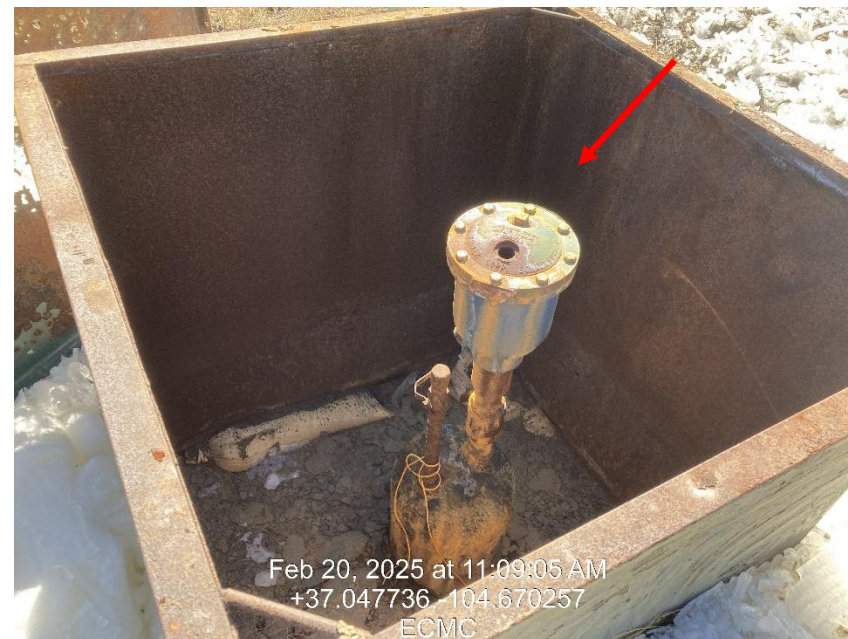
**Photo 8 – Equipment, source of leak**

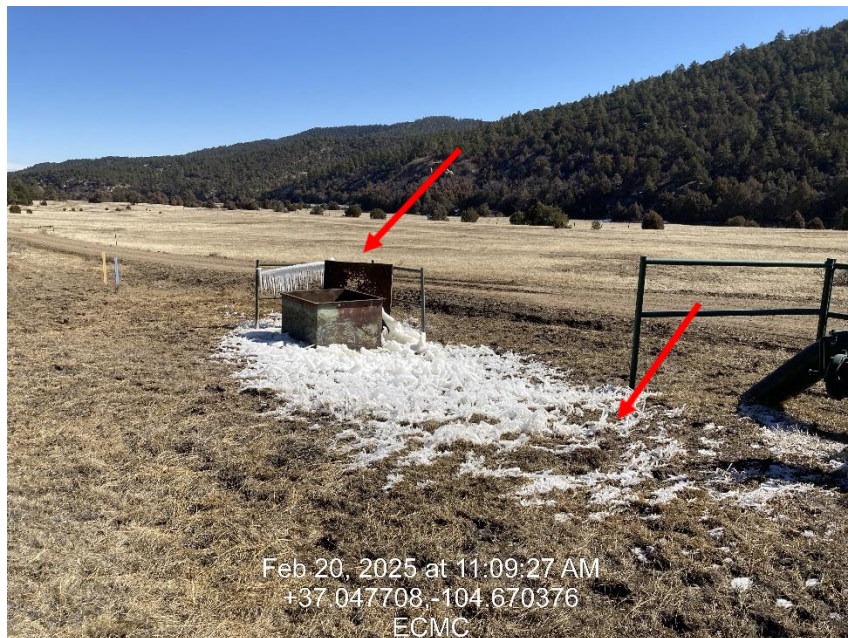
**Photo 9 – Area impacted by spill**

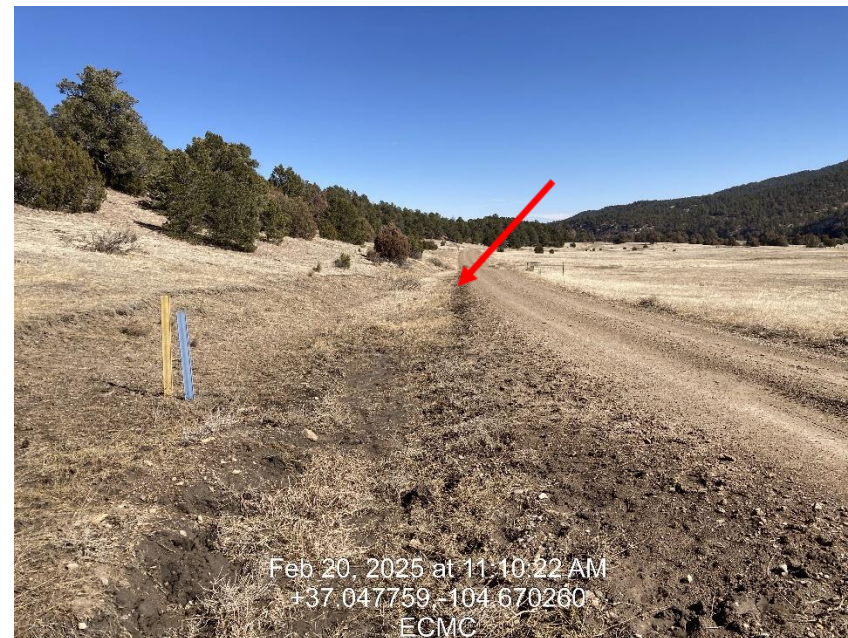
**Photo 10 – Spill Path**

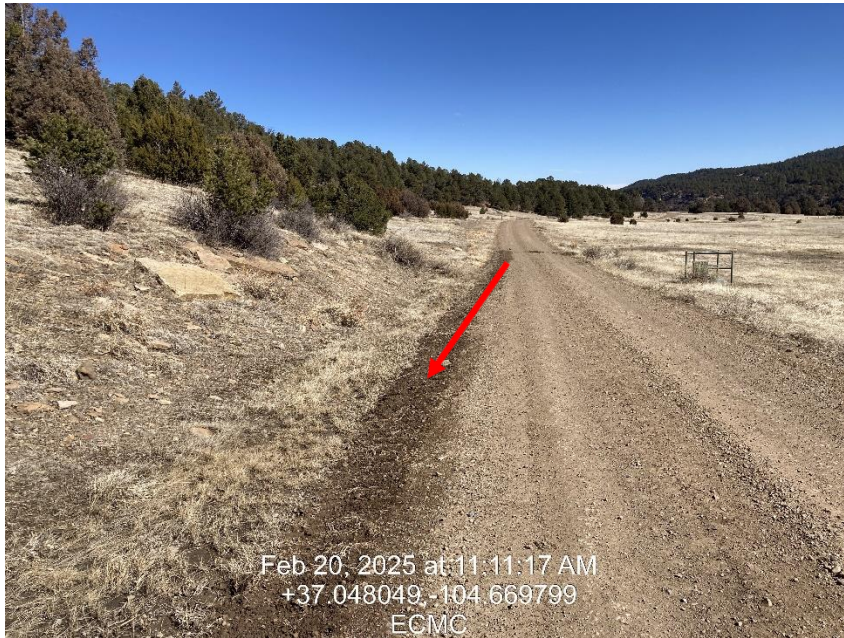
**Photo 11 – Spill Path**

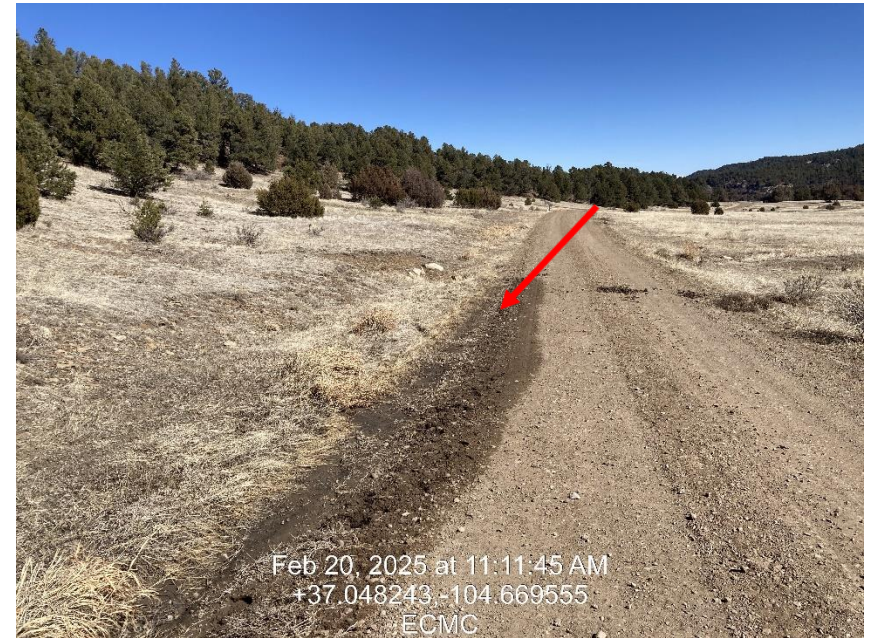
**Photo 12 – Spill Path leading to culvert**

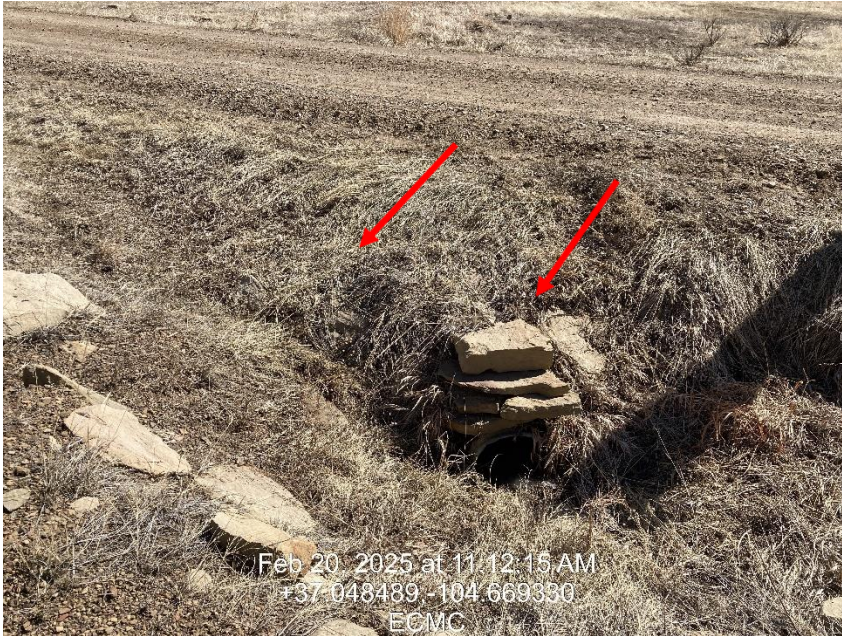
**Photo 13 – Culvert in road, direction change**

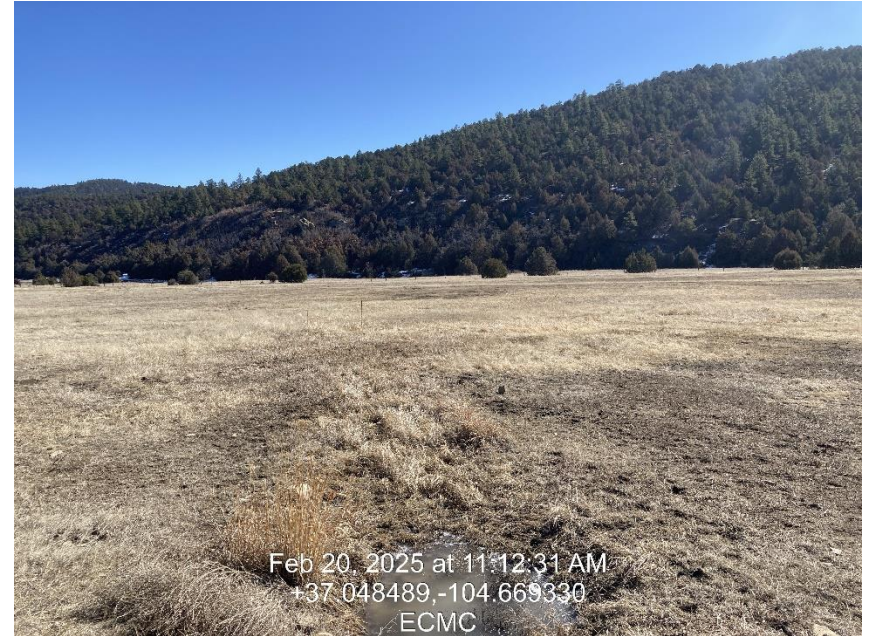
**Photo 14 – Pool at end of culvert**
