Inspection/Audit Photos

Location: QB ENERGY HYRUP/2-34B (PAD - 2 0)

Location ID: 334103

Date: 02/18/2025

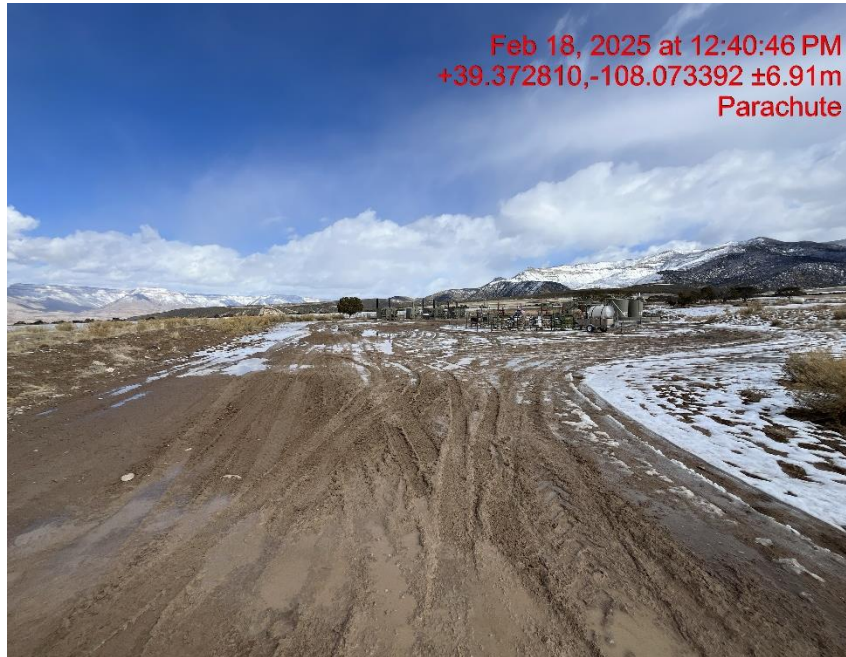
Photo # 5208 Entrance to location

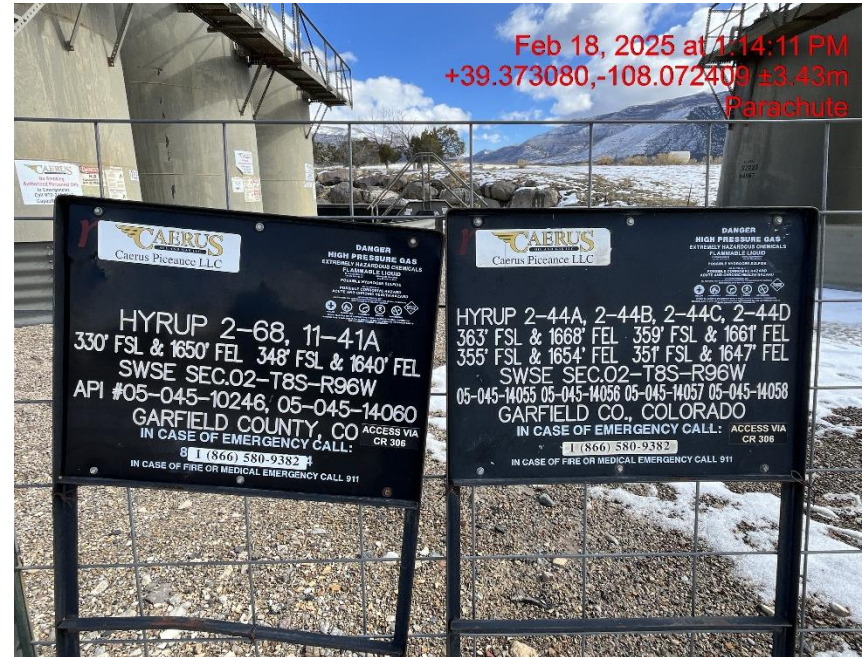
Photo # 5243 Location/Well 2-34A info is missing

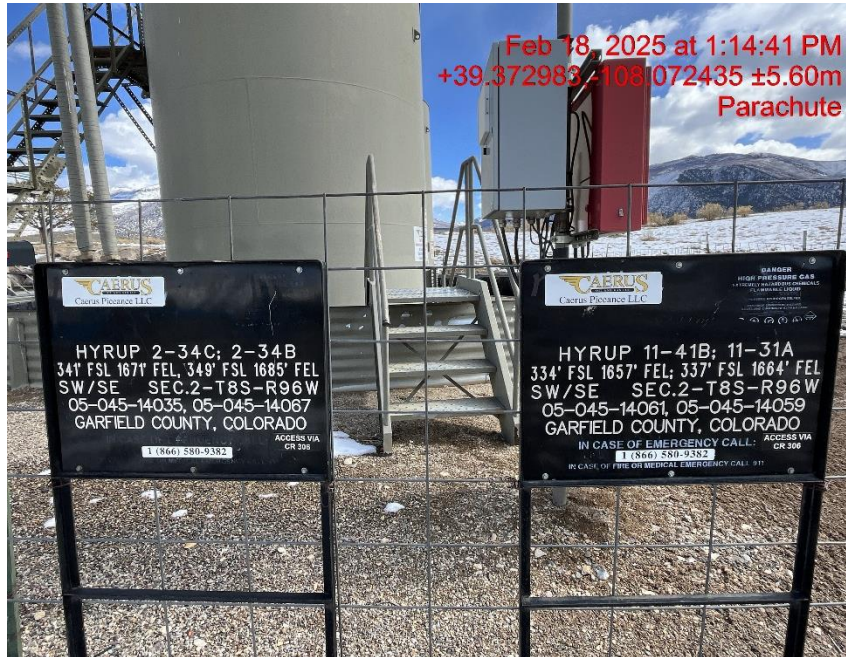
Photo # 5244 Location/Well 2-34A info is missing

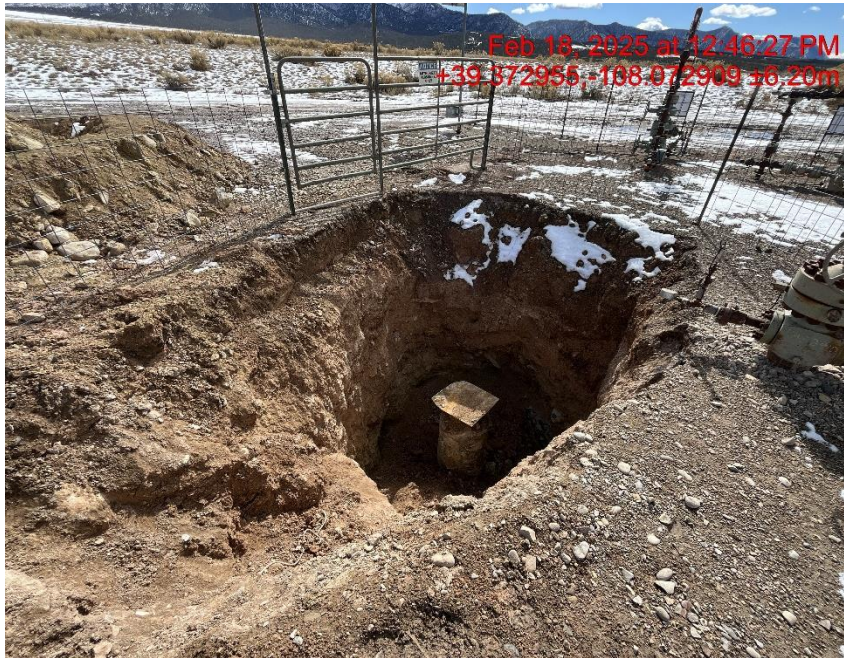
Photo # 5213 Open hole with no wildlife egress/wildlife hazard

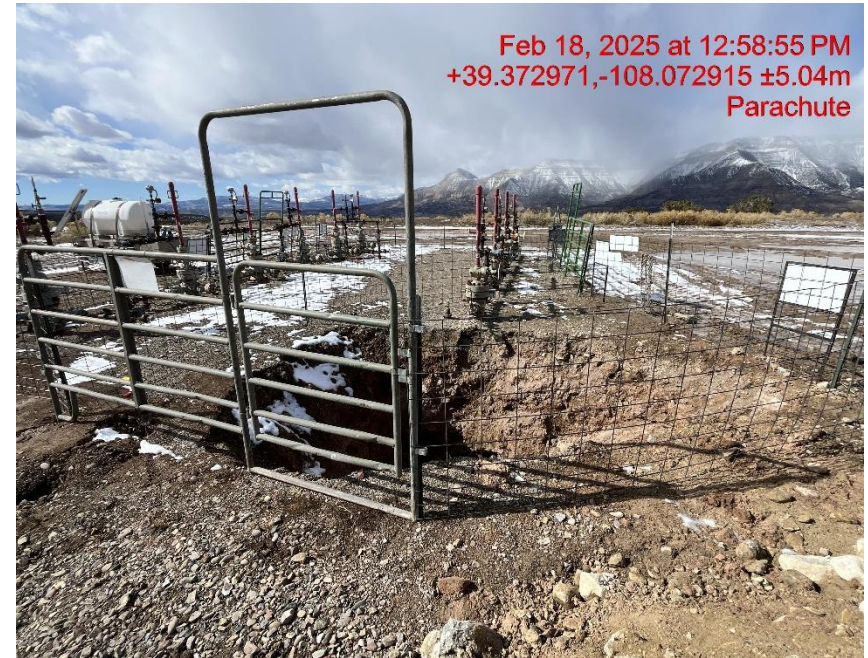
Photo # 5223 Open hole with no wildlife egress/wildlife hazard

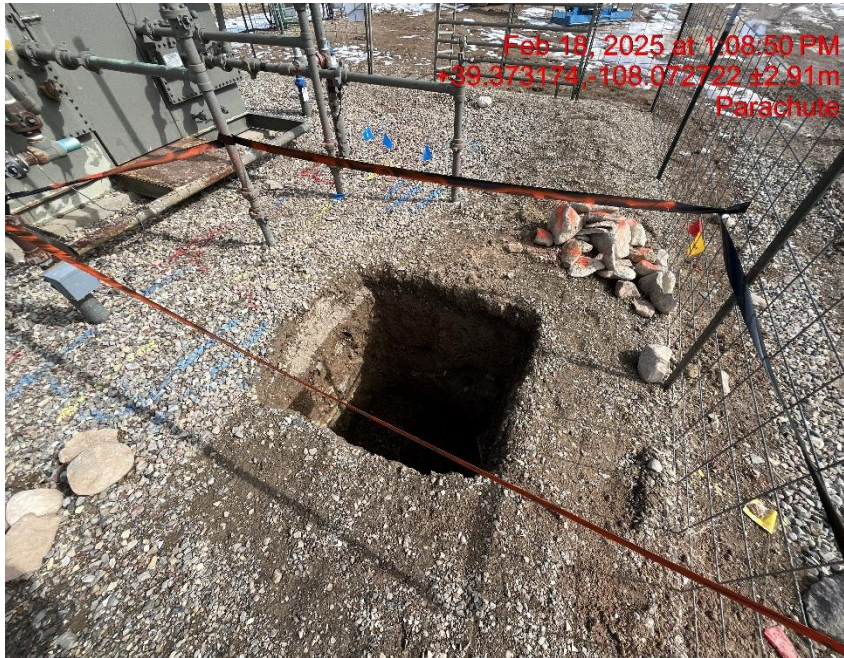
Photo # 5236 Open hole with no wildlife egress/wildlife hazard

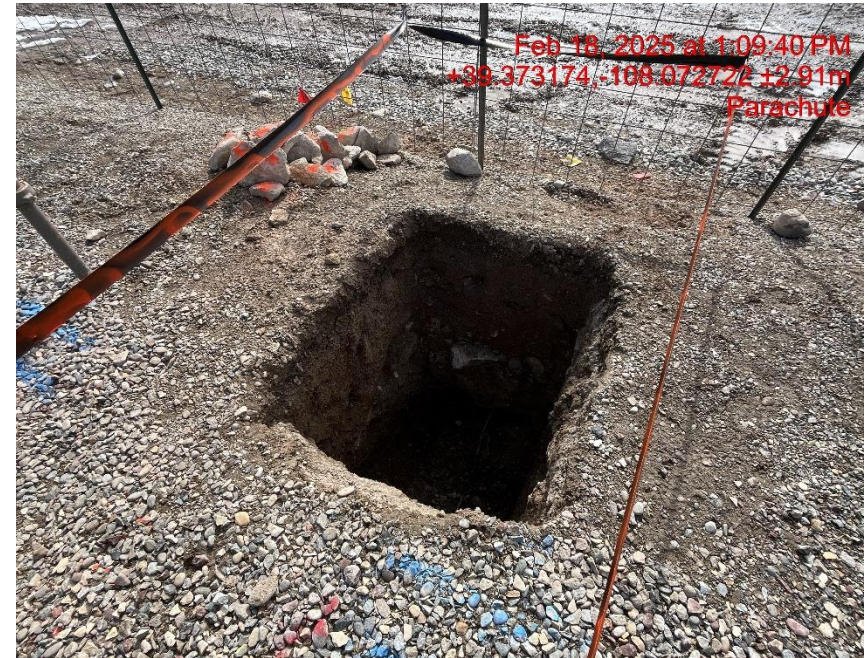
Photo # 5237 Open hole with no wildlife egress/wildlife hazard

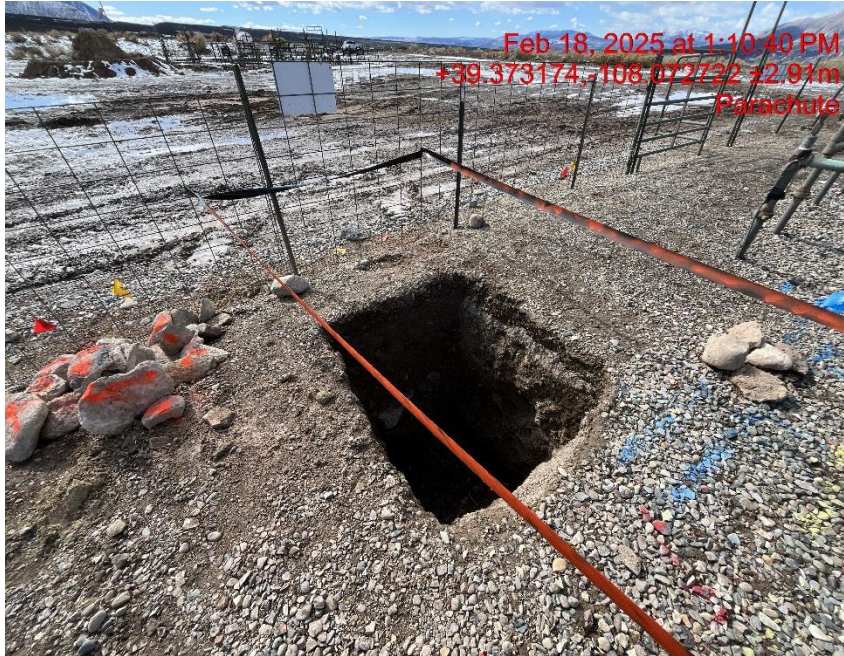
Photo # 5238 Open hole with no wildlife egress/wildlife hazard

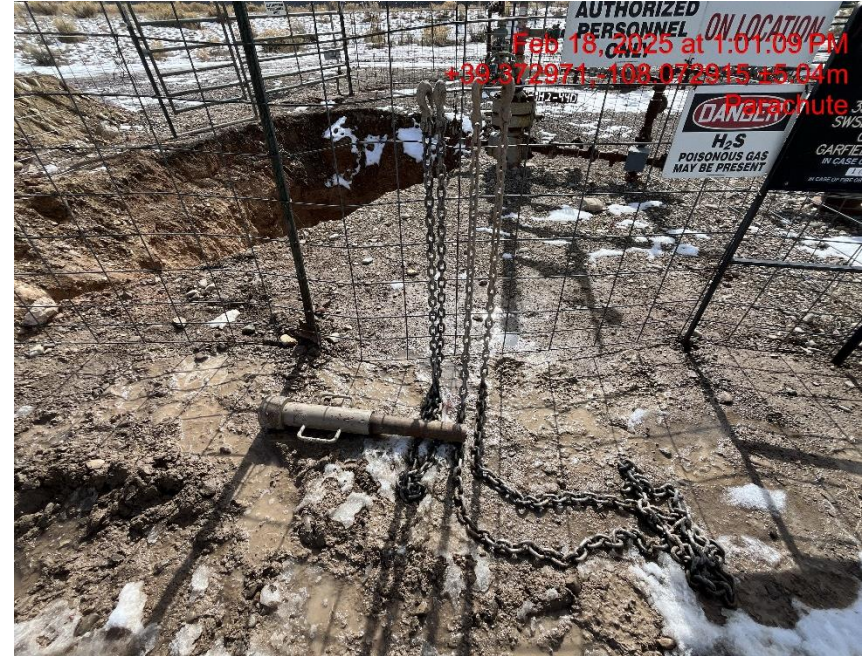
Photo # 5227 Debris
