Inspection Photos
Location Name: Champlin 126 Amoco A 2
Location ID: 320646

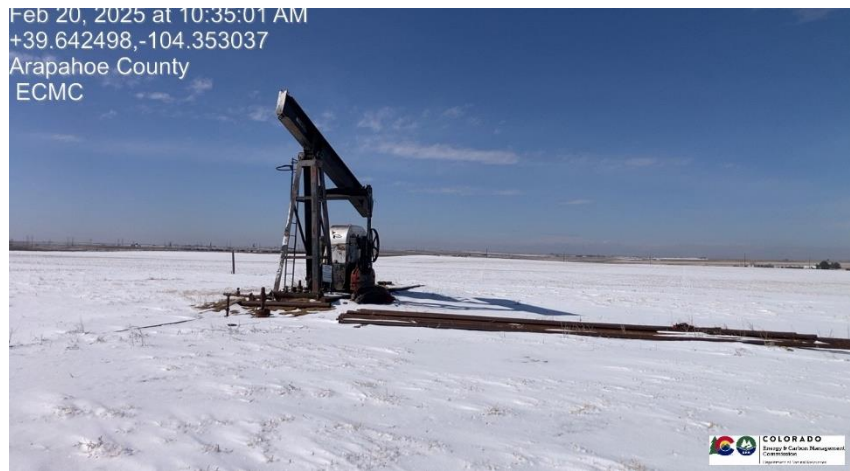
Pic 1 wellhead / pumpjack

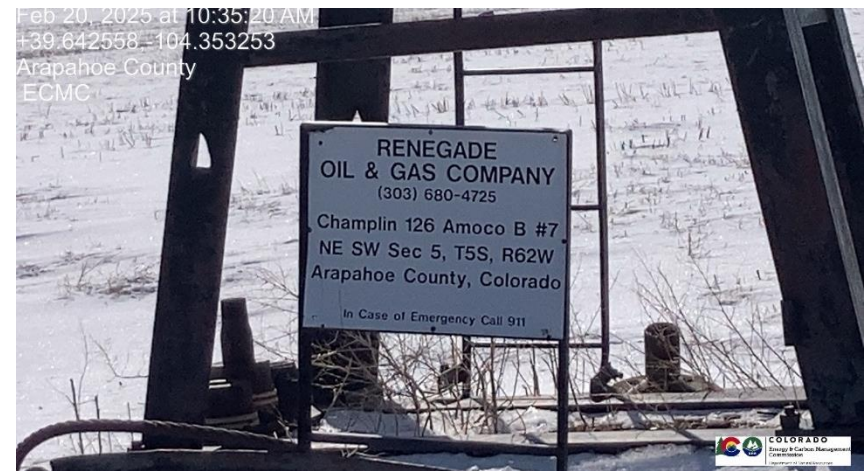
Pic 2 wellhead sign
