Inspection/Audit Photos

Location Name: TEP ROCKY MOUNTAIN LLC HANGS A Pad

Location ID: 336023

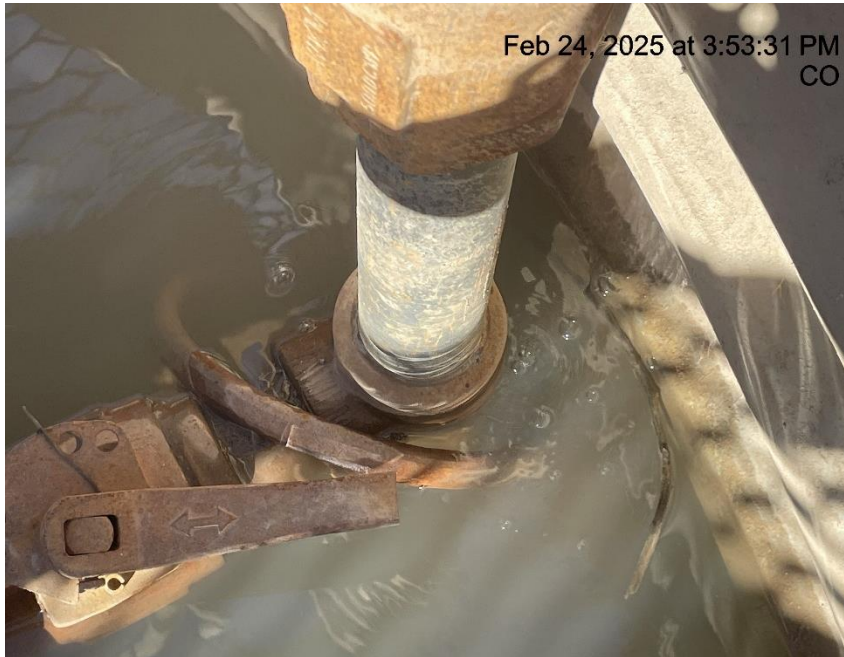
Photo # 8800 Mechanical Condition - Possible wellhead leak /gas bubbling up through water in cellar near casing valve (HANGS A2 wellhead)

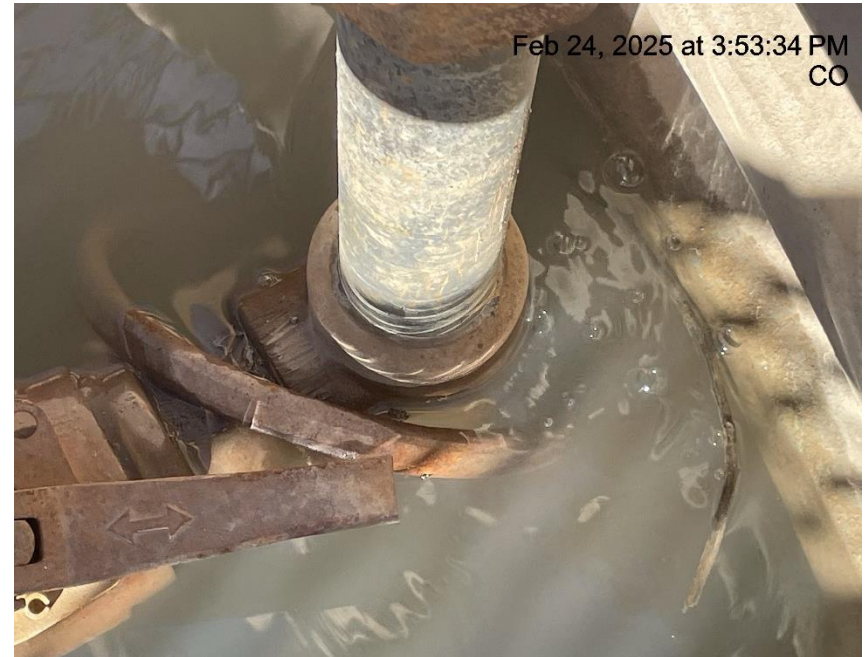
Photo # 8801 Mechanical Condition - Possible wellhead leak /gas bubbling up through water in cellar near casing valve (HANGS A2 wellhead)

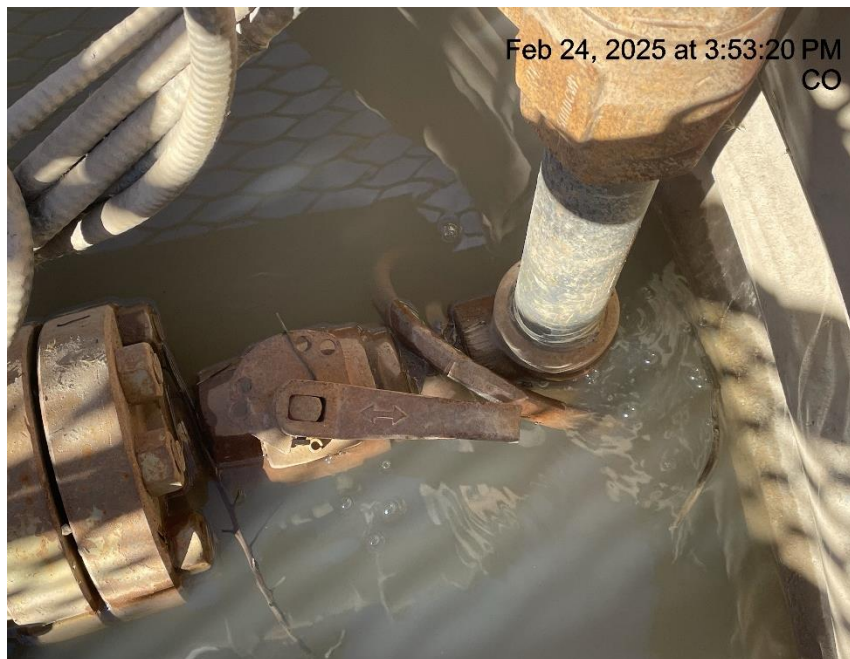
Photo # 8802 Mechanical Condition - Possible wellhead leak /gas bubbling up through water in cellar near casing valve (HANGS A2 wellhead)

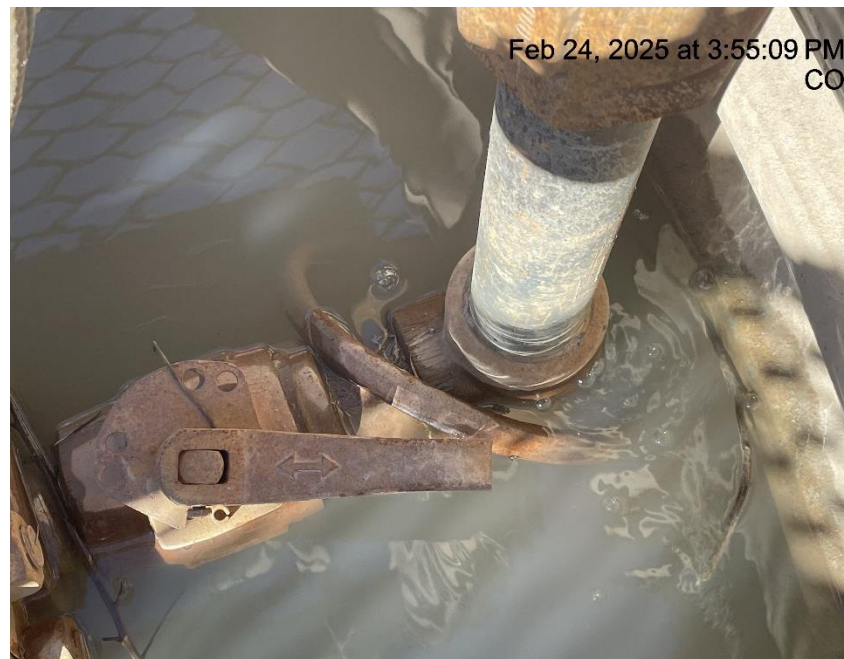
Photo # 8803 Mechanical Condition - Possible wellhead leak /gas bubbling up through water in cellar near casing valve (HANGS A2 wellhead)

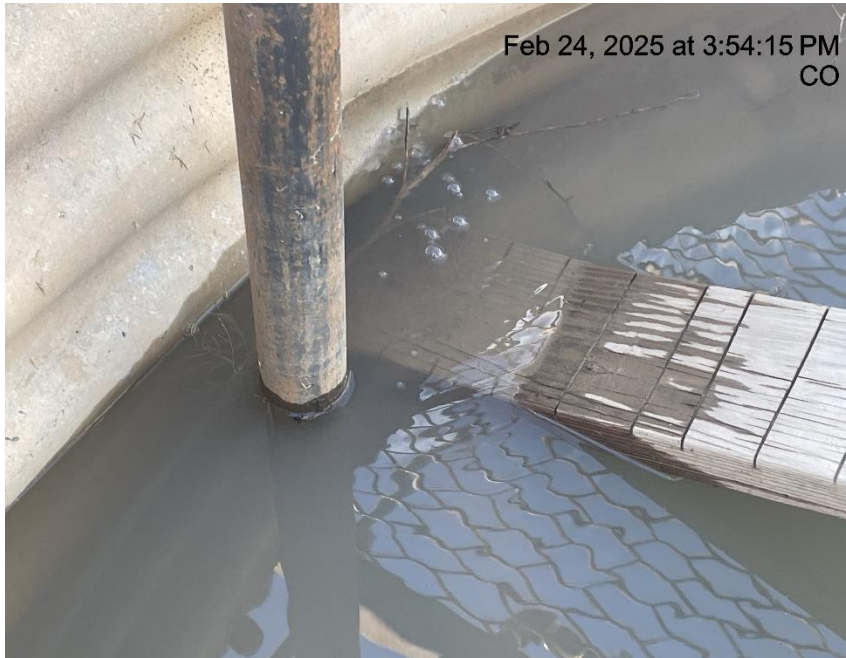
Photo # 8804 Mechanical Condition - Possible leak/gas bubbling up through water in cellar near bradenhead line (HANGS A2 well)

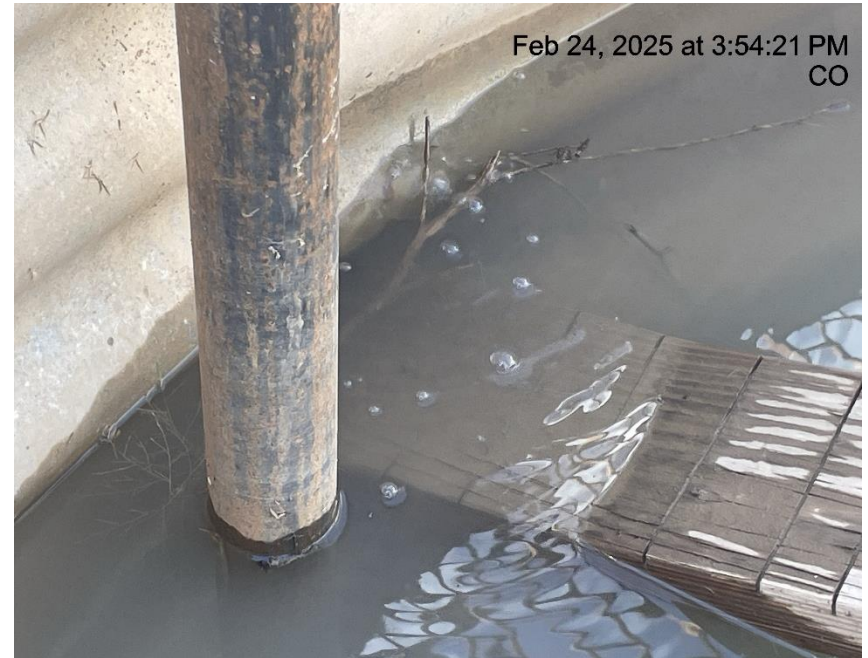
Photo # 8805 Mechanical Condition - Possible leak/gas bubbling up through water in cellar near bradenhead line (HANGS A2 well)

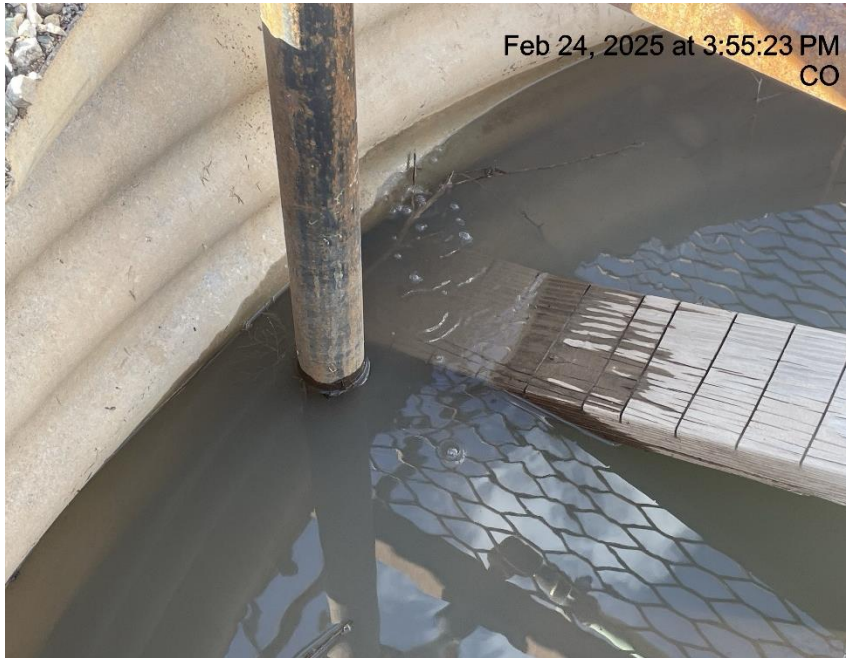
Photo # 8806 Mechanical Condition - Possible leak/gas bubbling up through water in cellar near bradenhead line (HANGS A2 well)

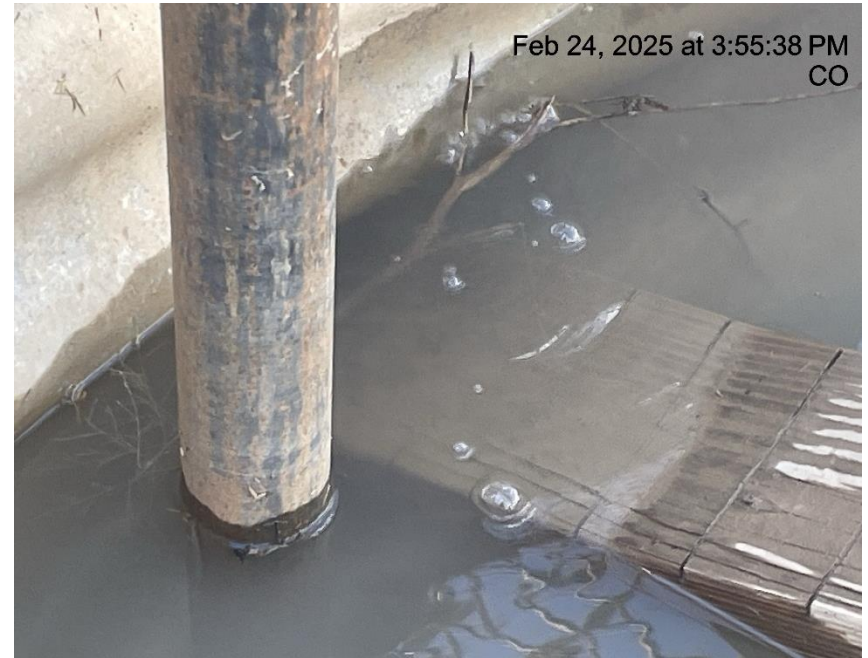
Photo # 8807 Mechanical Condition - Possible leak/gas bubbling up through water in cellar near bradenhead line (HANGS A2 well)

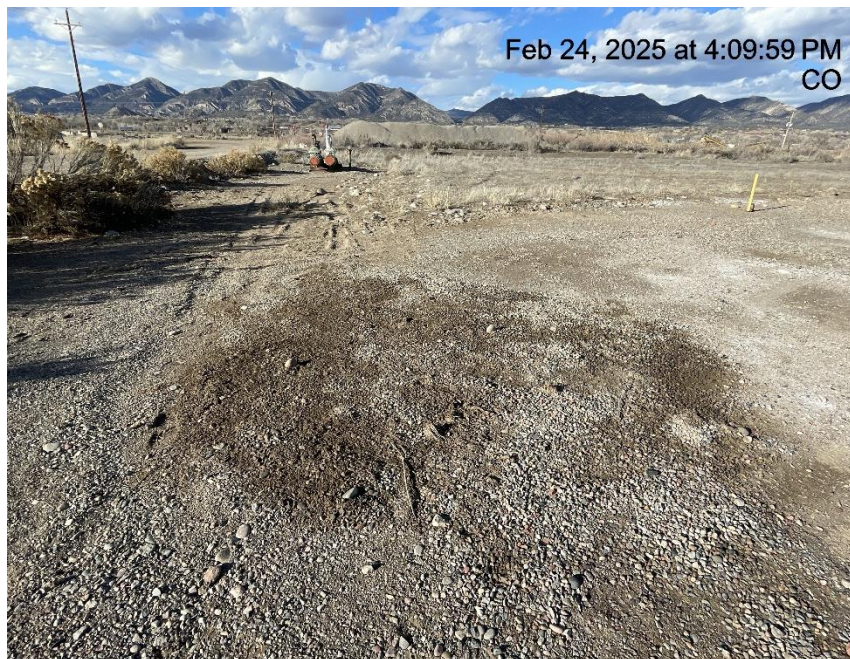
Photo # 8808 Staining

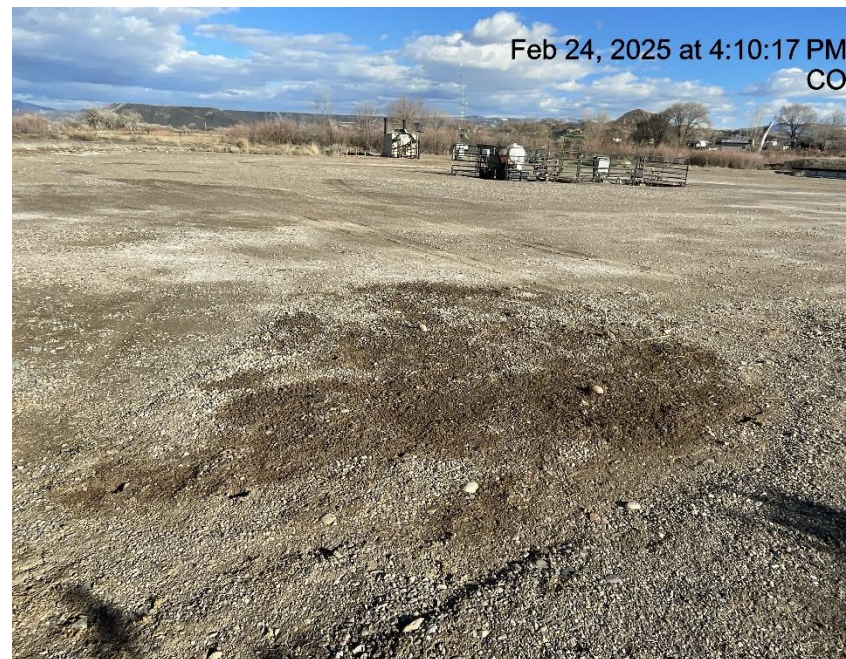
Photo # 8809 Same area of staining from a different angle

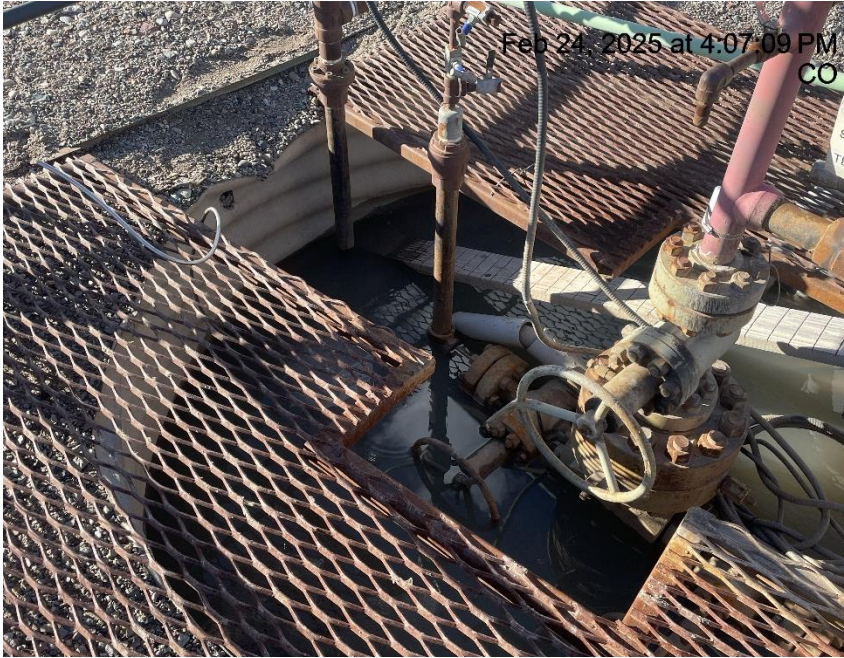
Photo # 8810 Cellar not properly covered/wildlife & personnel hazard
