Inspection/Audit Photos

Location: TEP ROCKY MOUNTAIN LLC Chevron/TR 32-21-597 PAD

Location ID: 335603

Date: 02/24/2025

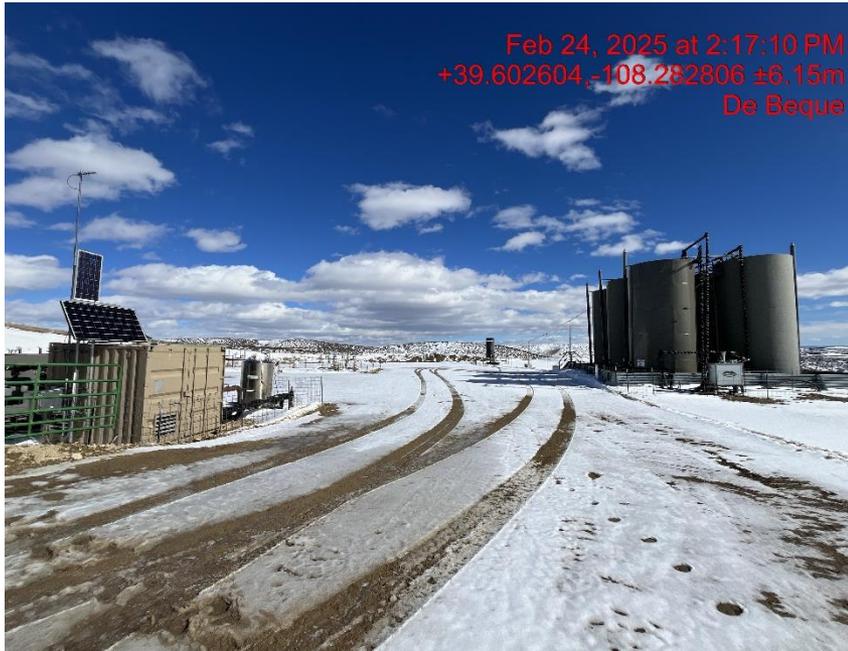
Photo # 5736 Entrance to location

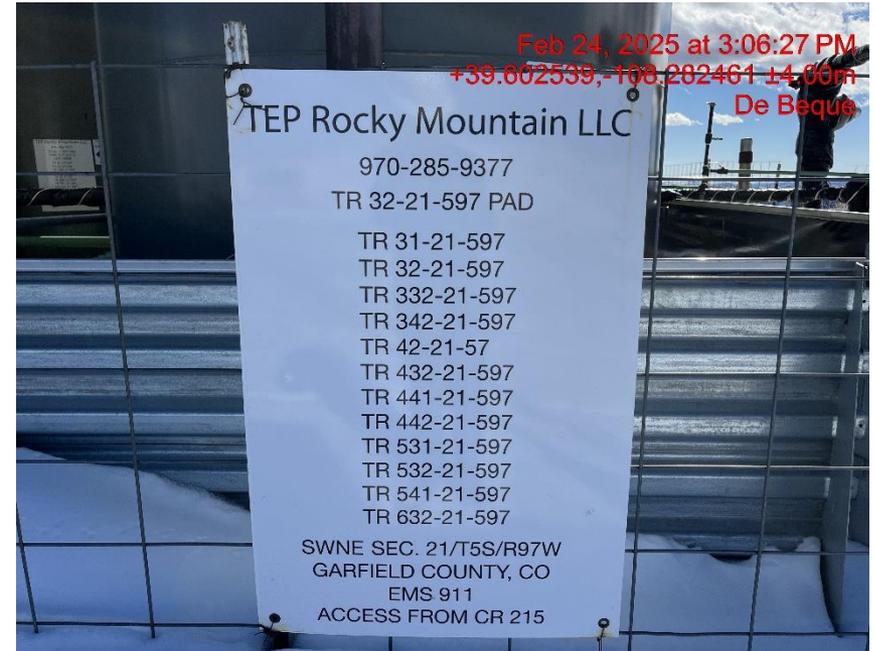
Photo # 5766 Location

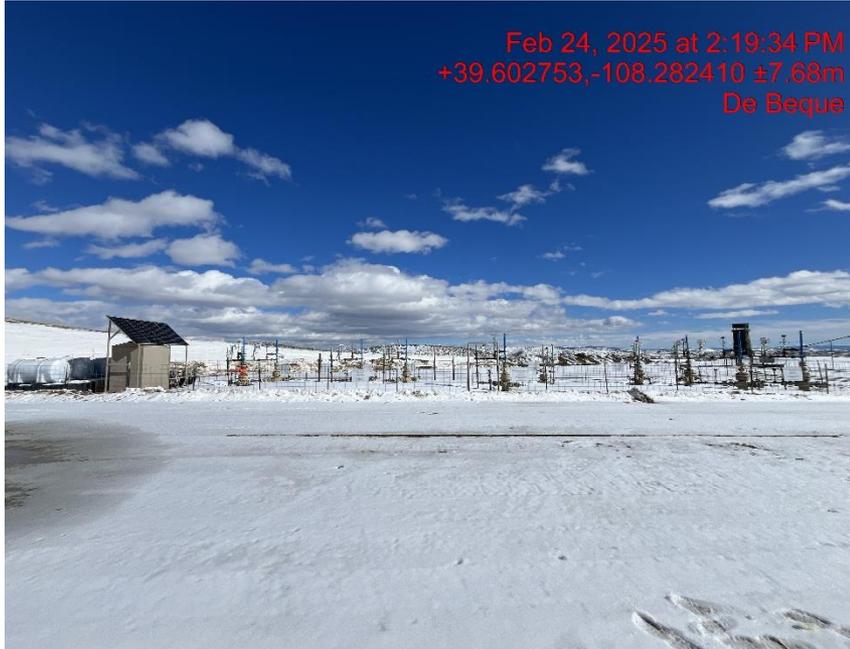
Photo # 5737 Location

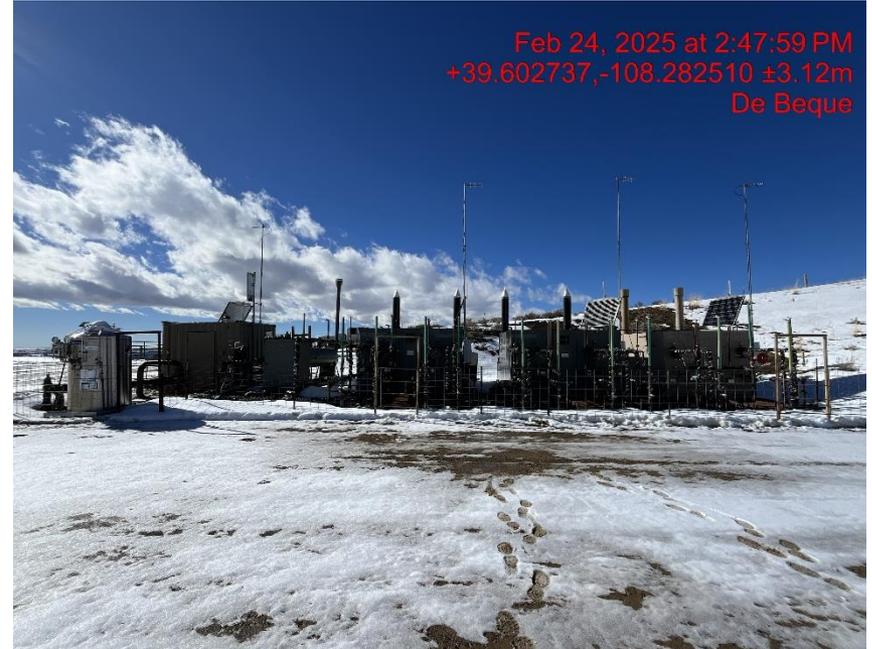
Photo # 5754 Location

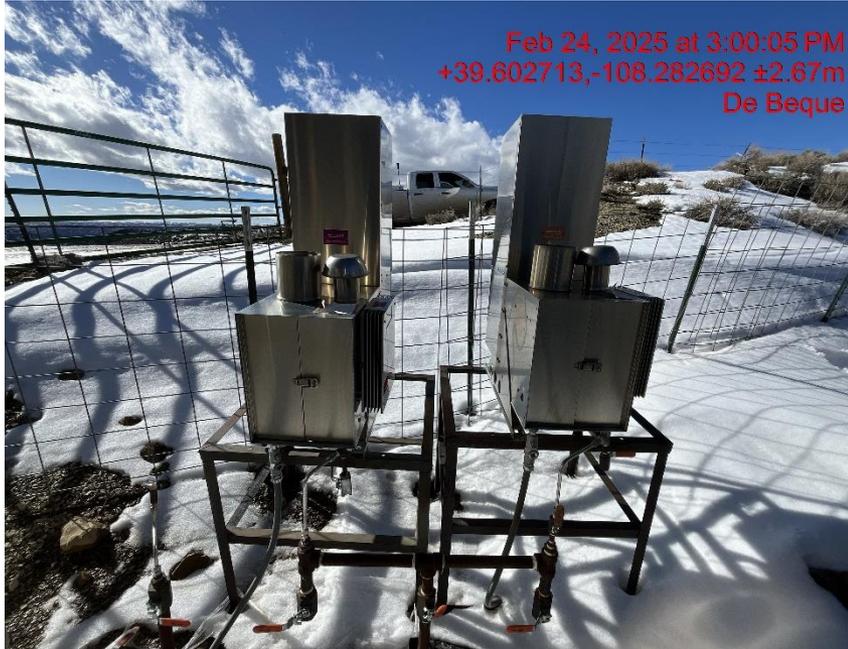
Photo # 5760 Location

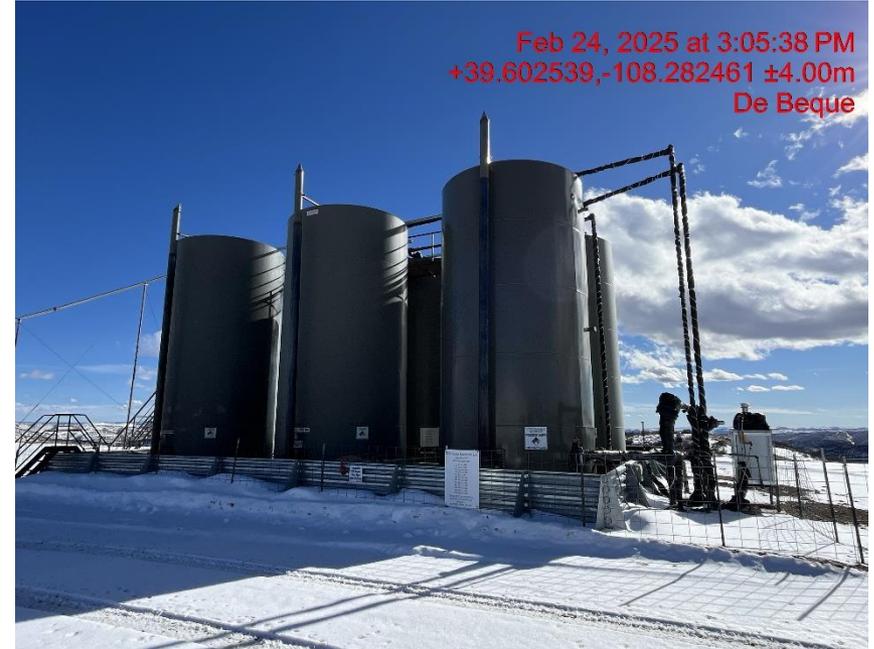
Photo # 5765 Location

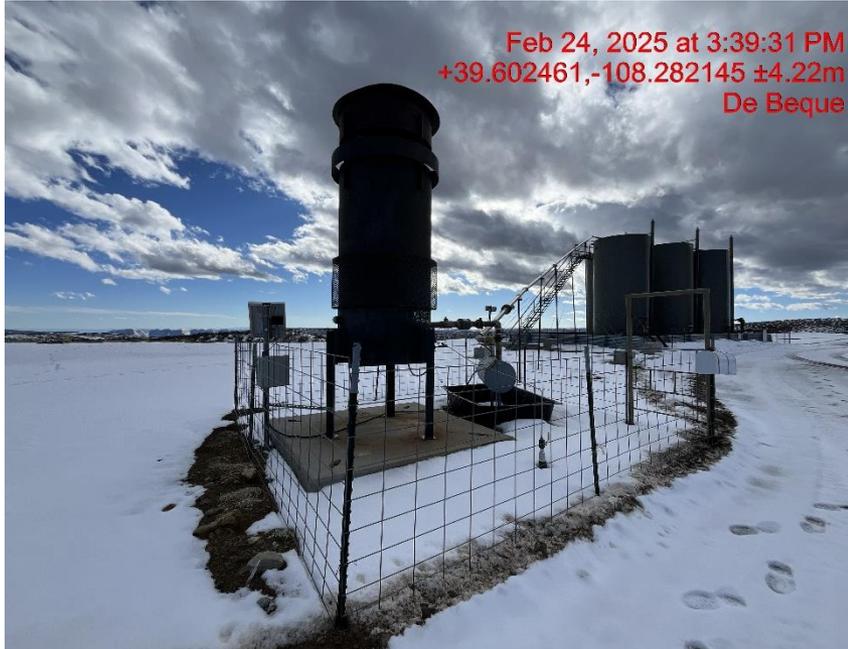
Photo # 5795 Location

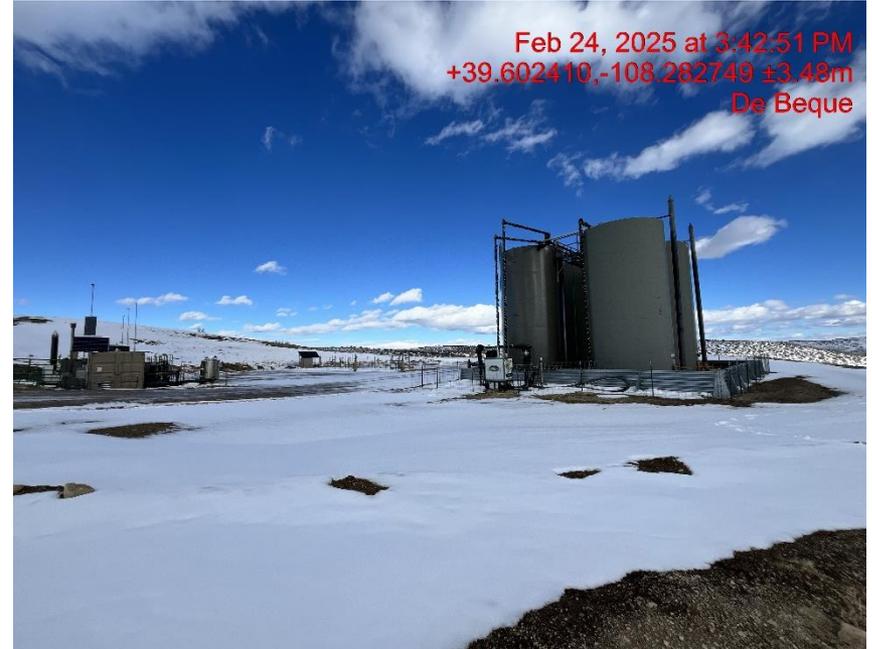
Photo # 5797 SW corner of location

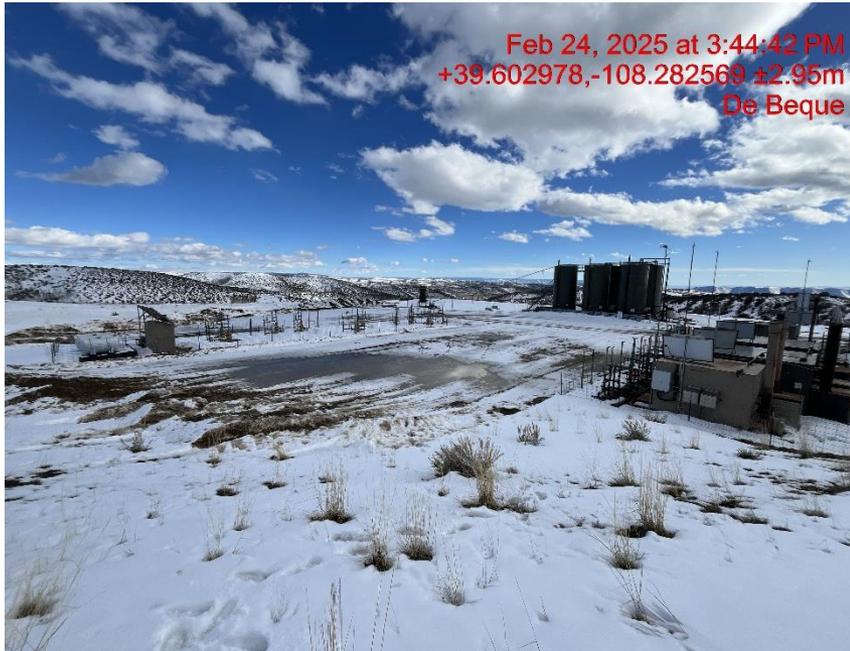
Photo # 5798 NW corner of location

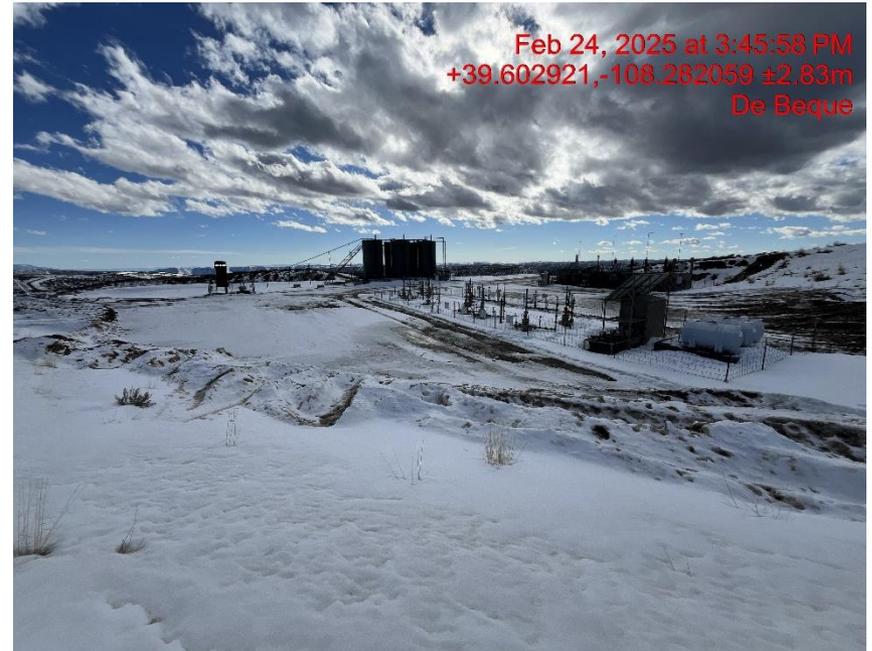
Photo # 5799 NE corner of location

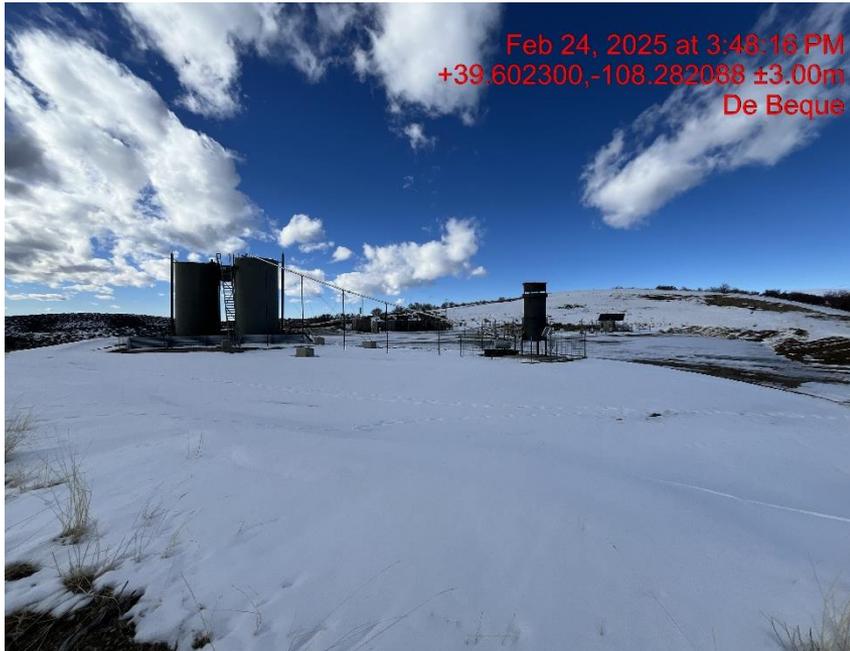
Photo # 5800 SE corner of location

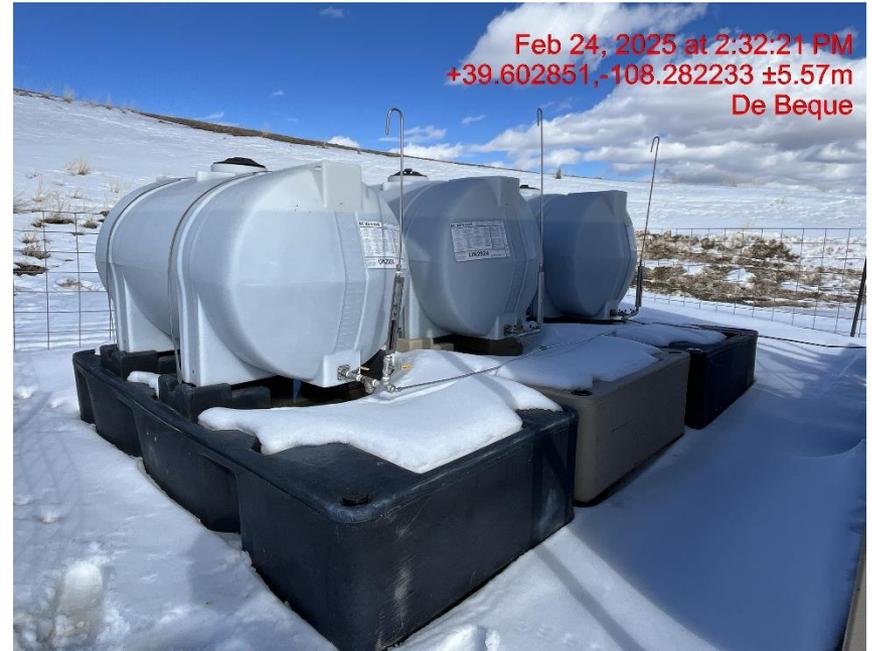
Photo # 5745 Failure to maintain chemical BMP's/chemical containments full of fluid & not sufficient to contain possible spill

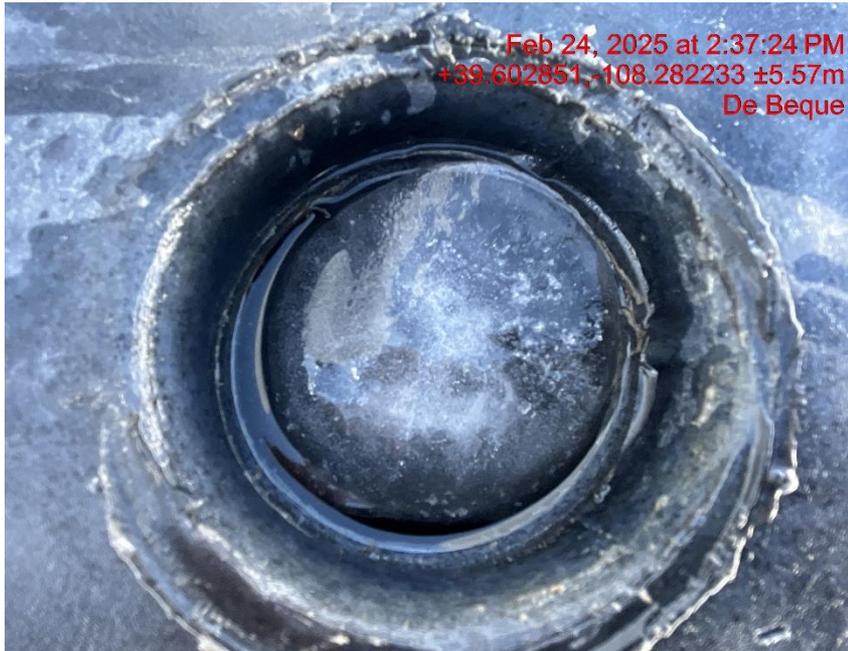
Photo # 5748 Failure to maintain chemical BMP's/chemical containments full of fluid & not sufficient to contain possible spill

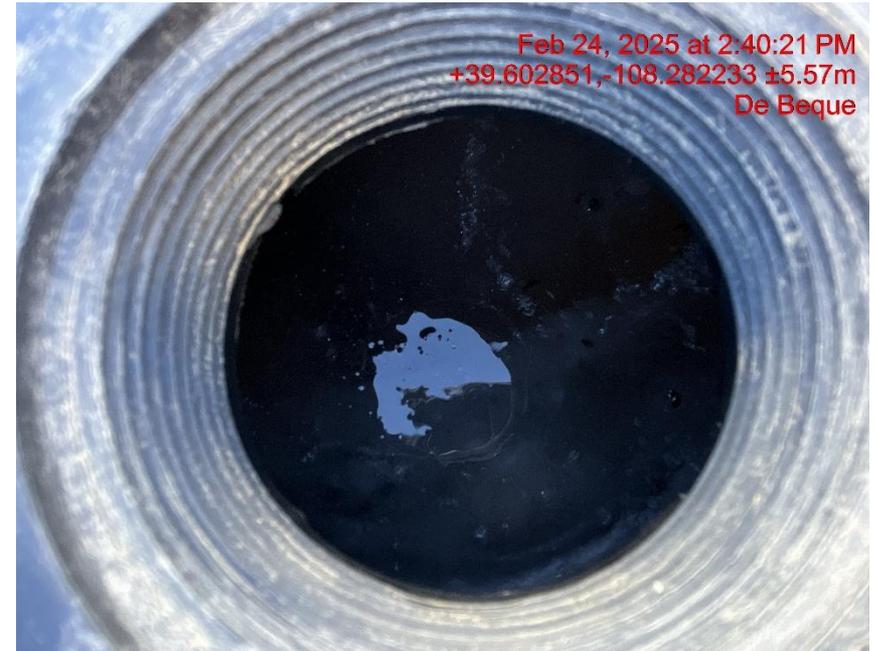
Photo # 5749 Failure to maintain chemical BMP's/chemical containments full of fluid & not sufficient to contain possible spill

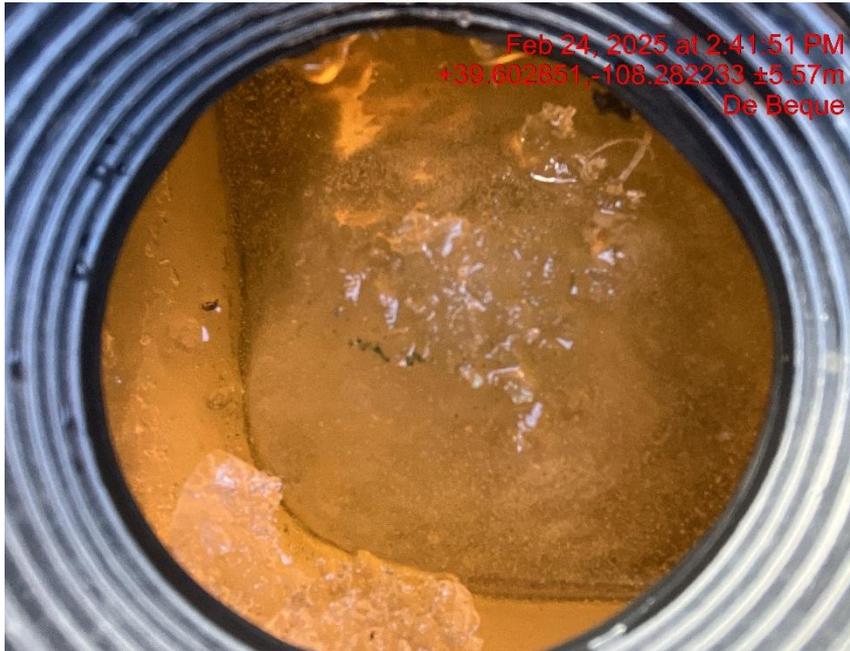
Photo # 5750 Failure to maintain chemical BMP's/chemical containments full of fluid & not sufficient to contain possible spill

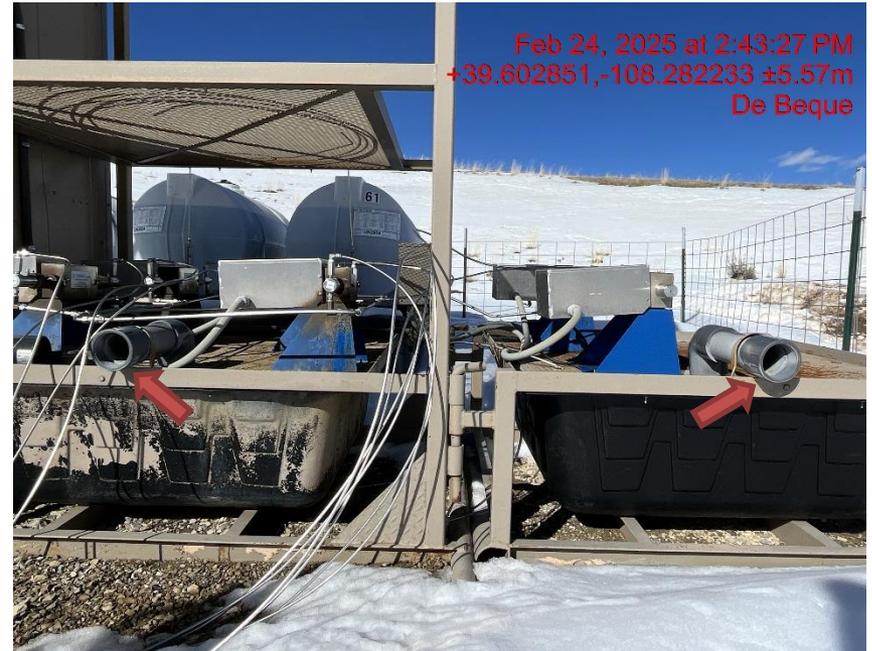
Photo # 5751 Open ended piping on chemical pumps containments/wildlife hazard/available for entry by wildlife

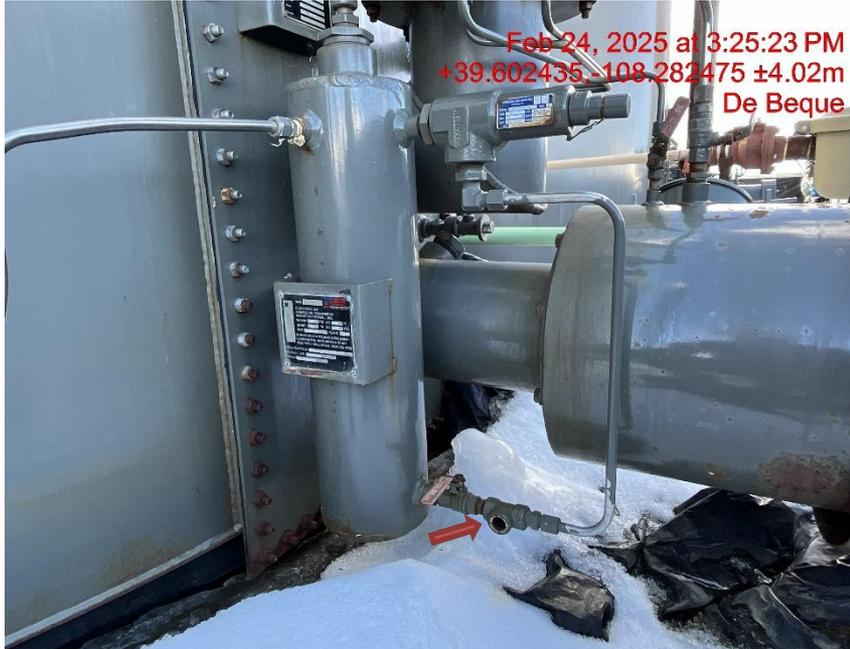
Photo # 5782 PRV vent lines on tank heaters do not comply with CECMC pressure safety device rules

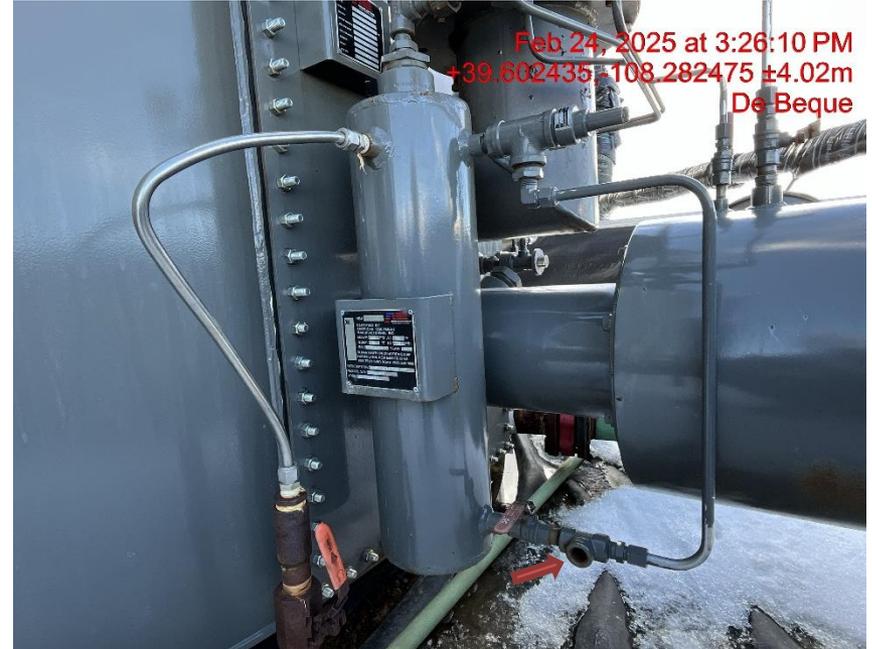
Photo # 5783 PRV vent lines on tank heaters do not comply with CECMC pressure safety device rules

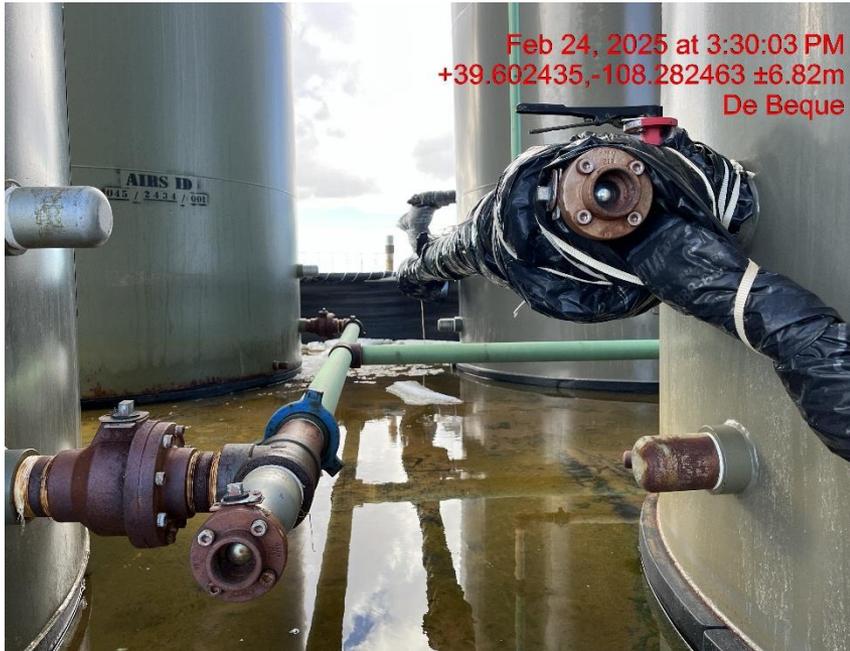
Photo # 5786 Open ended load lines

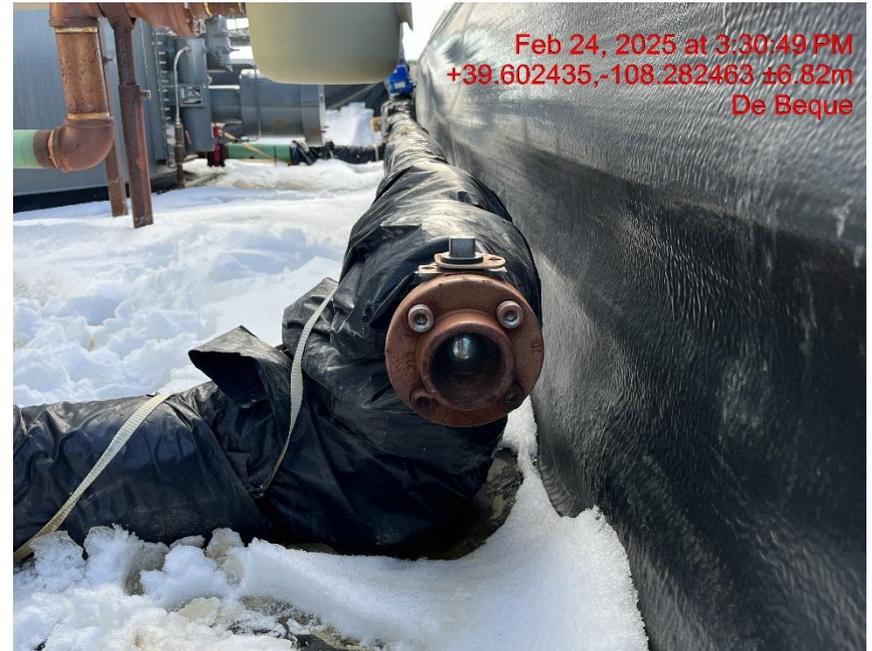
Photo # 5787 Open ended load line

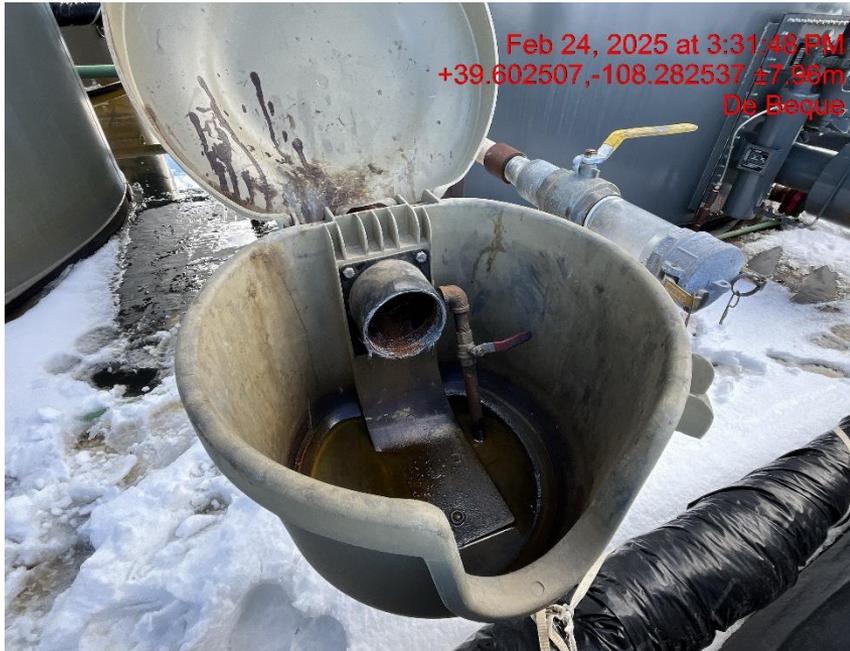
Photo # 5789 Open ended load line

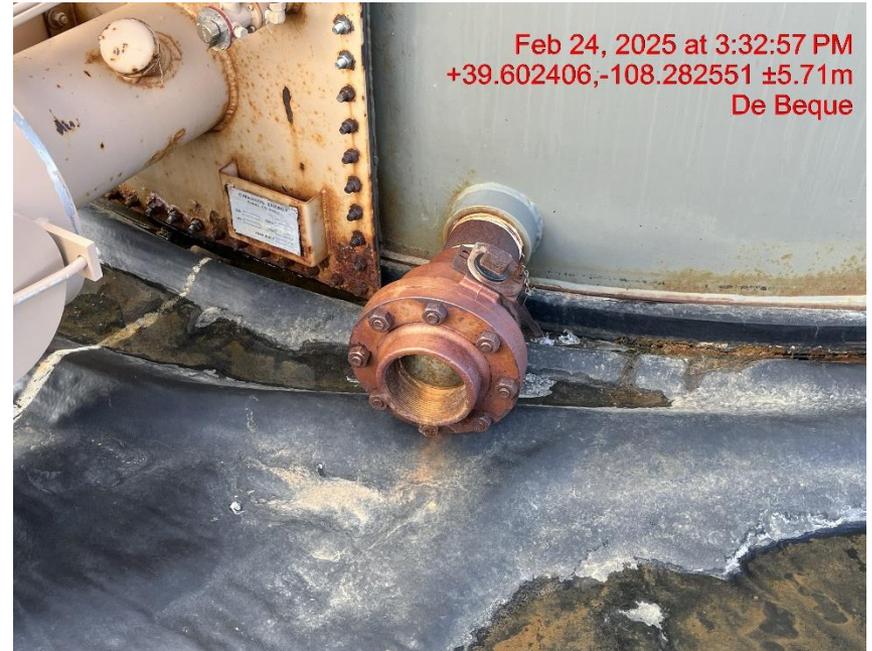
Photo # 5790 Open ended load line

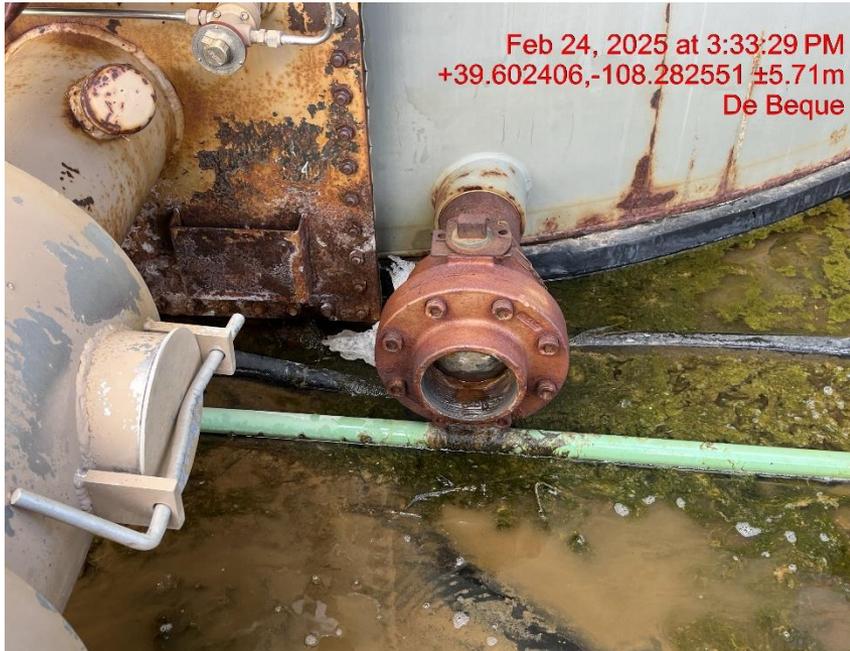
Photo # 5791 Open ended load line

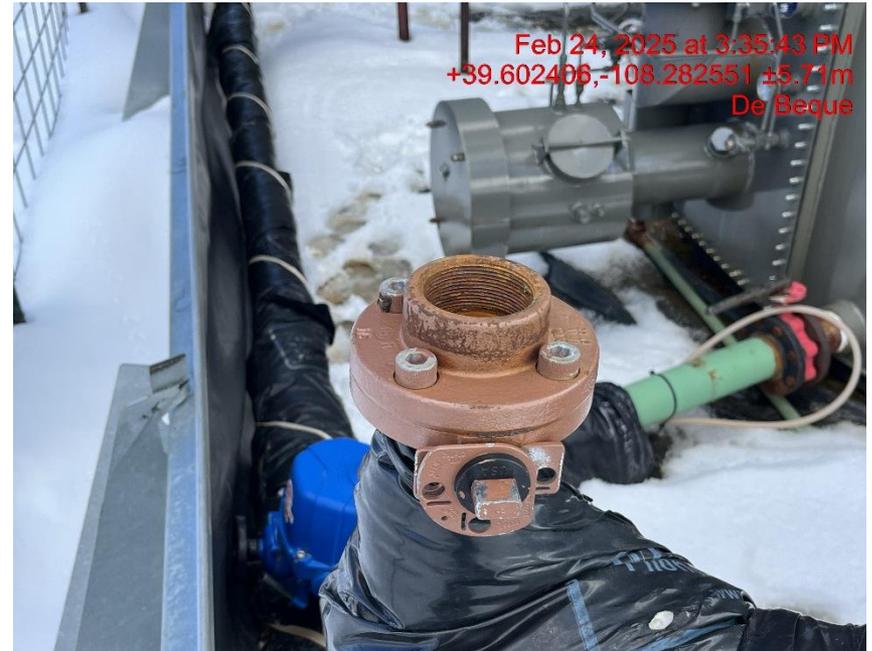
Photo # 5792 Open ended load line

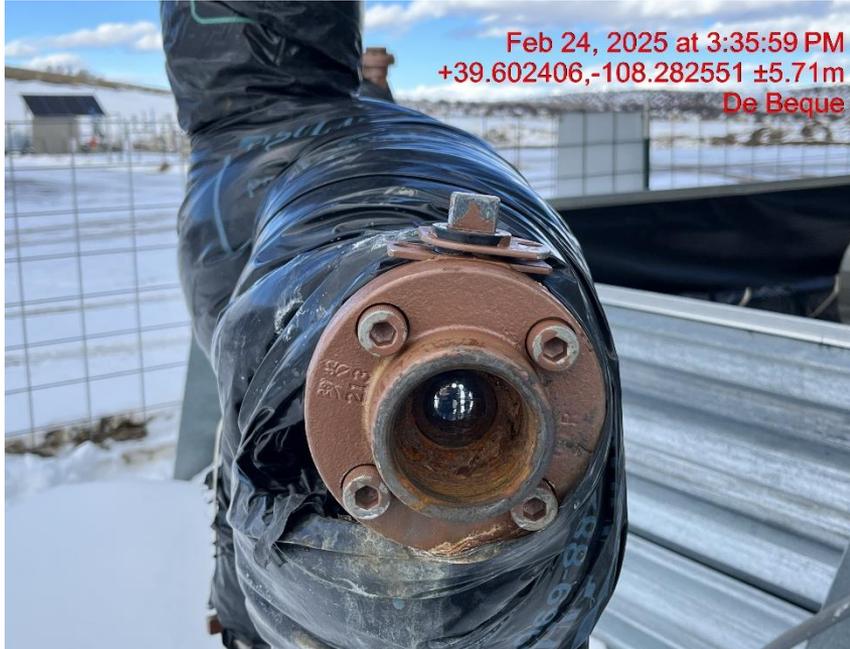
Photo # 5793 Open ended load line

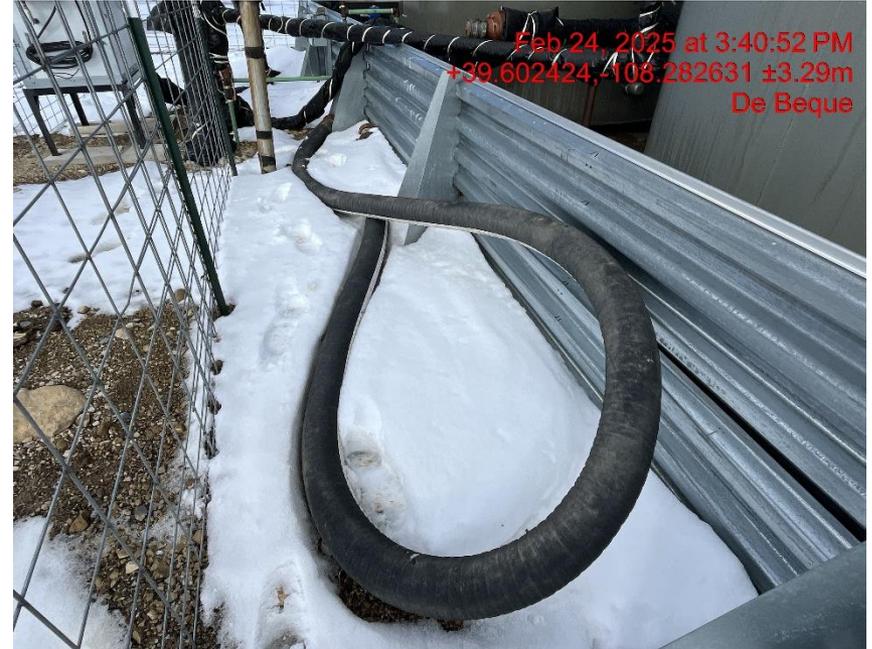
Photo # 5796 Unused hose
