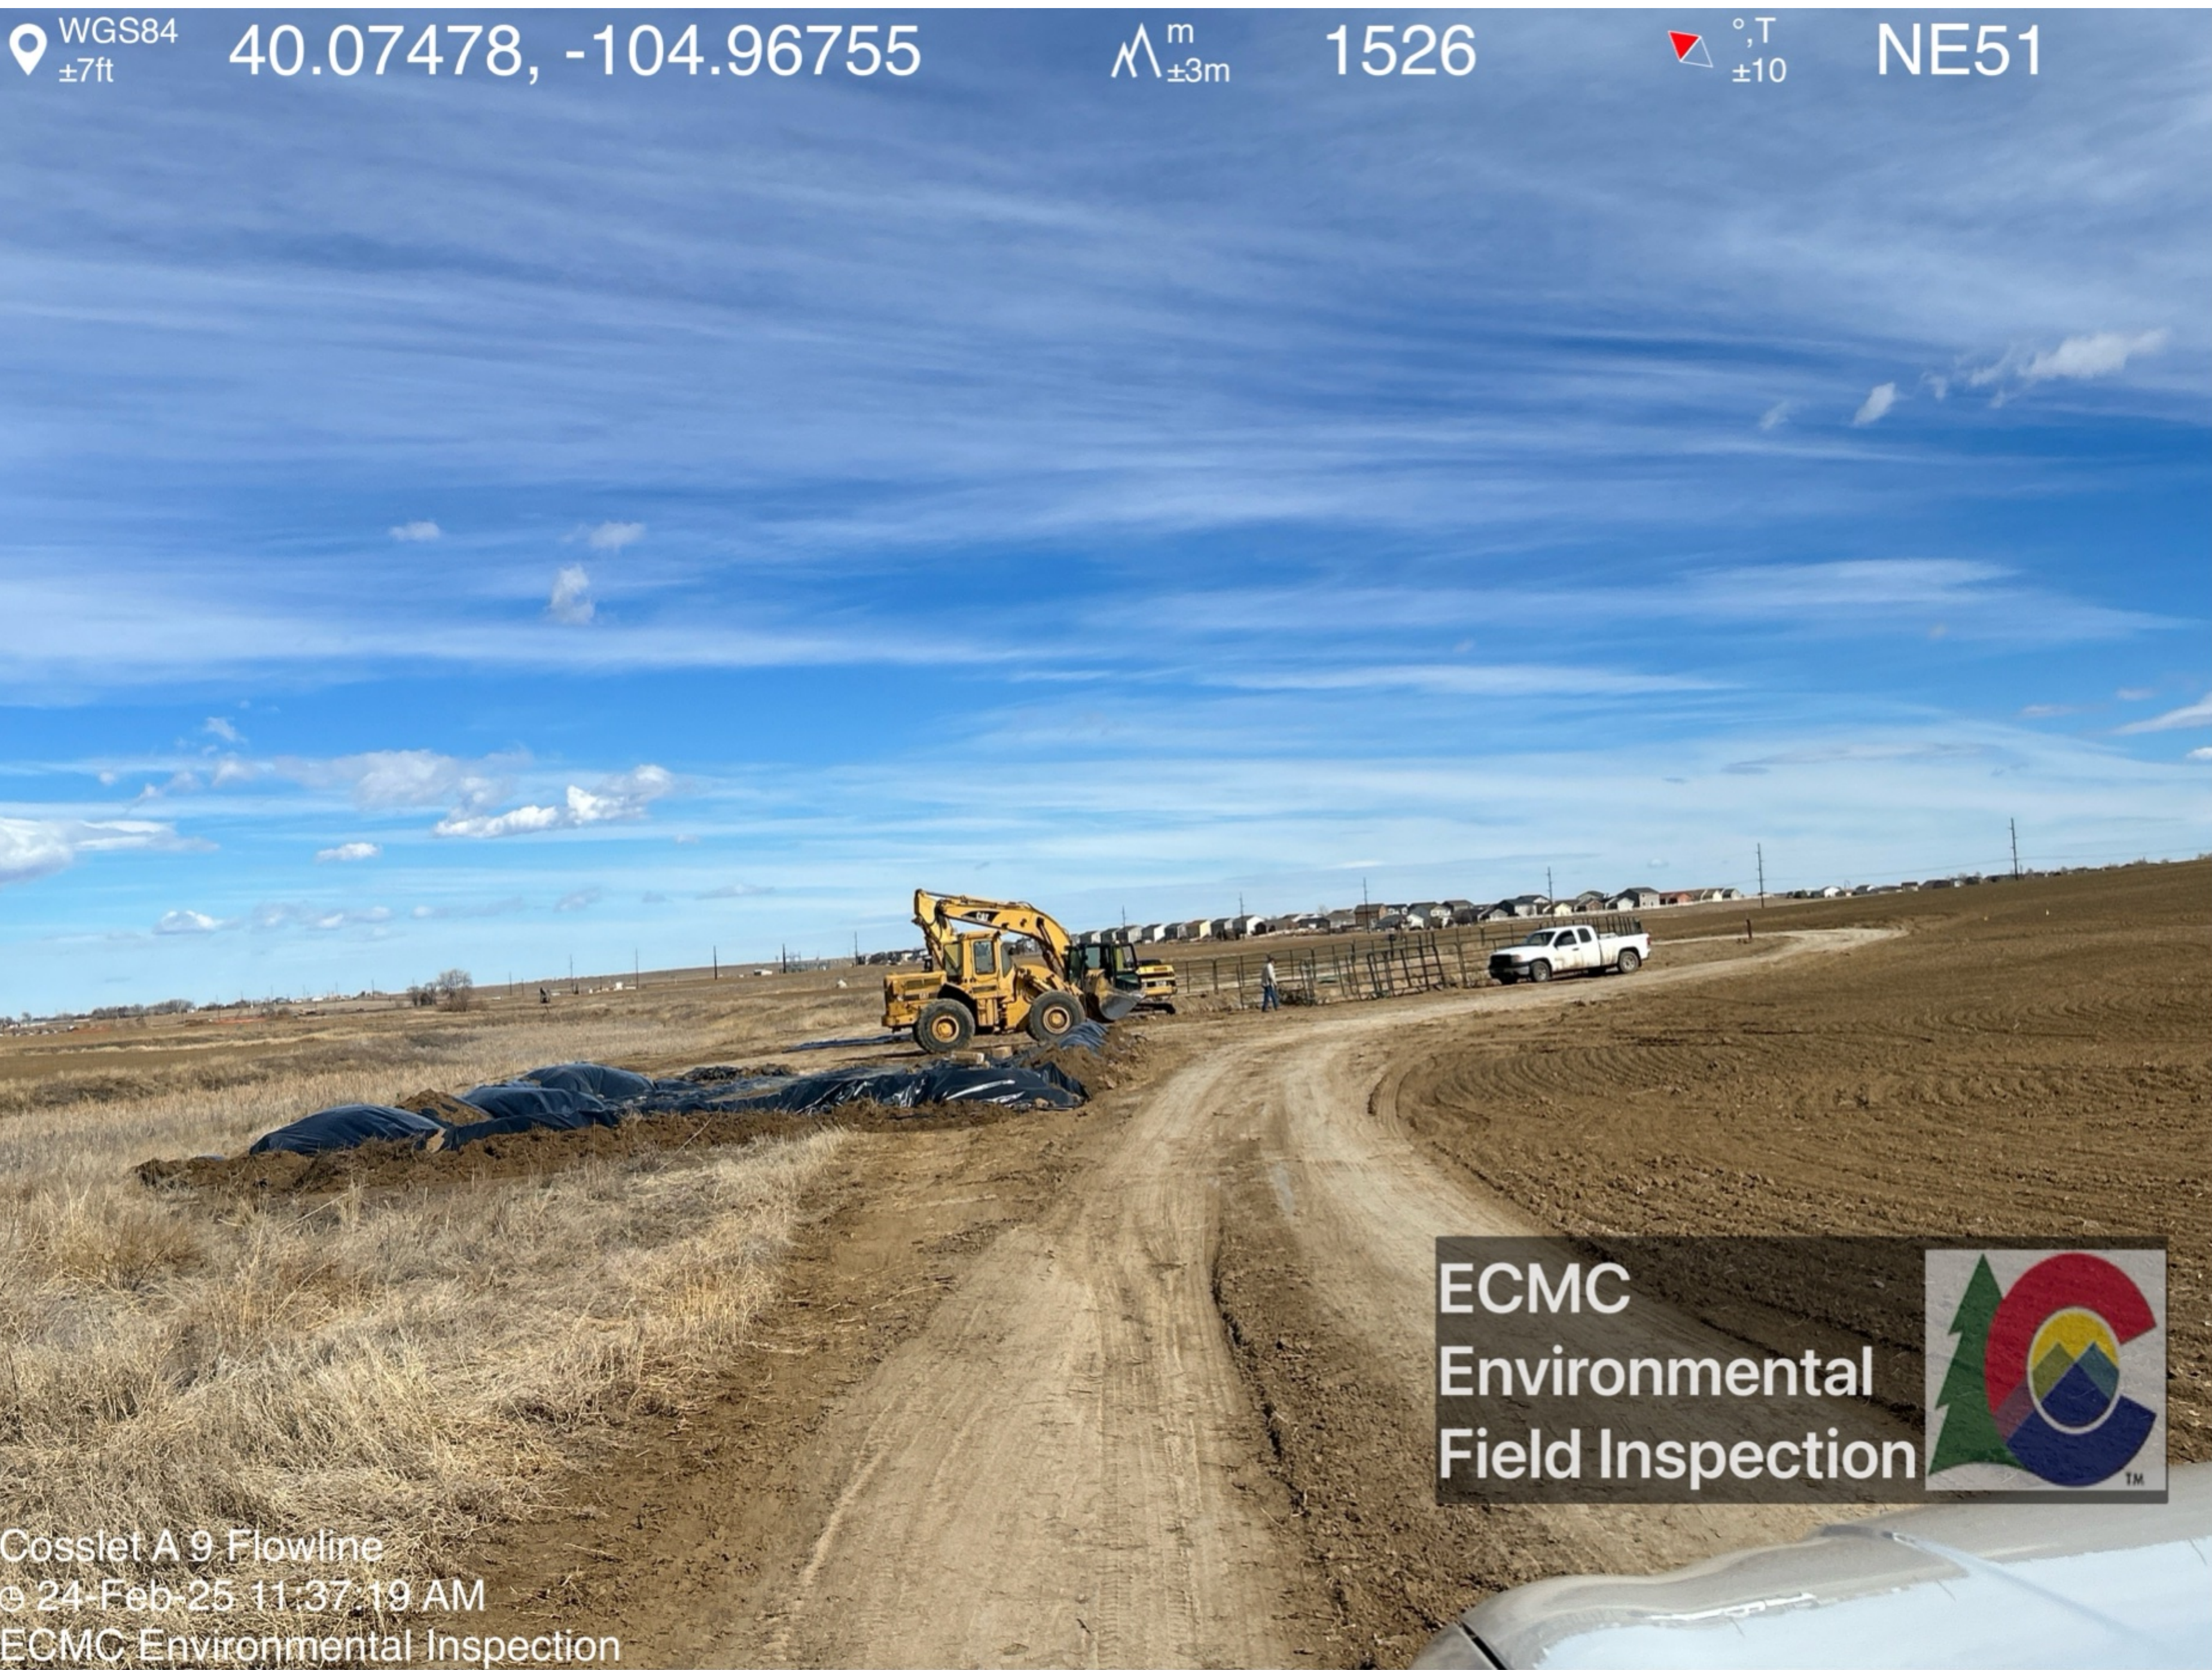
Operator personnel were on location at the time of inspection.

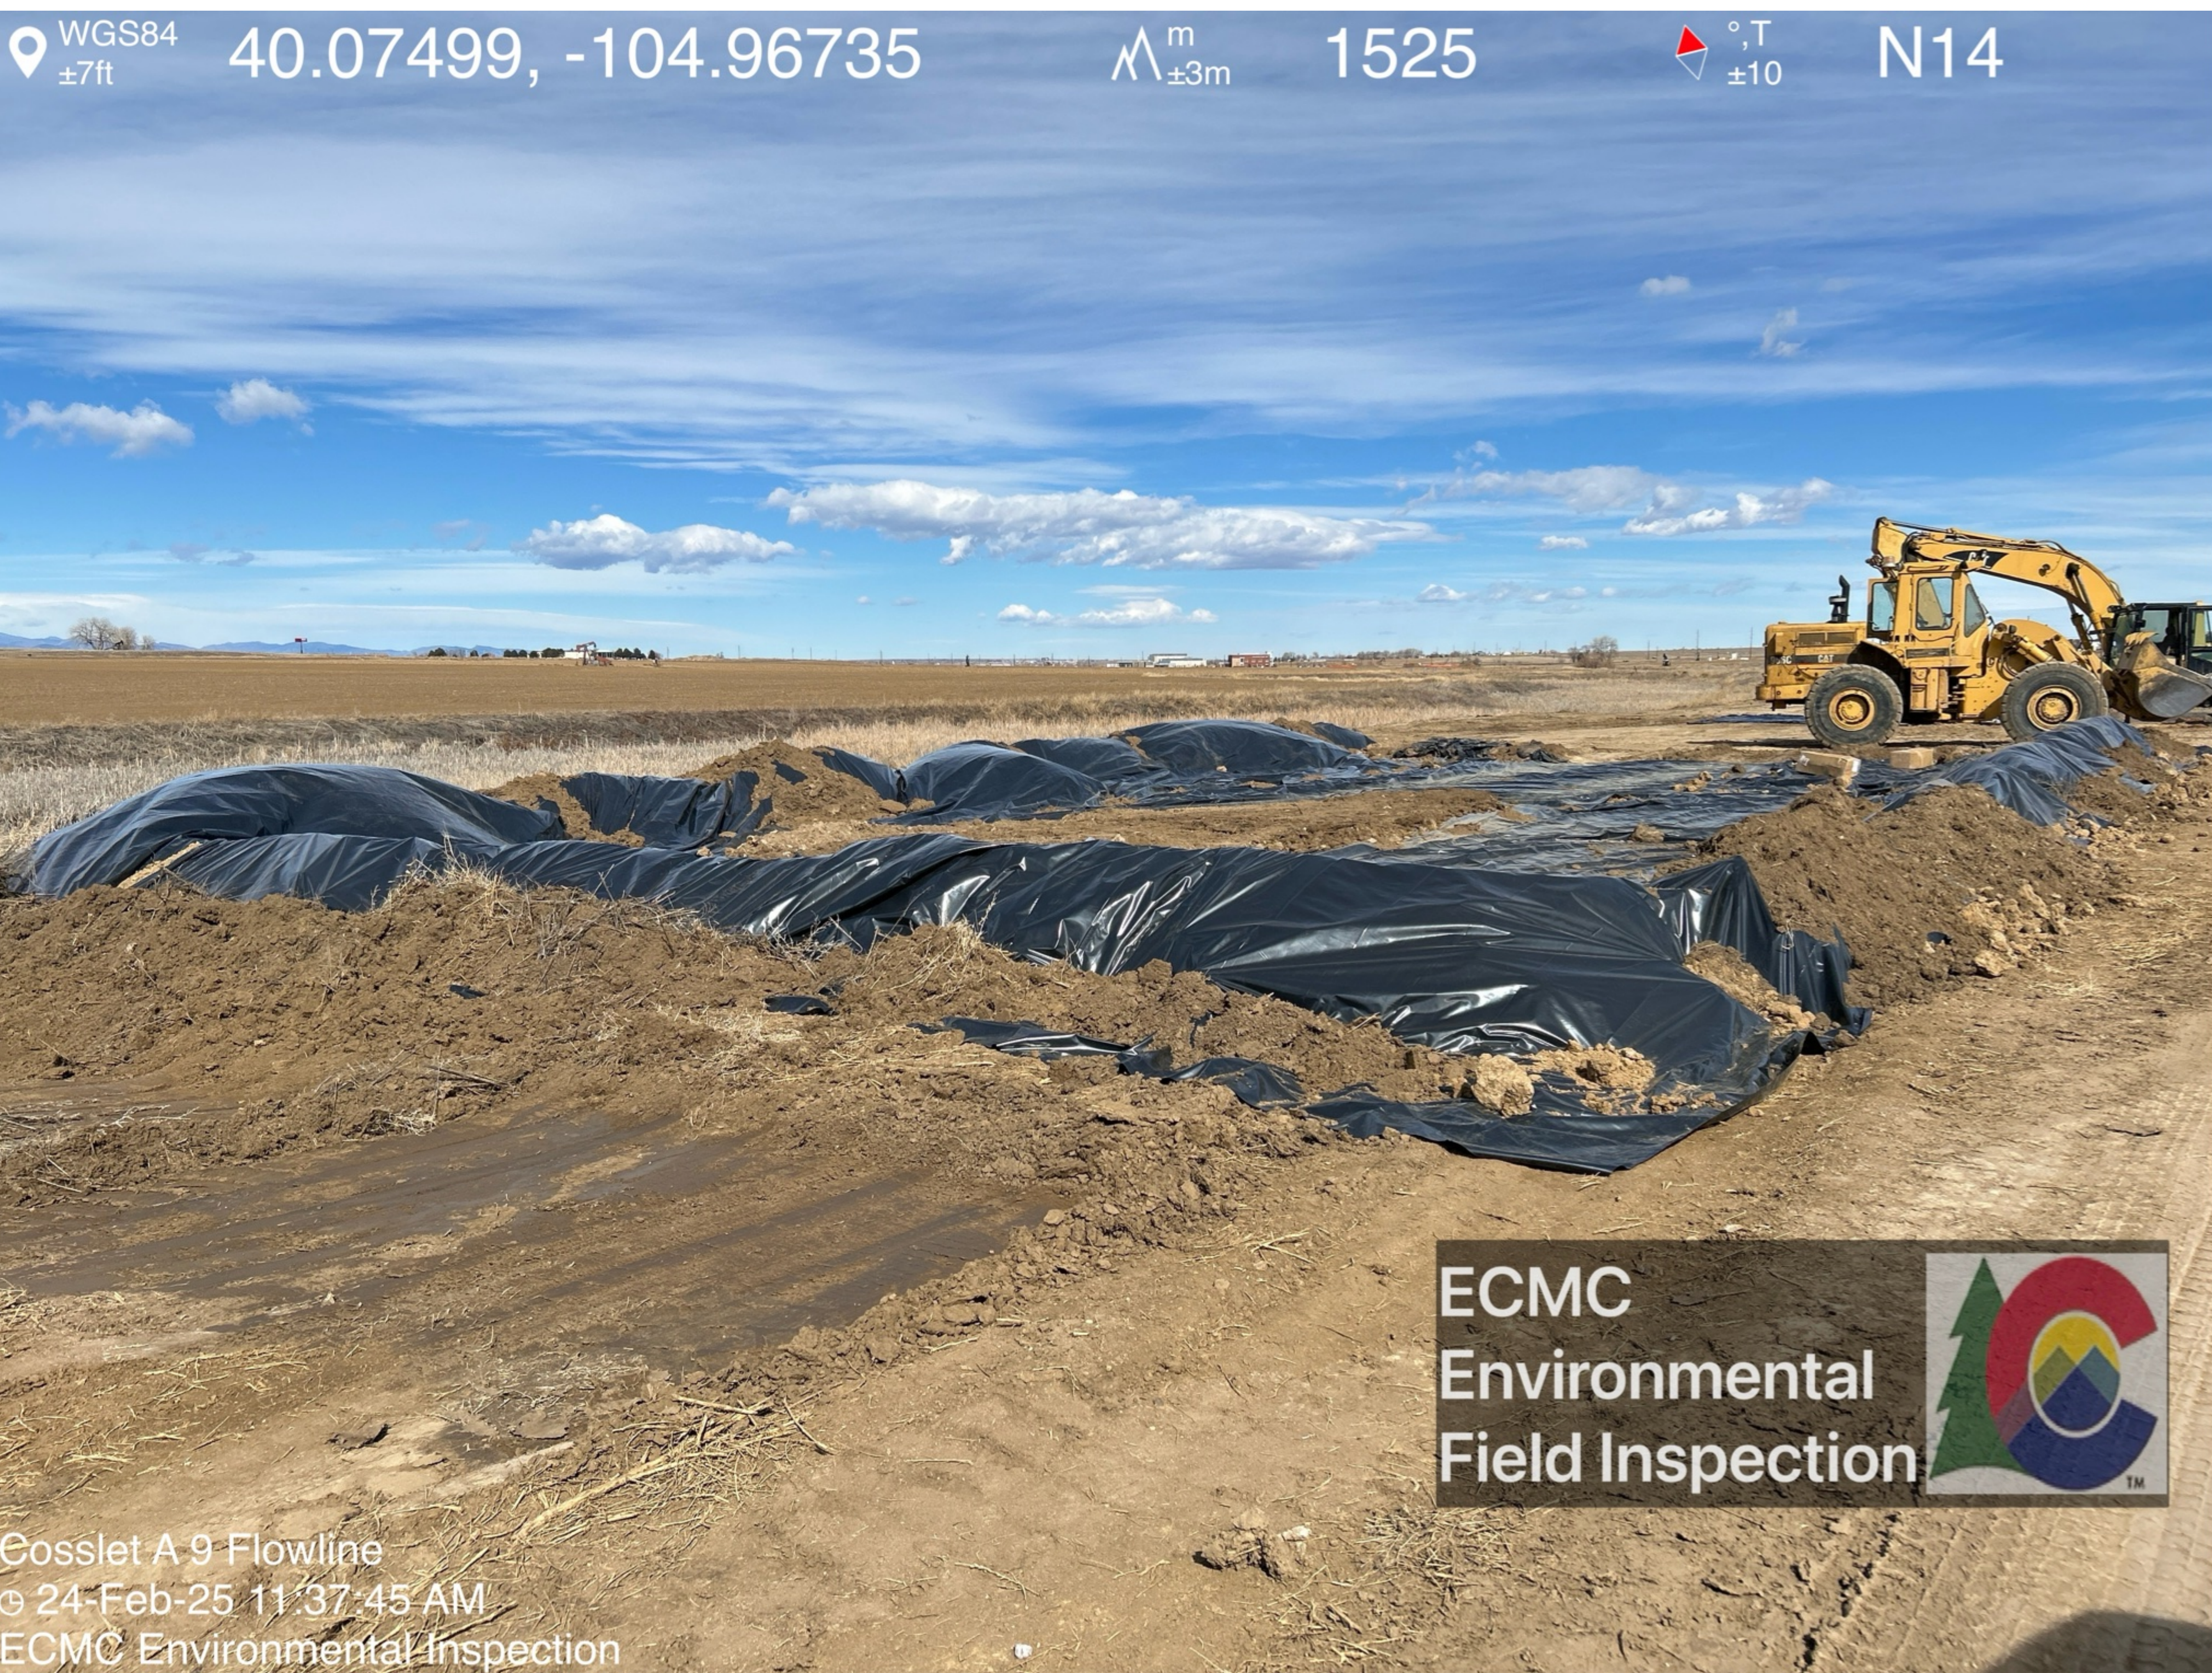
Stockpile previously labeled "clean" is no longer present on location. A liner has been installed on location.

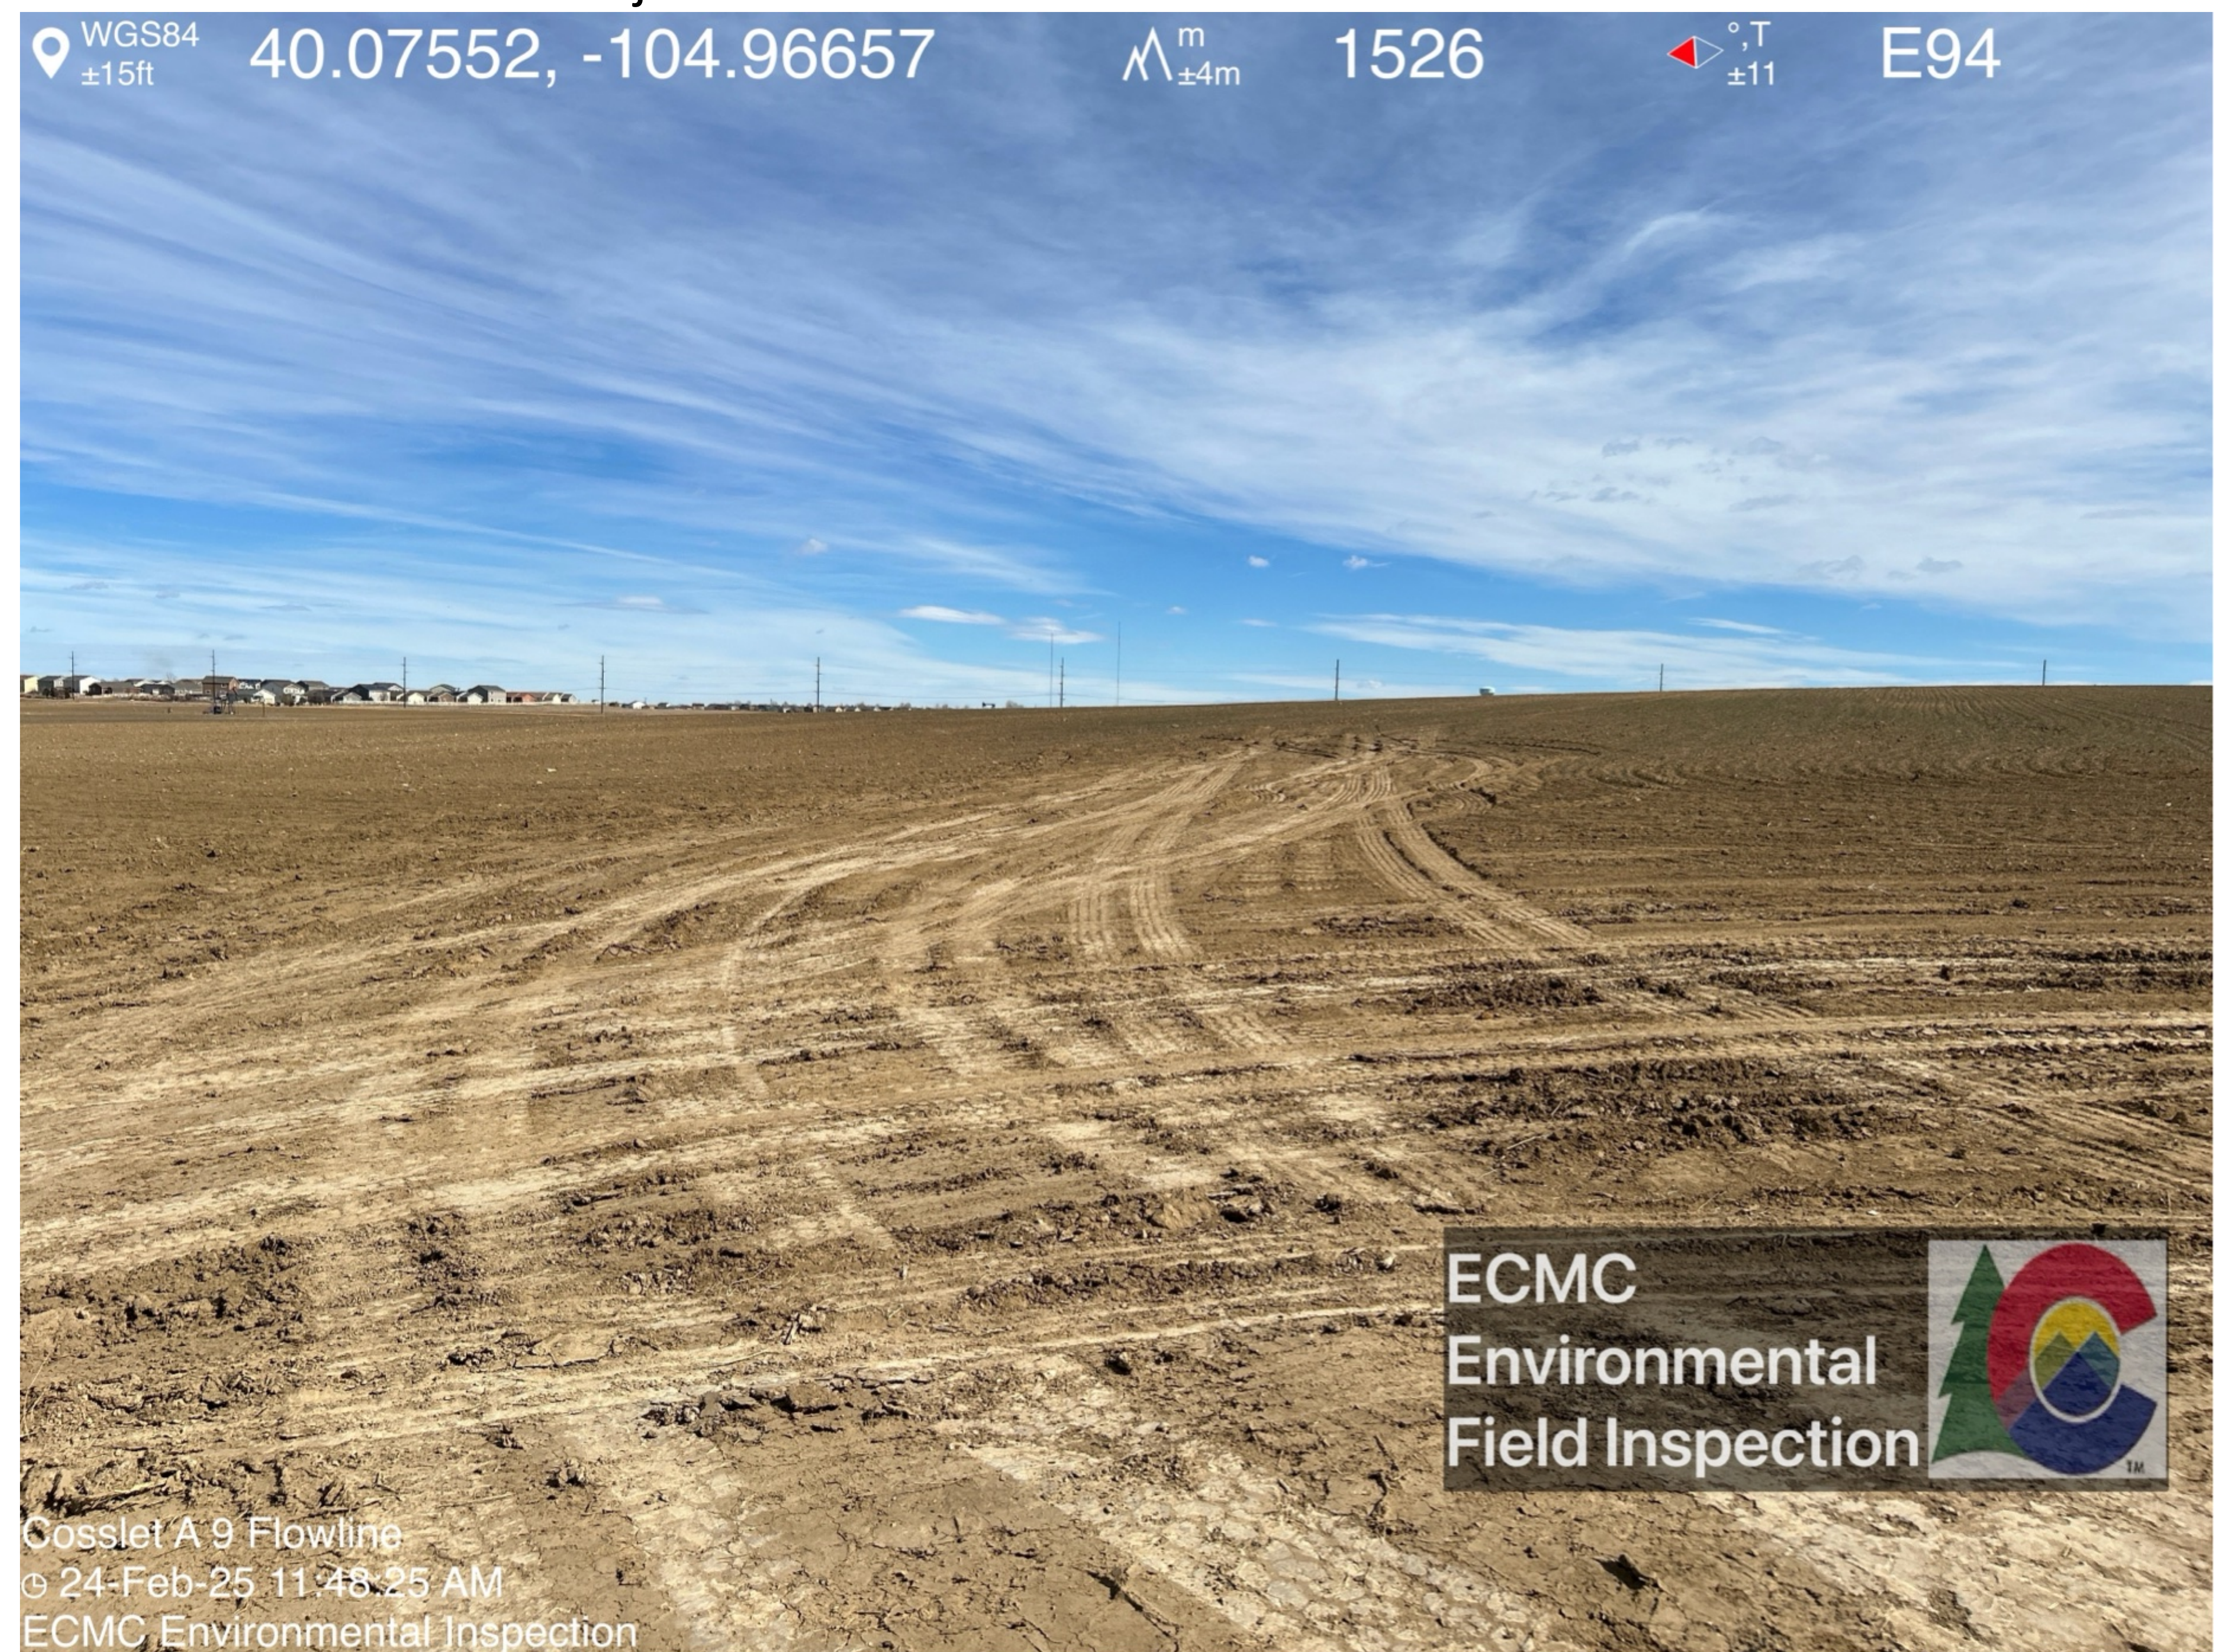
Tire marks are visible in adjacent field.

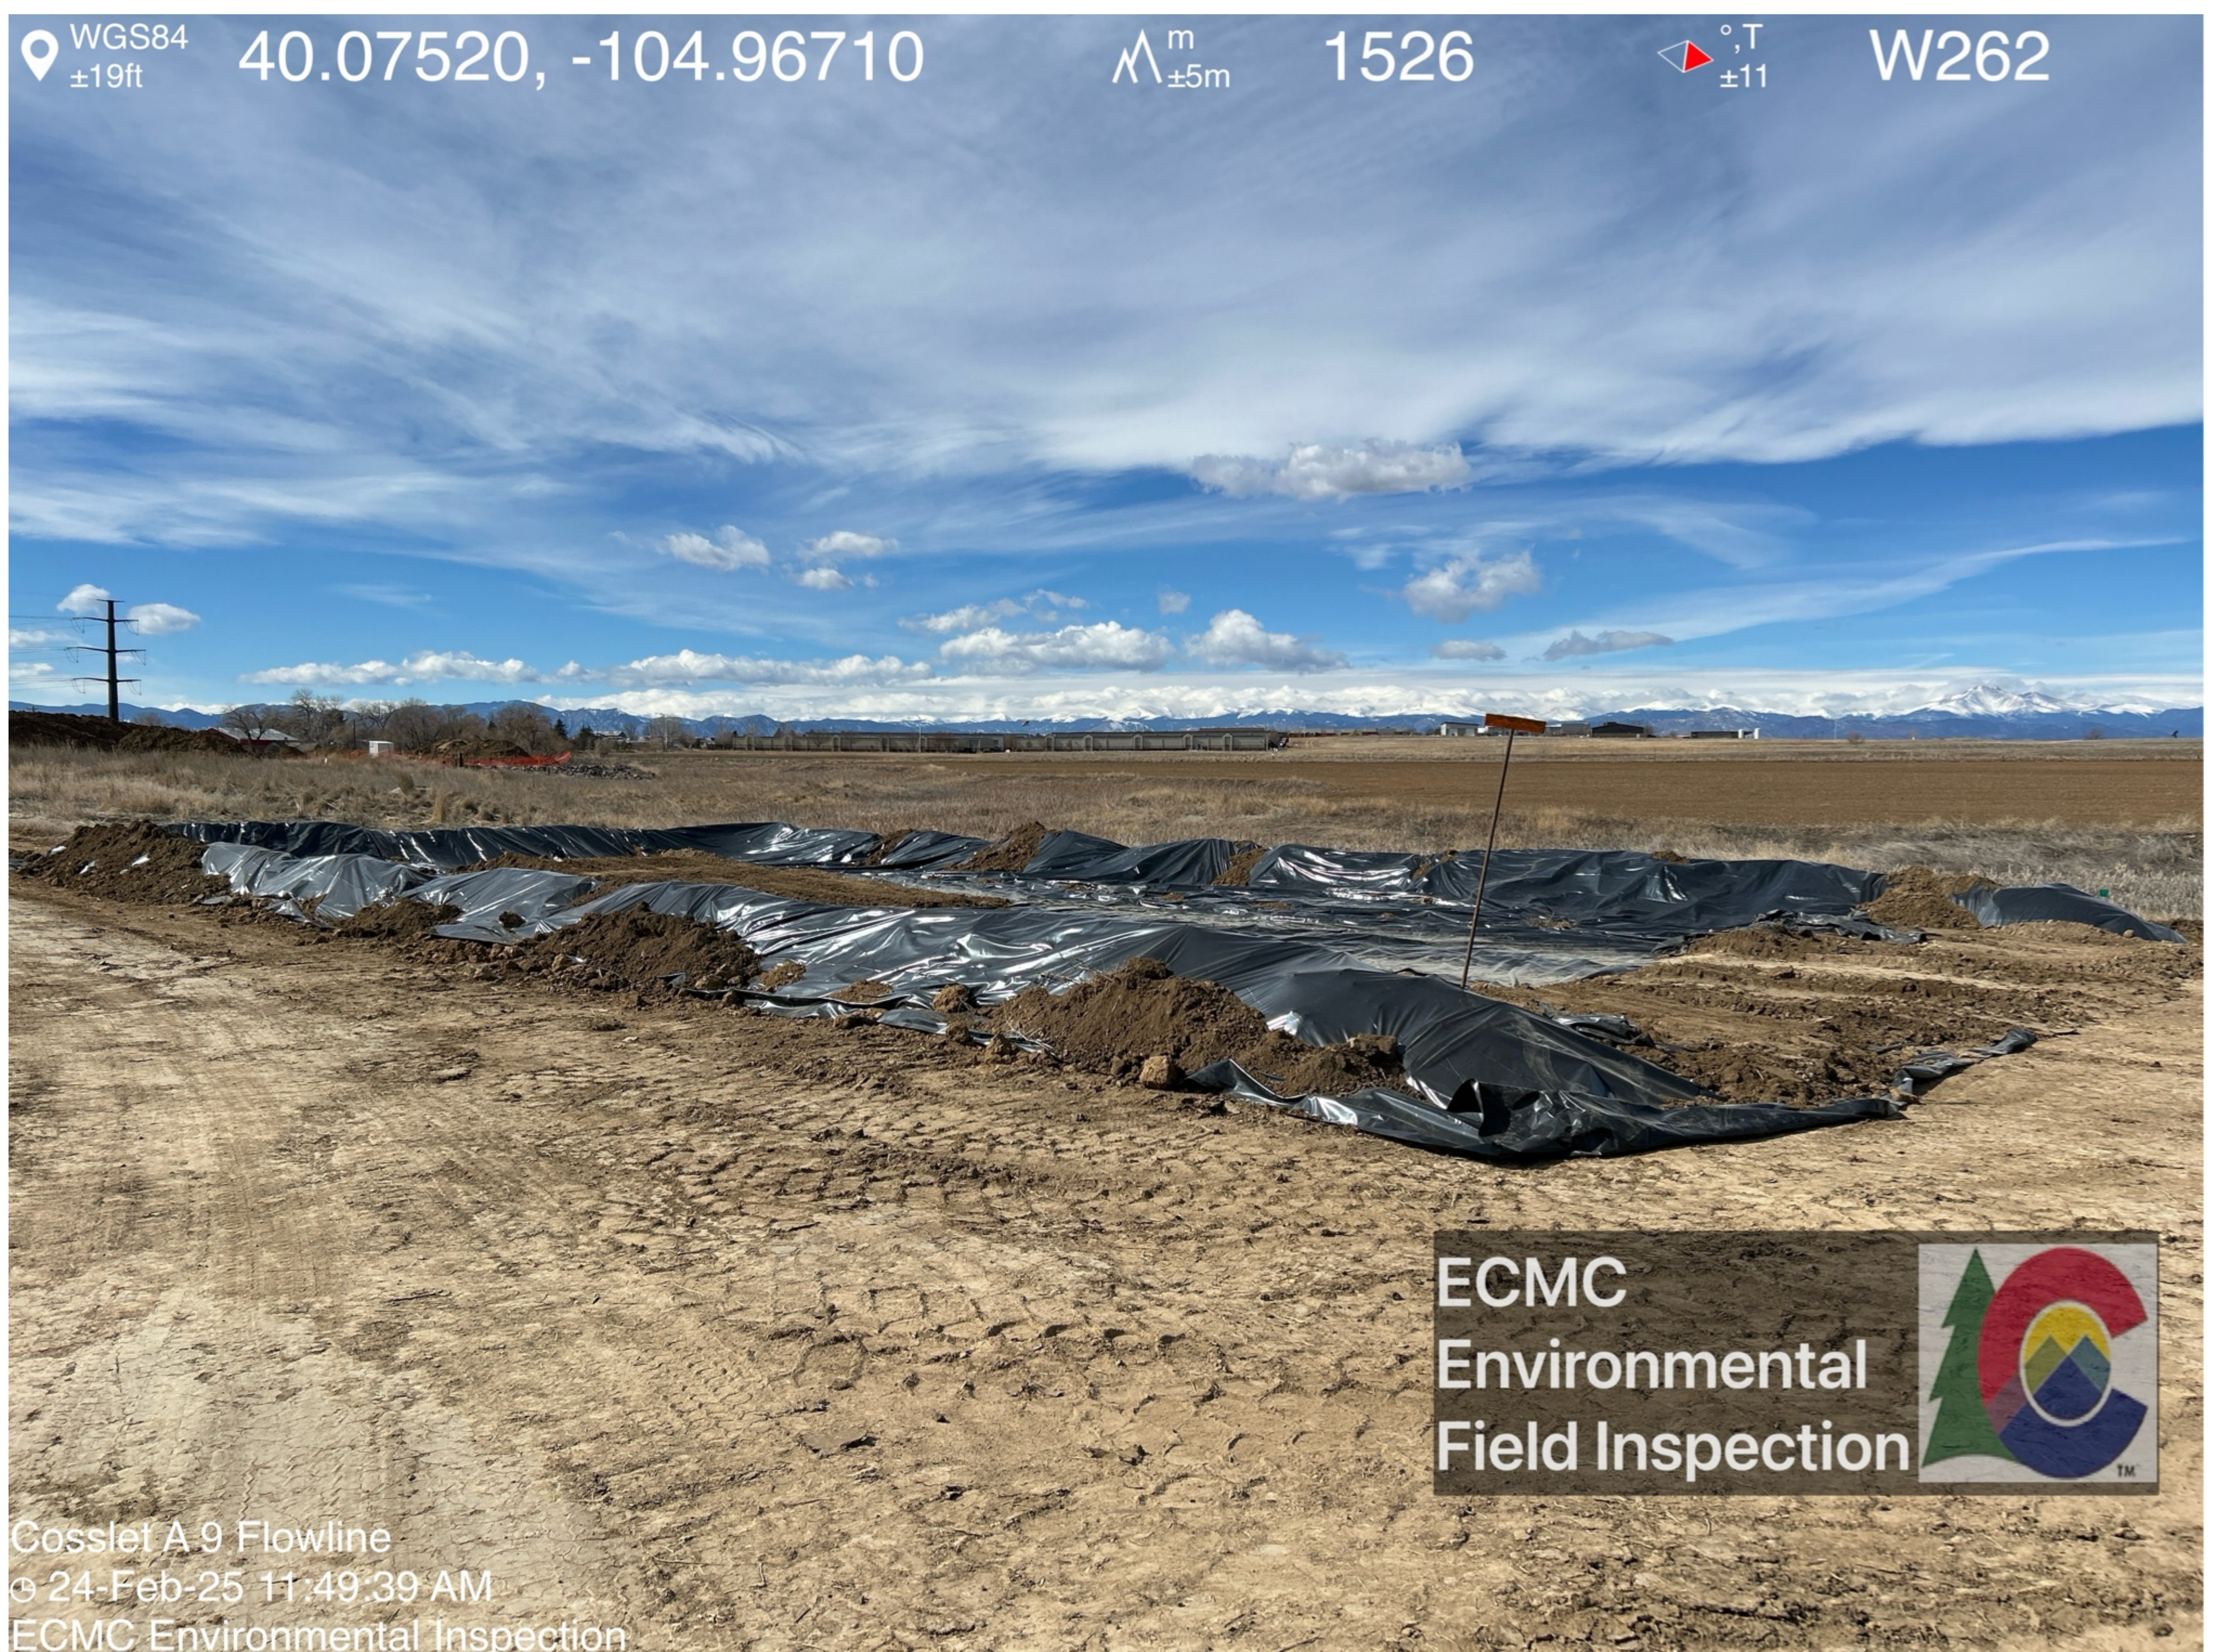
Berm with liner is marked "contaminated".

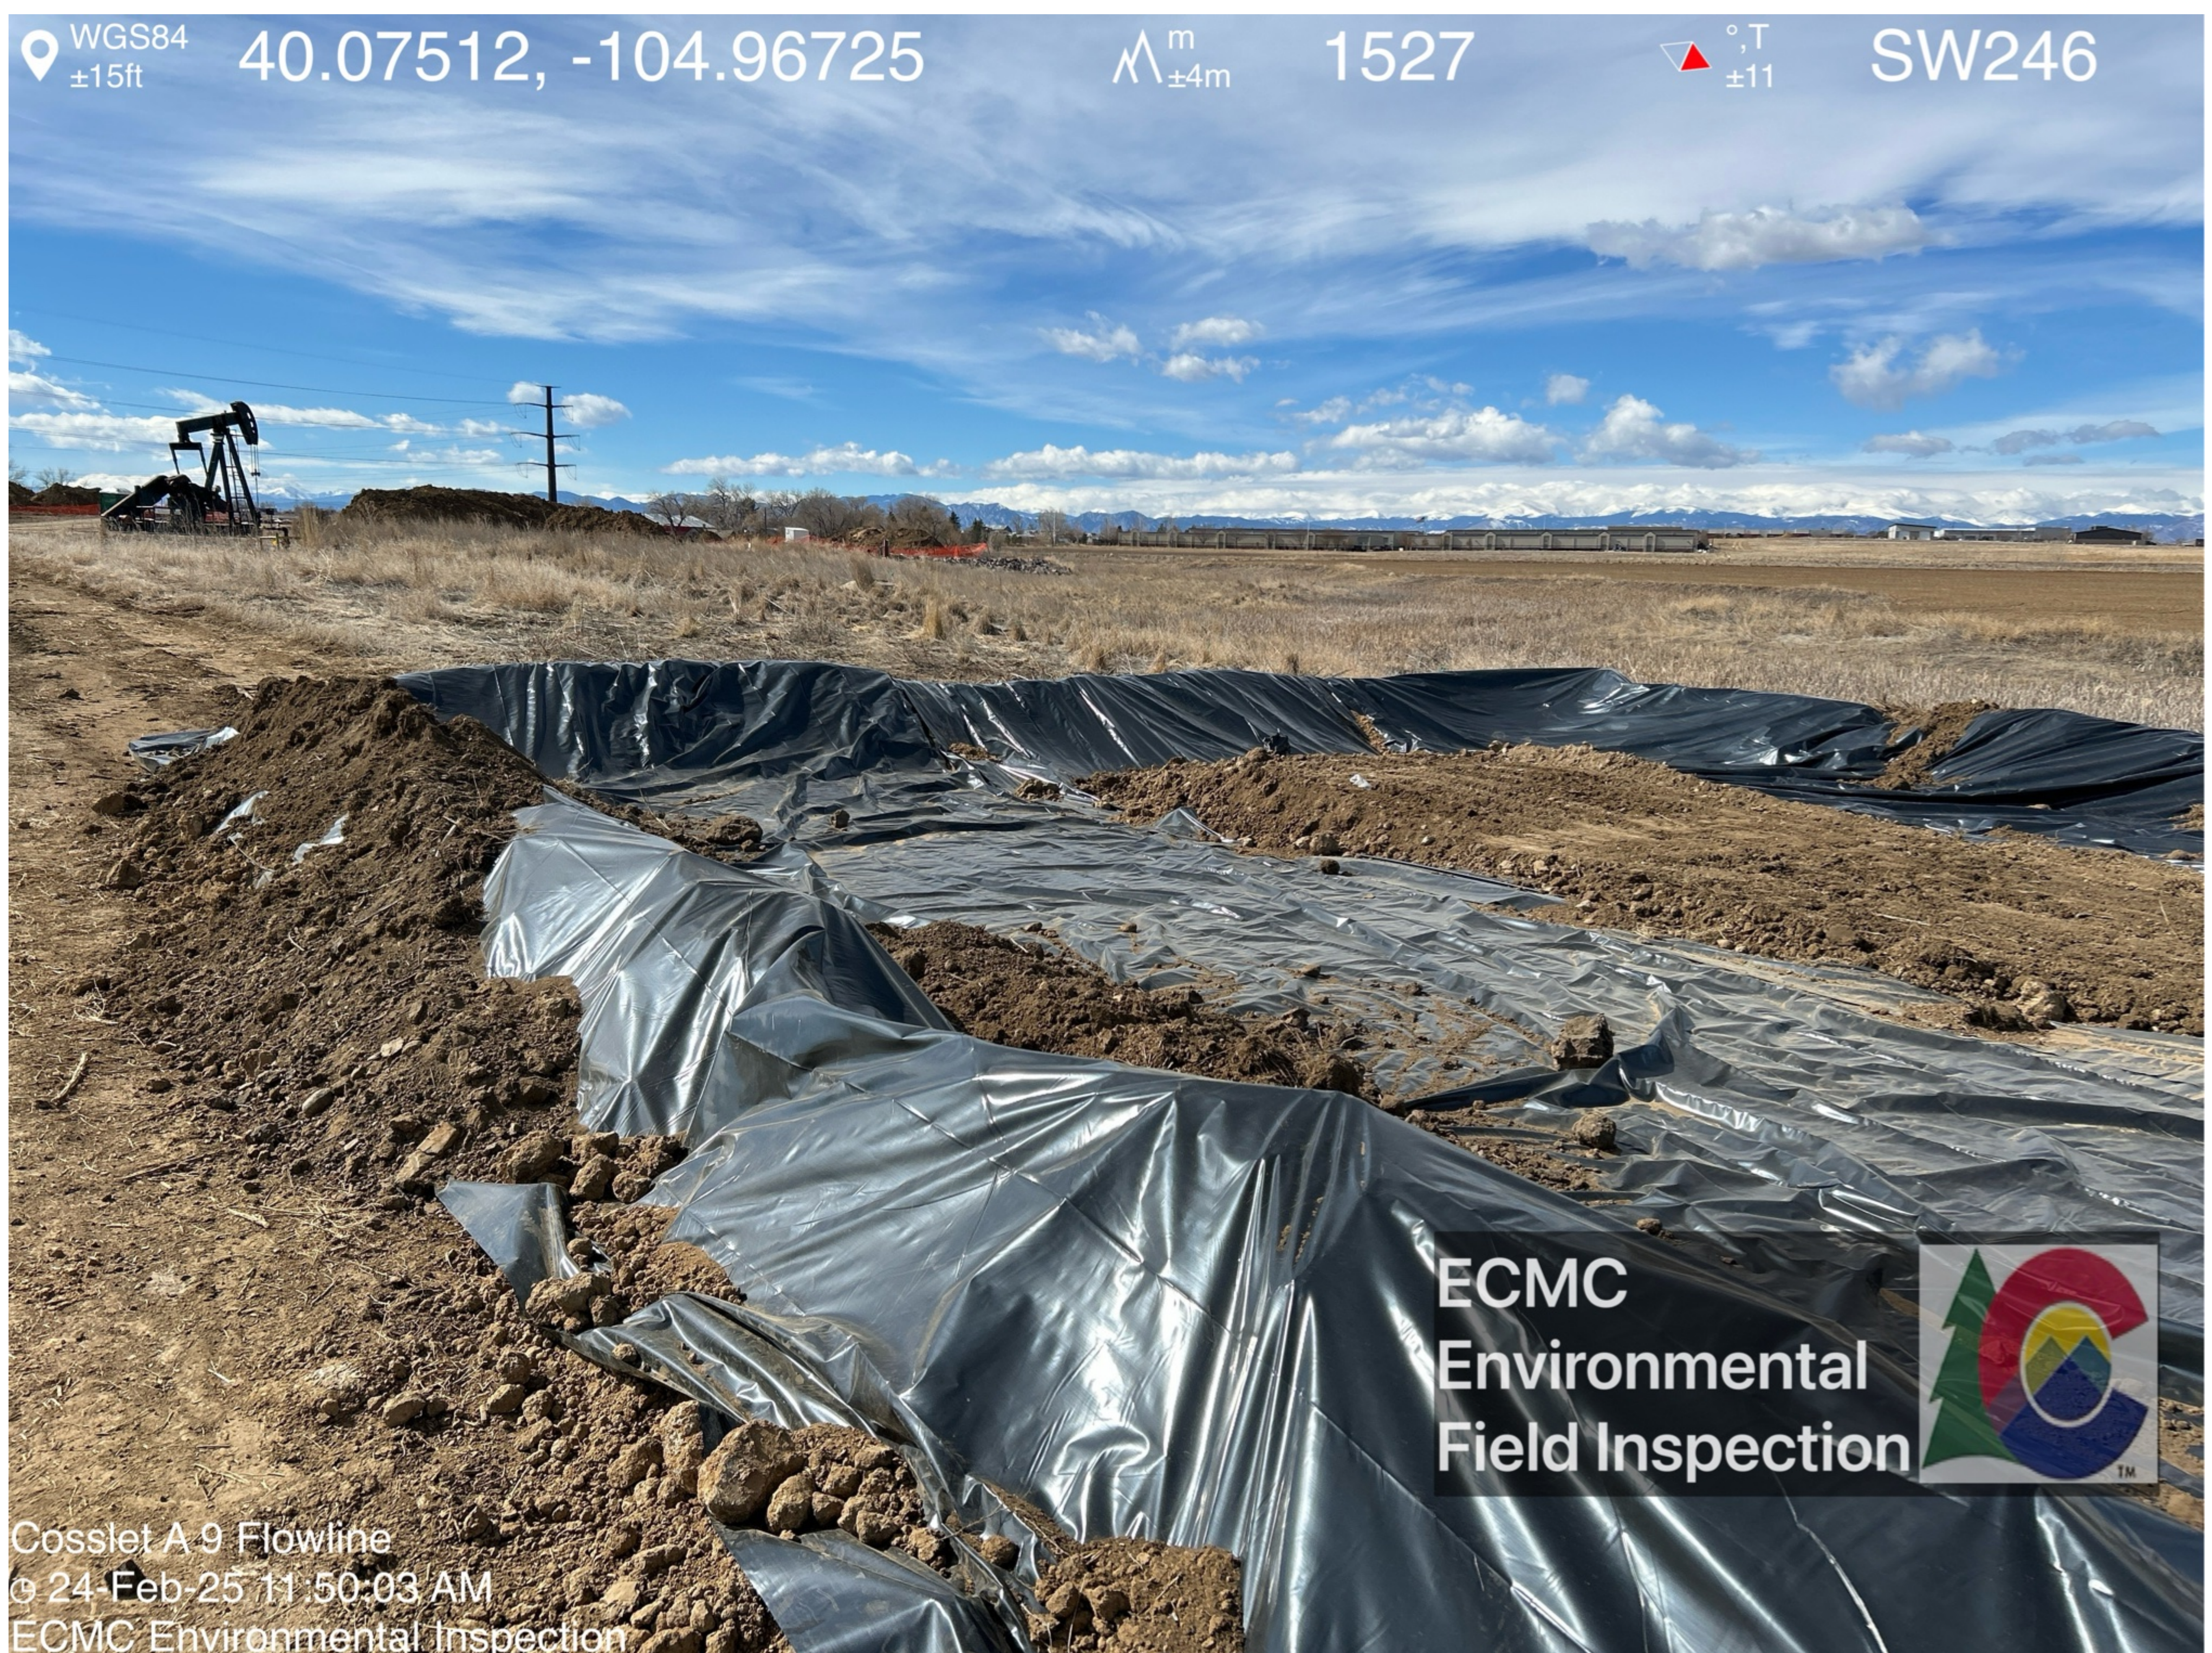
Liner condition appears to be adequate.

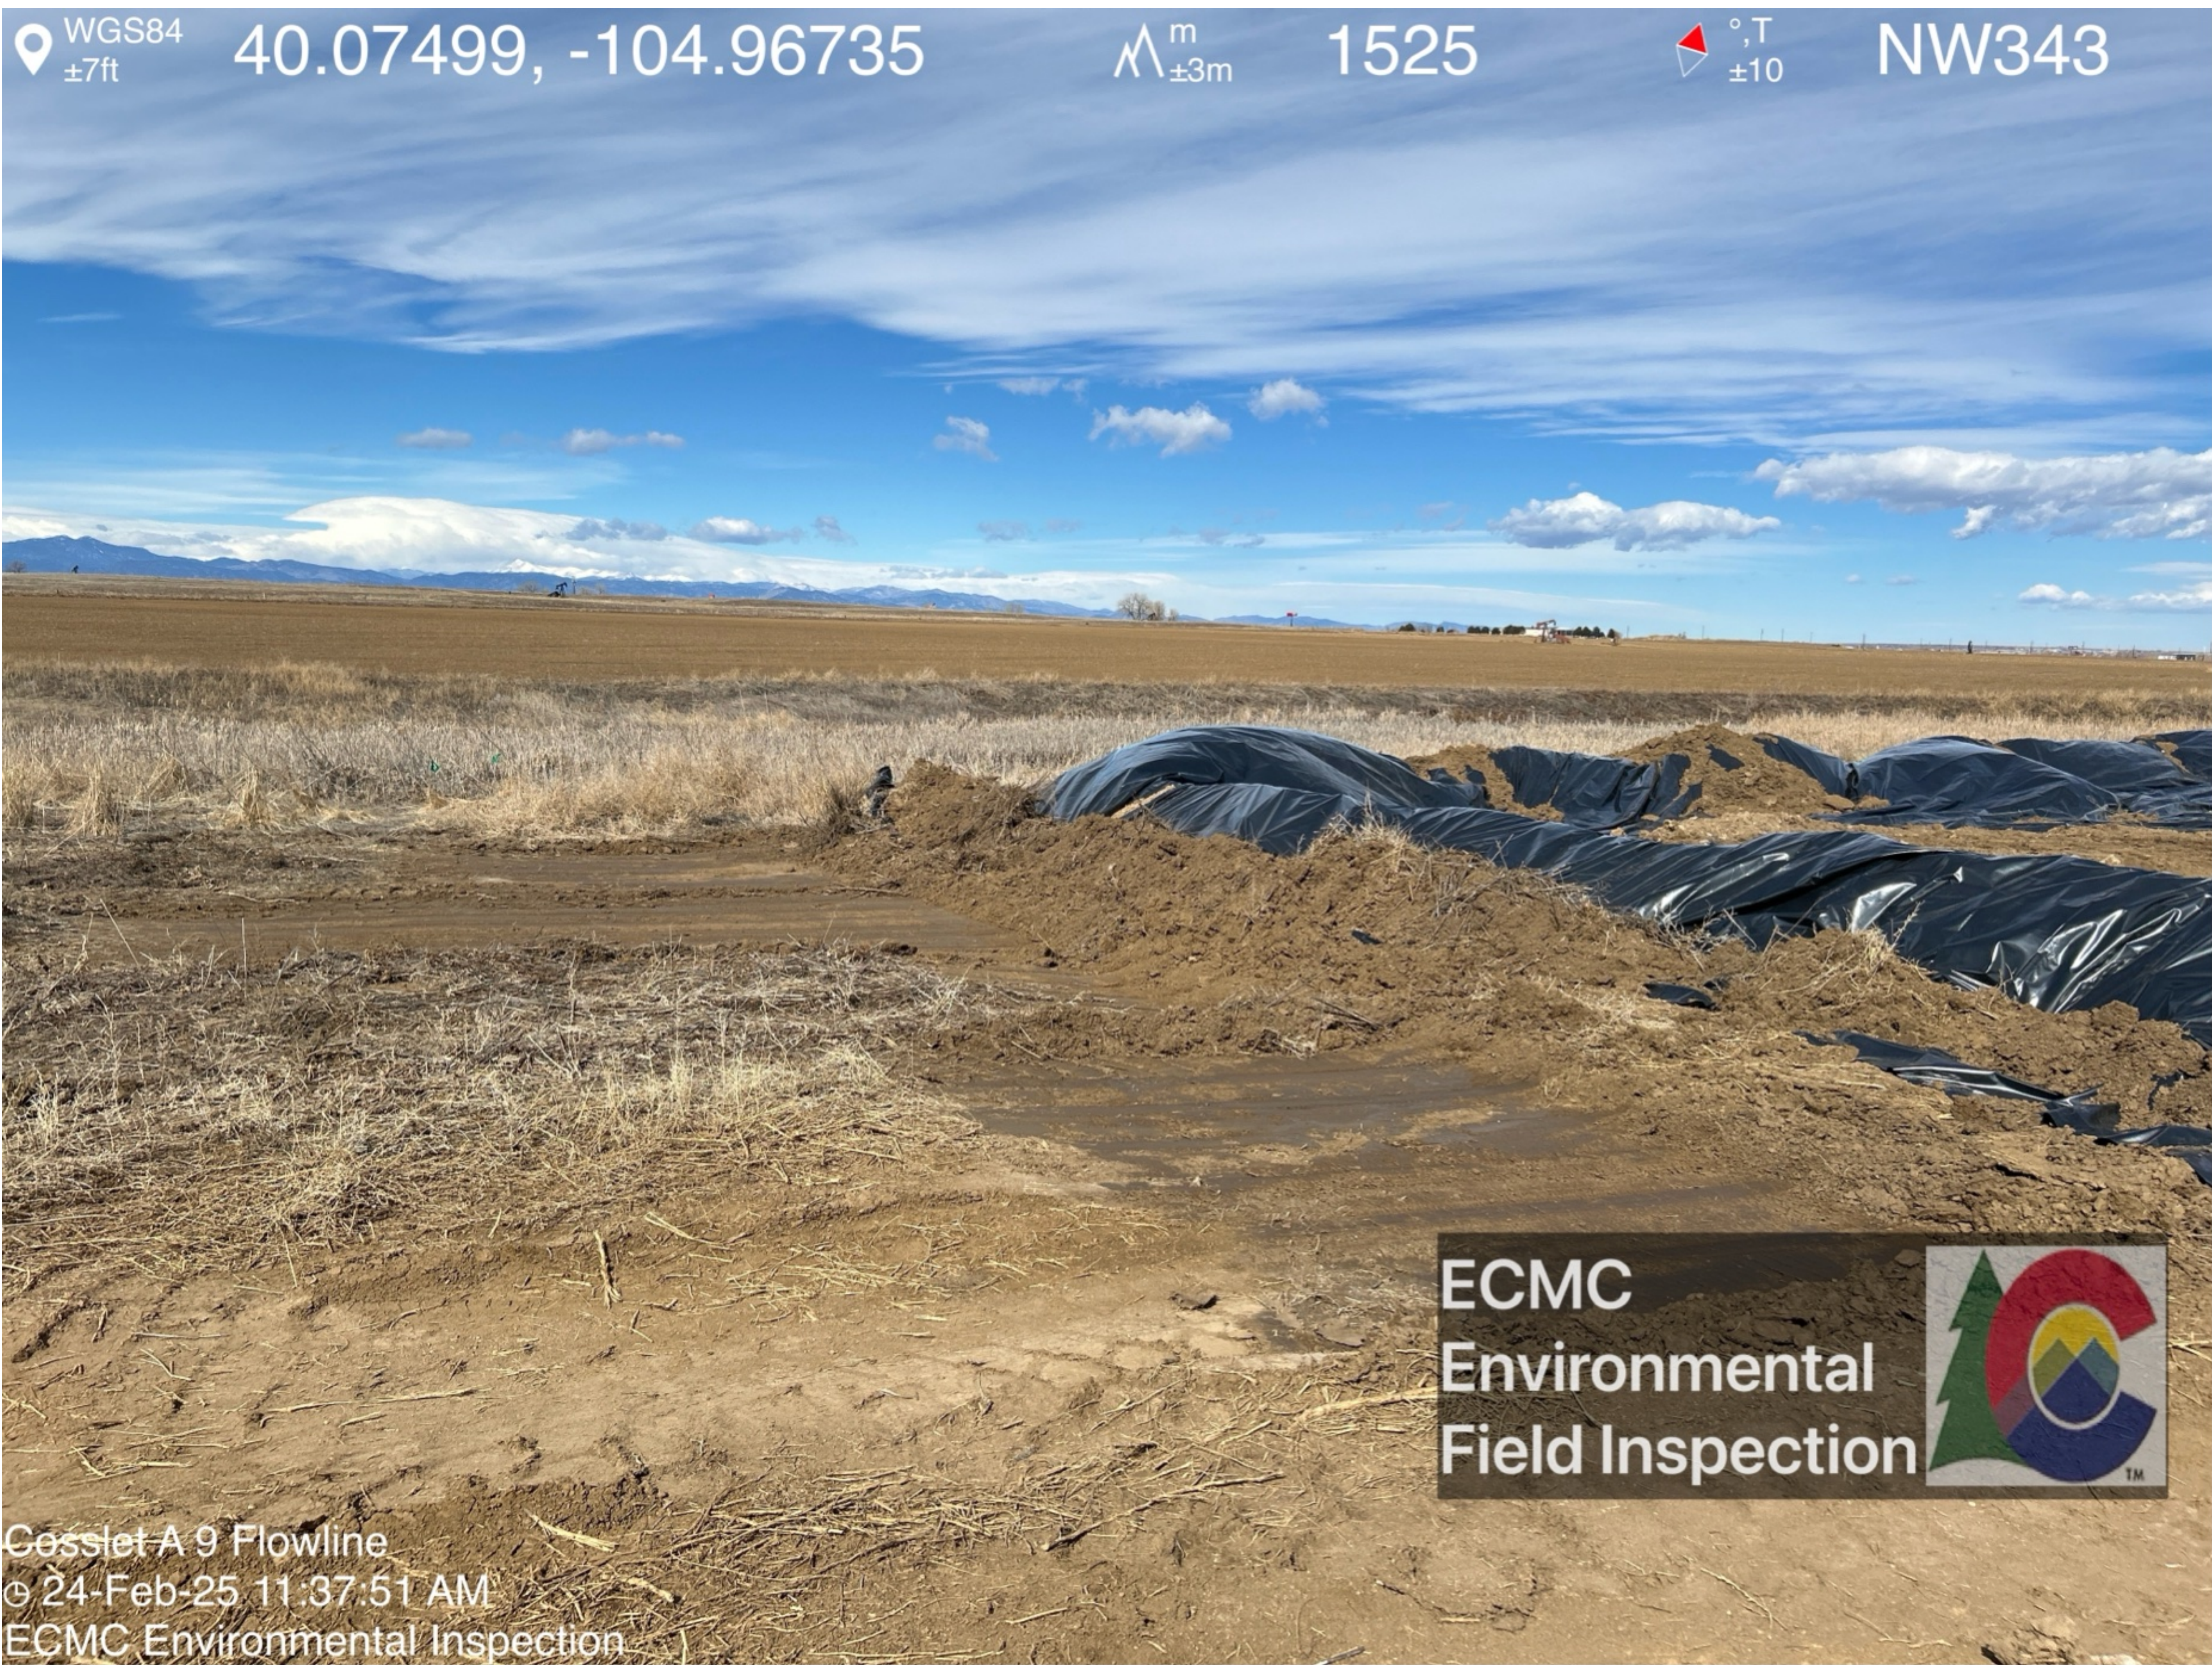
Nearby topsoil and vegetation appear to have been scraped to construct a berm under the liner.
