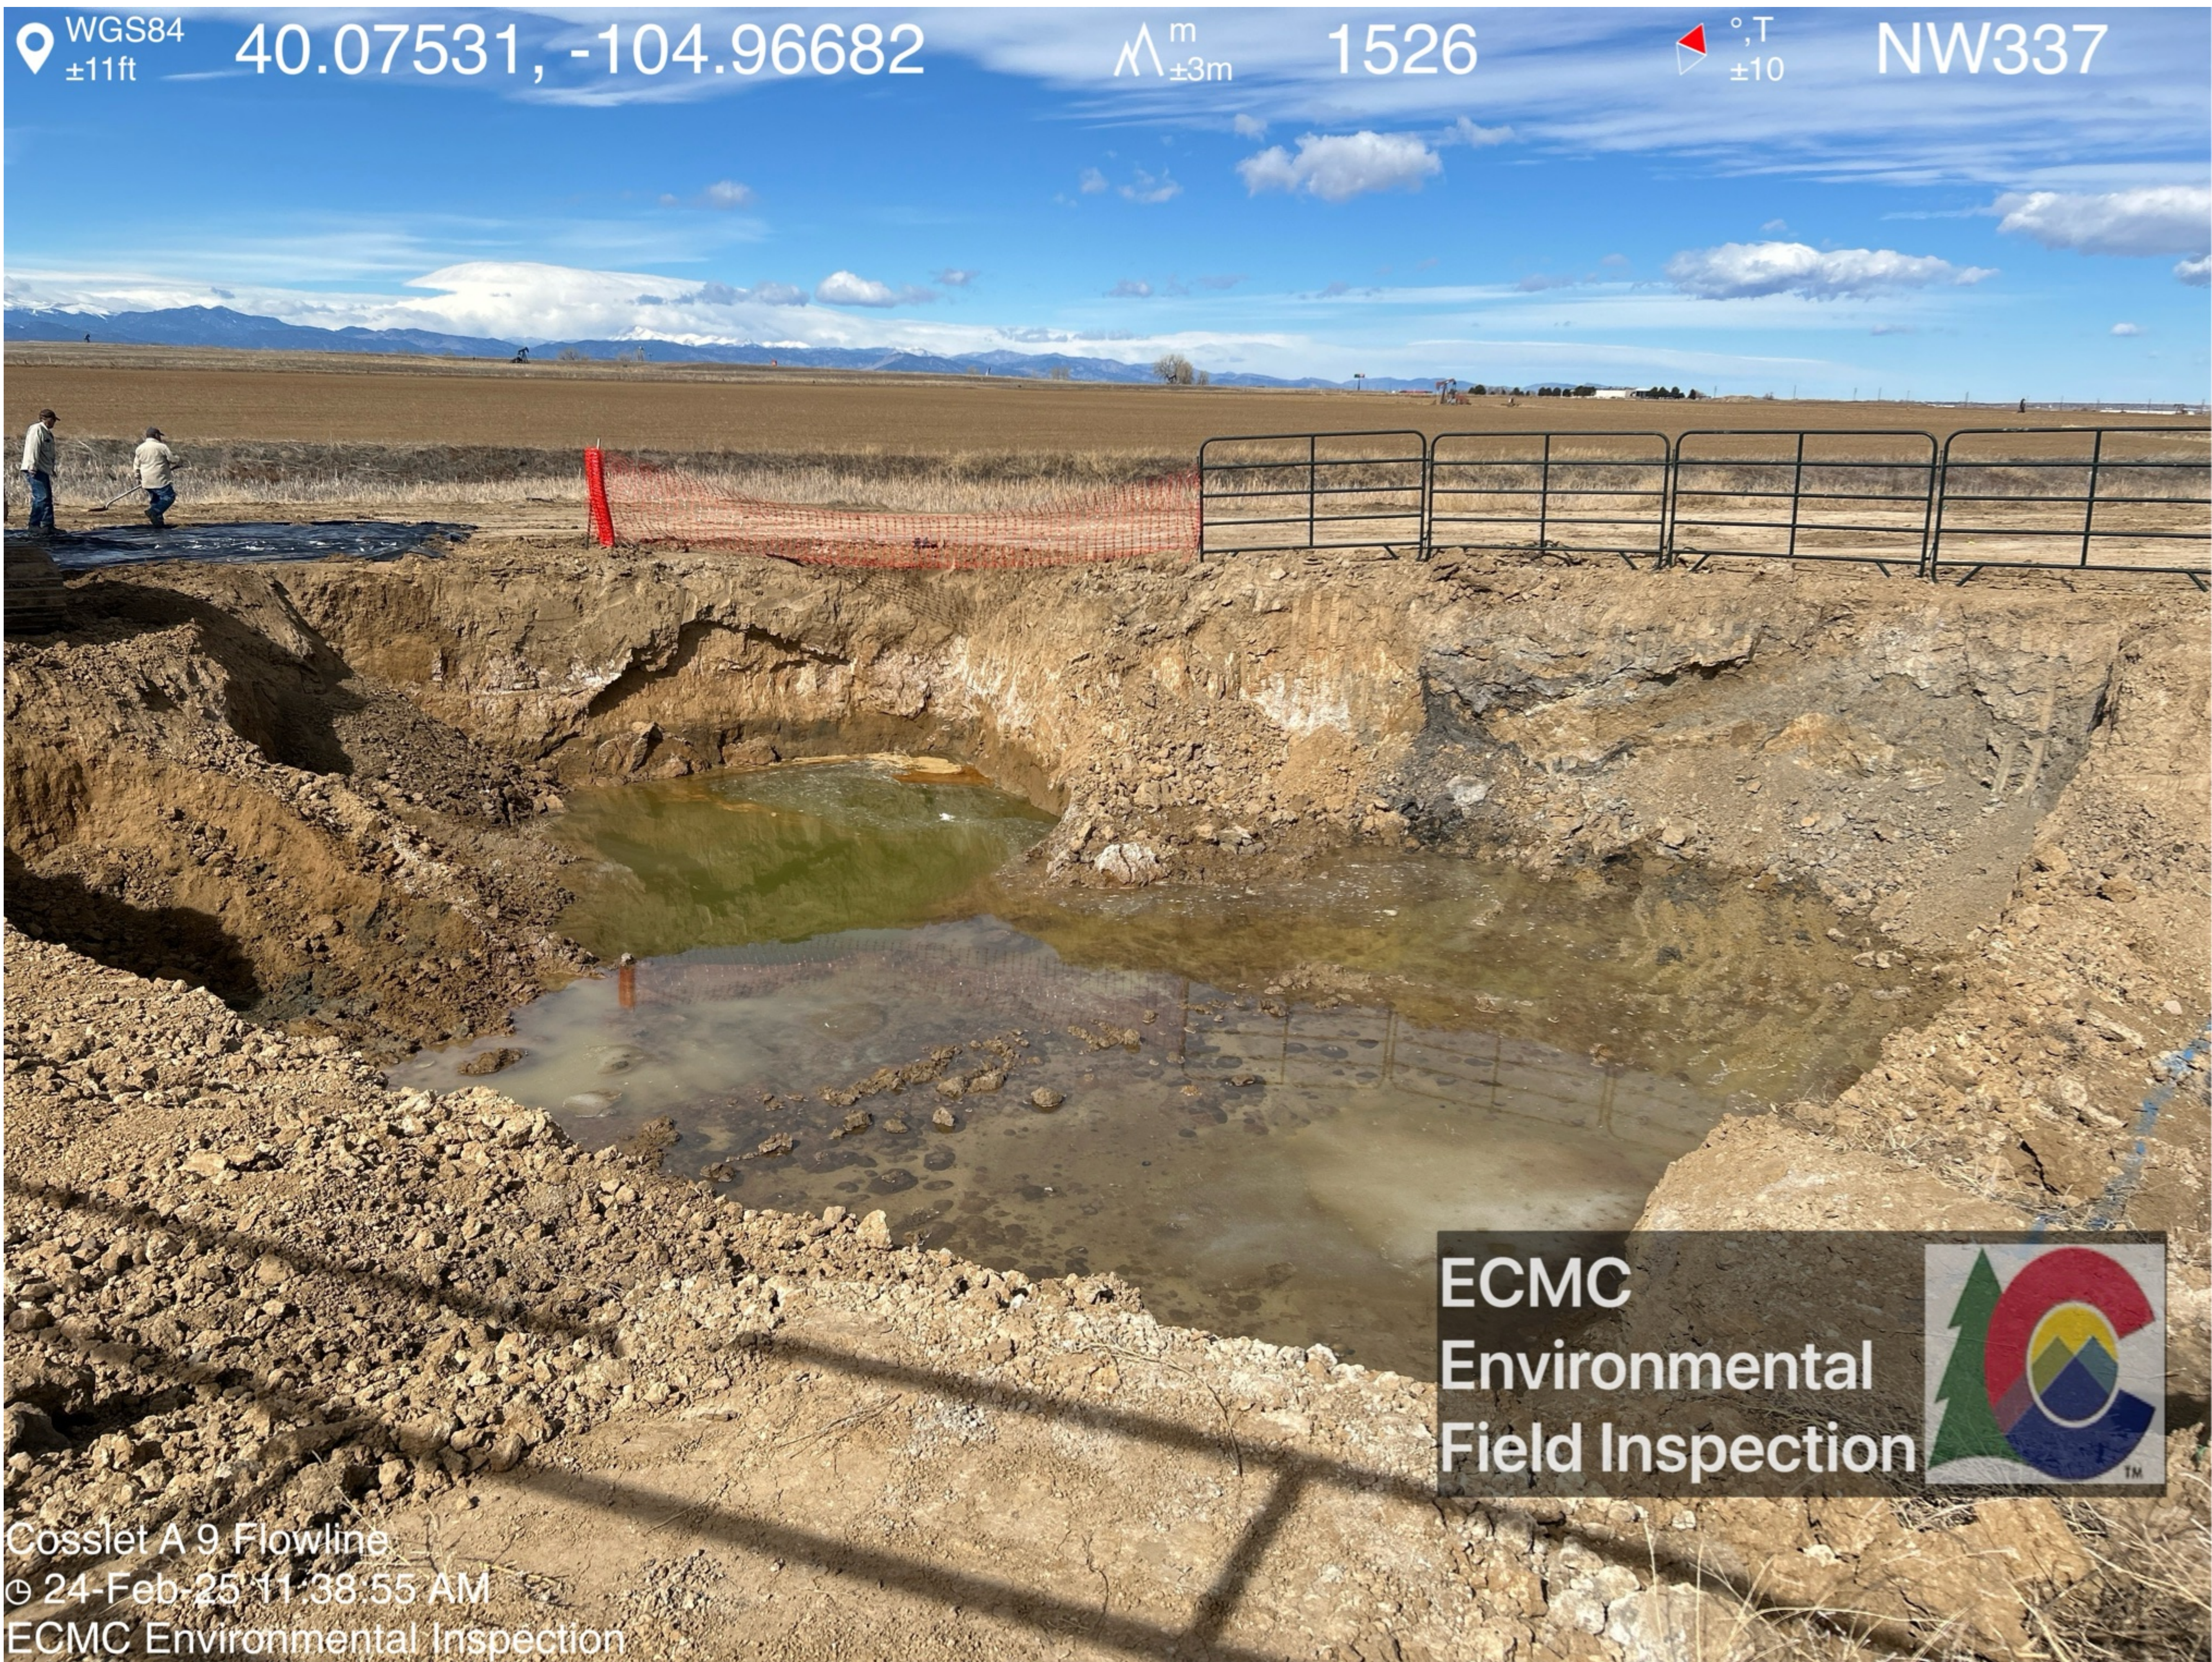
Excavation remains open. Minimal additional soil appears to have been excavated since the previous inspection on 02/13/2025. Gray and black petroleum hydrocarbon staining is visible in situ. Free product is visible on groundwater.

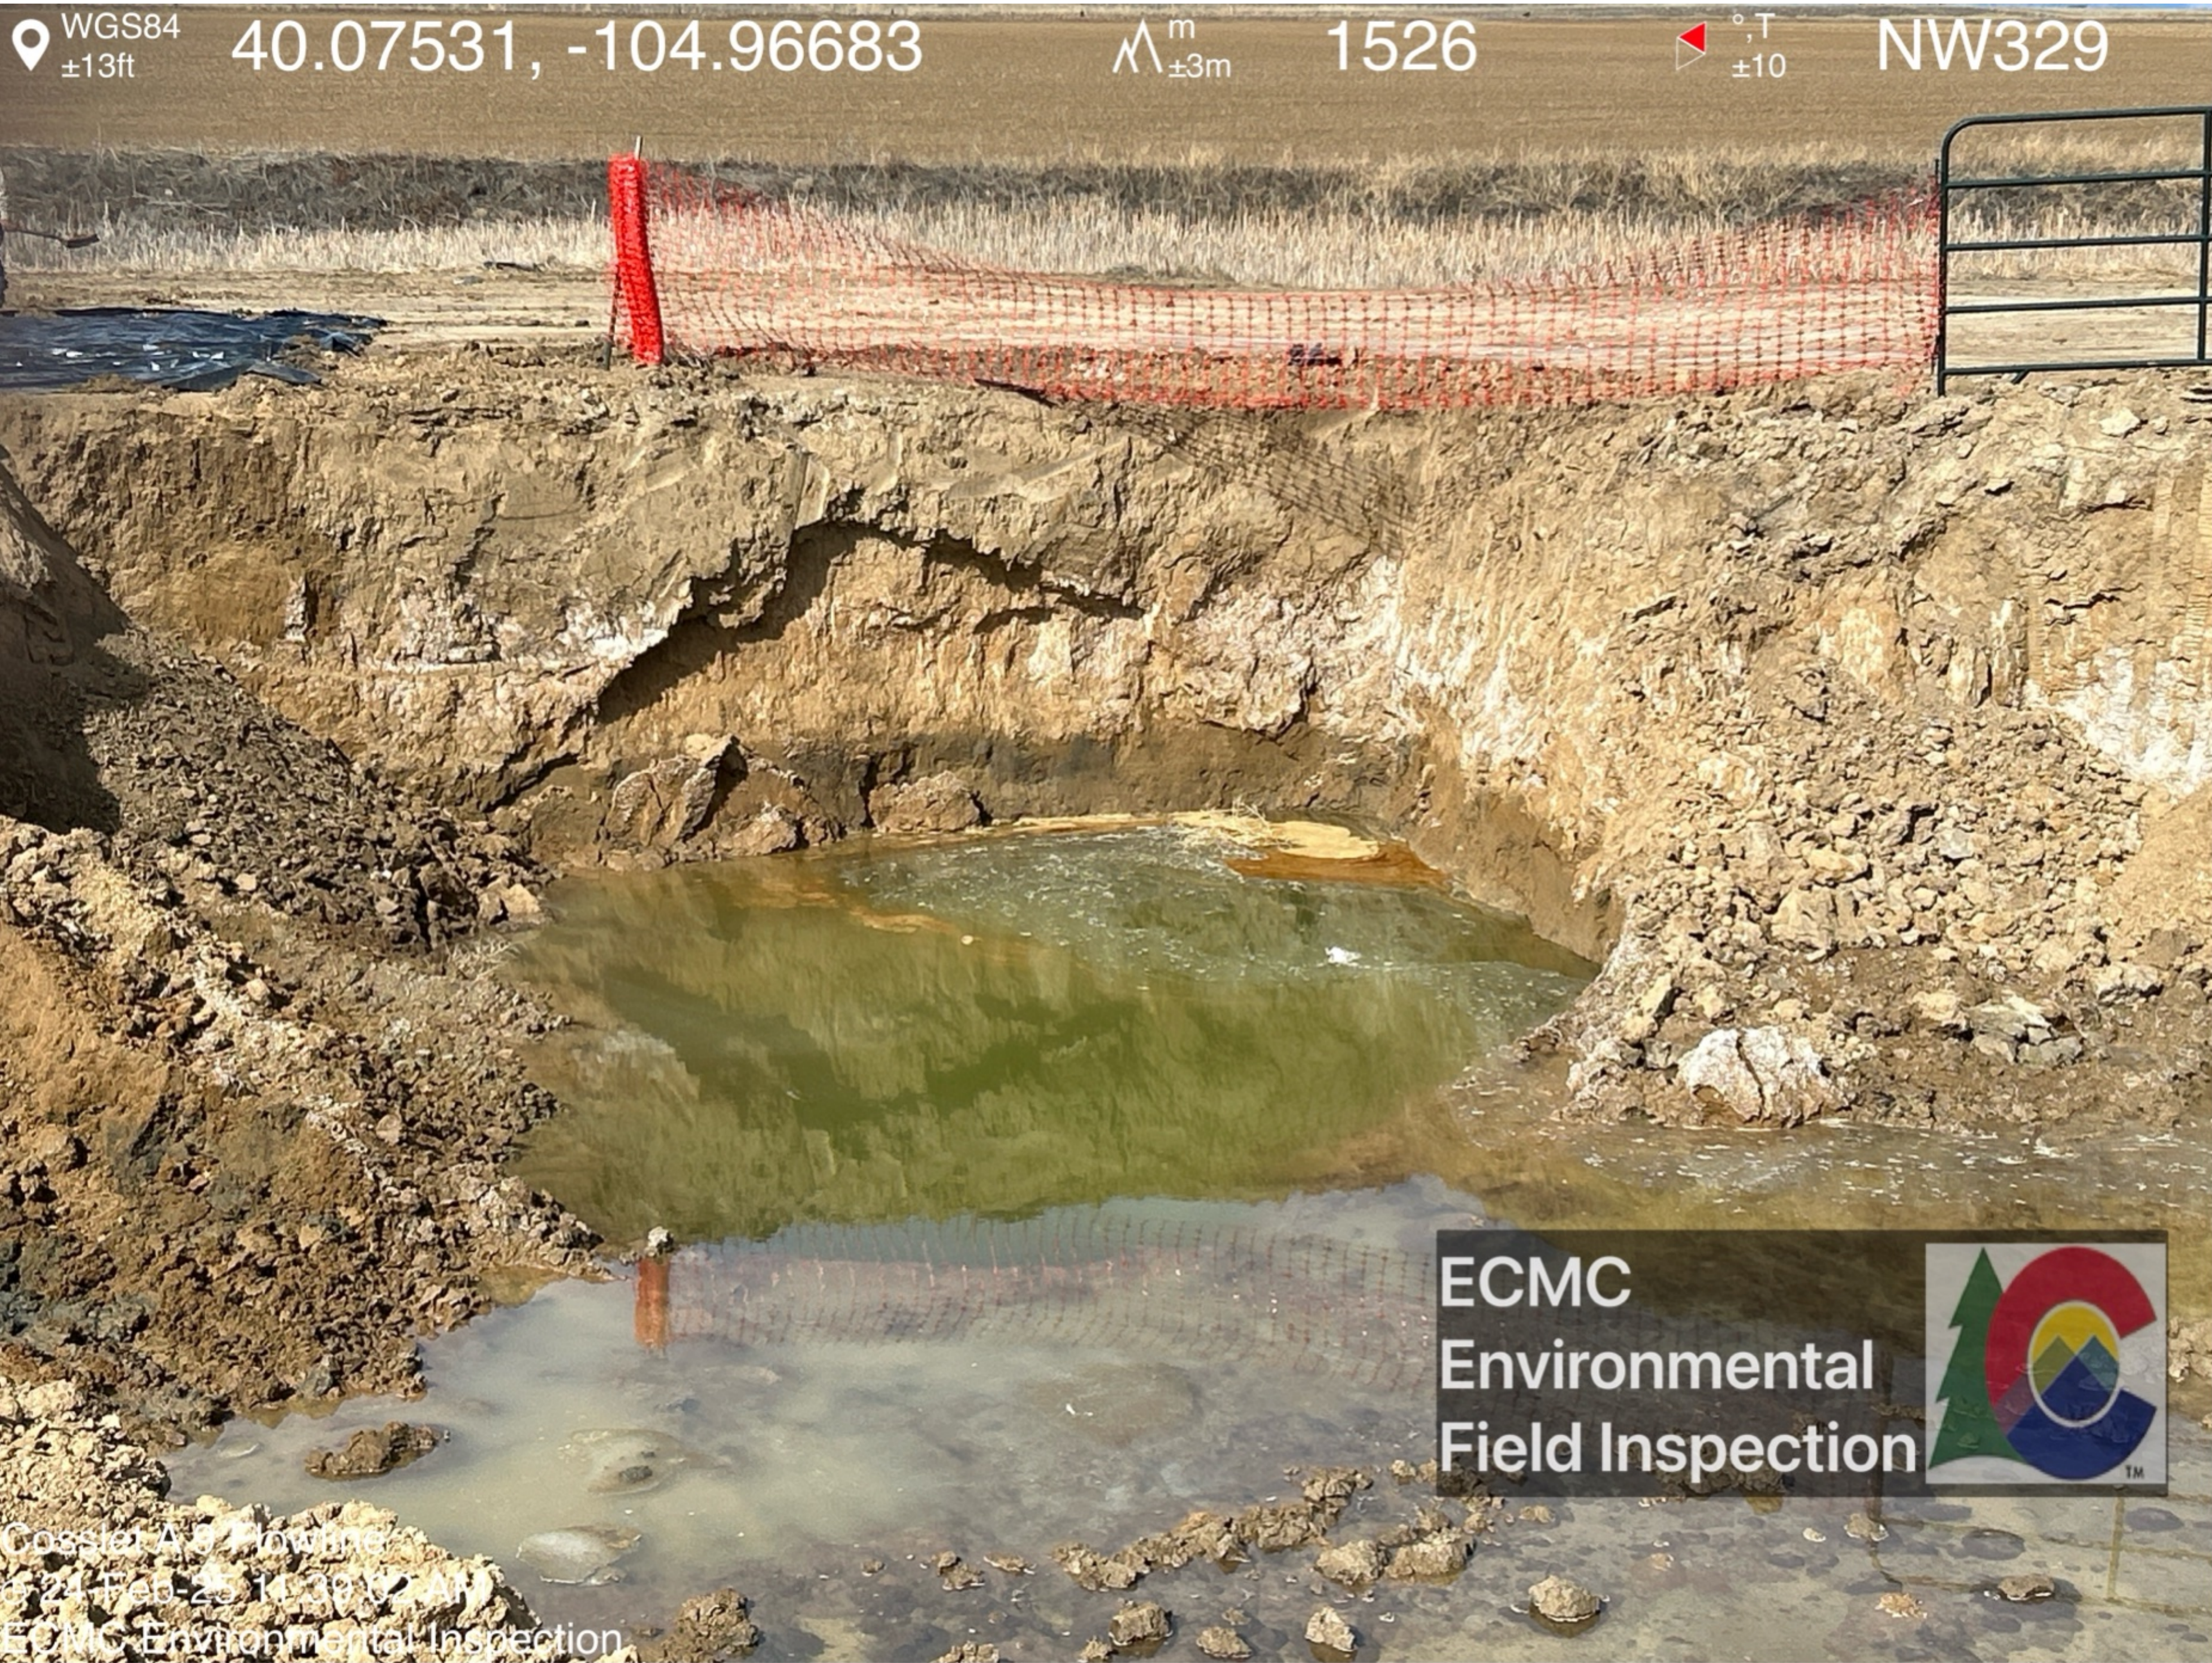
Gray and black petroleum hydrocarbon staining is visible on the sidewalls of the excavation. Free product is visible on groundwater.

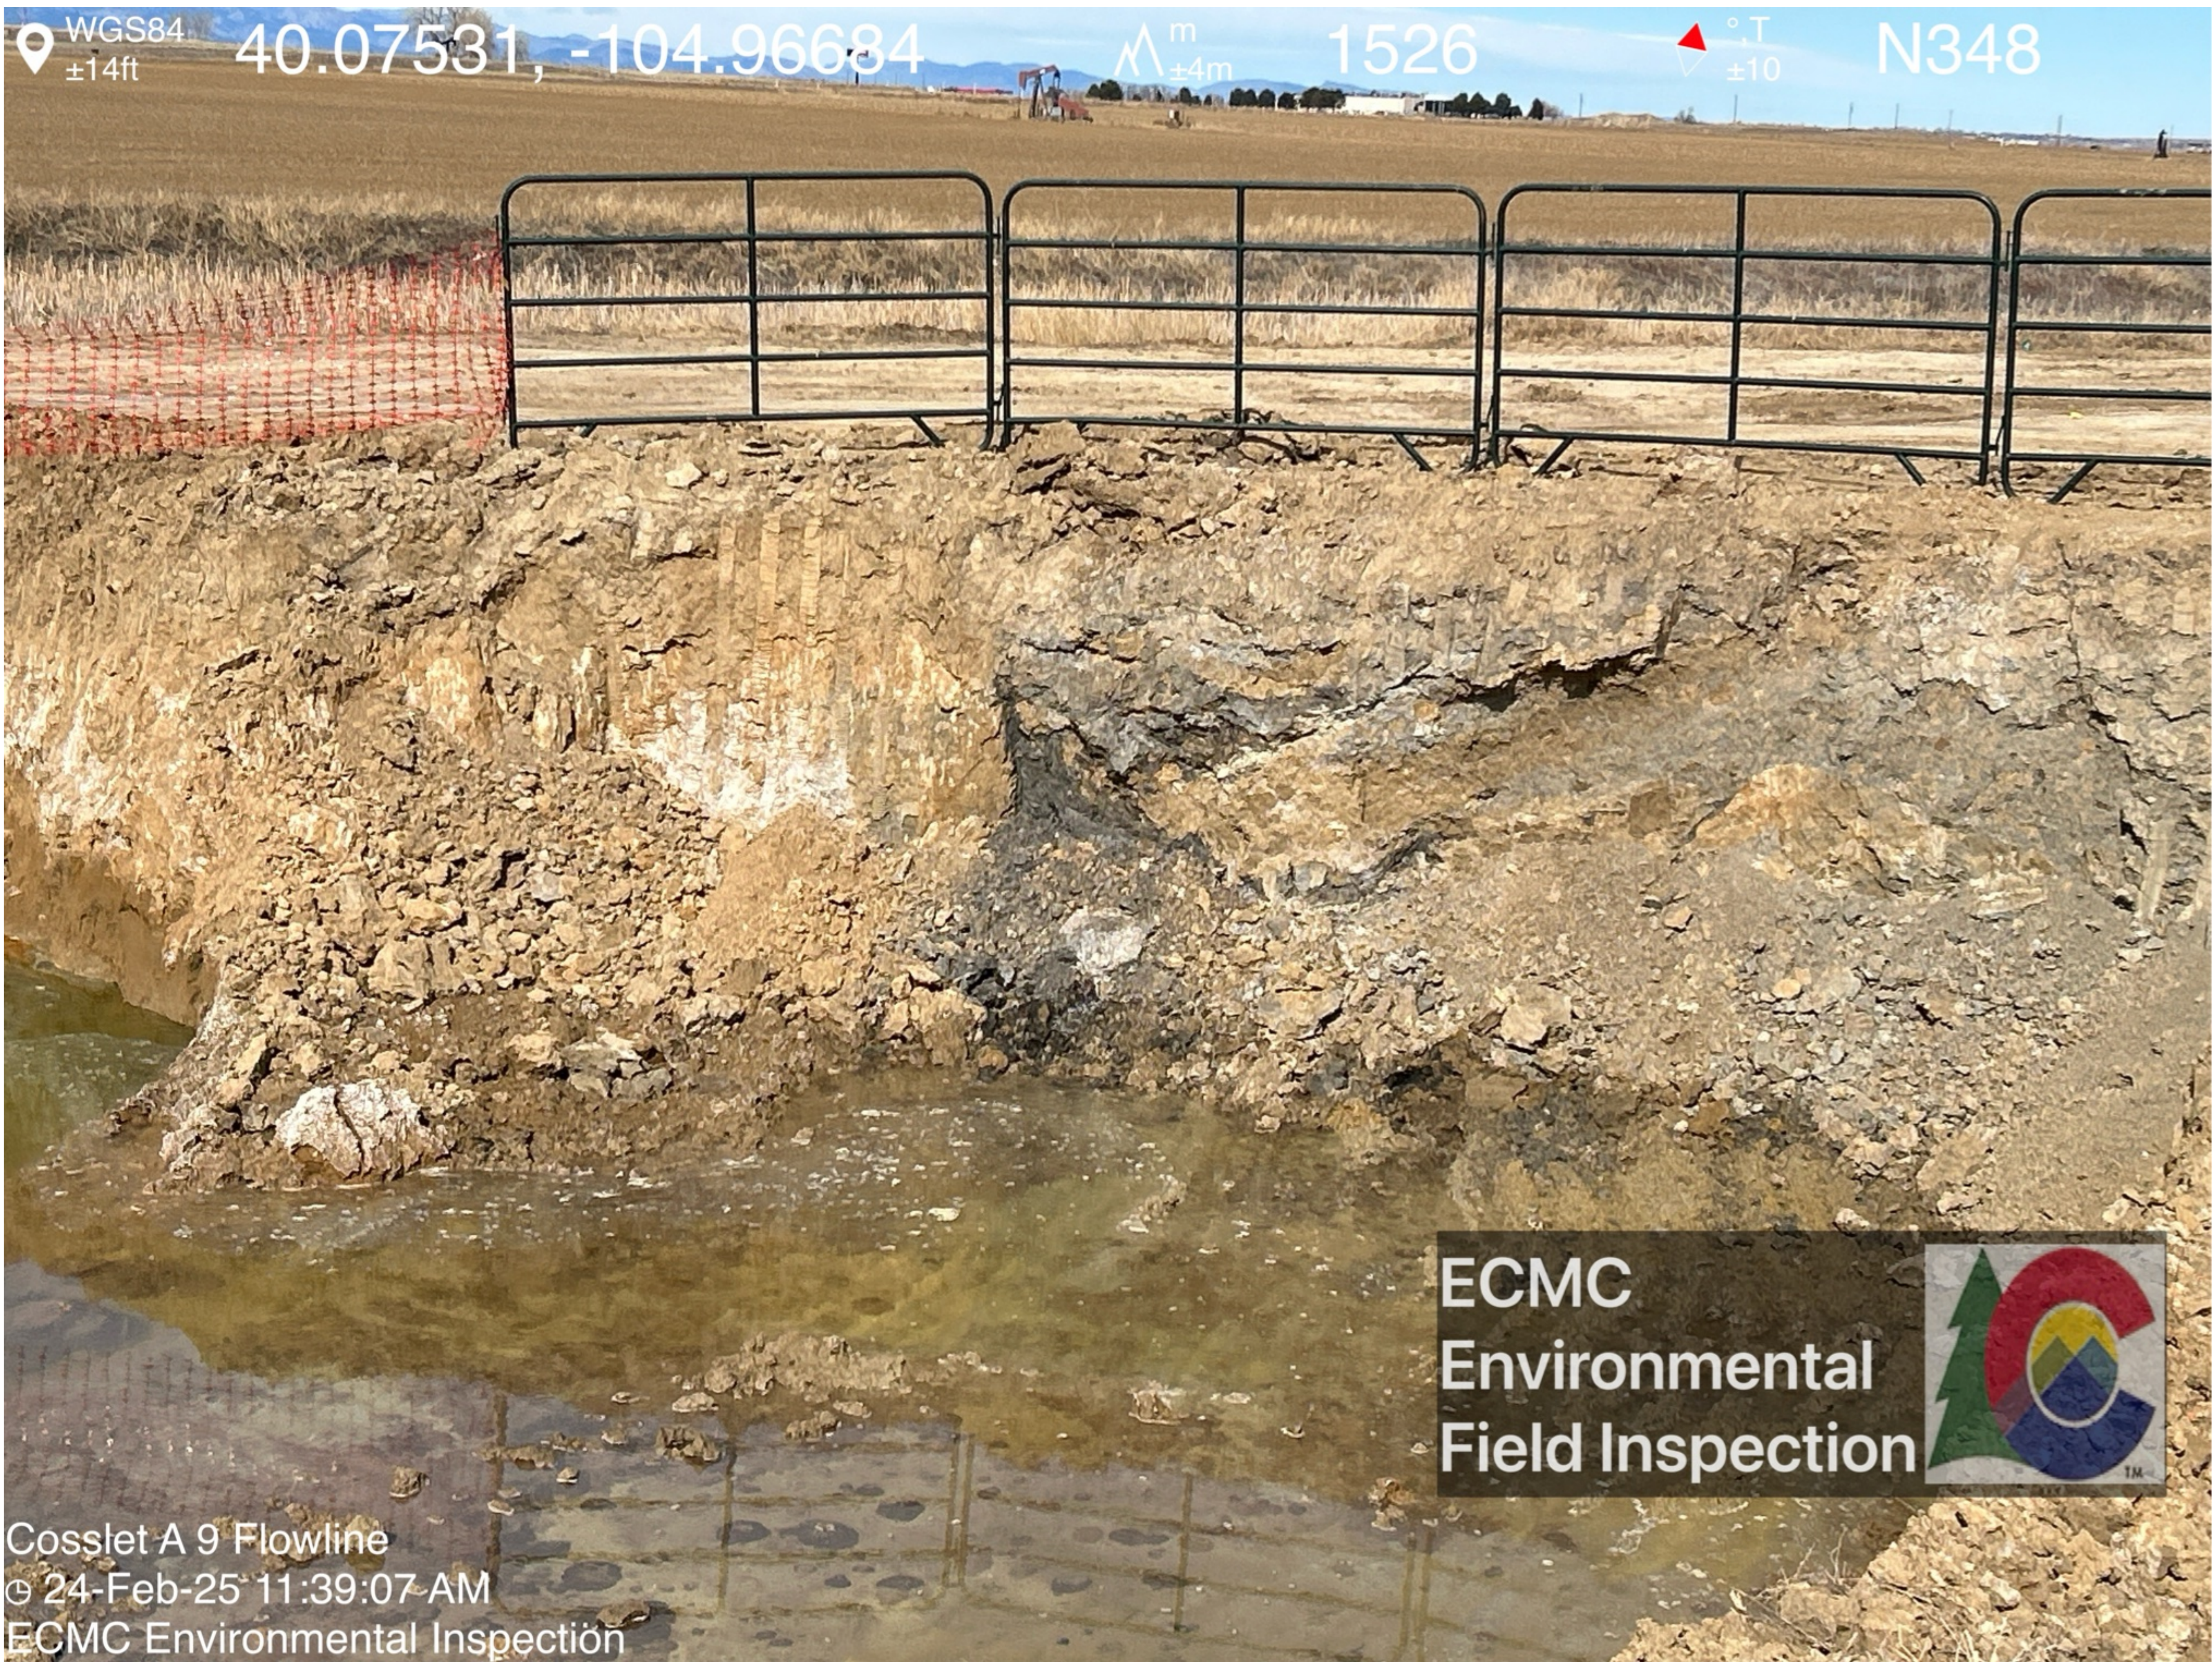
Gray and black petroleum hydrocarbon staining is visible in situ on the excavation sidewalls.

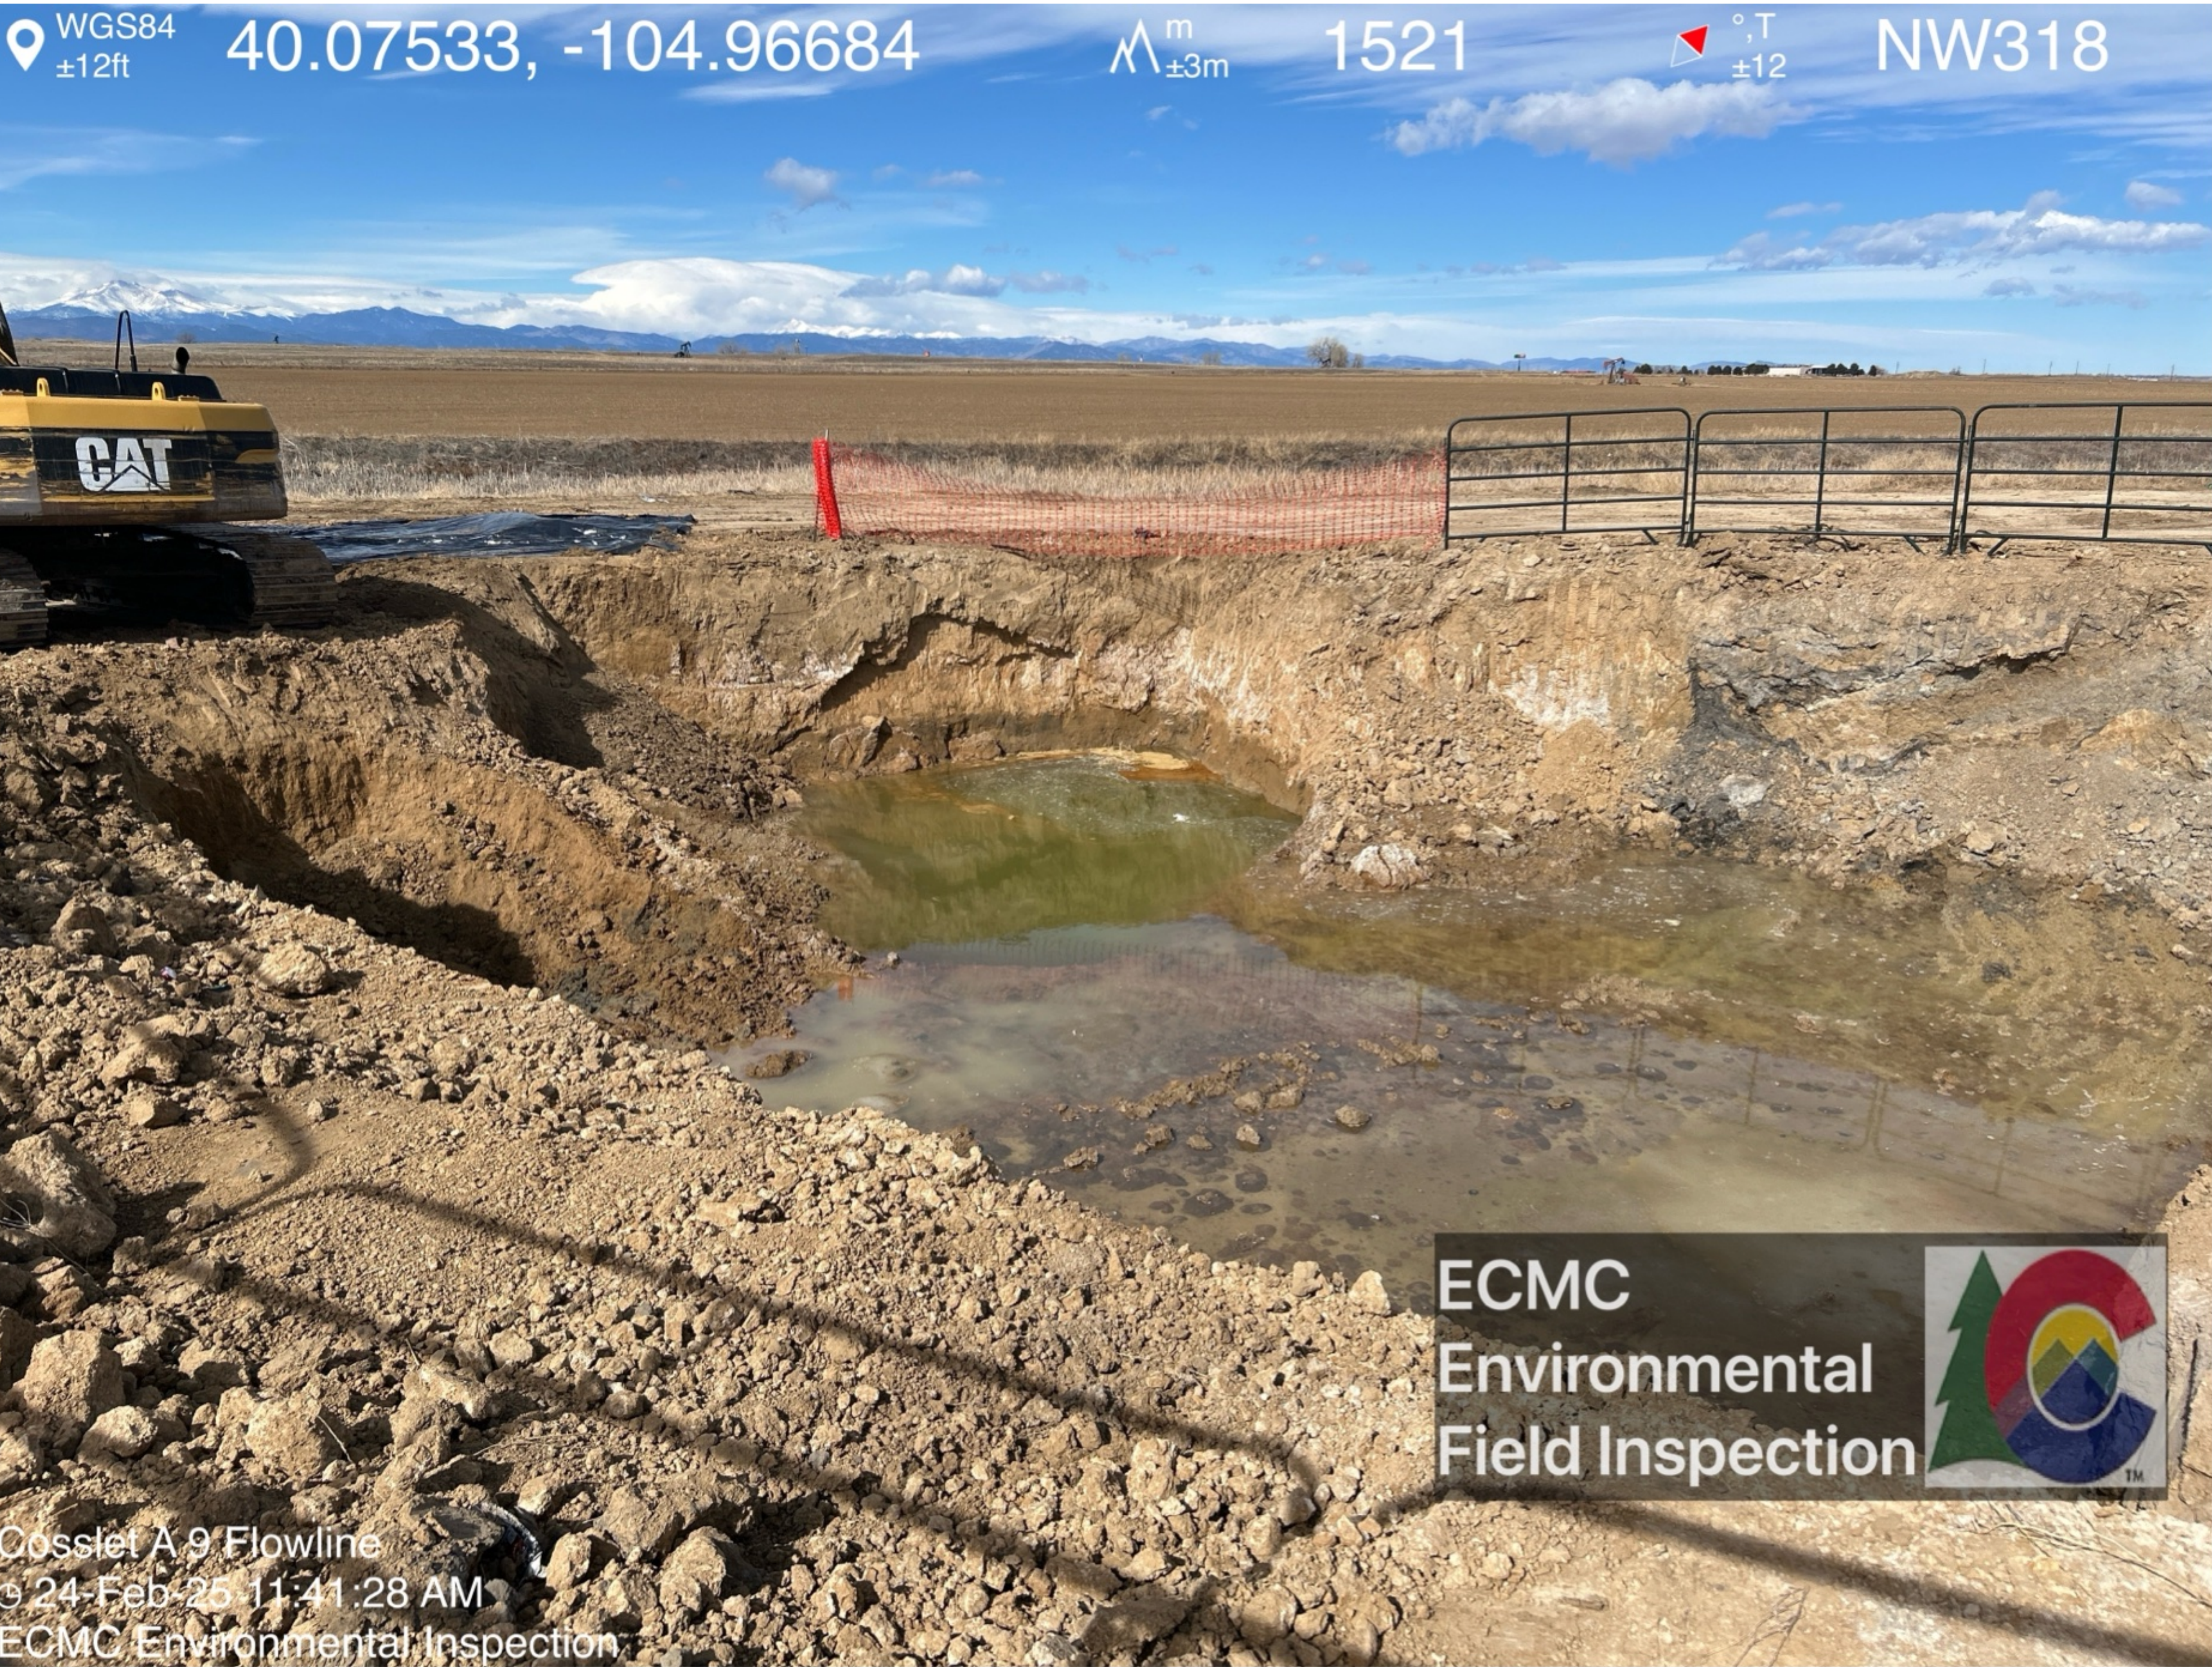
Groundwater is visible covering the deeper portion of the excavation; free product is visible.

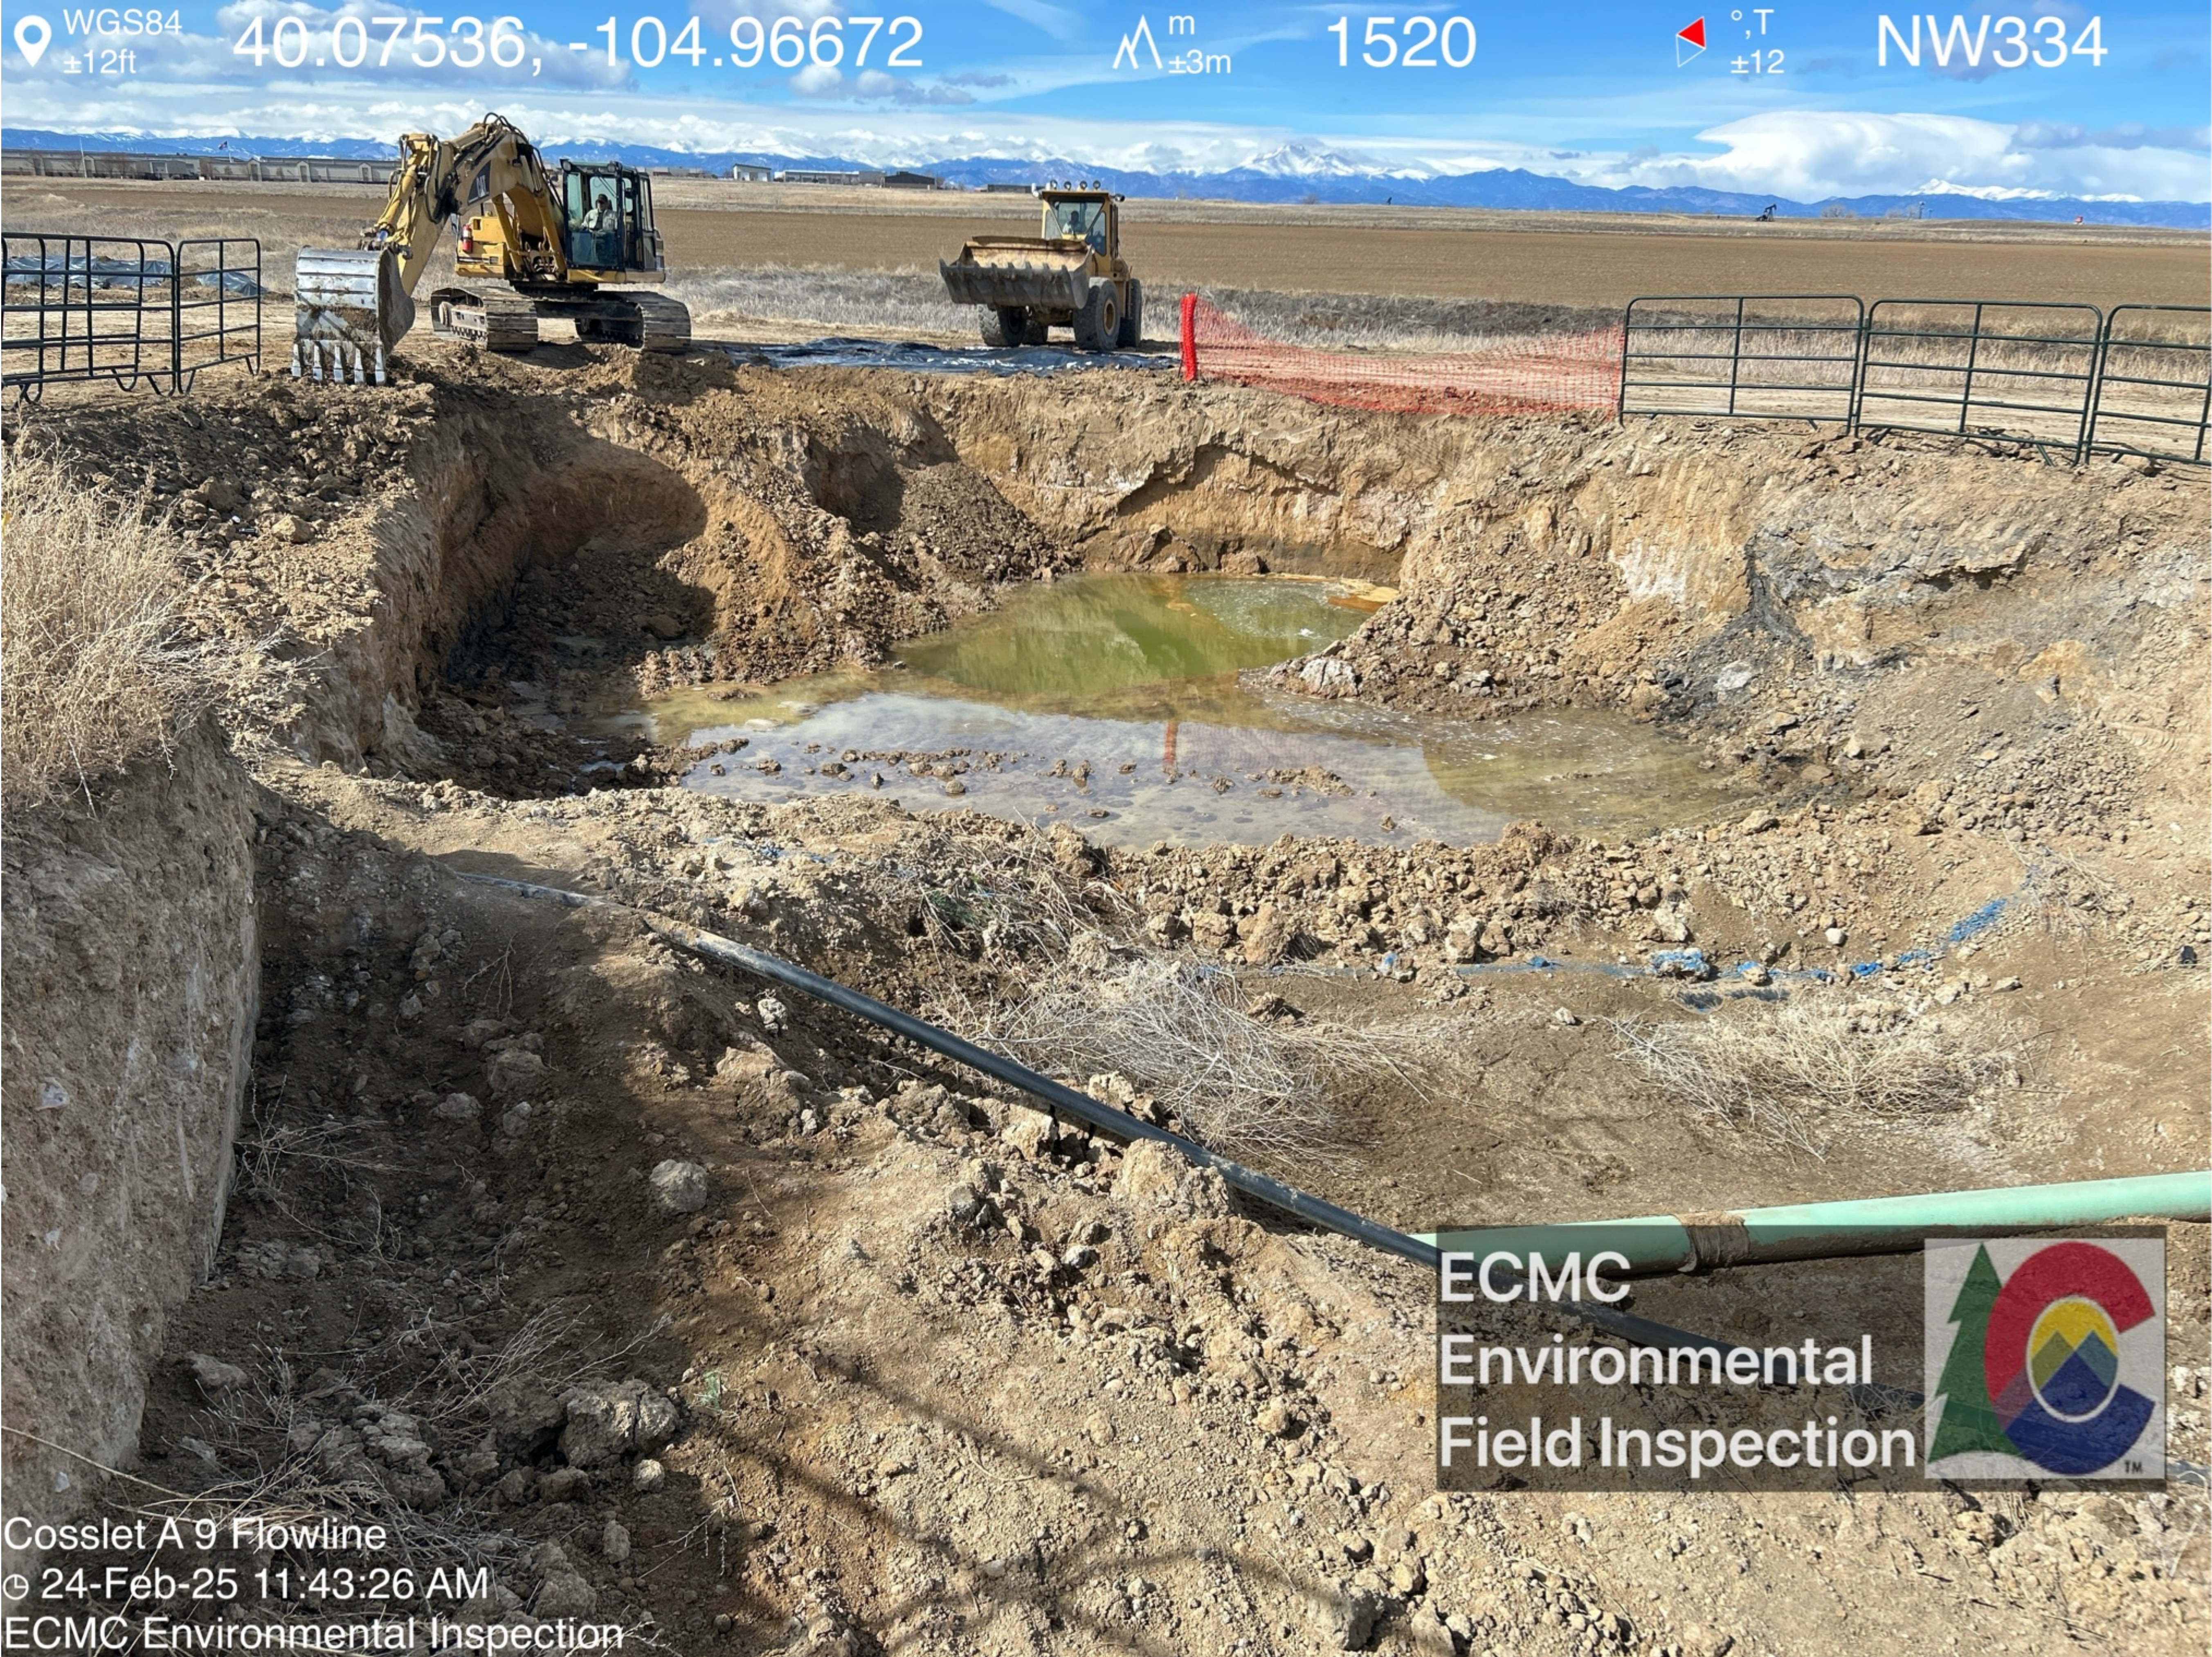
Exposed flowlines and weeds remain within the shallow portion of the excavation.
