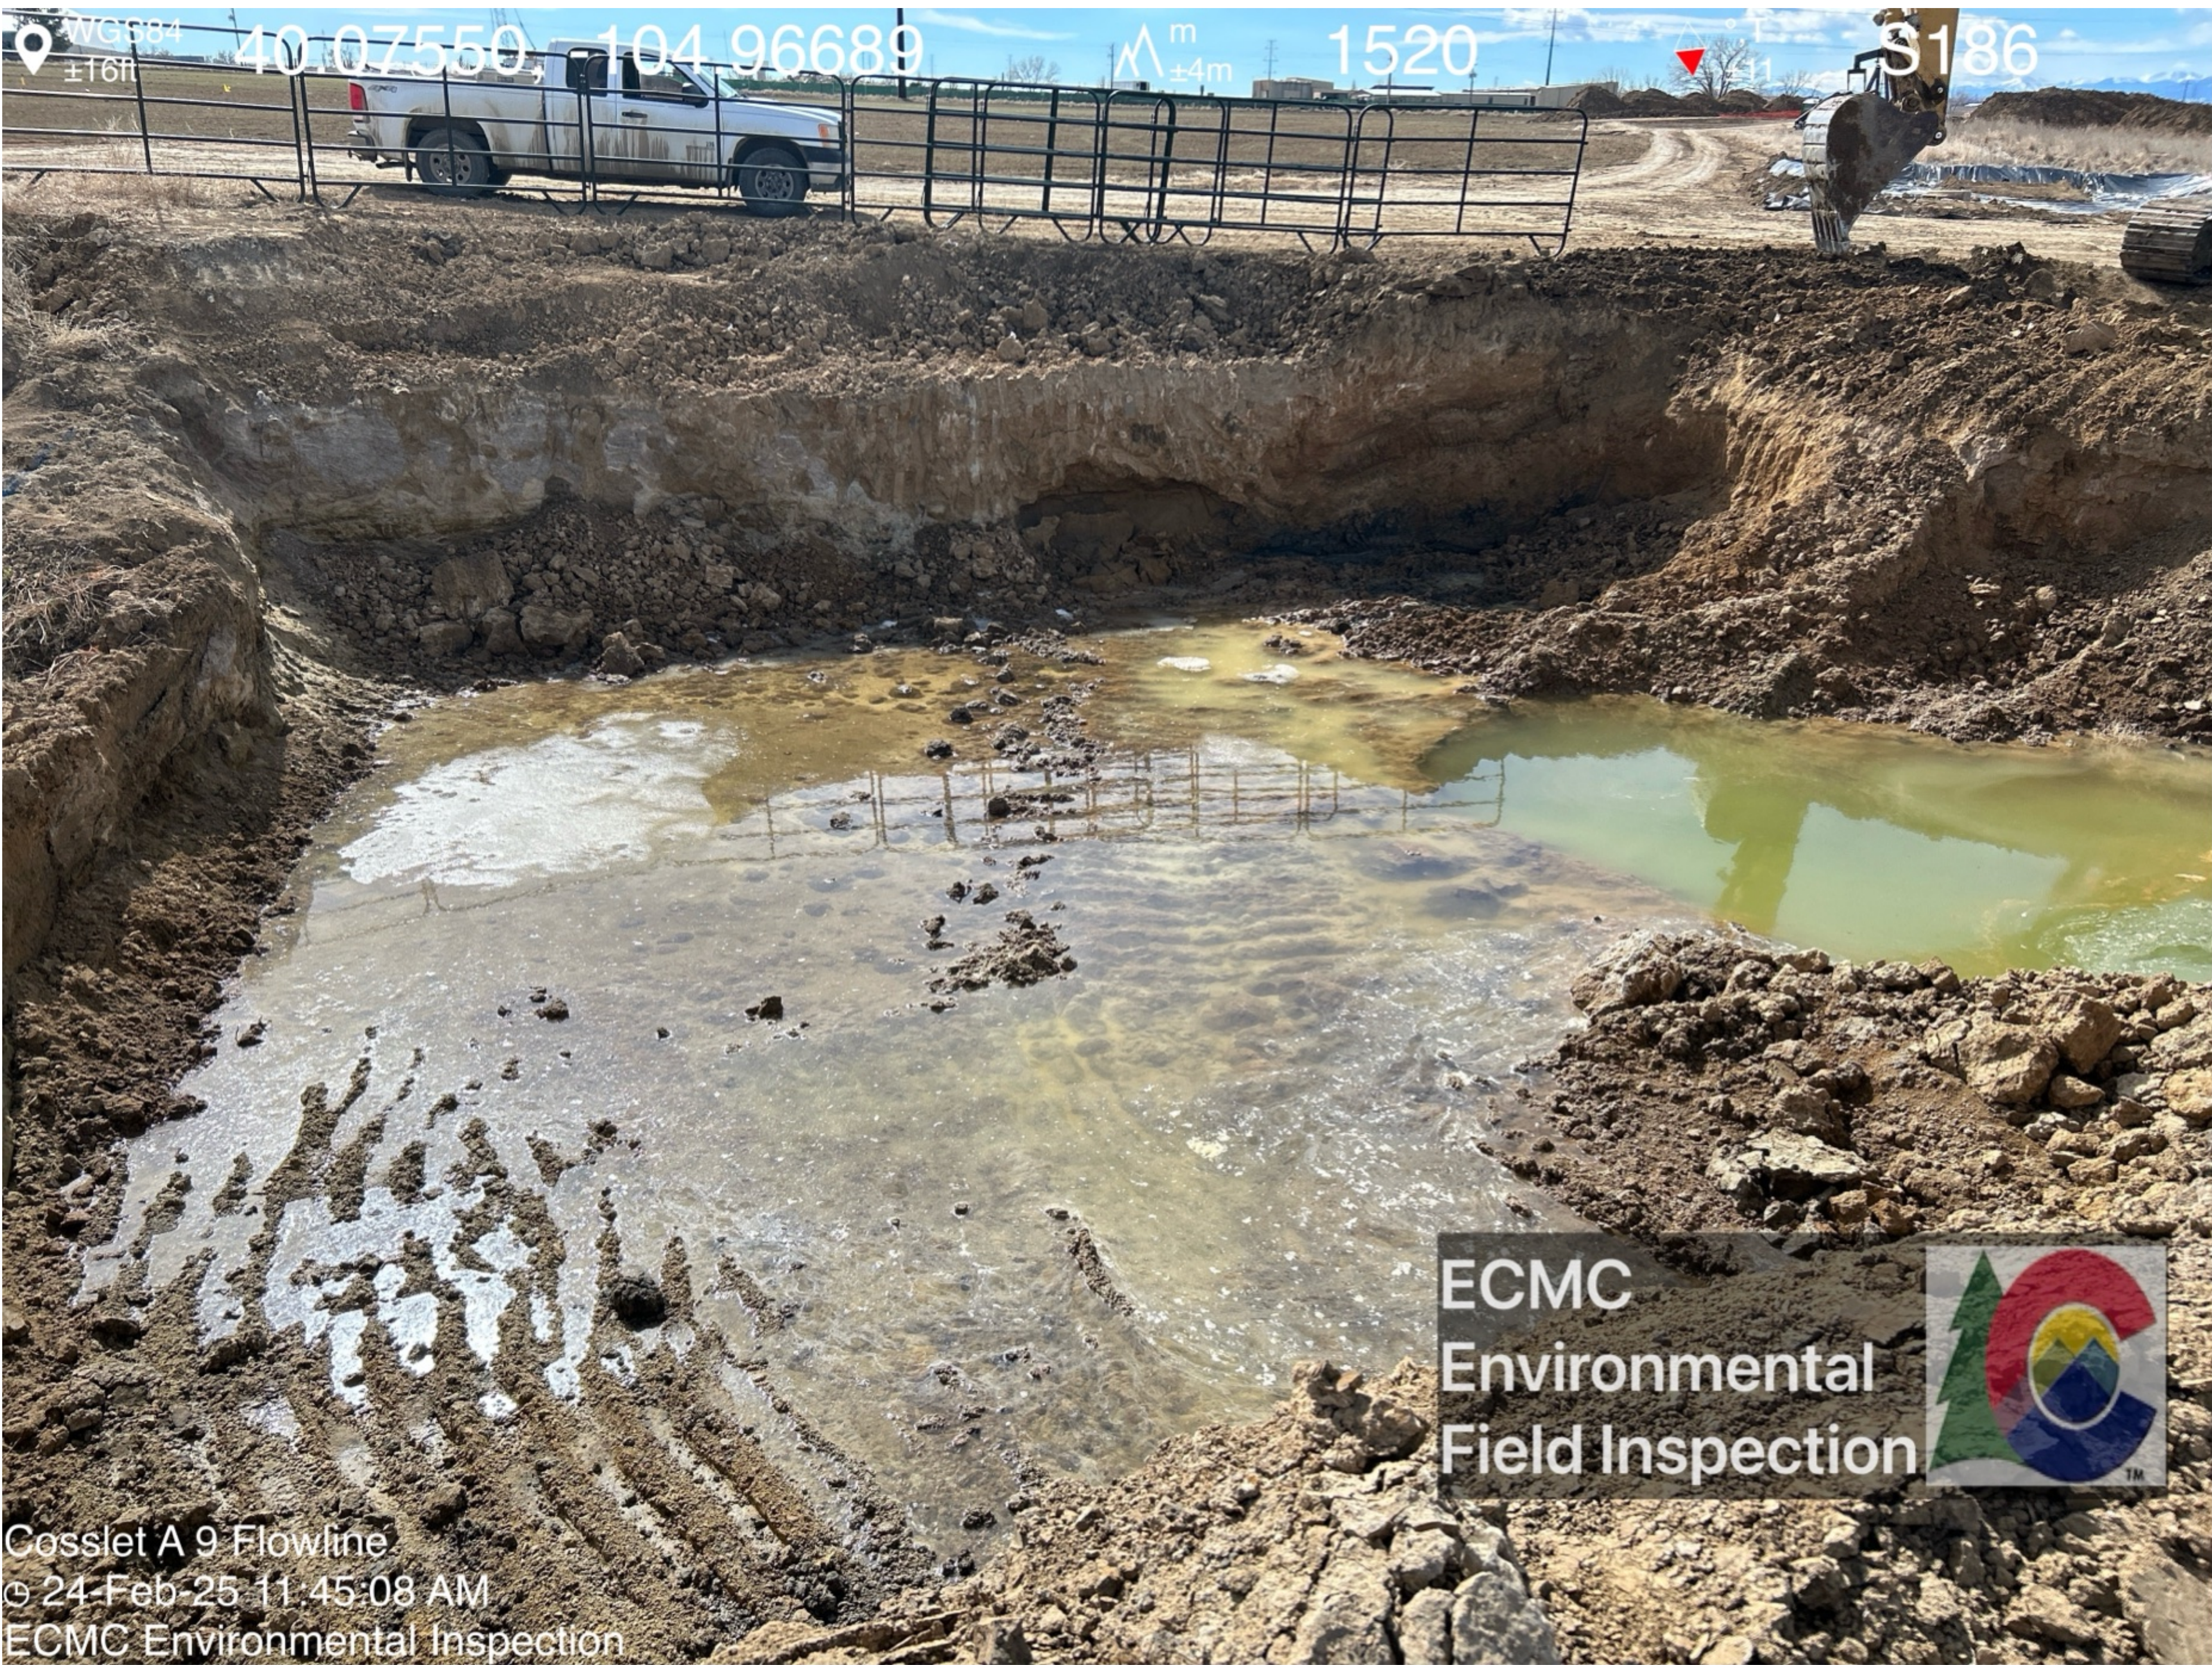
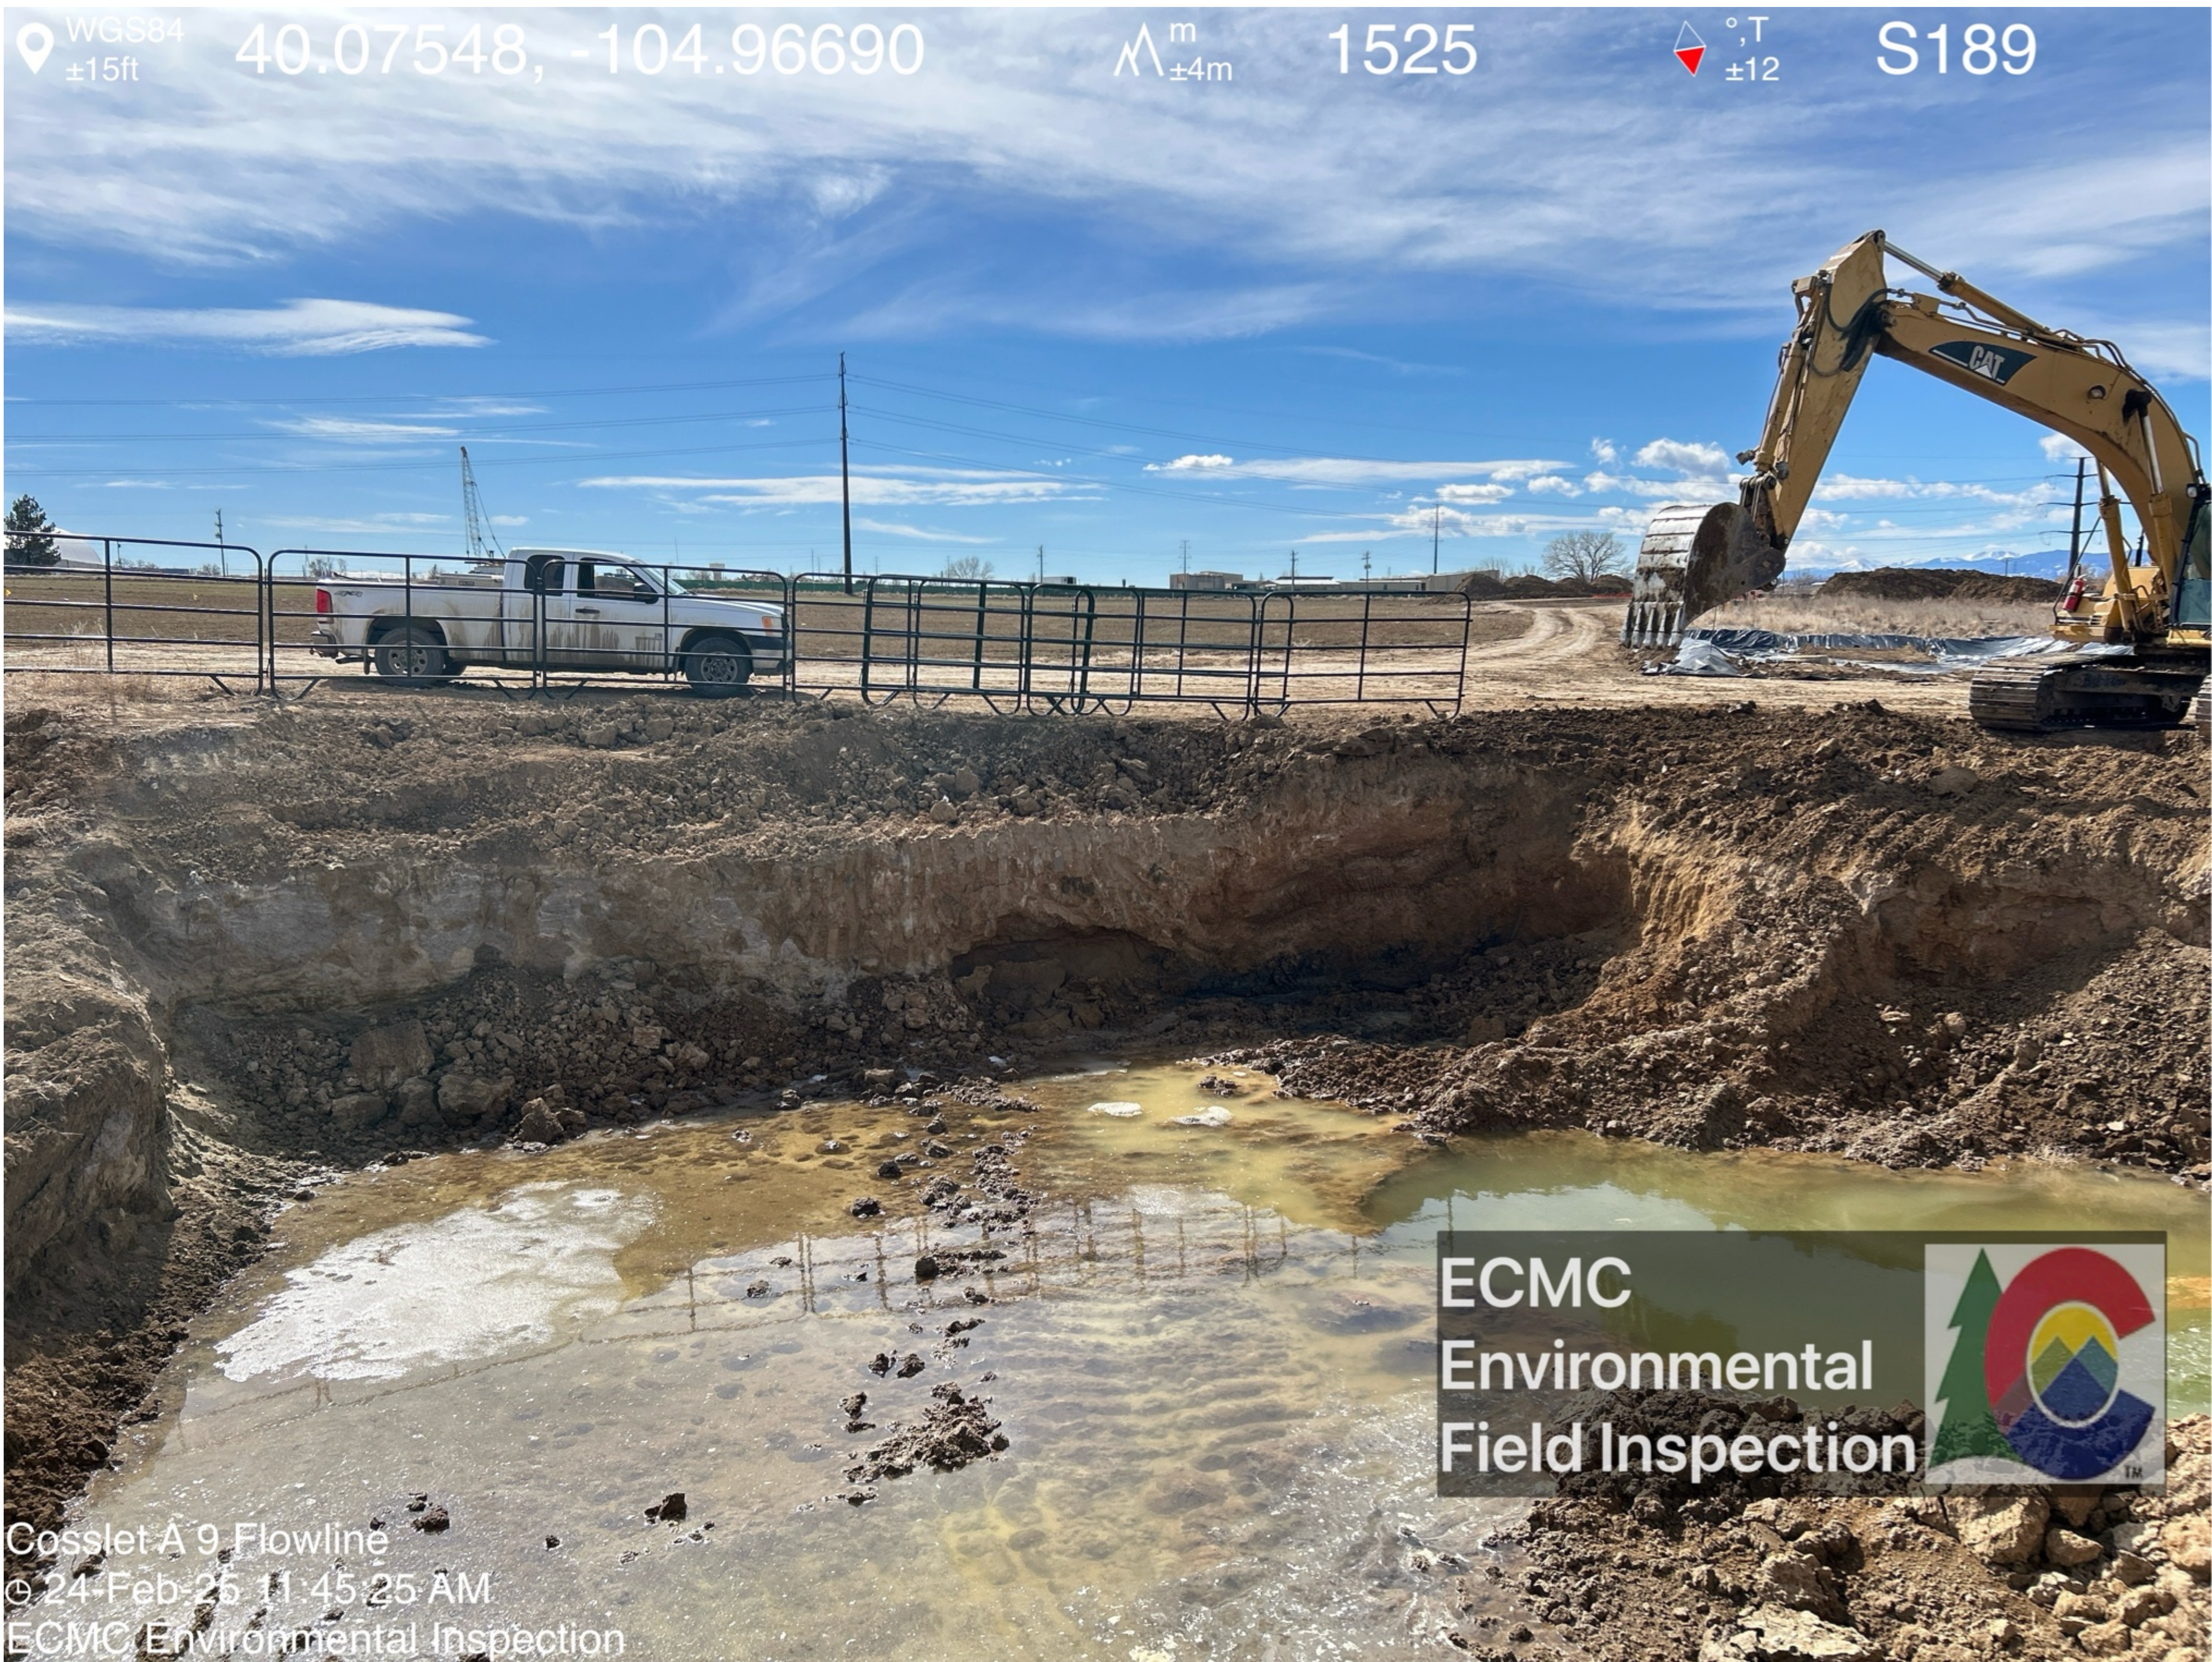
Gray and black petroleum hydrocarbon staining is visible in situ on the excavation sidewalls. Free product is visible on groundwater.

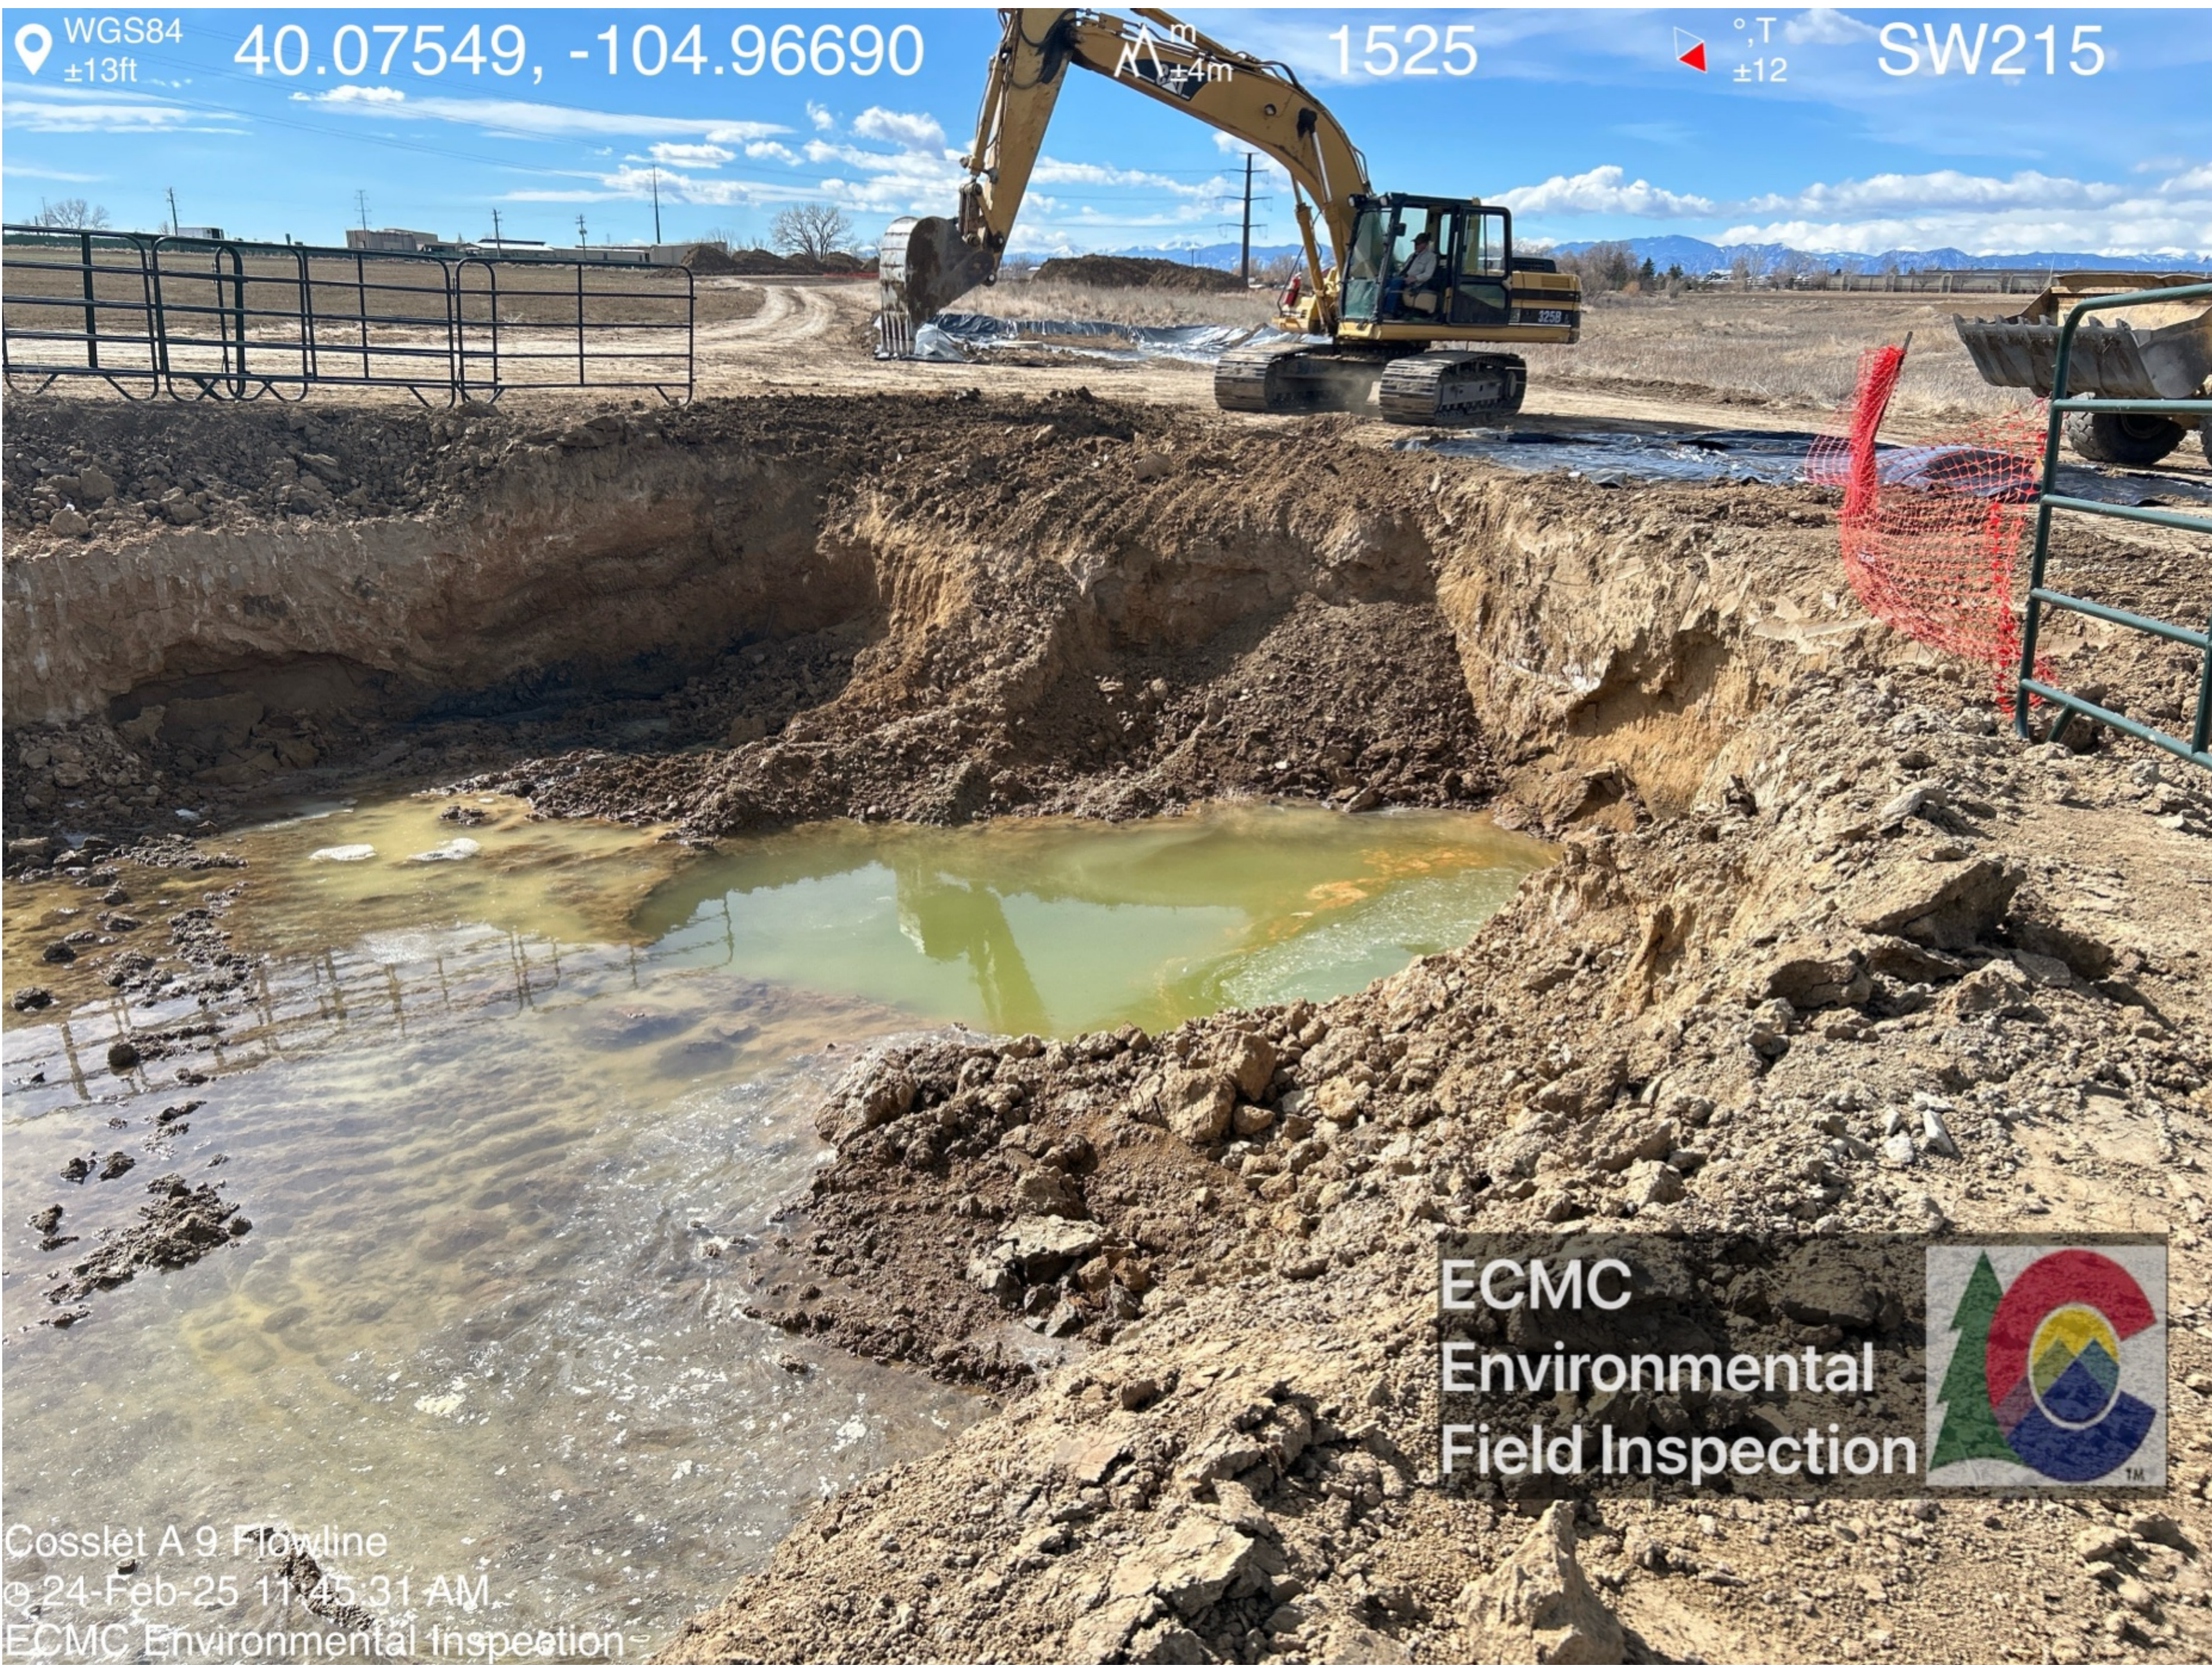
Operator personnel were observed extending the excavation to the southwest. Petroleum hydrocarbon odor was observed when soil was disturbed.

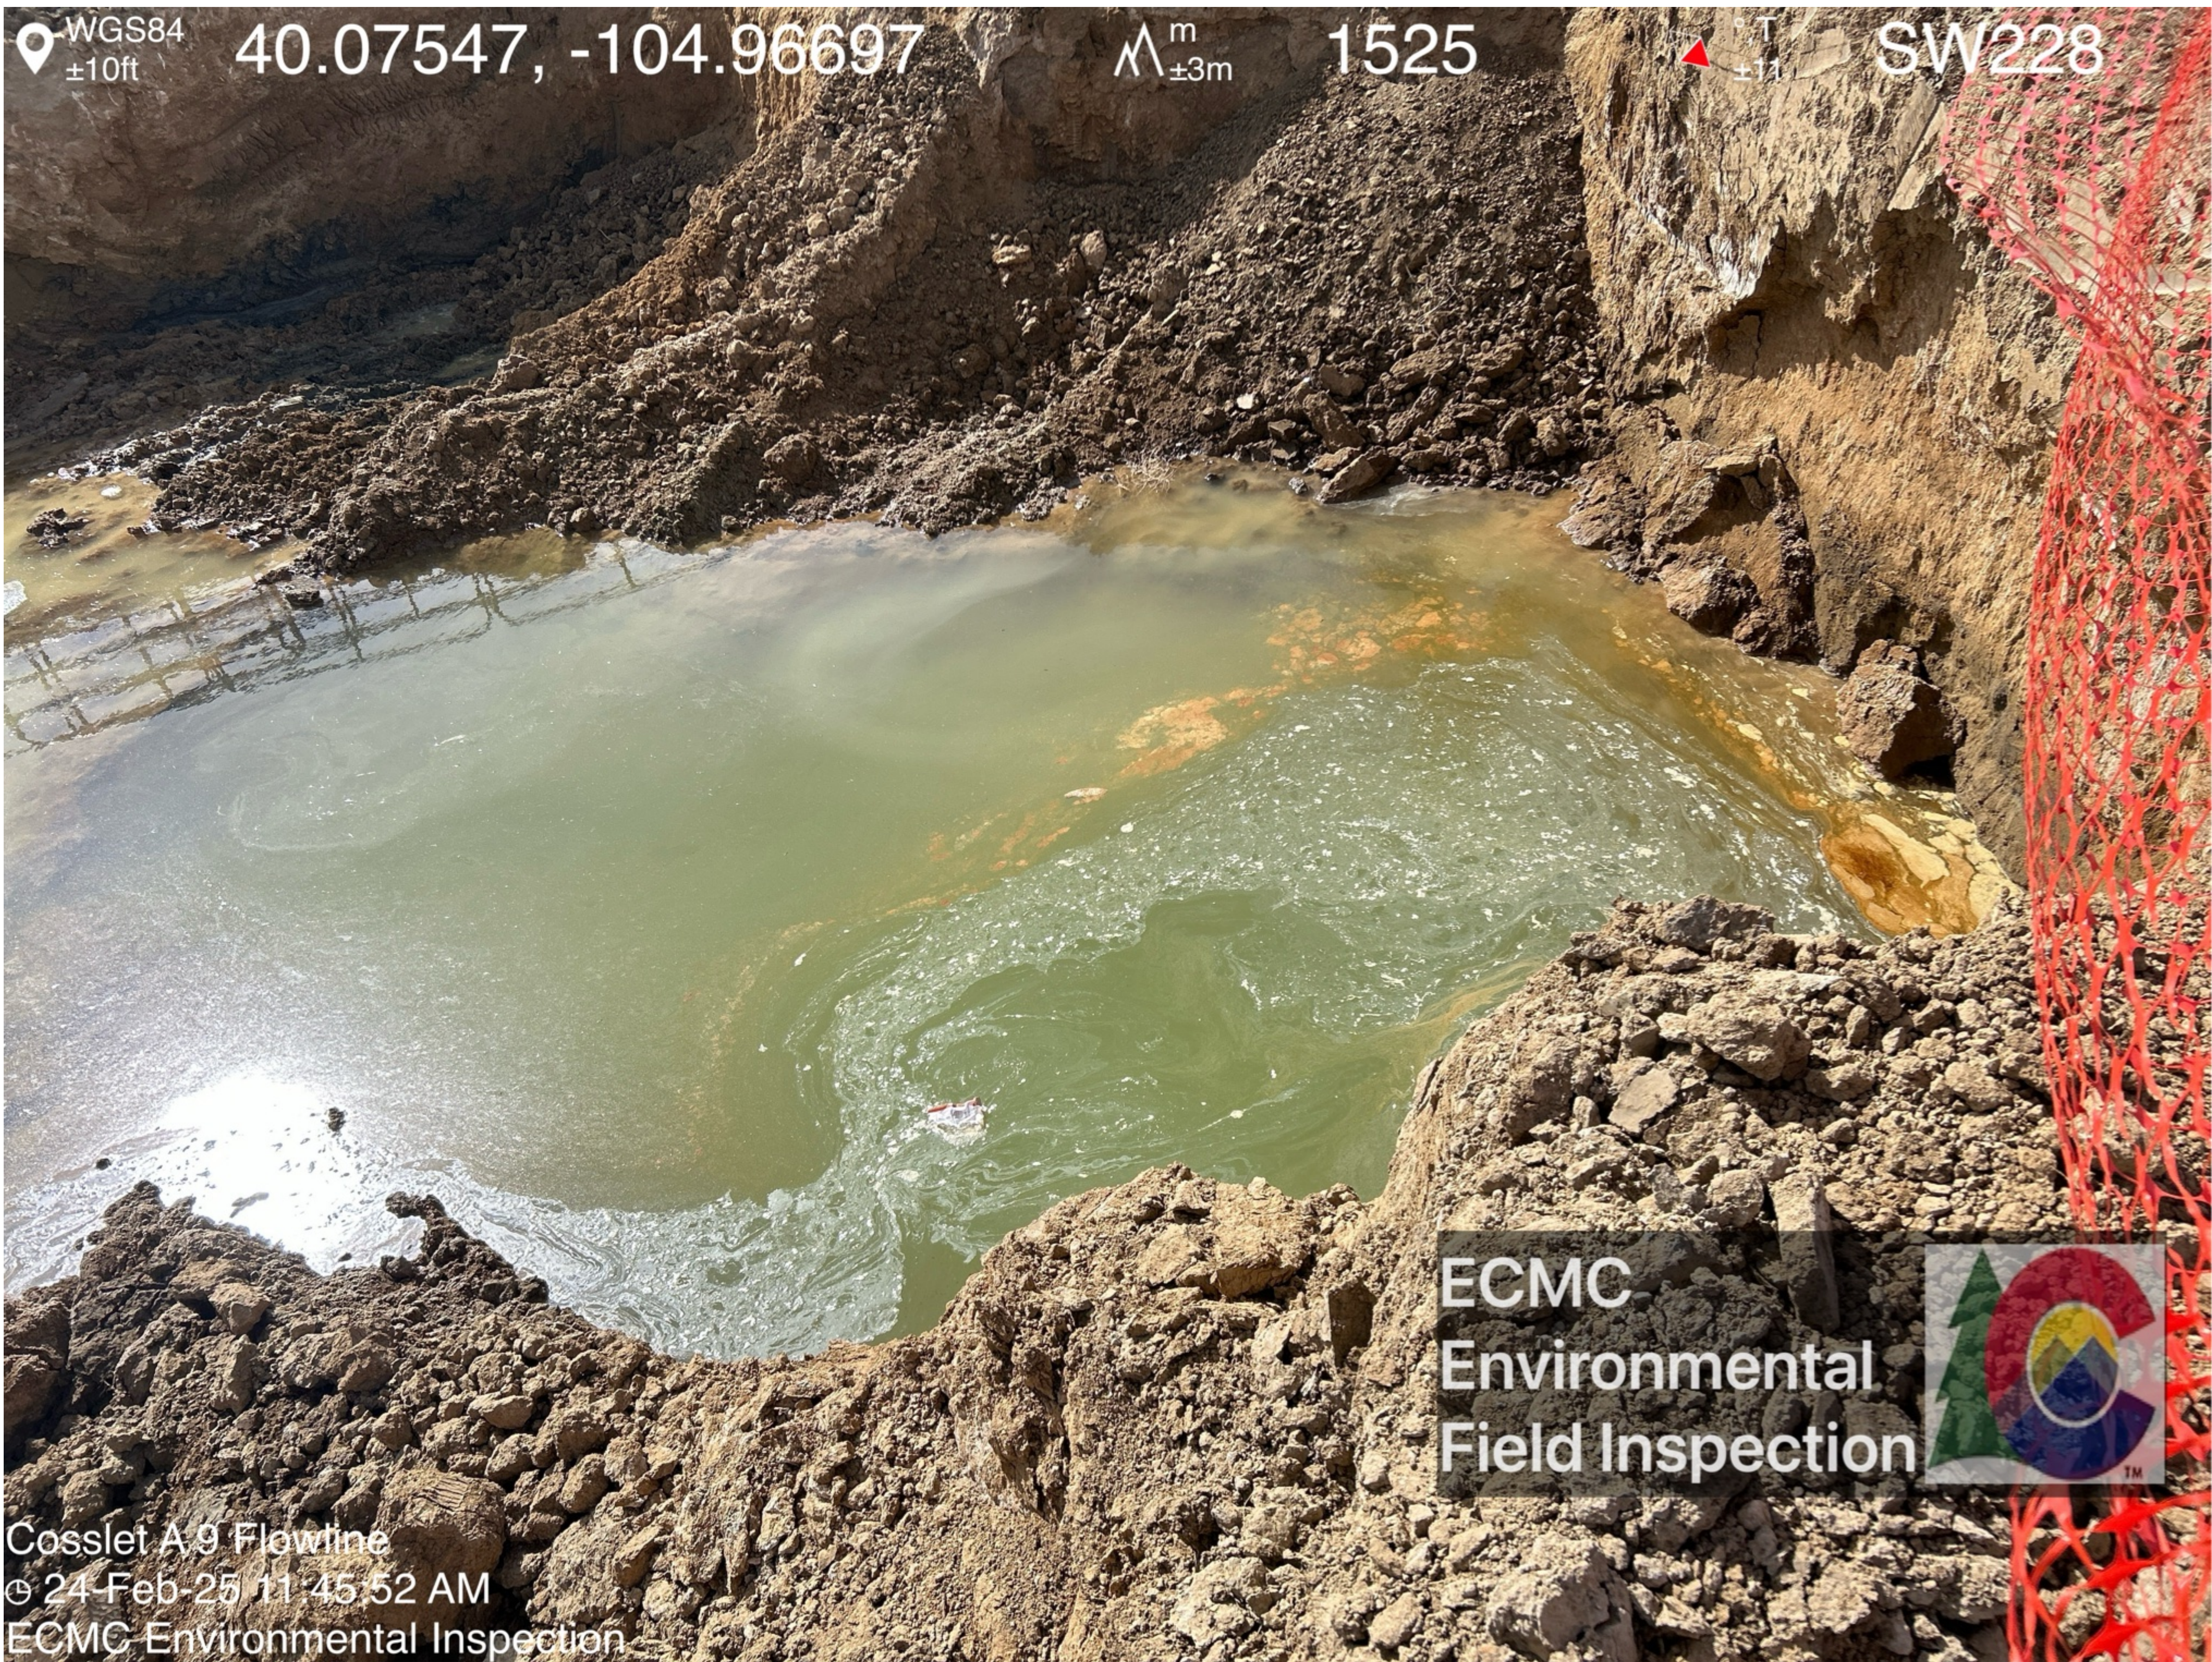
Free product is visible on groundwater.

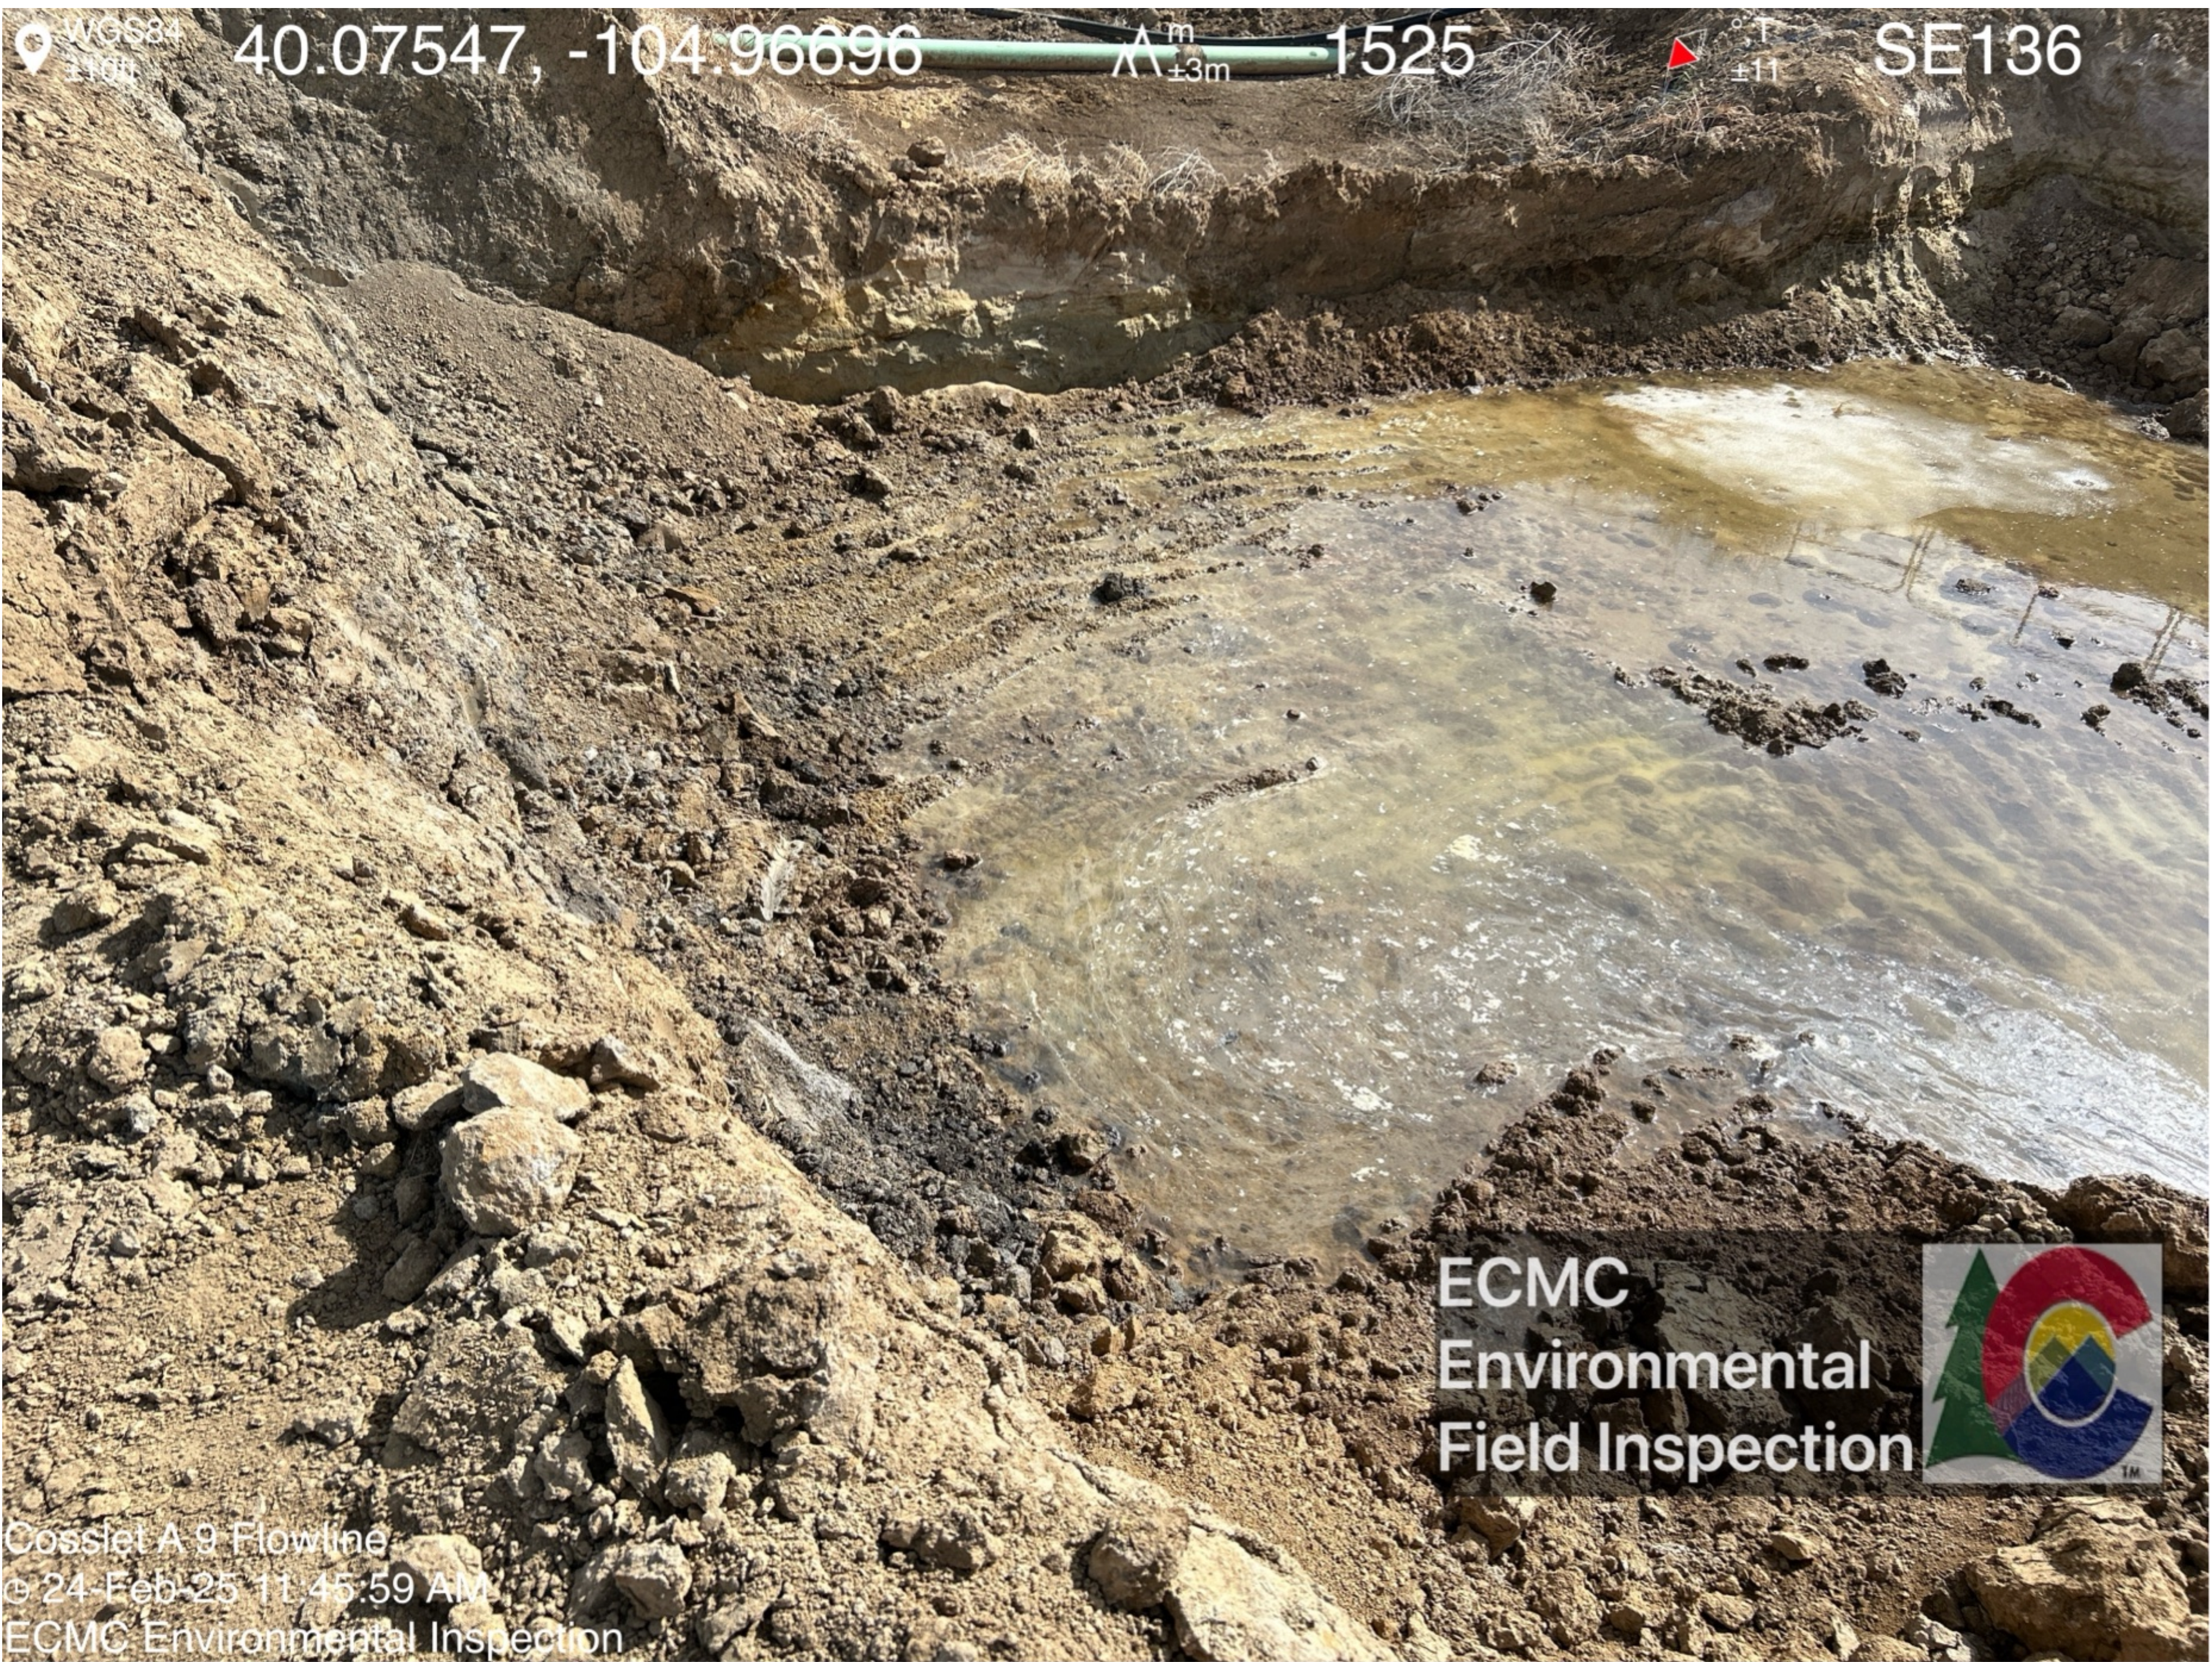
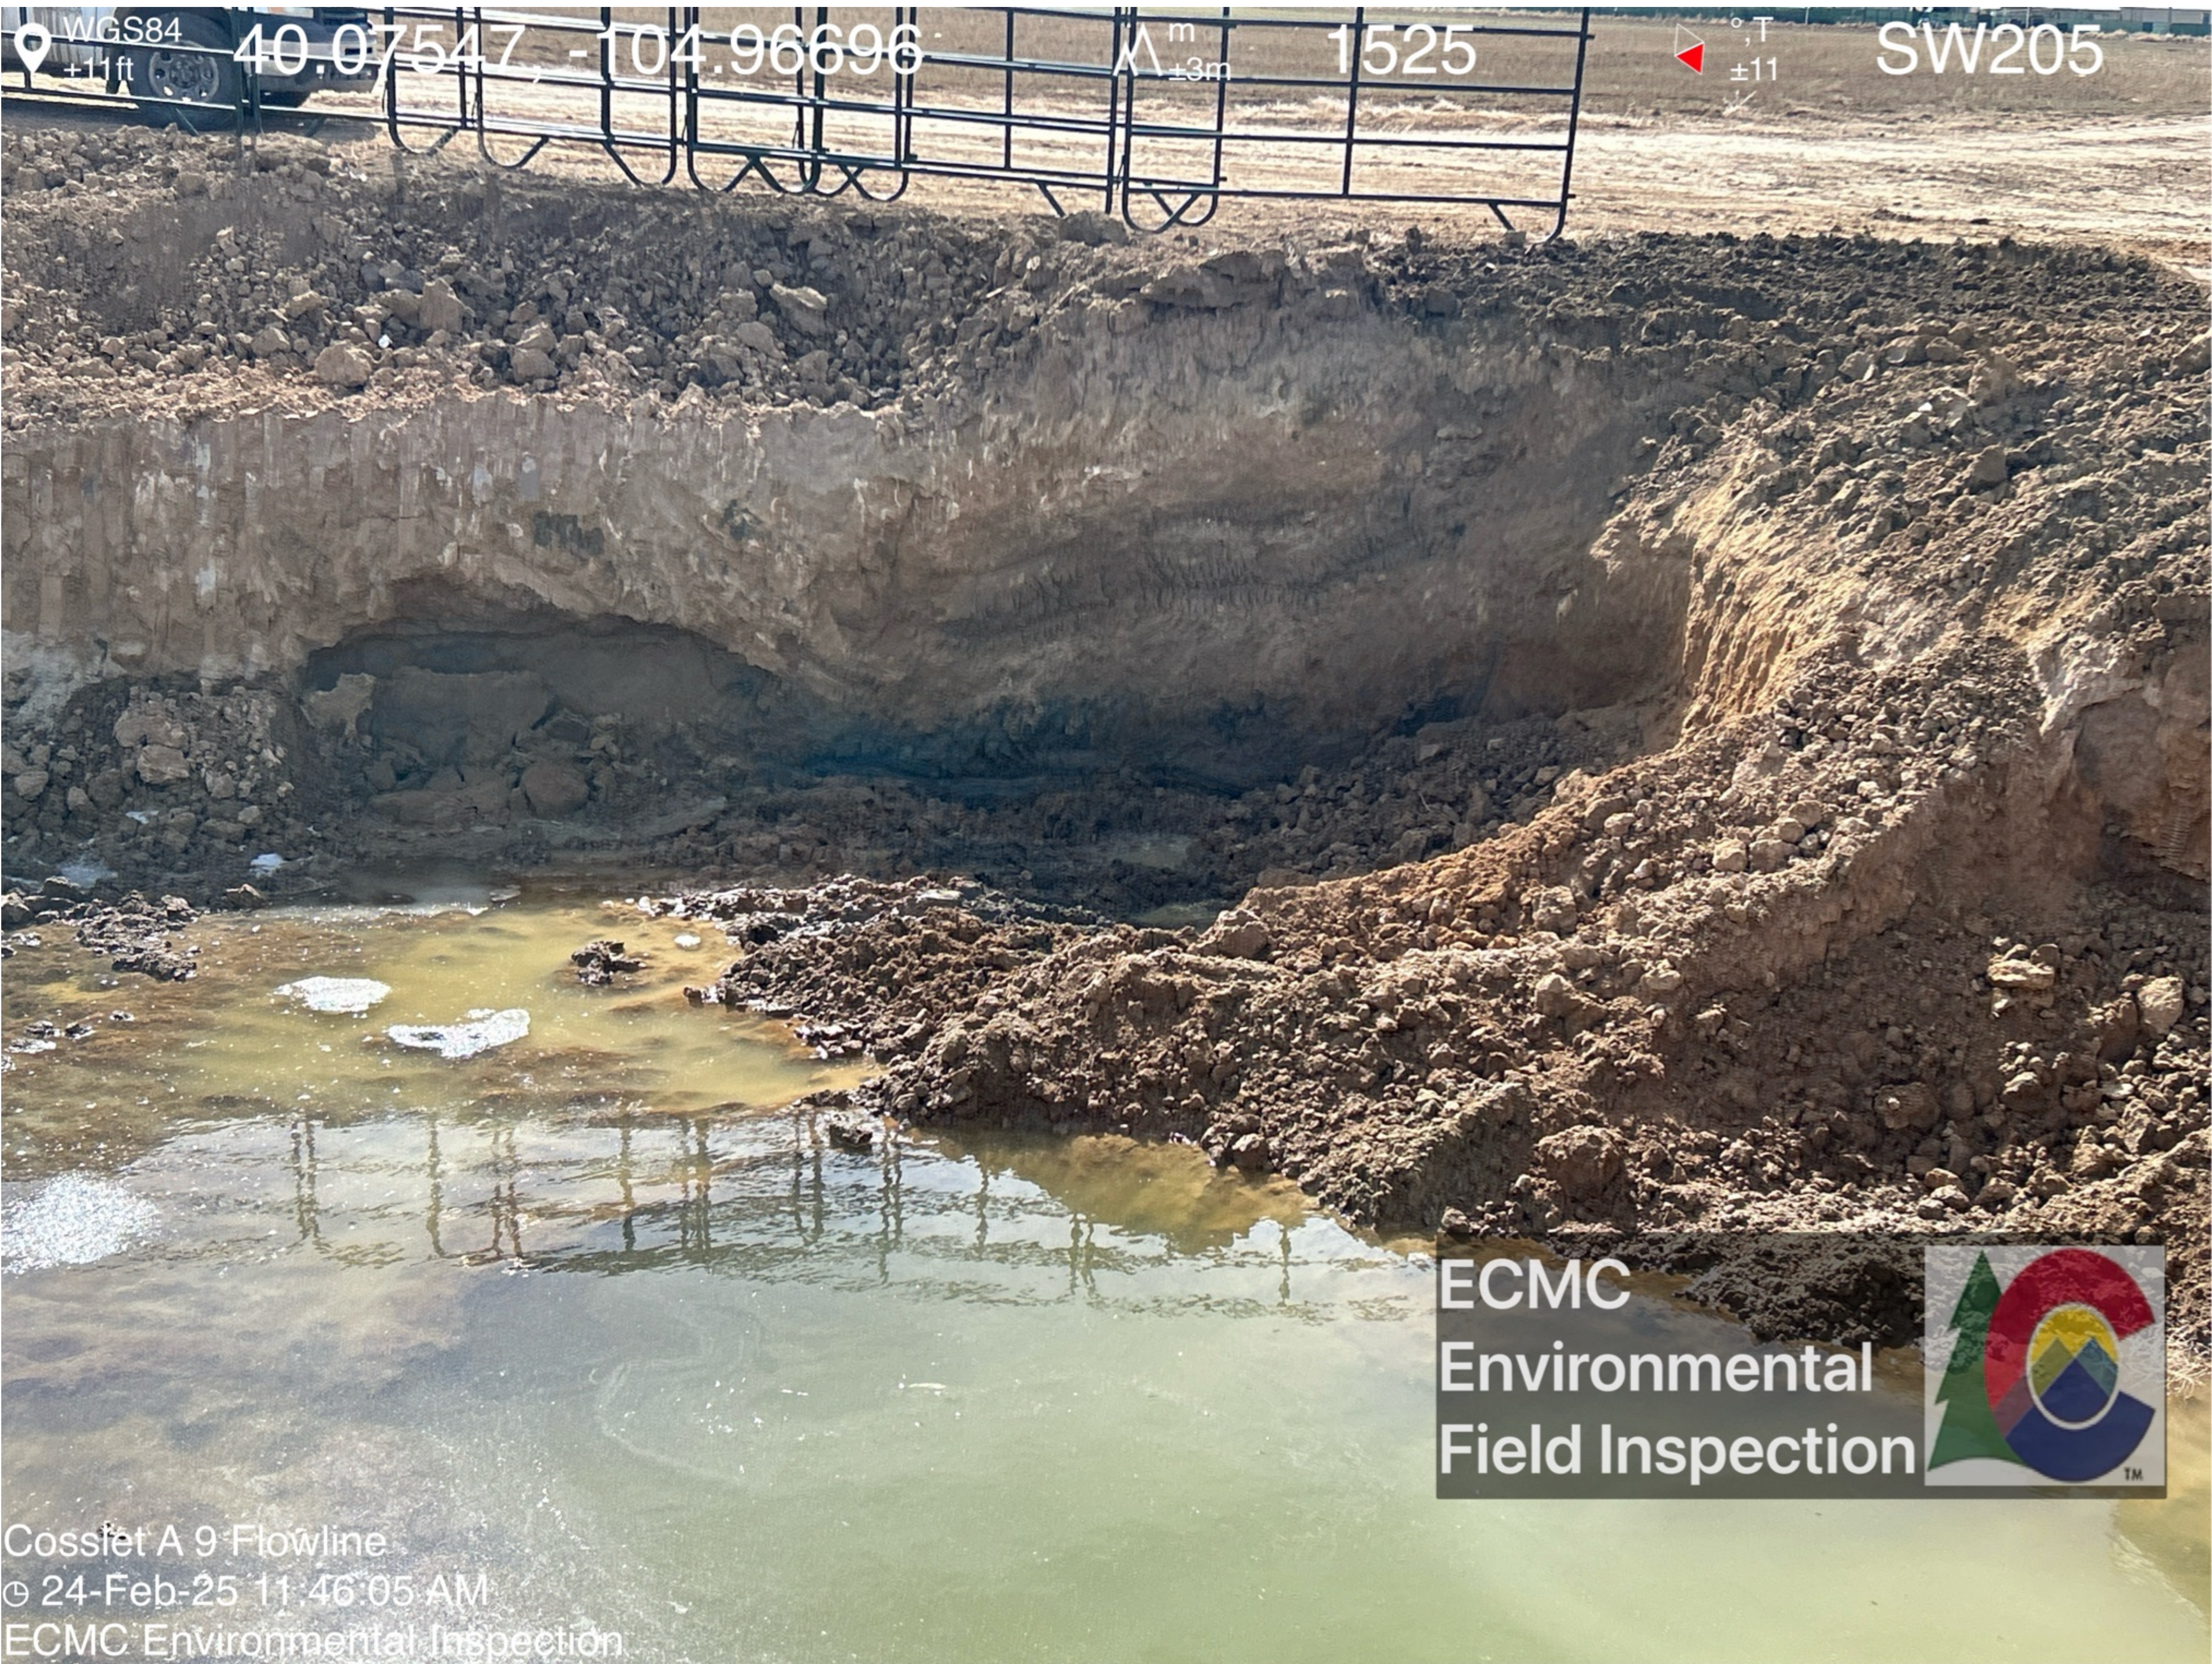
Gray and black petroleum hydrocarbon staining is visible in situ.
