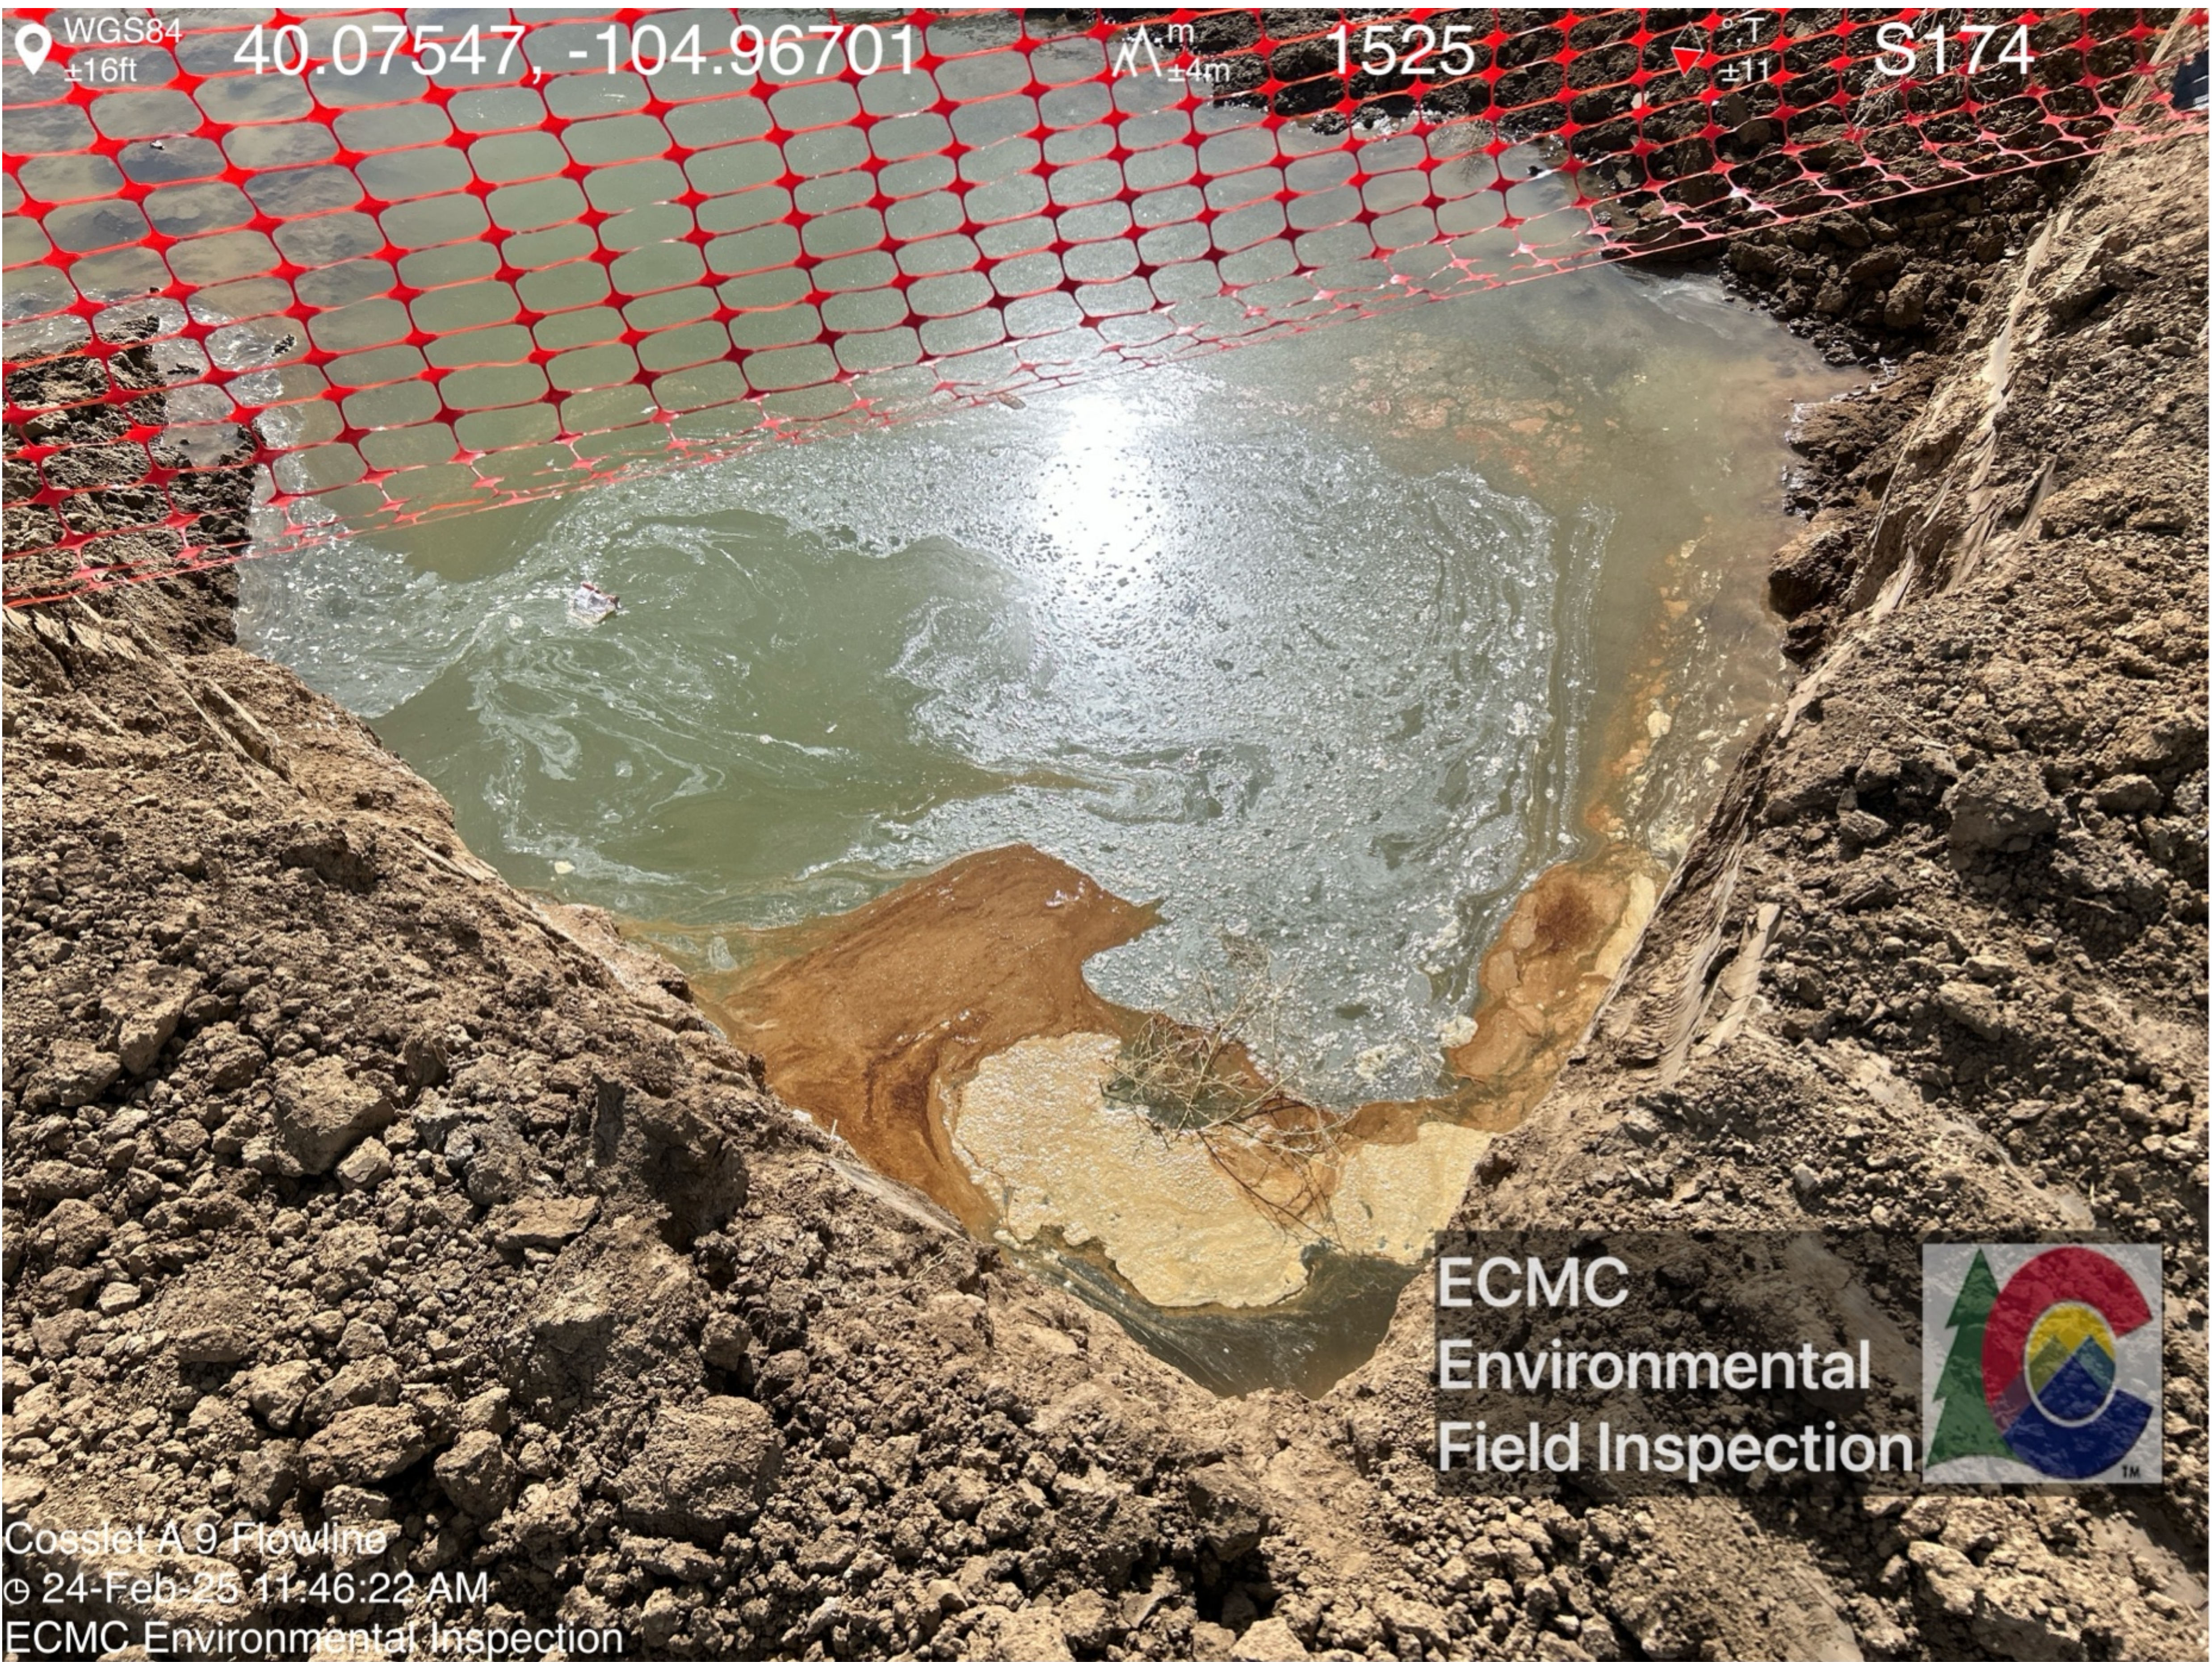
Free product is visible on groundwater. Orange construction fencing does not fully encompass the perimeter of the excavation.

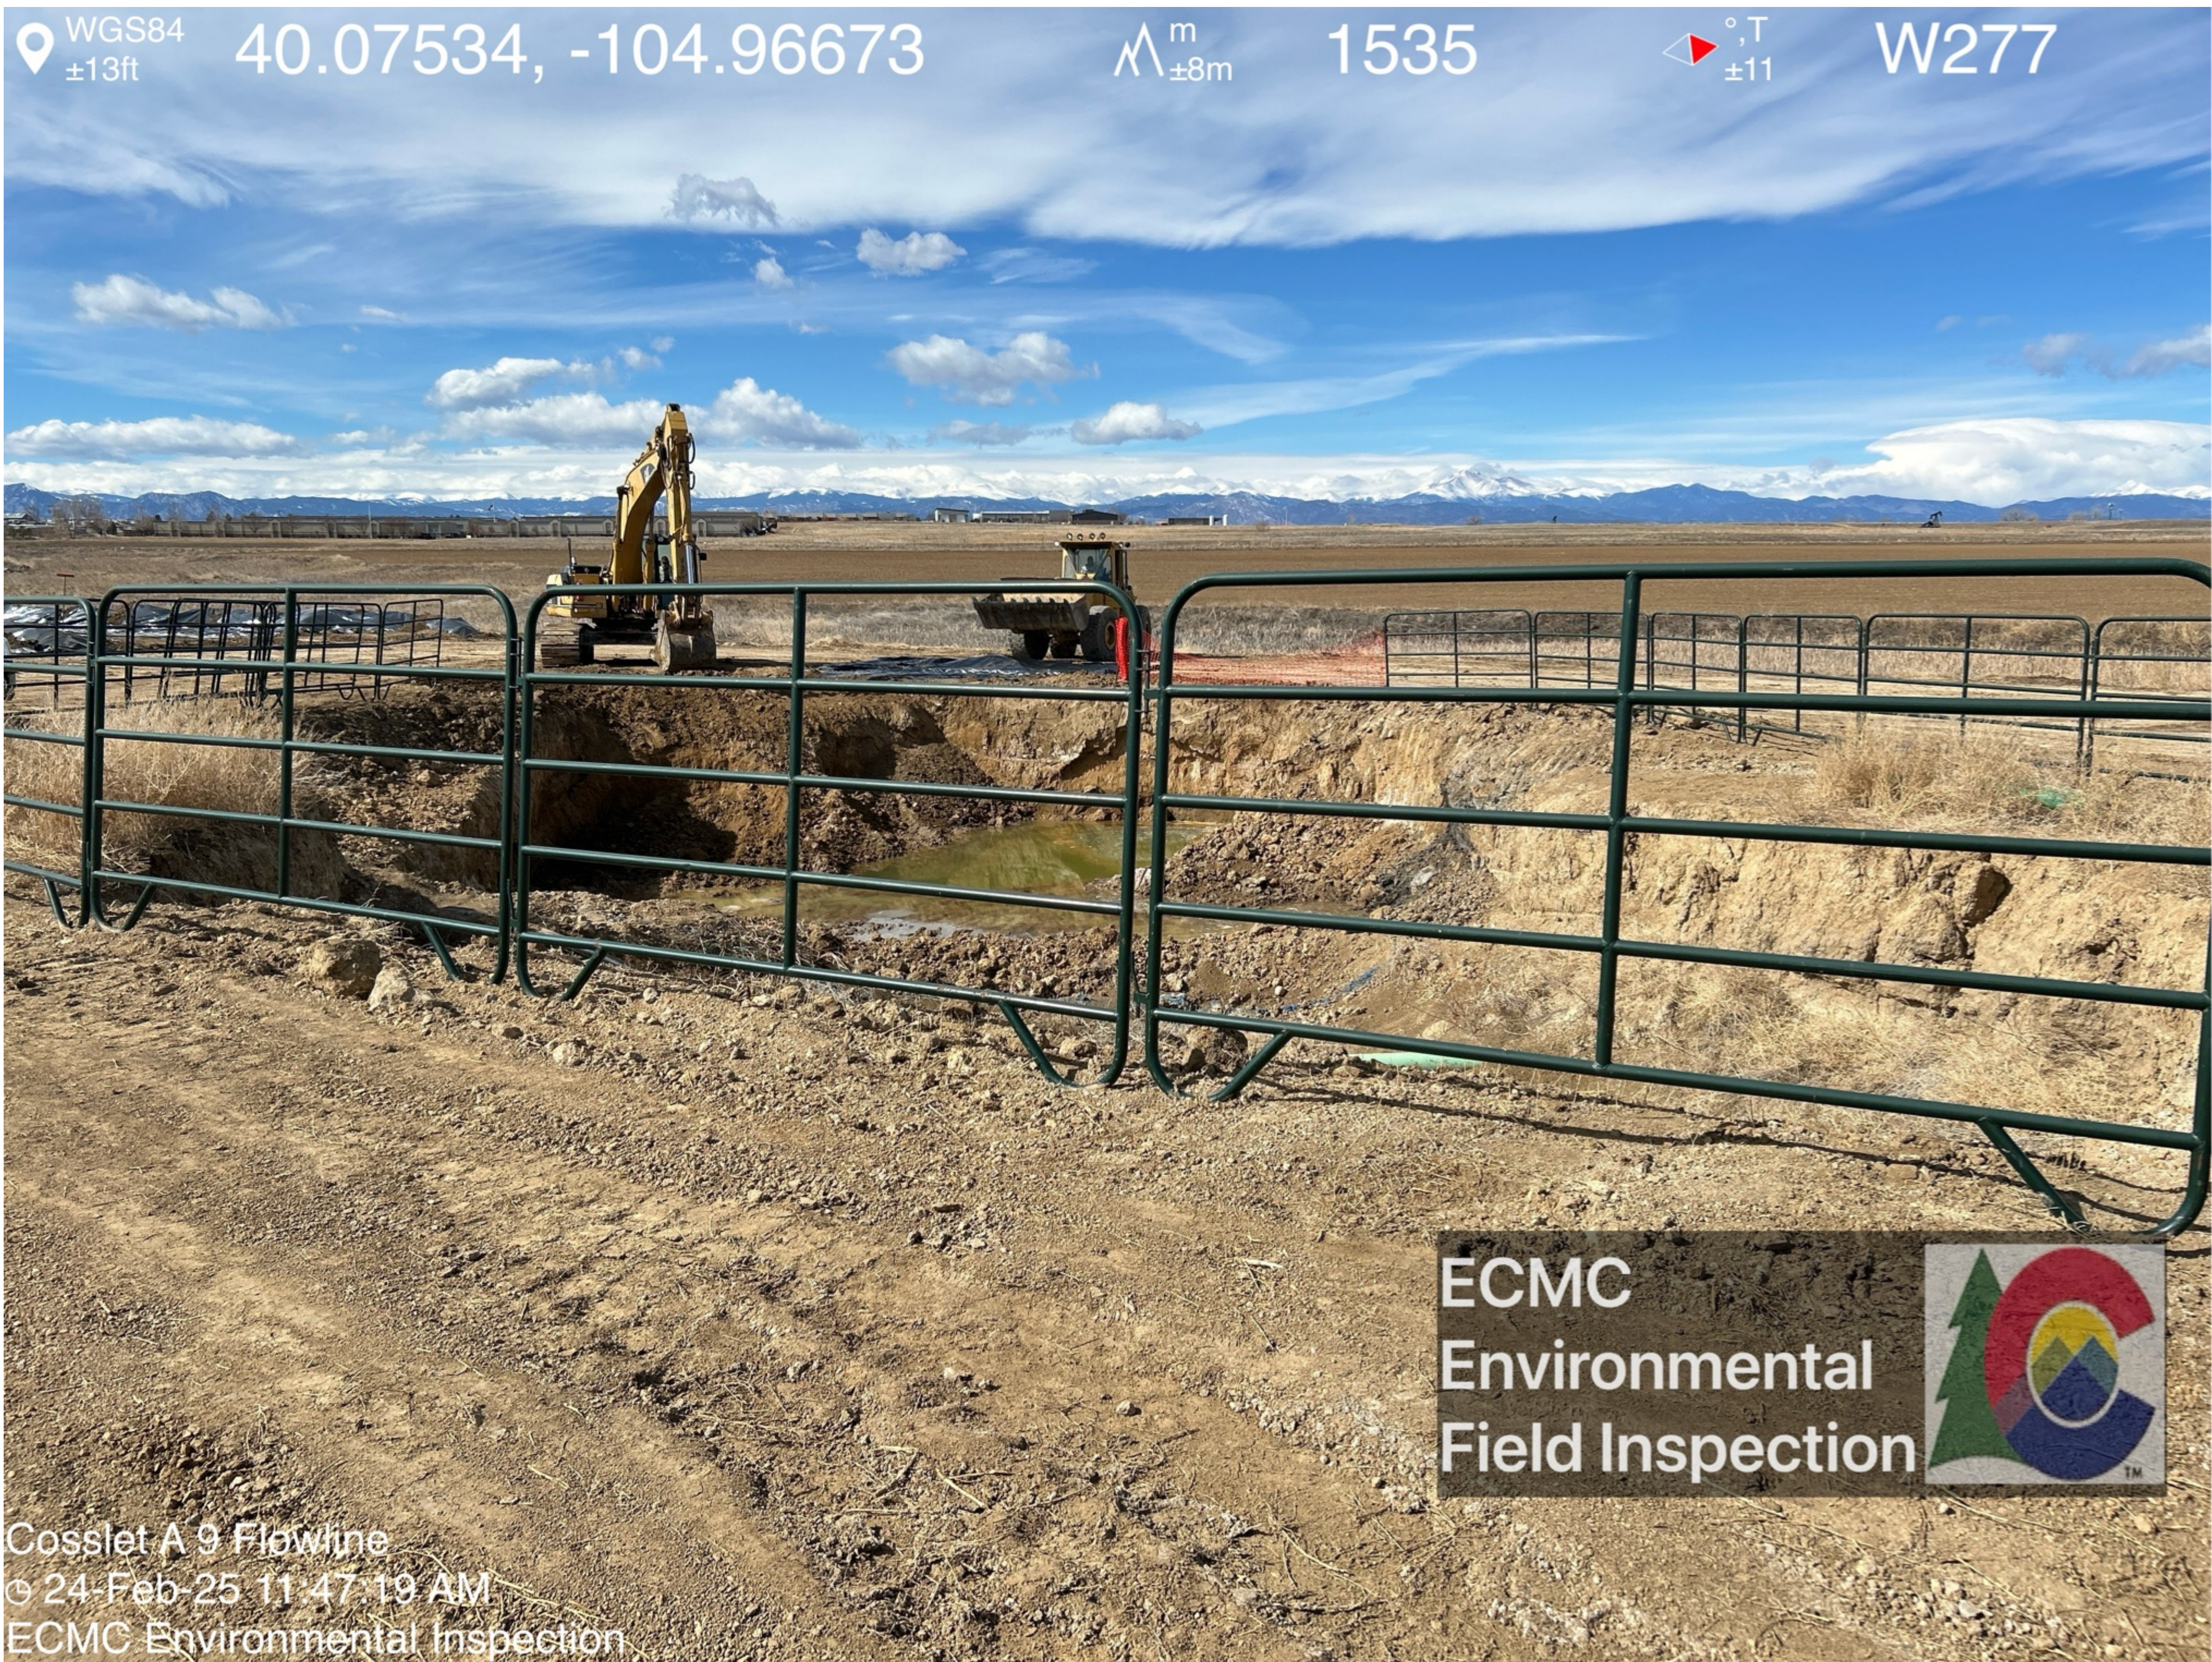
Metal fencing has been installed around portions of the excavation.
