Inspection Photos

API: 011-05055

Loc: 321208

Operator: RENEGADE OIL & GAS COMPANY LLC

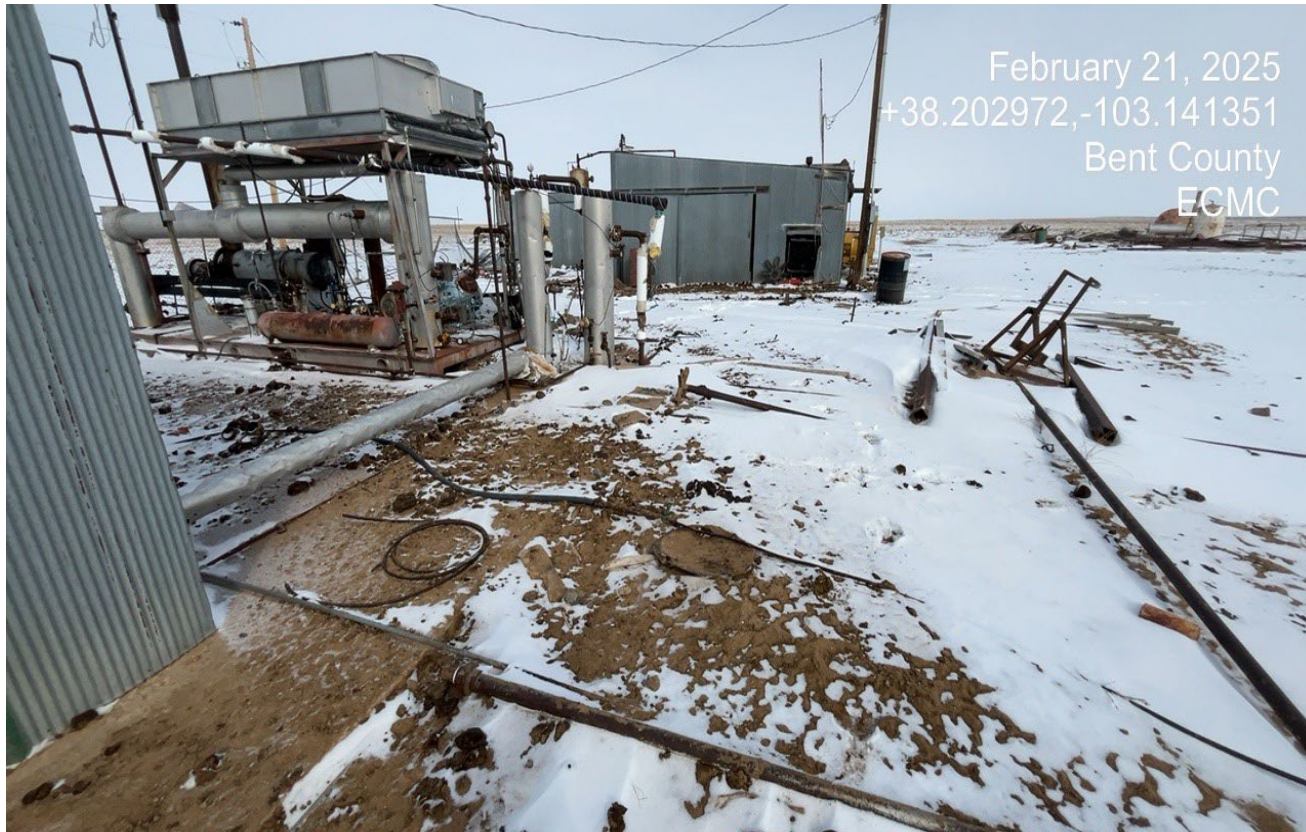
Photo 2. Facing northwest toward the GAS PROCESSING PLANT and Wellsite. There is various supplies and debris scattered throughout the location.

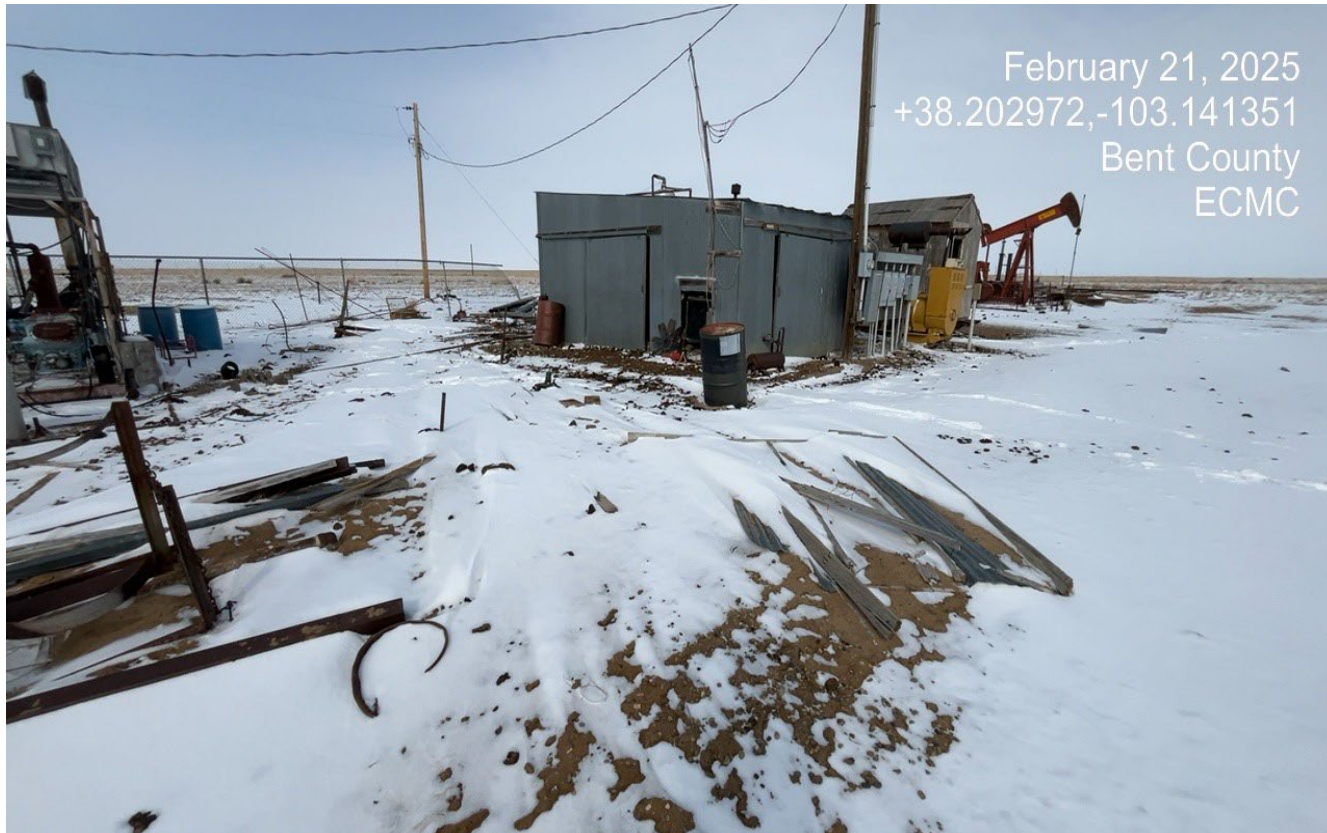
Photo 3. Facing northwest at the sheds and various equipment which are in disrepair. There is chemical barrels with no containment and various debris laying on the ground.

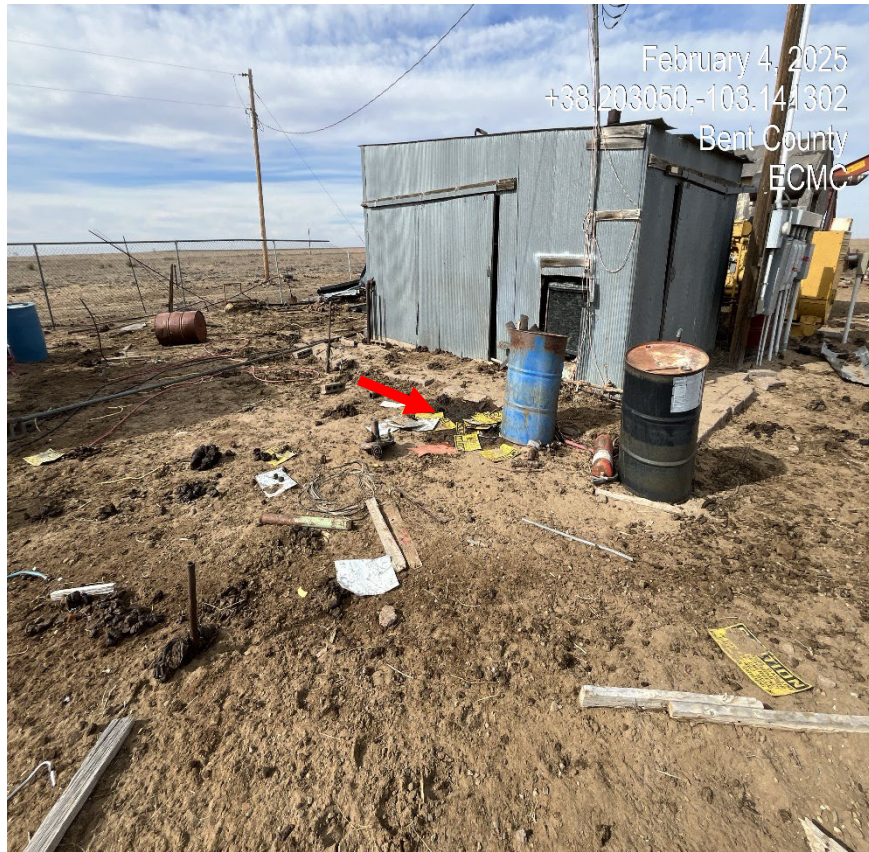
Photo 4. Previous inspection observed the blue barrel had leaked out oily fluid onto the ground.

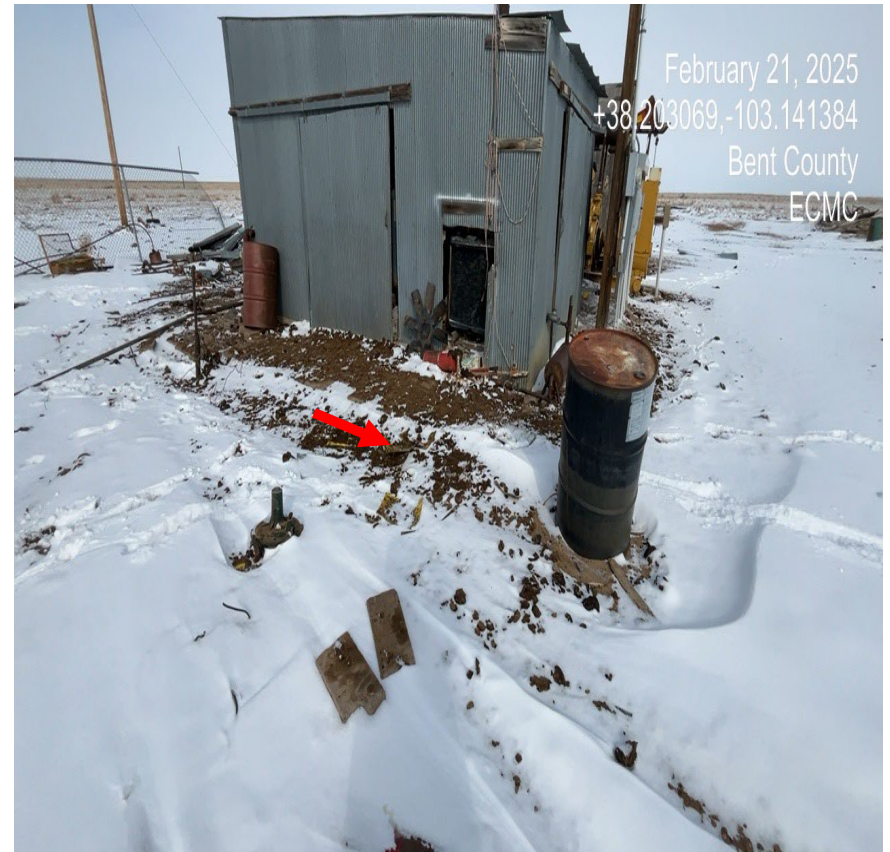
Photo 5. The blue barrel was removed however the oil stained soils still remain.

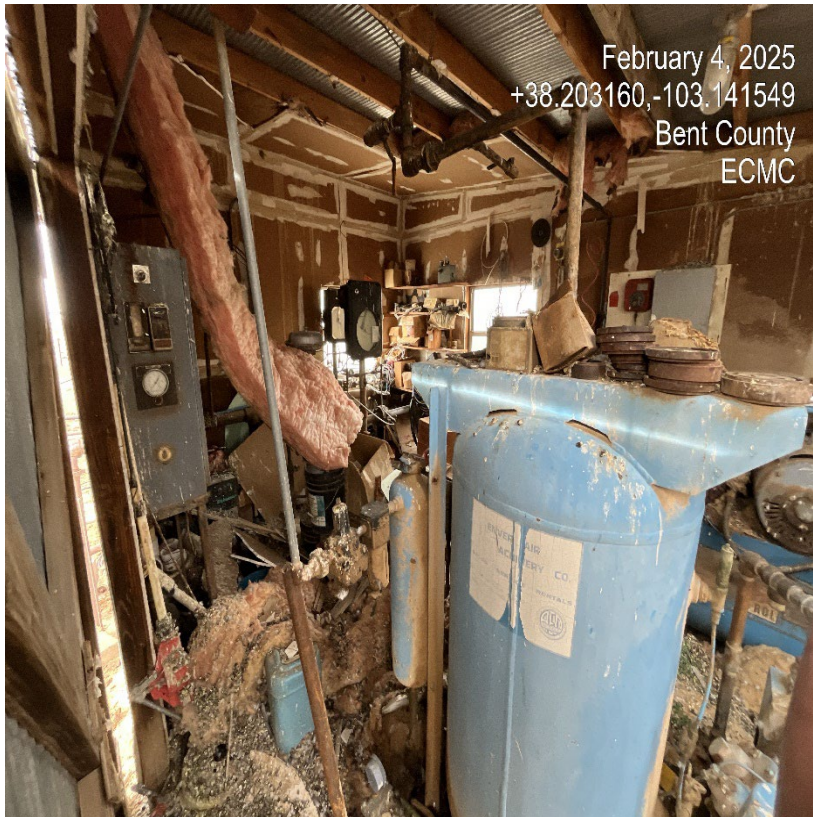
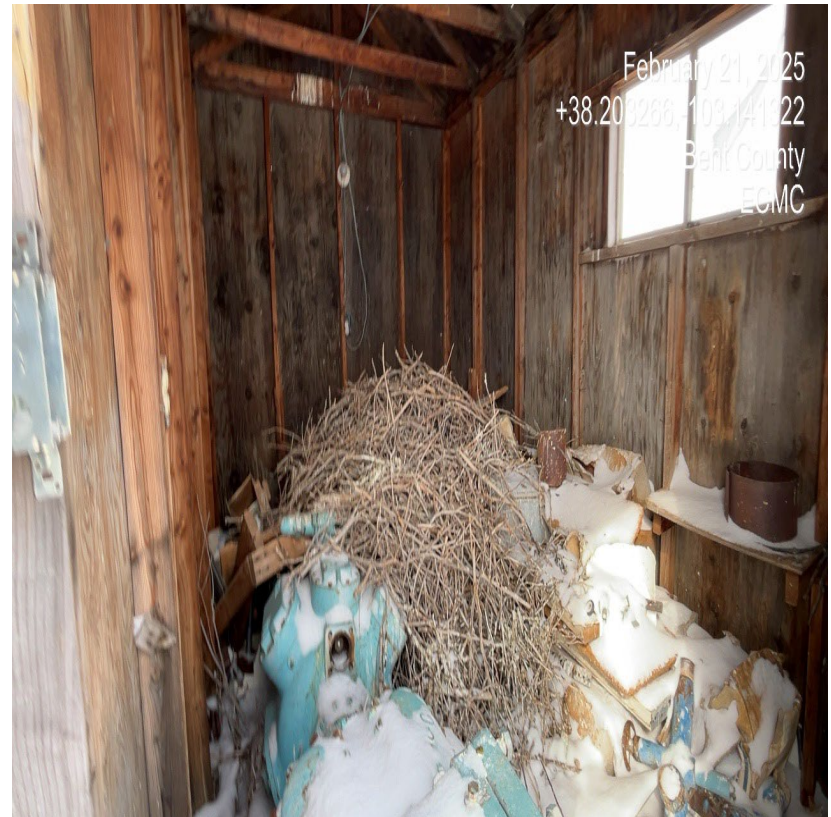
Photo 6&7. There are sheds in disrepair with large bird nests. Operator will need to consult with USFS and CPW regarding time restrictions and relocation of any migratory bird nests.

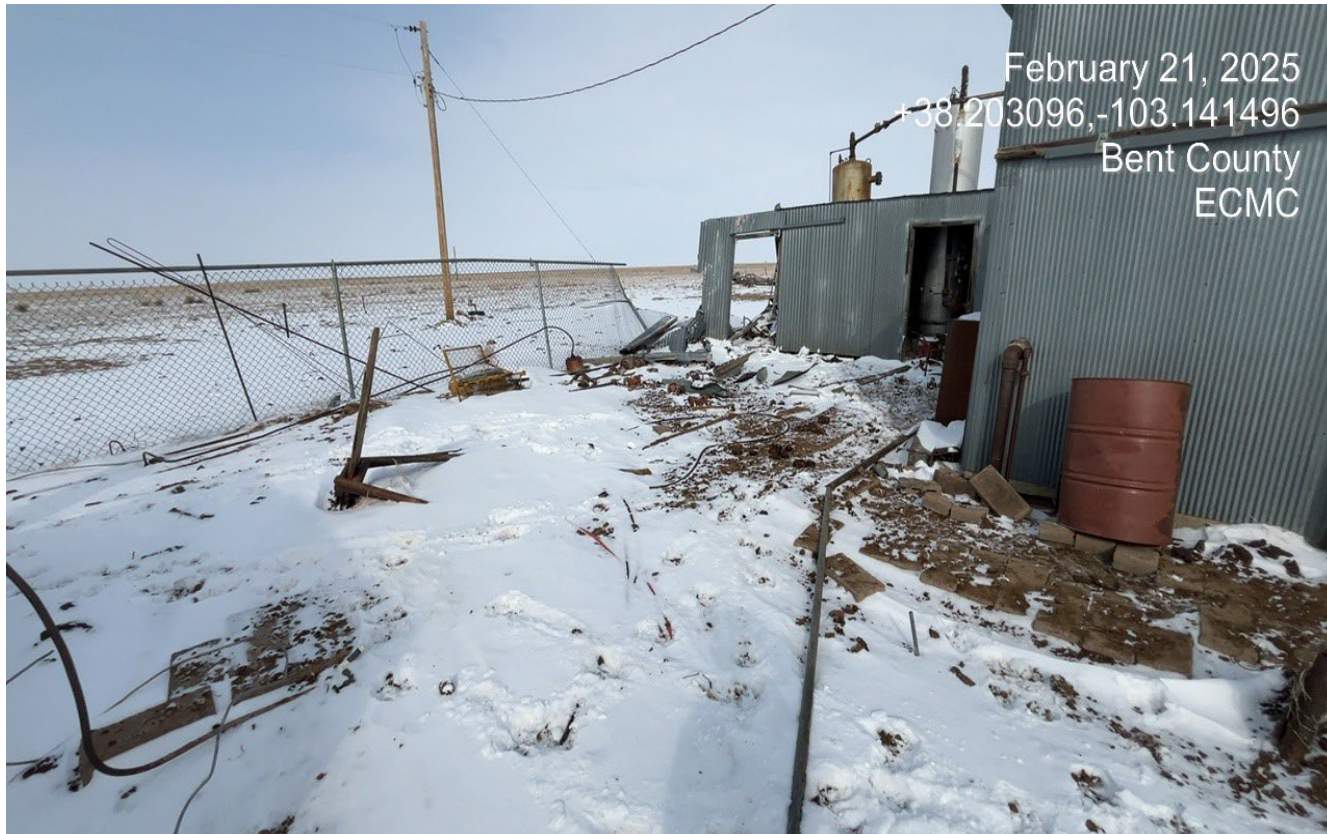
Photo 8. Facing northwest at the sheds and equipment which are in disrepair. There are cattle tracks in the snow which the debris could cause injury to the livestock.

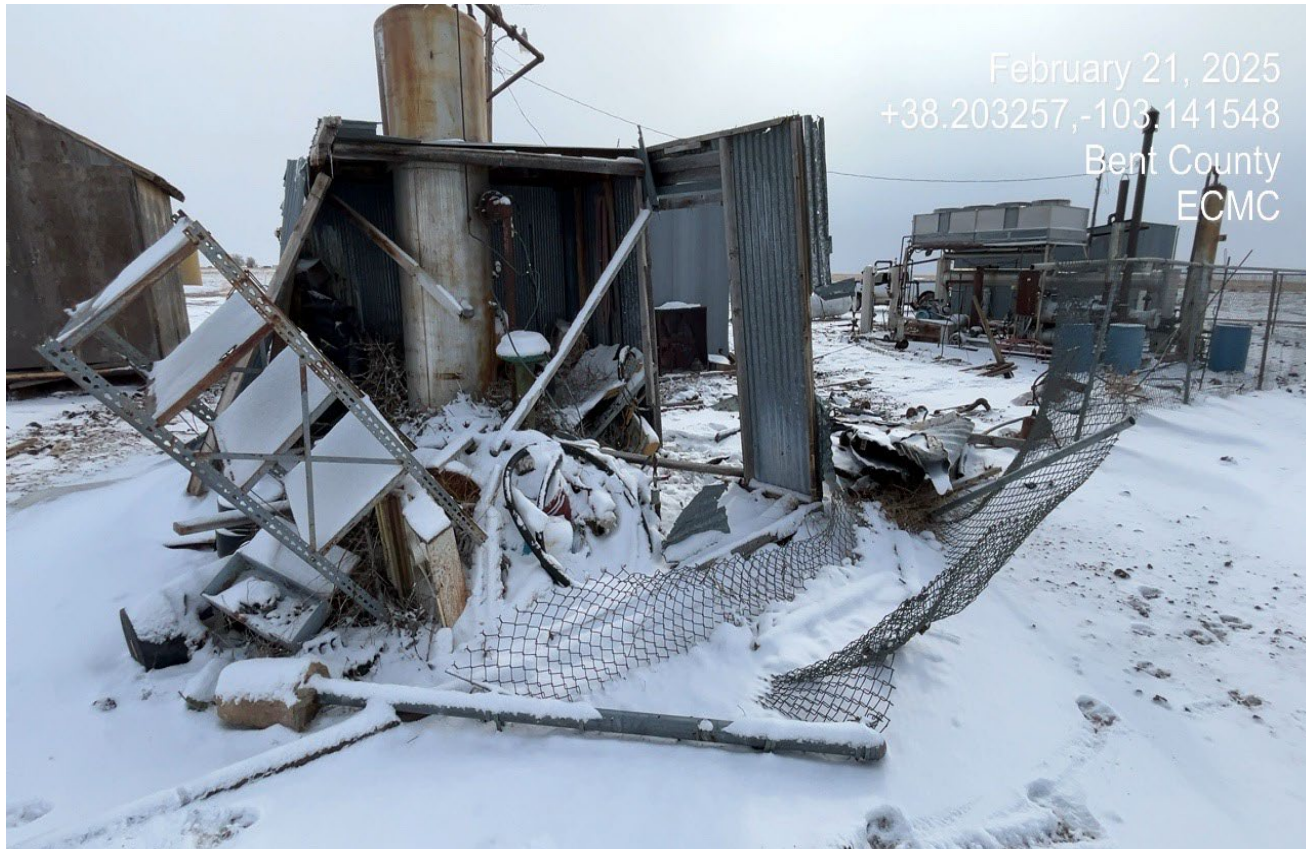
Photo 9. Facing southeast at the west side of the location. This shed and fence are in disrepair with supplies have fallen out of the dilapidated shed.

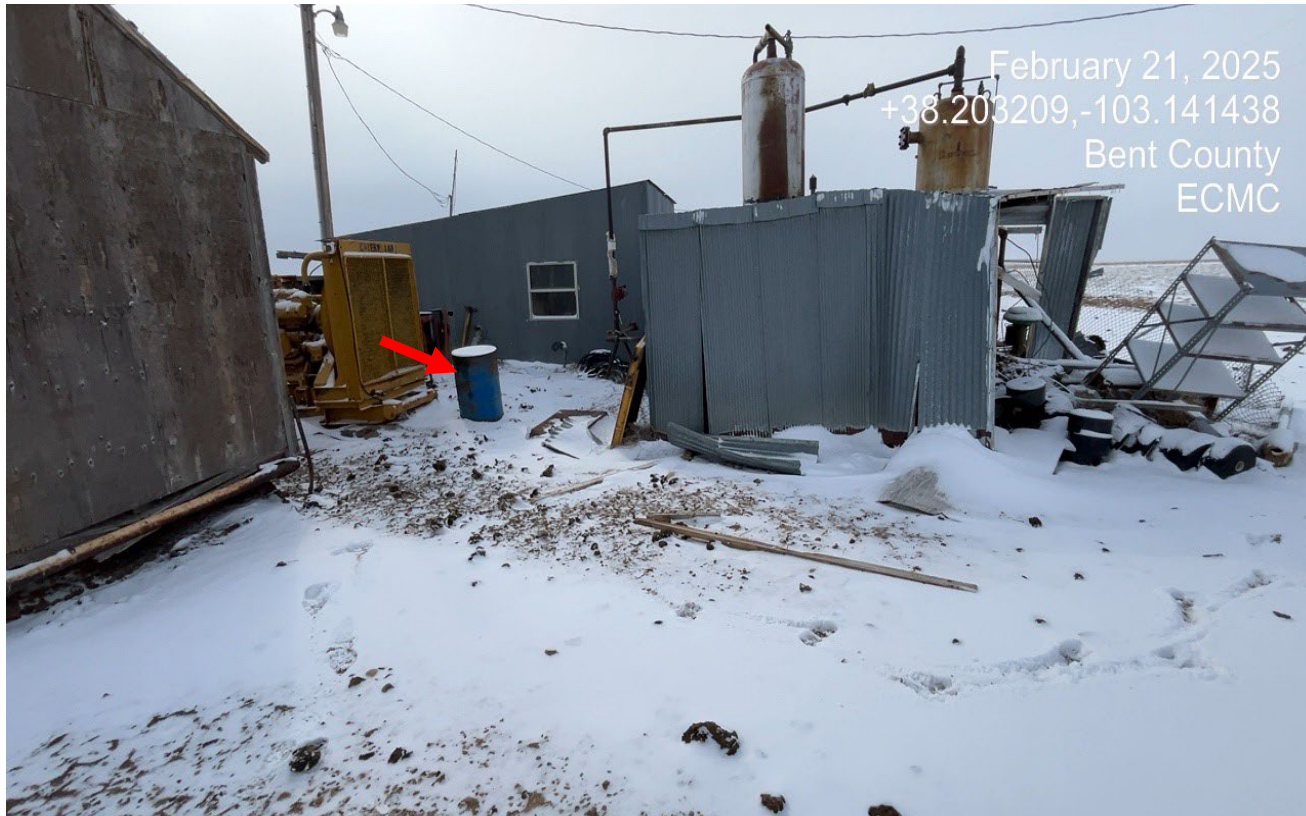
Photo 10. There is panels, boards, and a blue barrel laying on the ground which has leaked out fluids onto the ground.

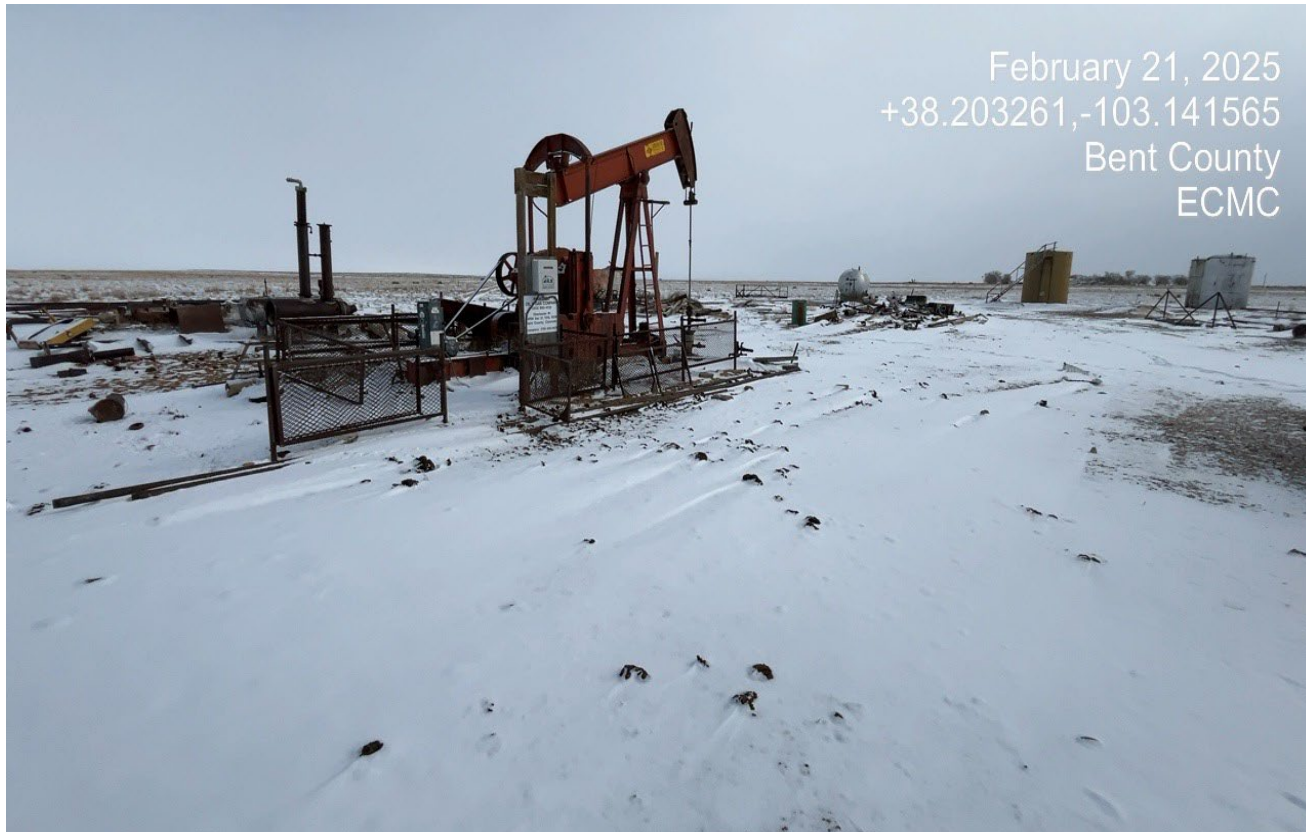
Photo 11. Facing northeast toward the well. The fence around the pumpjack is in disrepair and there is unused equipment stored near the well.

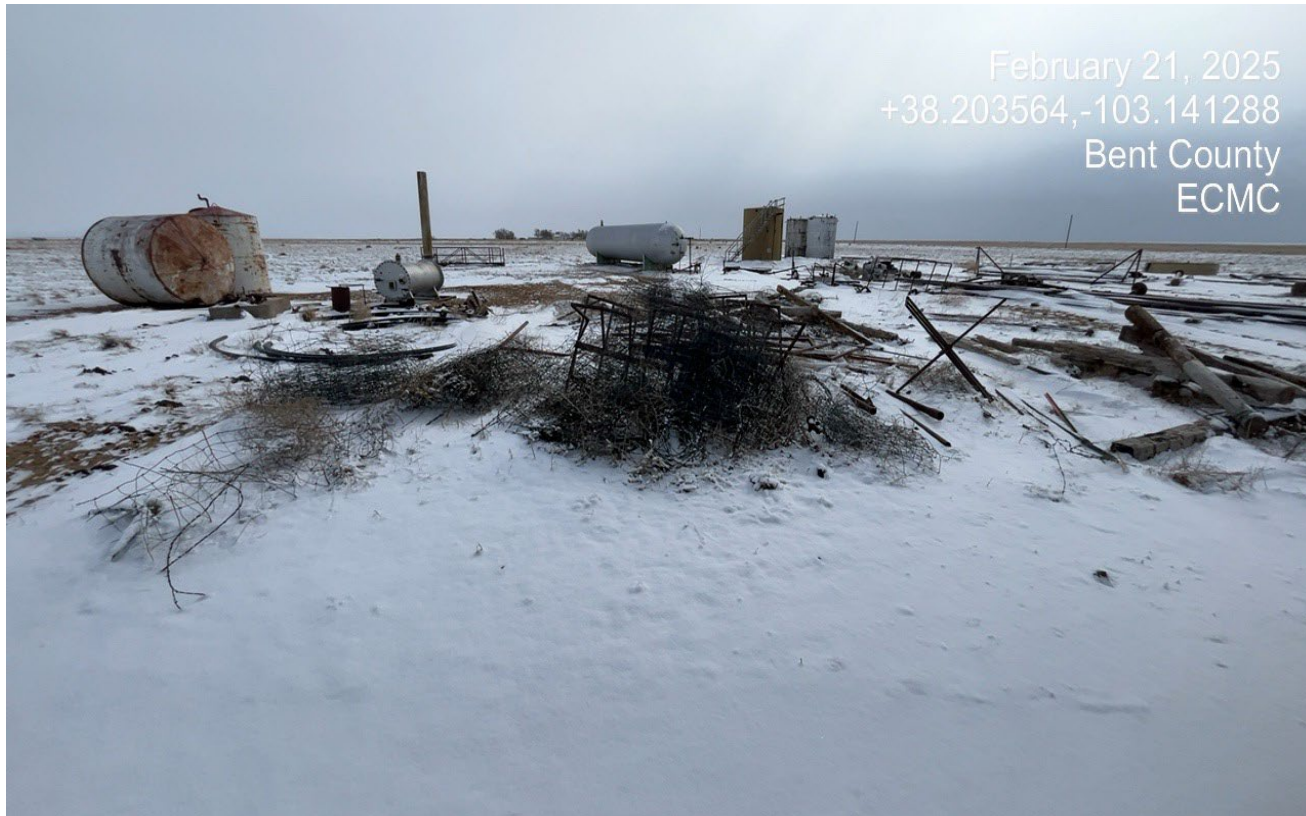
Photo 12. Facing southeast at the location. There are various unused equipment, wire, and debris stored on location that needs to be removed.

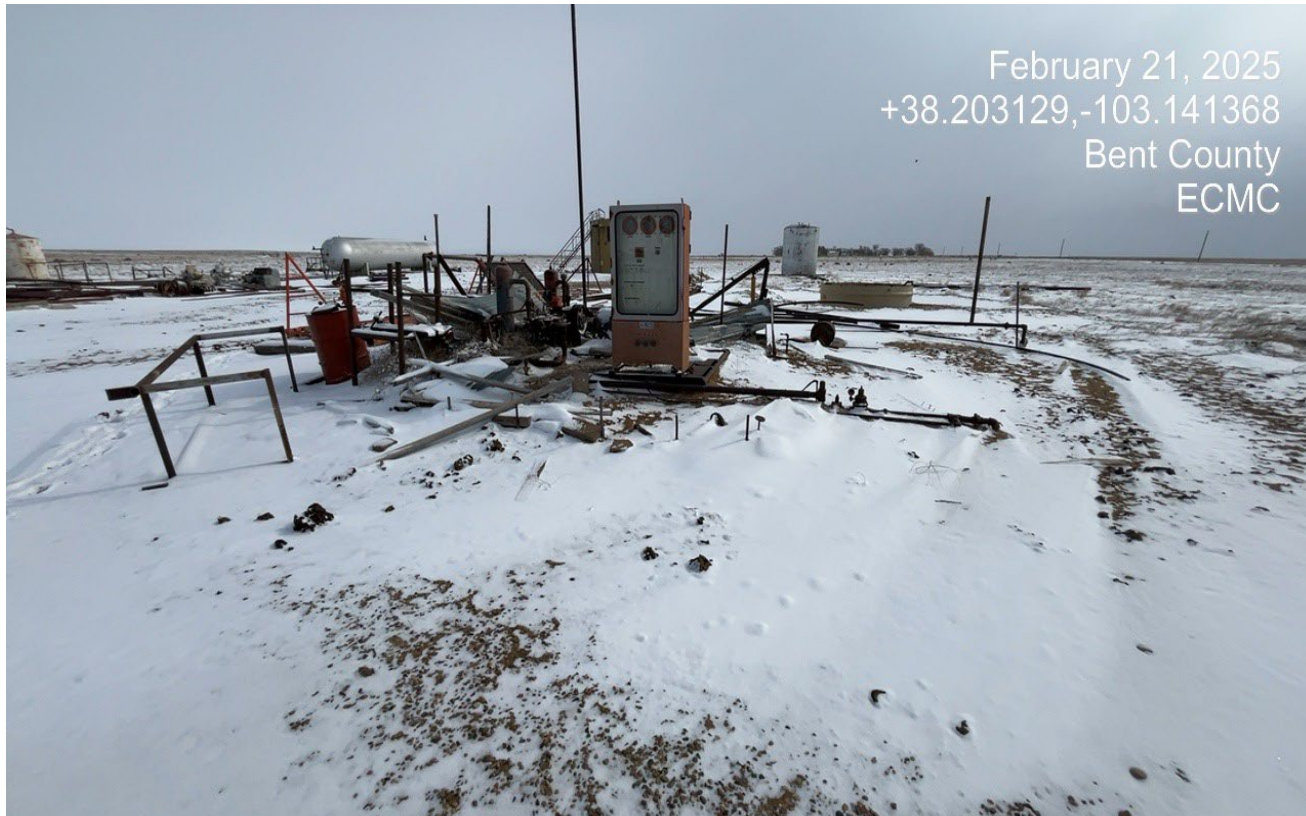
Photo 13. Facing northeast at the location. There is various unused equipment, supplies and tanks stored at the location that will need to be removed.

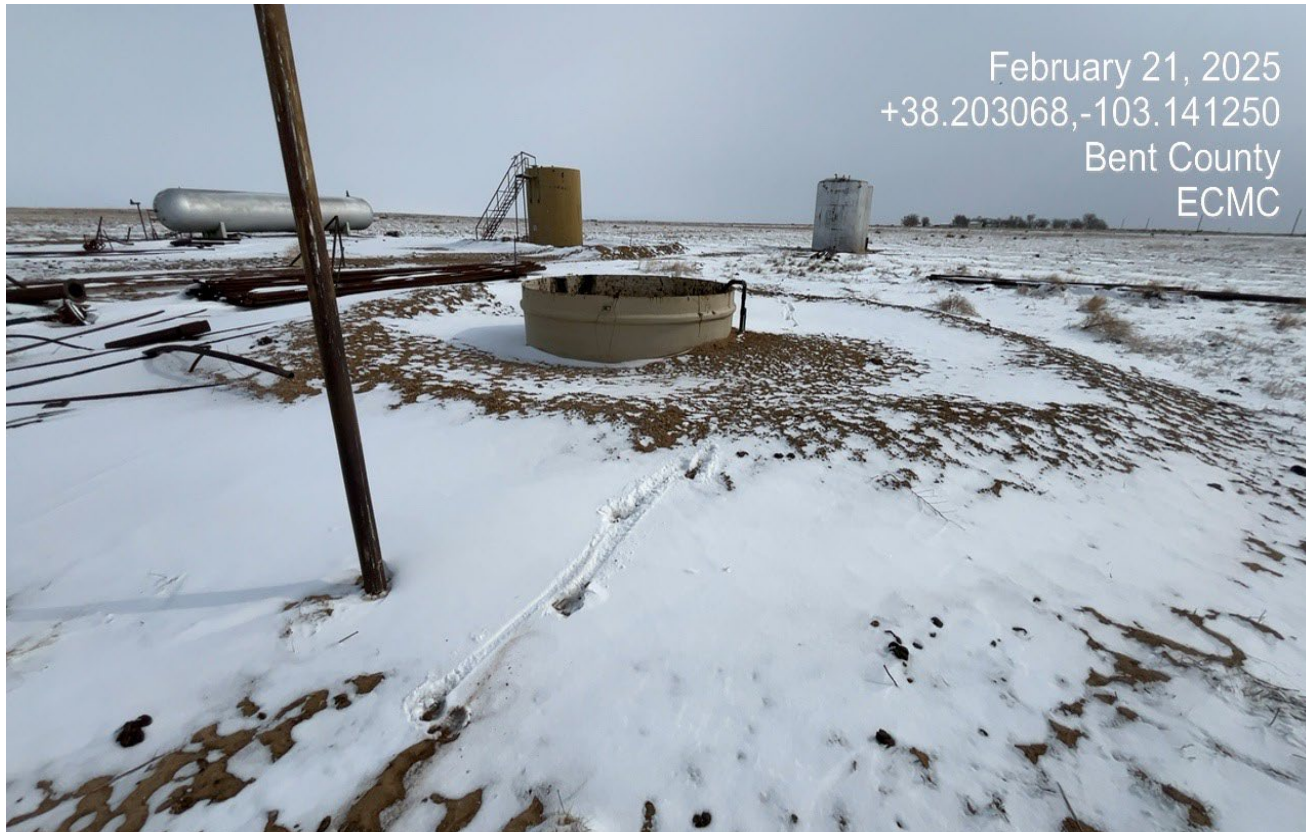
Photo 14. Facing east at the south side of the location. This open top tank remains with oily fluids and a cattle track in the snow goes right up to the tank.

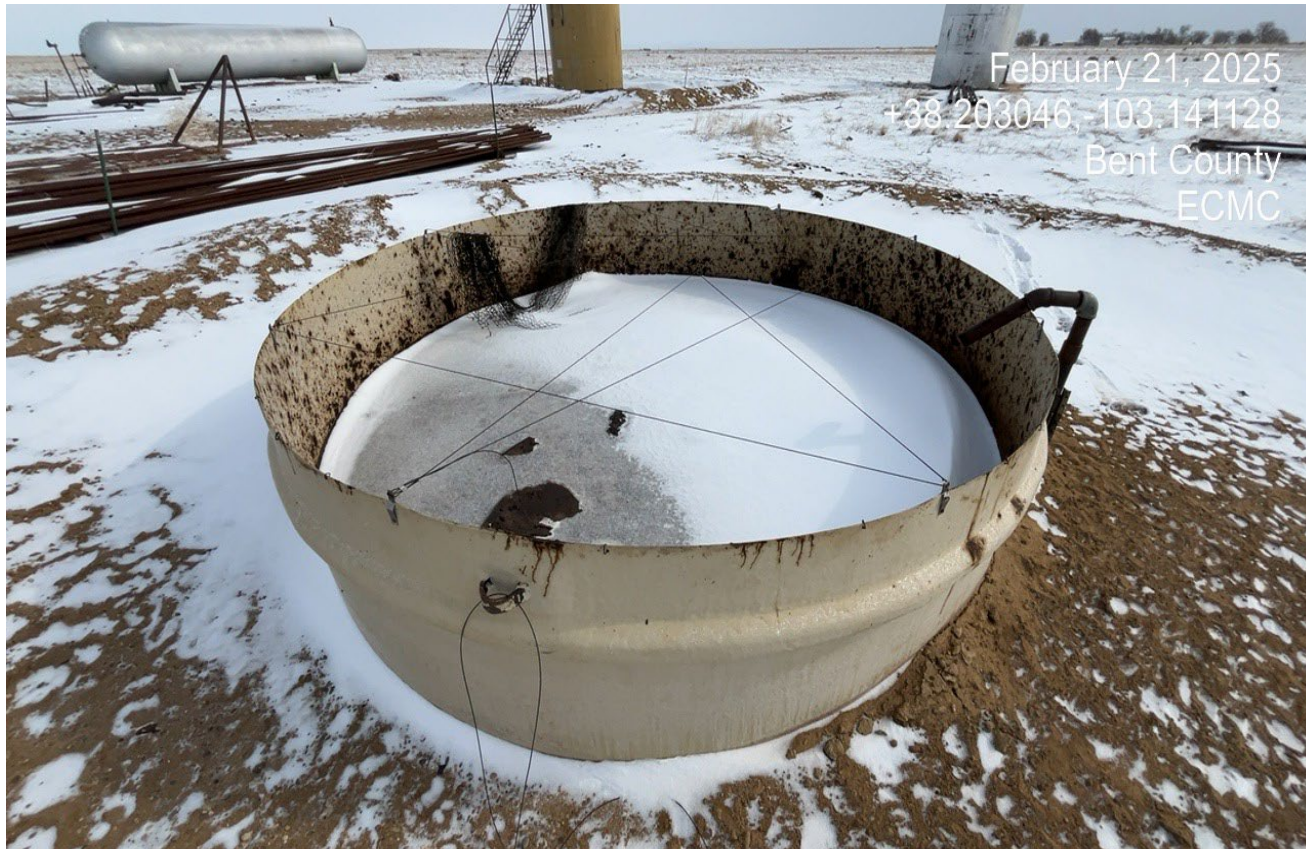
Photo 15. Facing toward the open top tank which has oil condensate inside the tank with no wildlife or livestock protections. The liquids were frozen at the time of inspection. Operator ignored the previous notification and corrective action.

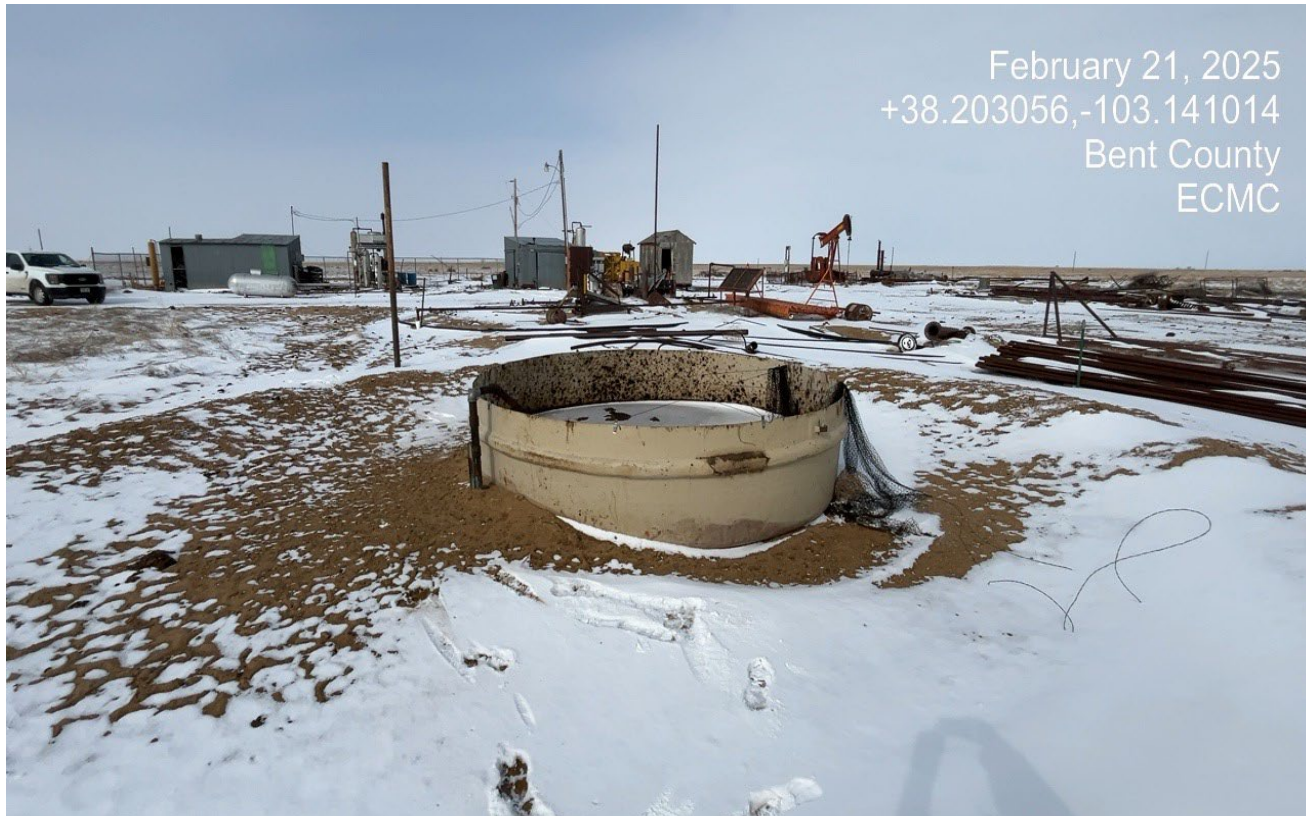
Photo 16. Facing northwest at the south side of the location. There is an open top fiberglass condensate tank with no wildlife or livestock protections. There are cattle tracks all around the tank indicating that cattle could be drinking out of this tank.

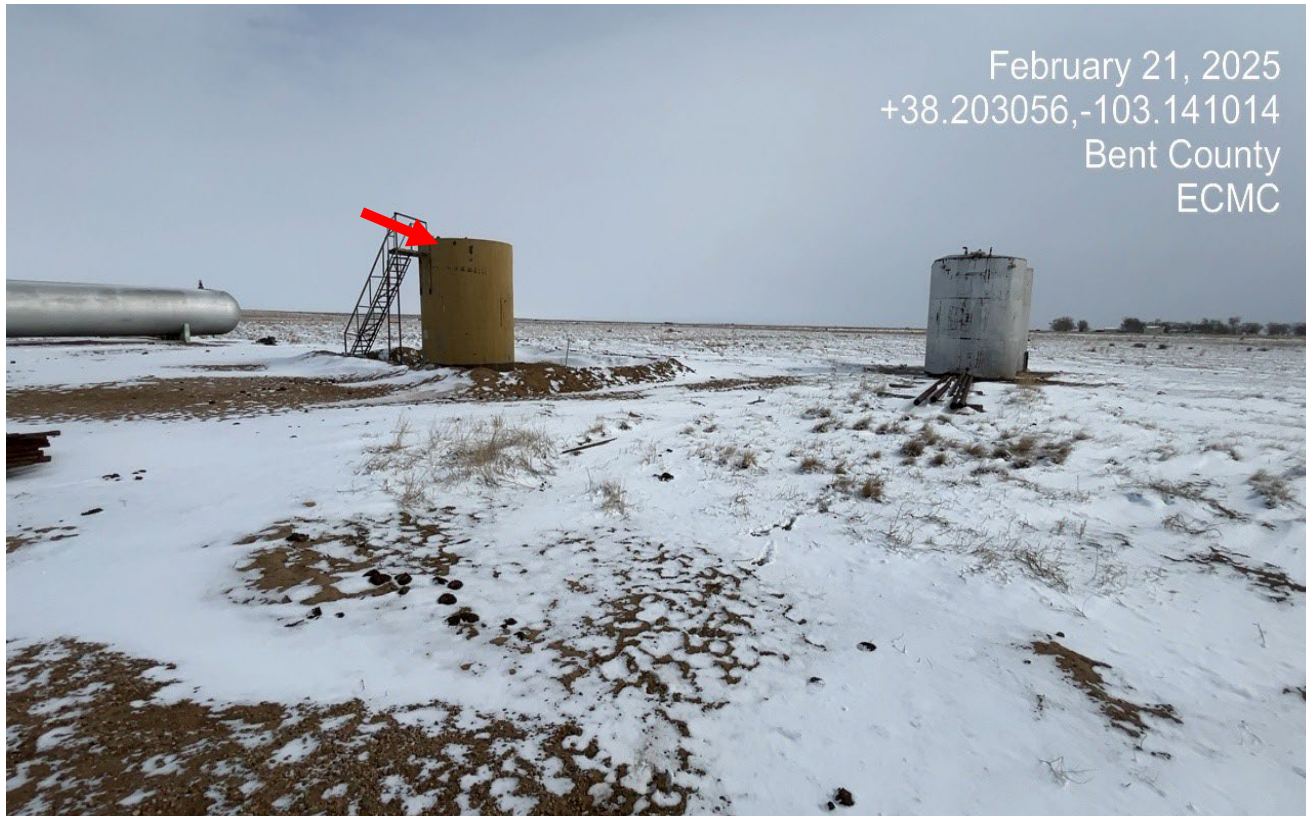
Photo 17. Facing northeast at the location. The tank at red arrow was recently installed since the 8/7/24 inspection.
