Inspection Photos

Operator: Hilcorp Energy Company - 10133

Location ID: 306987

Inspection Document #: 714001872

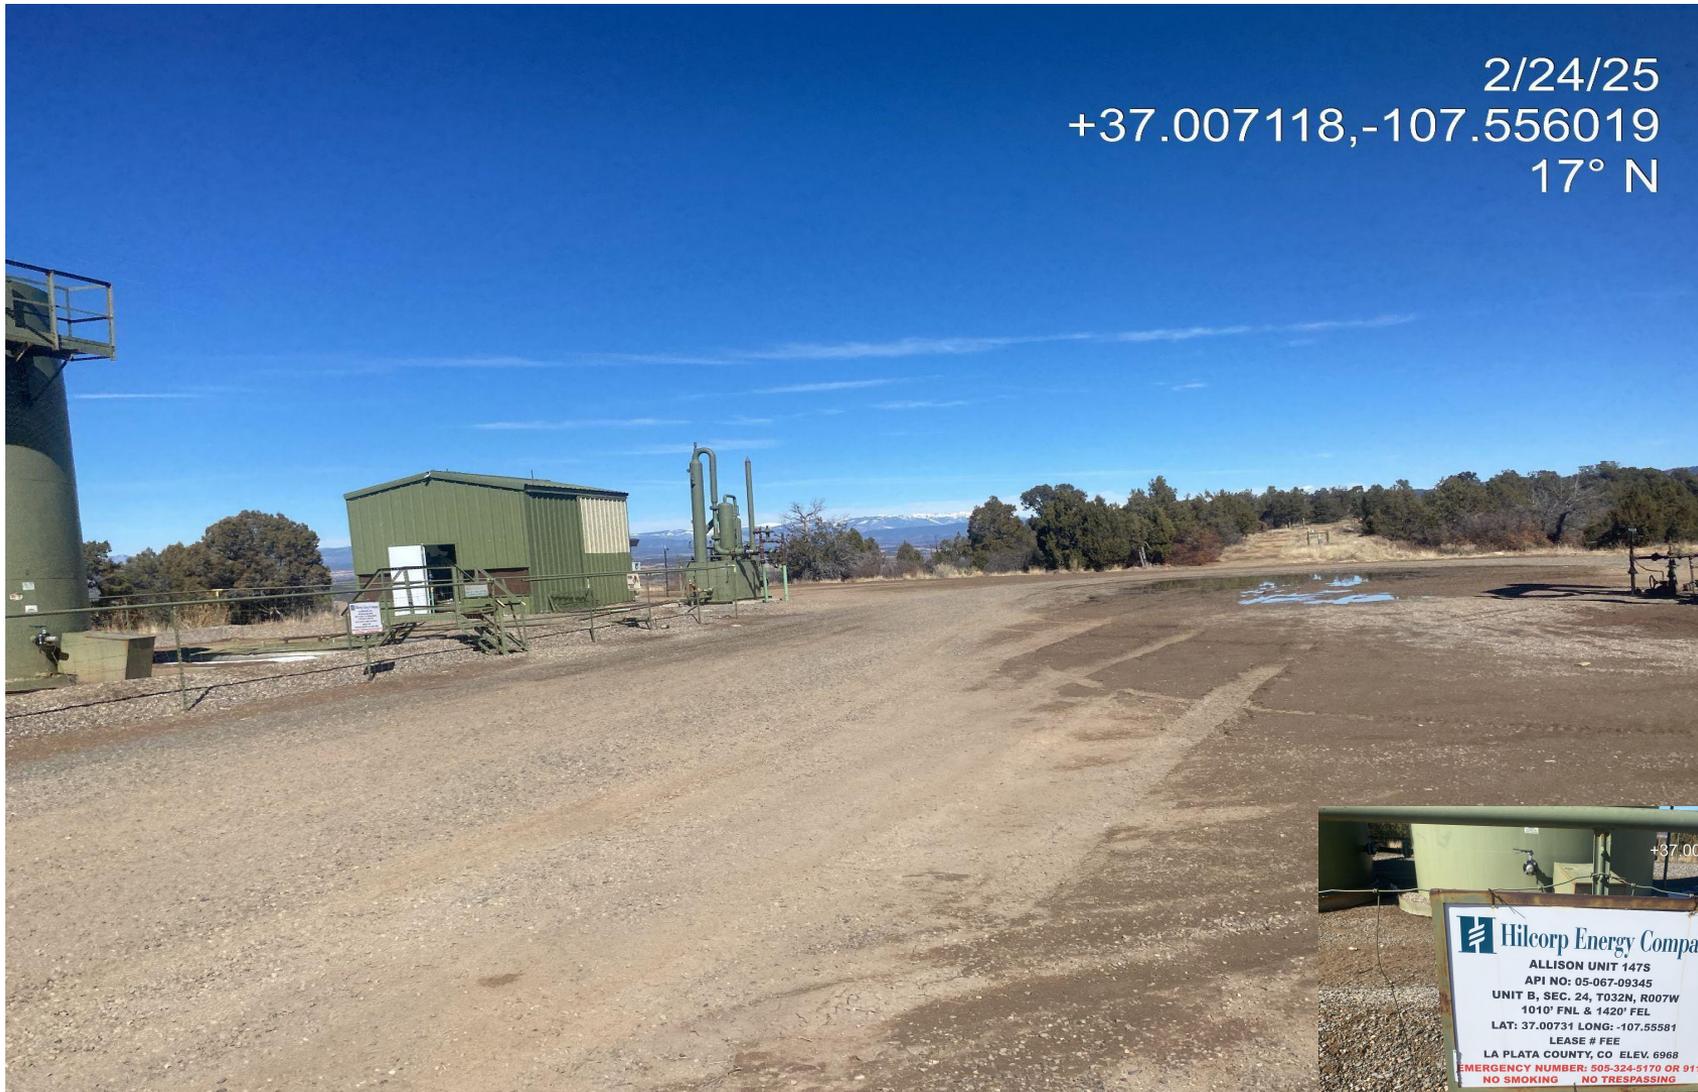
Photo 1. View of the well pad taken from the access point facing center.

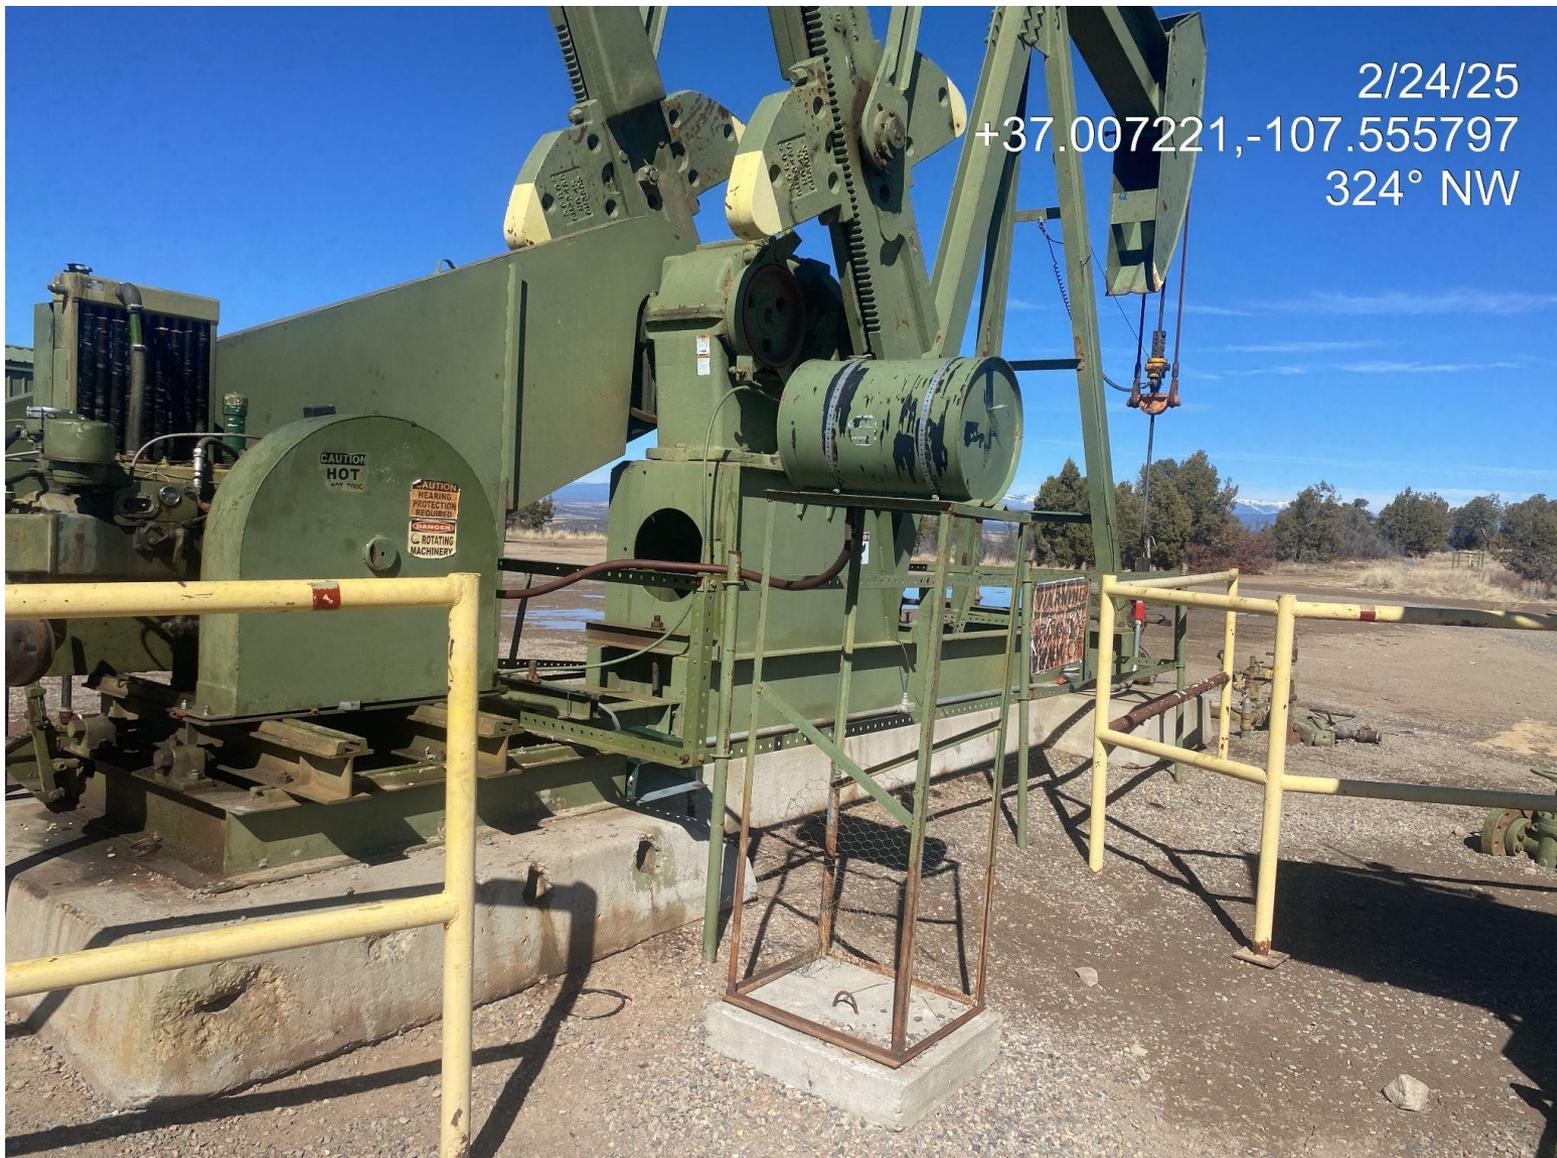
Photo 2. Oil/lube container at pump jack has no spill prevention/secondary containment.

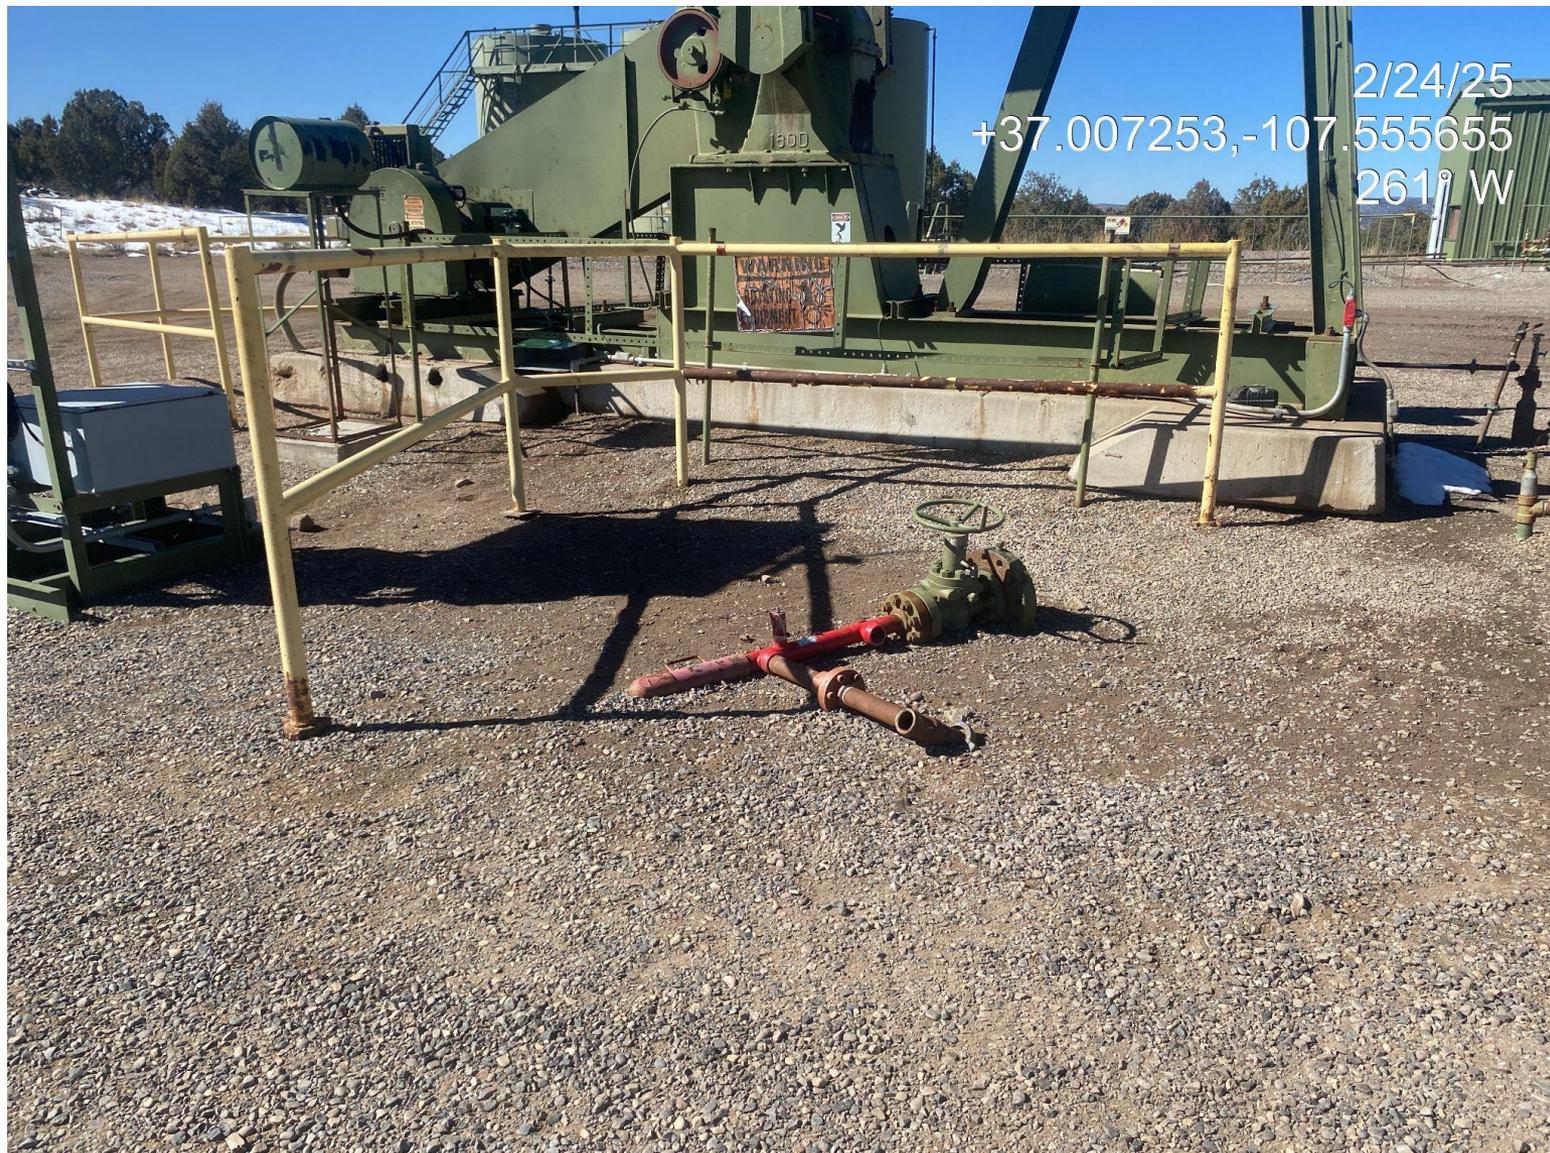
Photo 3. Unused oil and gas equipment at pump jack.

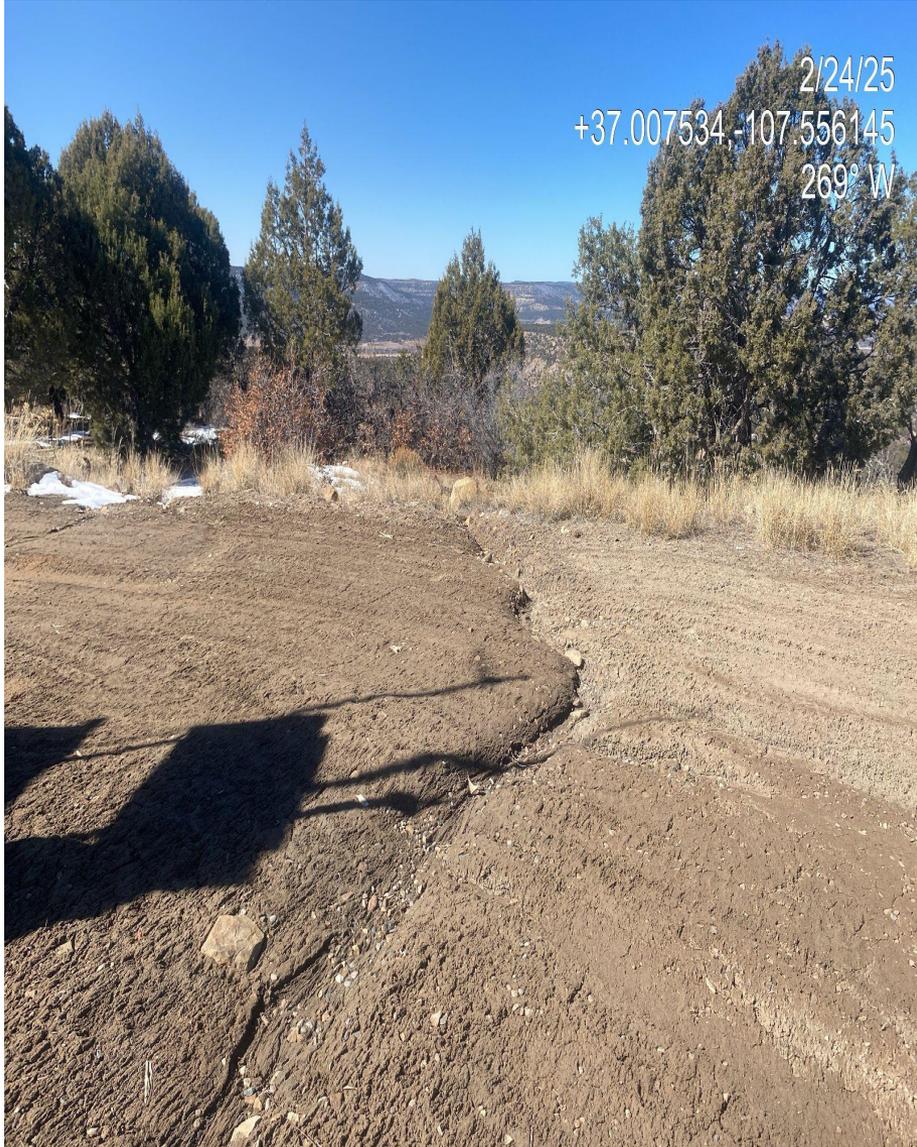
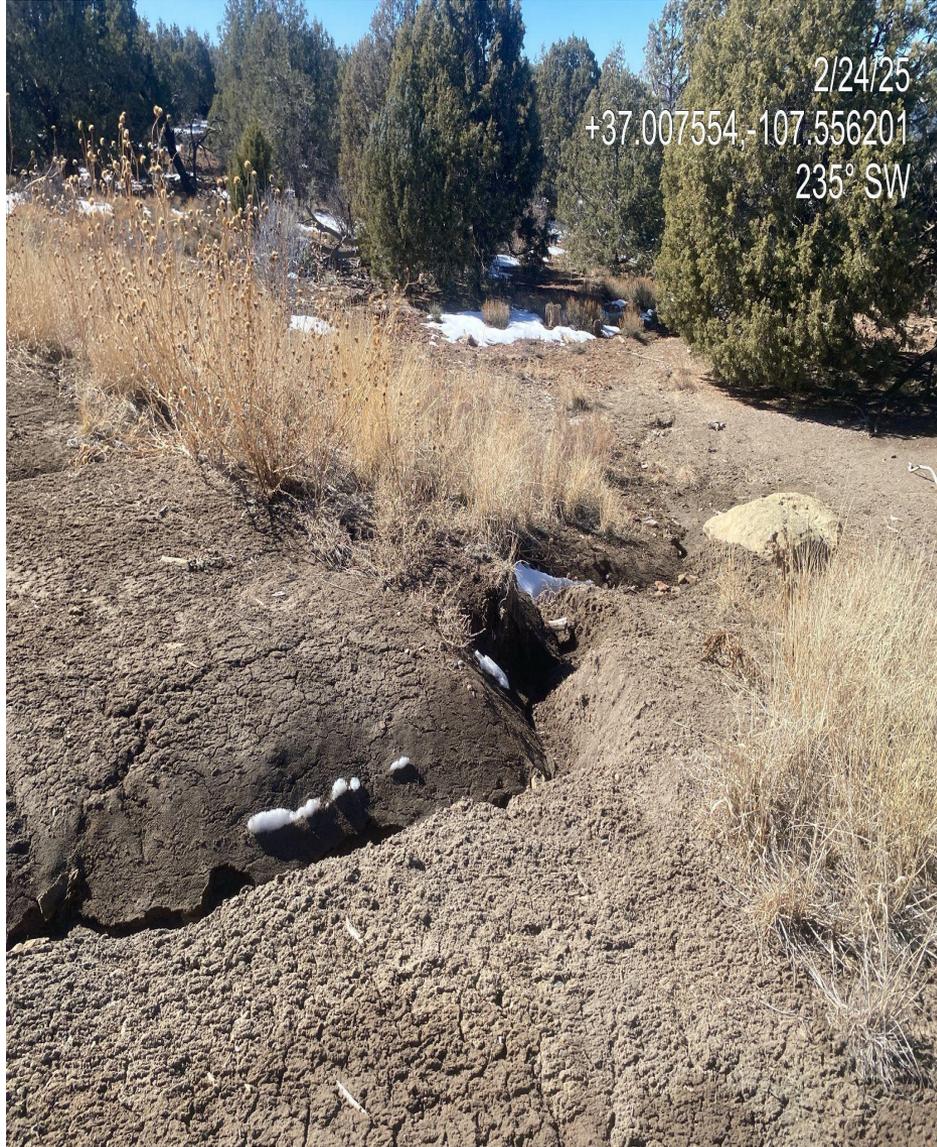
Photo 4. Erosion forming on the western edge of the pad.

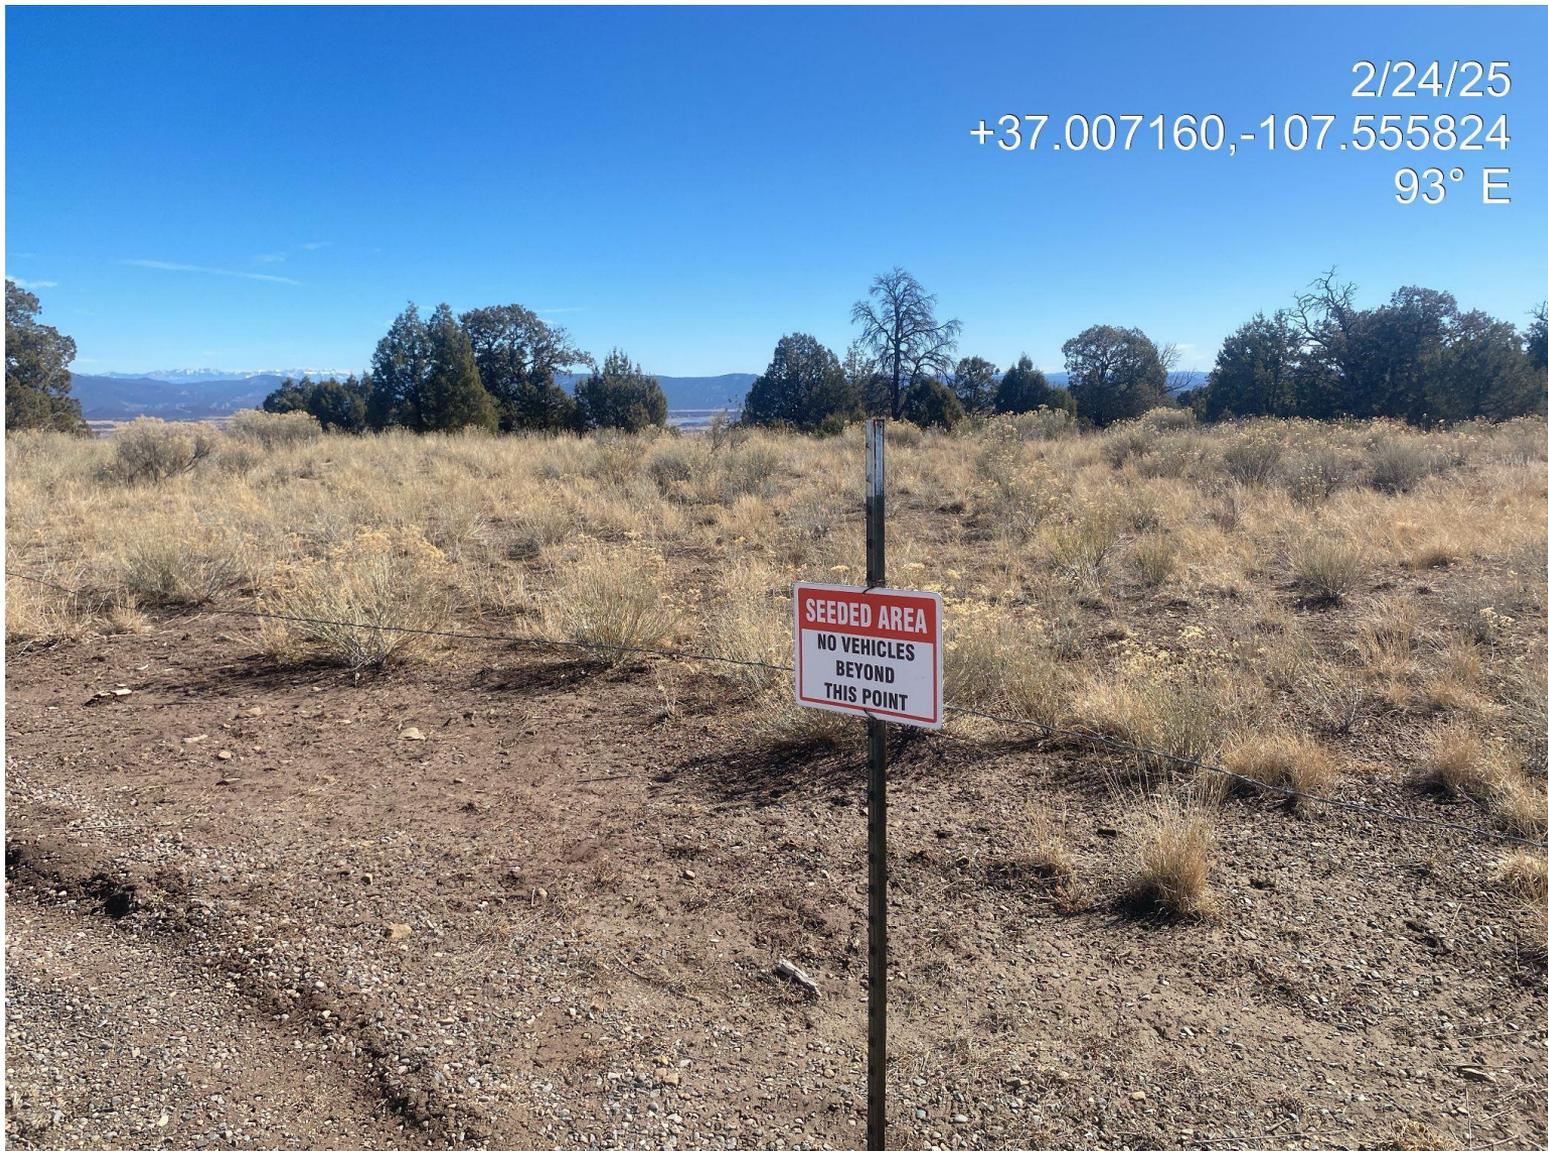
Photo 5. Interim reclamation exclusion fence/sign installed on eastern edge of the pad.

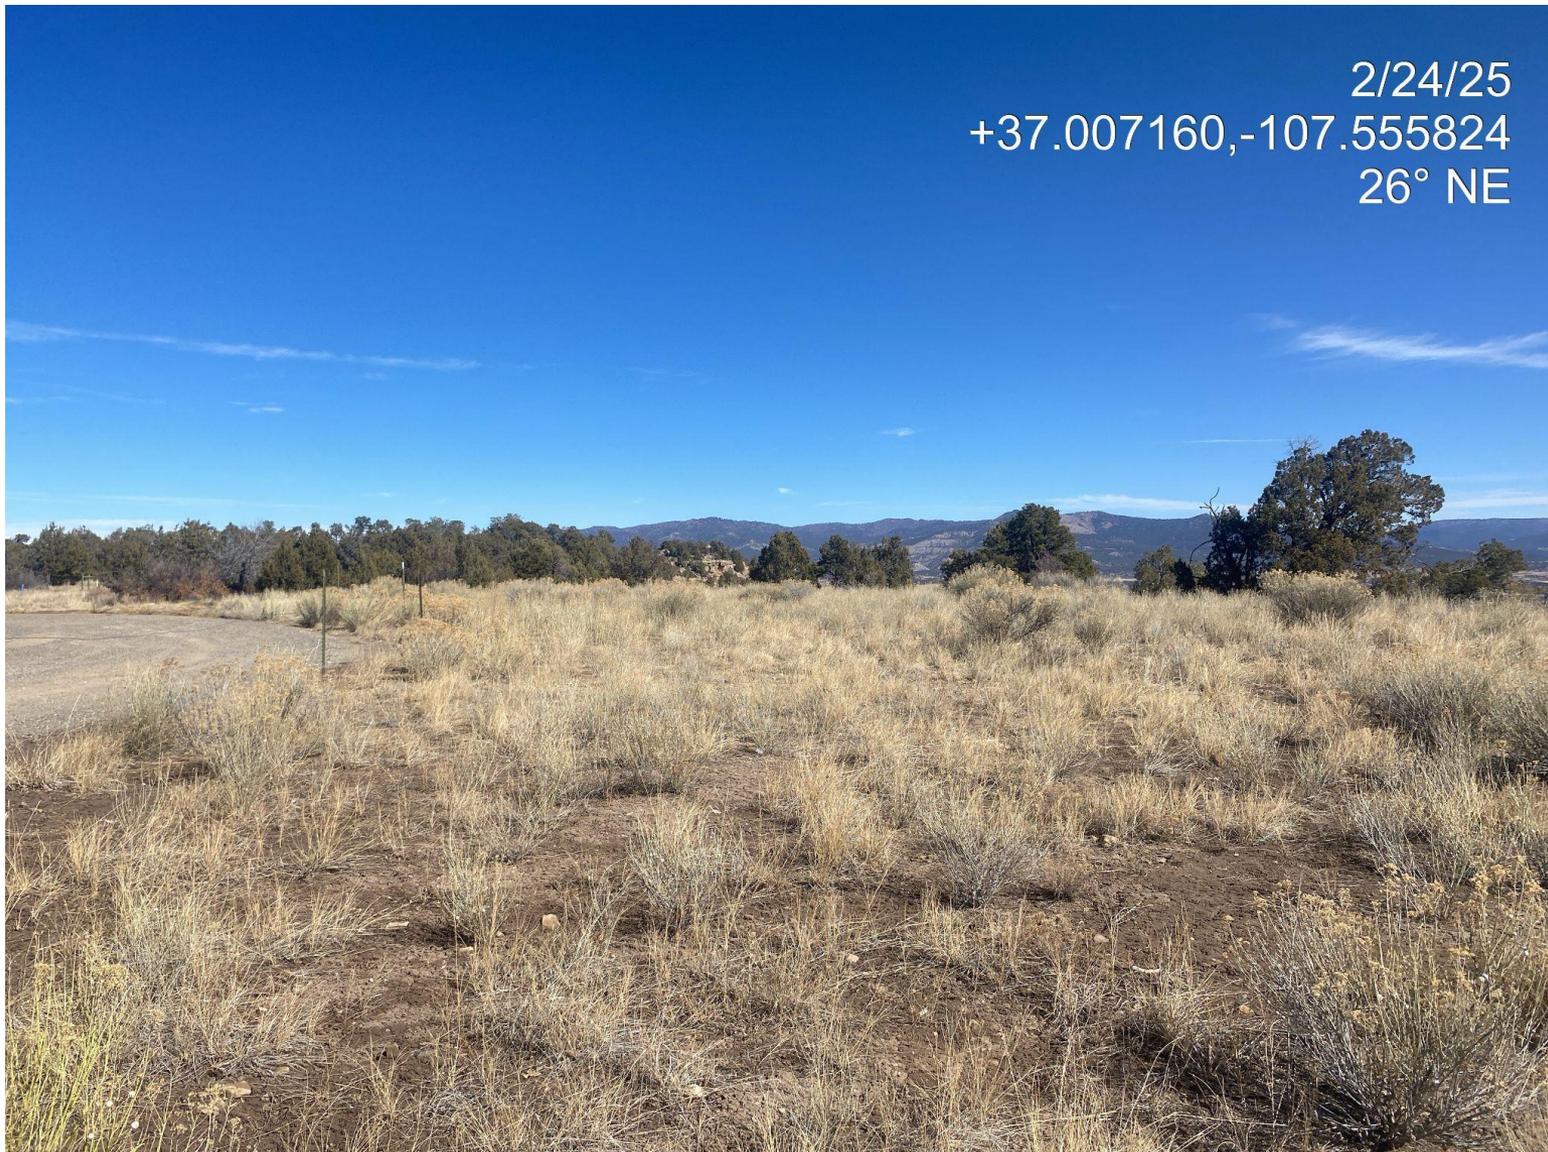
Photo 6. Interim reclamation area composed of Crested Wheatgrass, Western Wheatgrass, Sand Dropseed and Rabbitbrush.

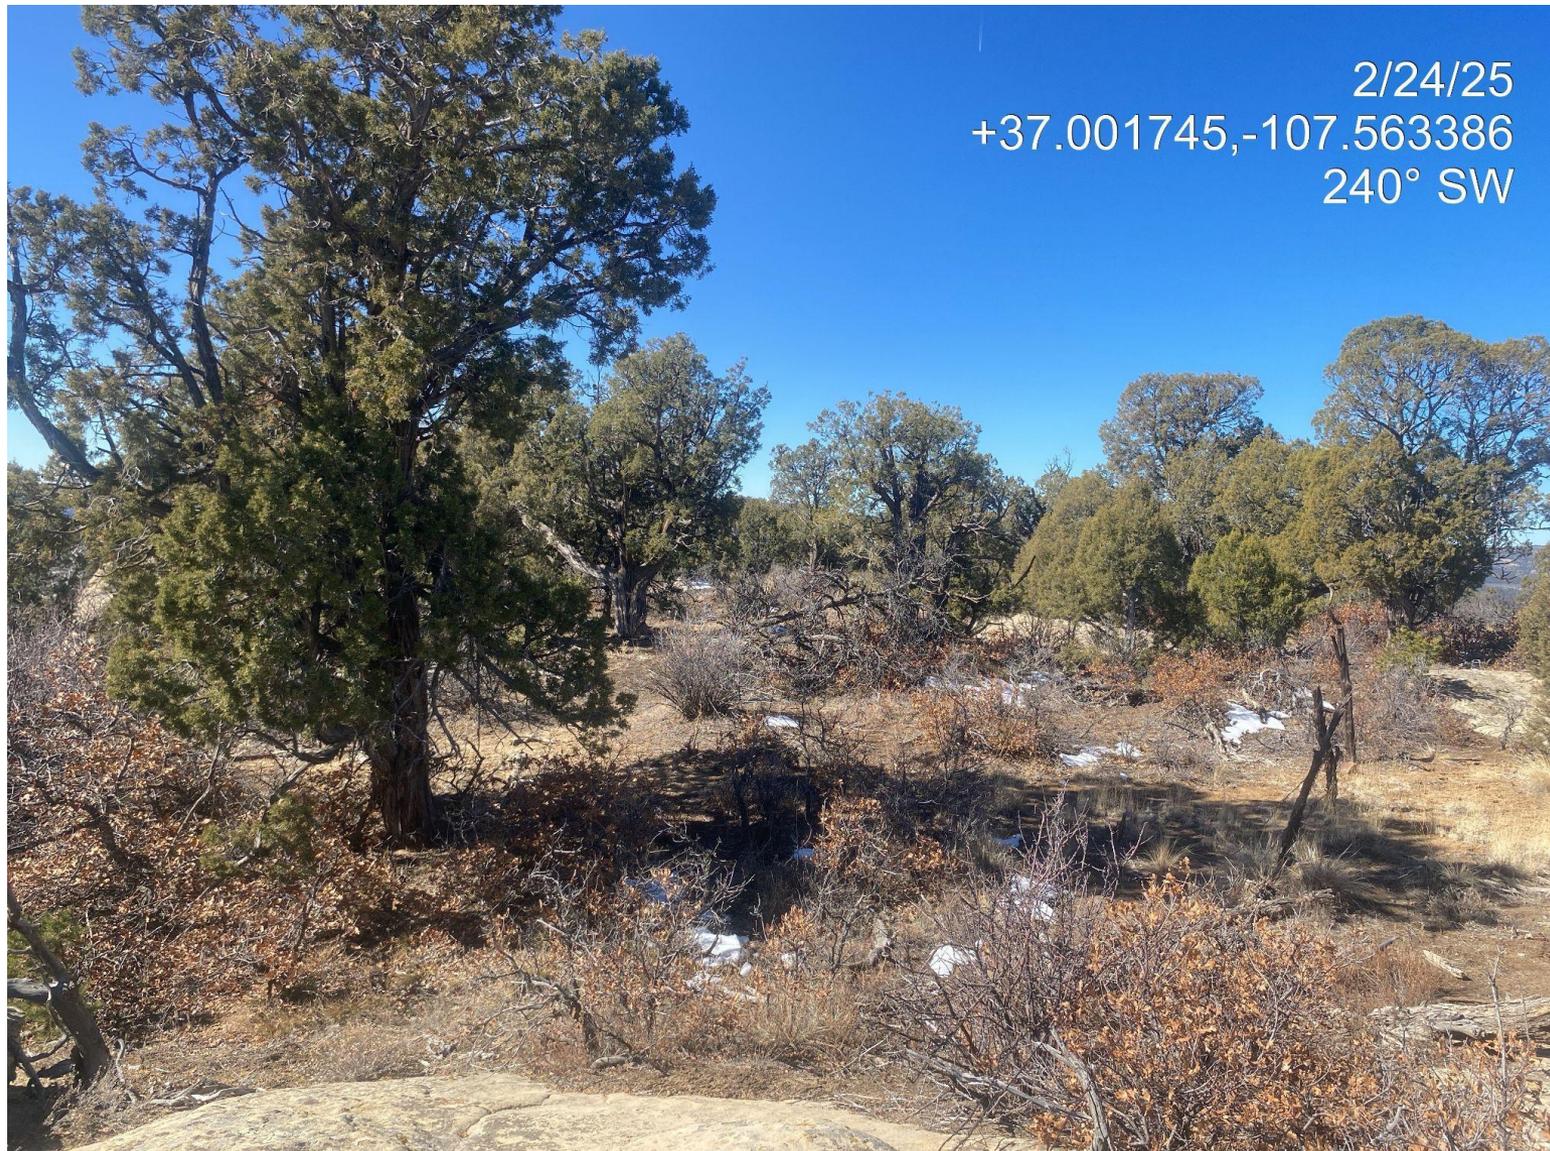
Photo 7. Reference area composed of Juniper, Gambel Oak, Indian Ricegrass and Grama.
