Inspection Photos

Operator: Hilcorp Energy Company - 10133

Location ID: 306787

Inspection Photos
Location Name: Levey 100
Location ID: 306787

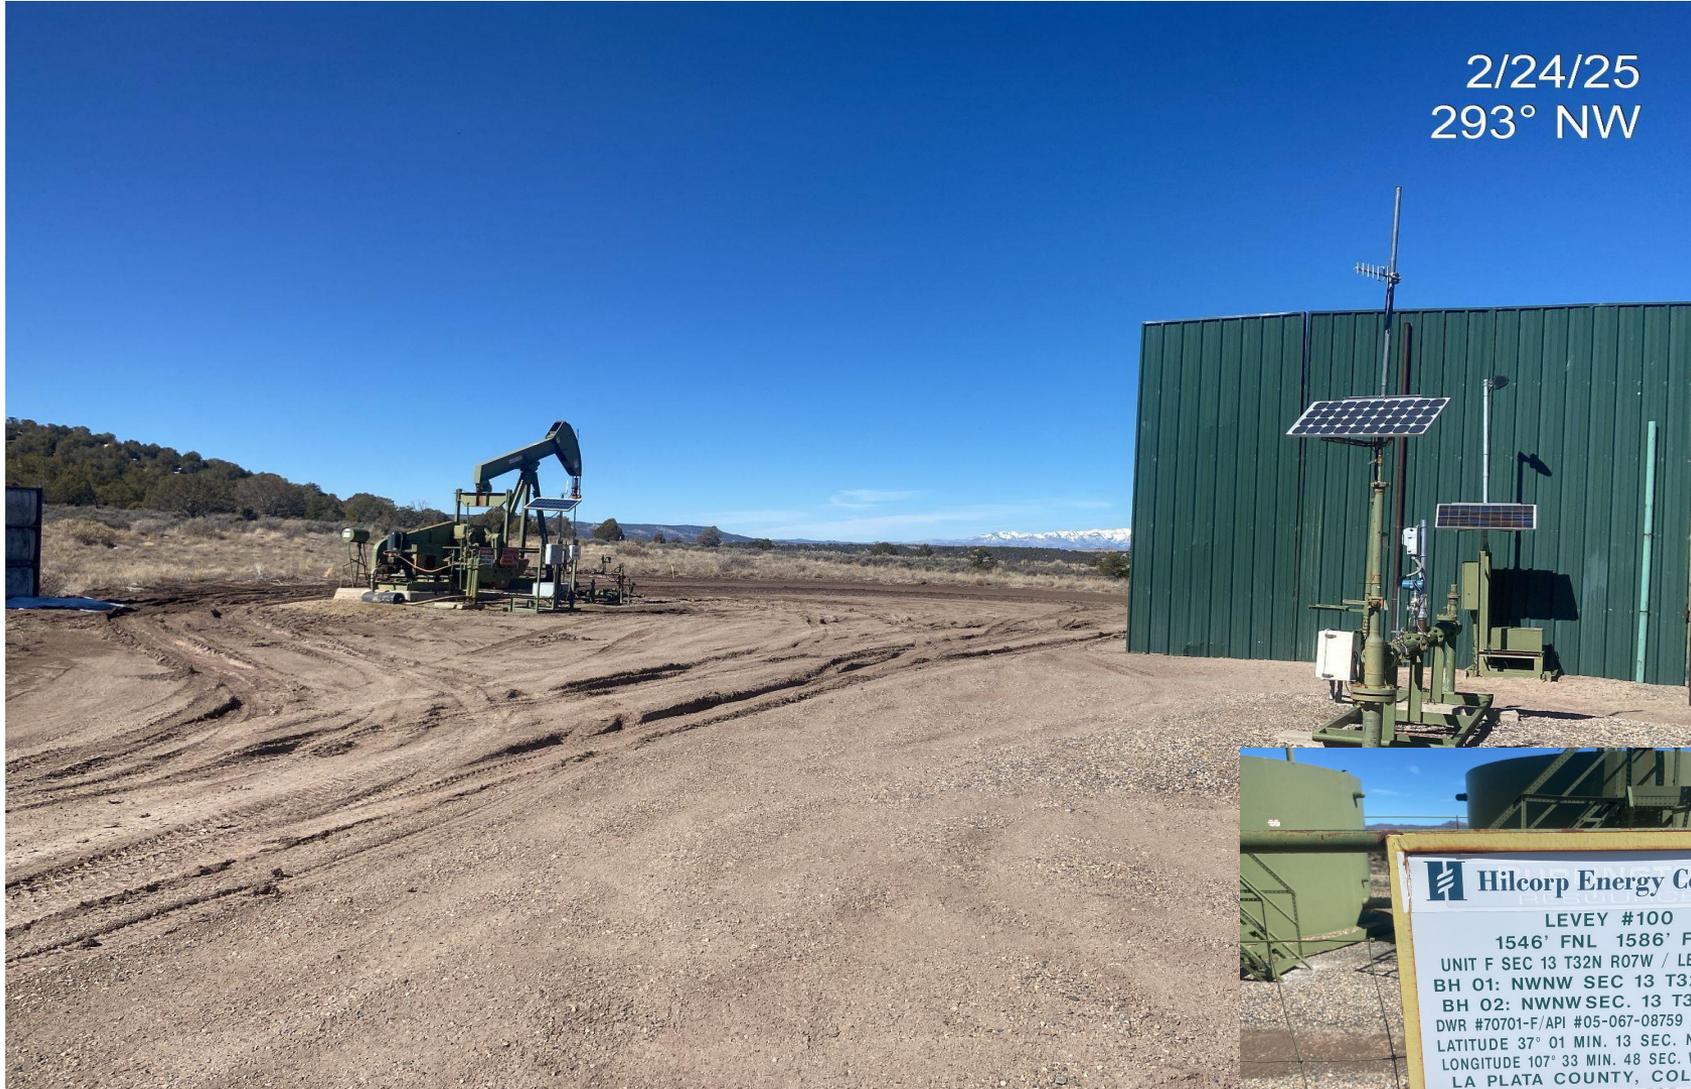
Photo 1. View of the well pad taken from the access point facing center.

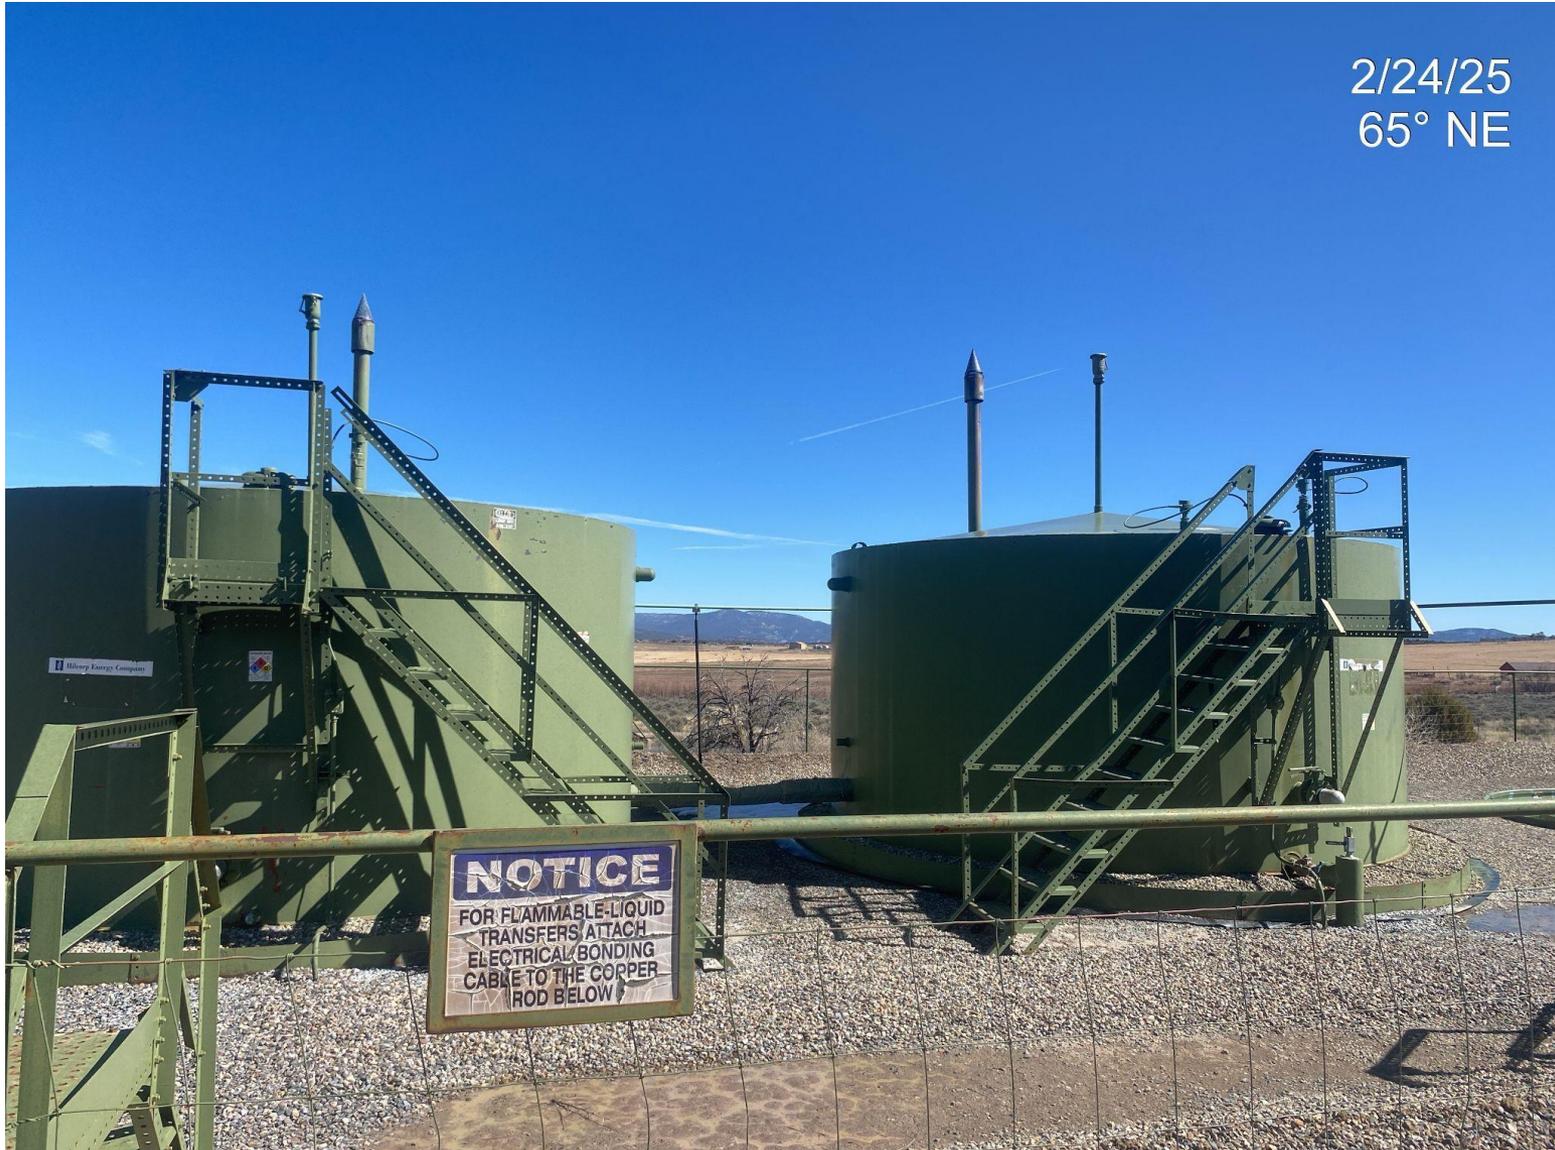
Photo 2. Capacity not displayed at produced water tank labels.

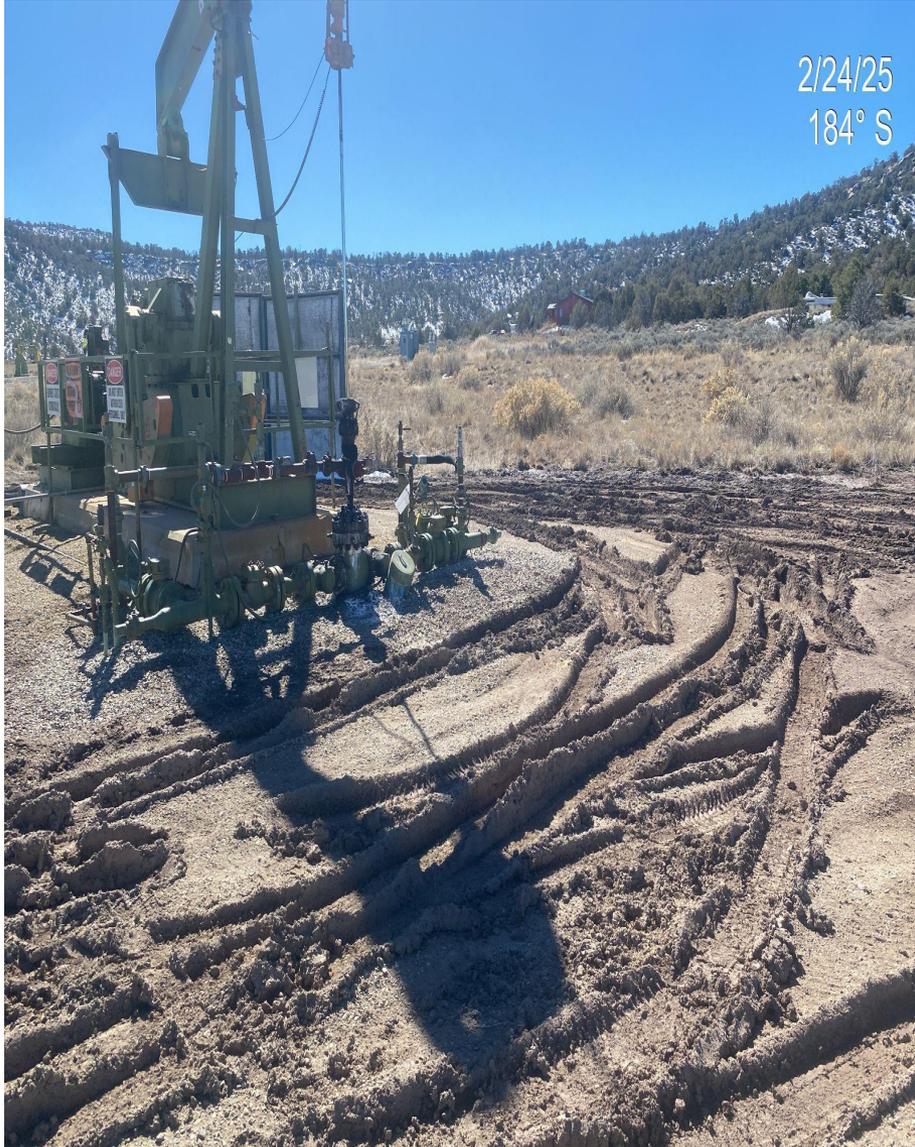
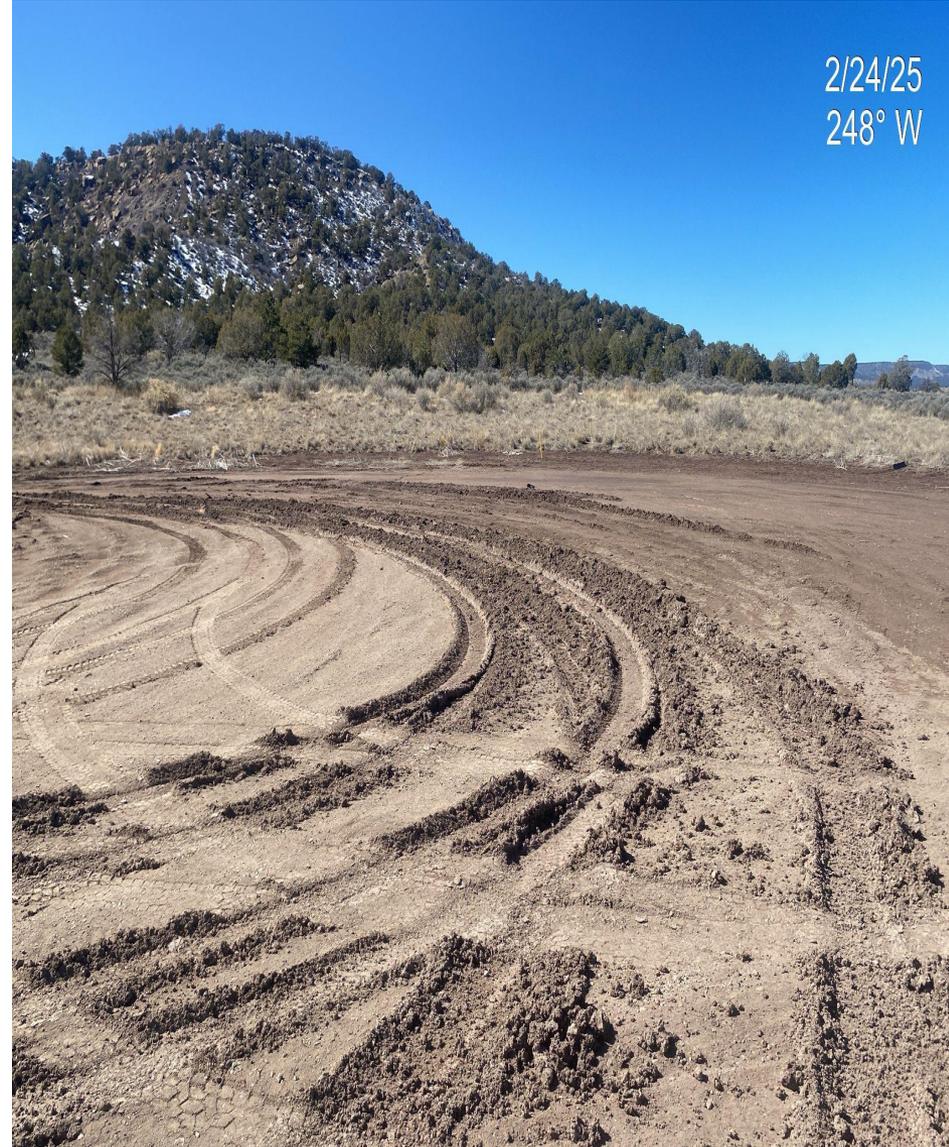
Photo 3. Rutting occurring on active pad, additional stabilization/grading is needed to minimize degradation to the pad surface.

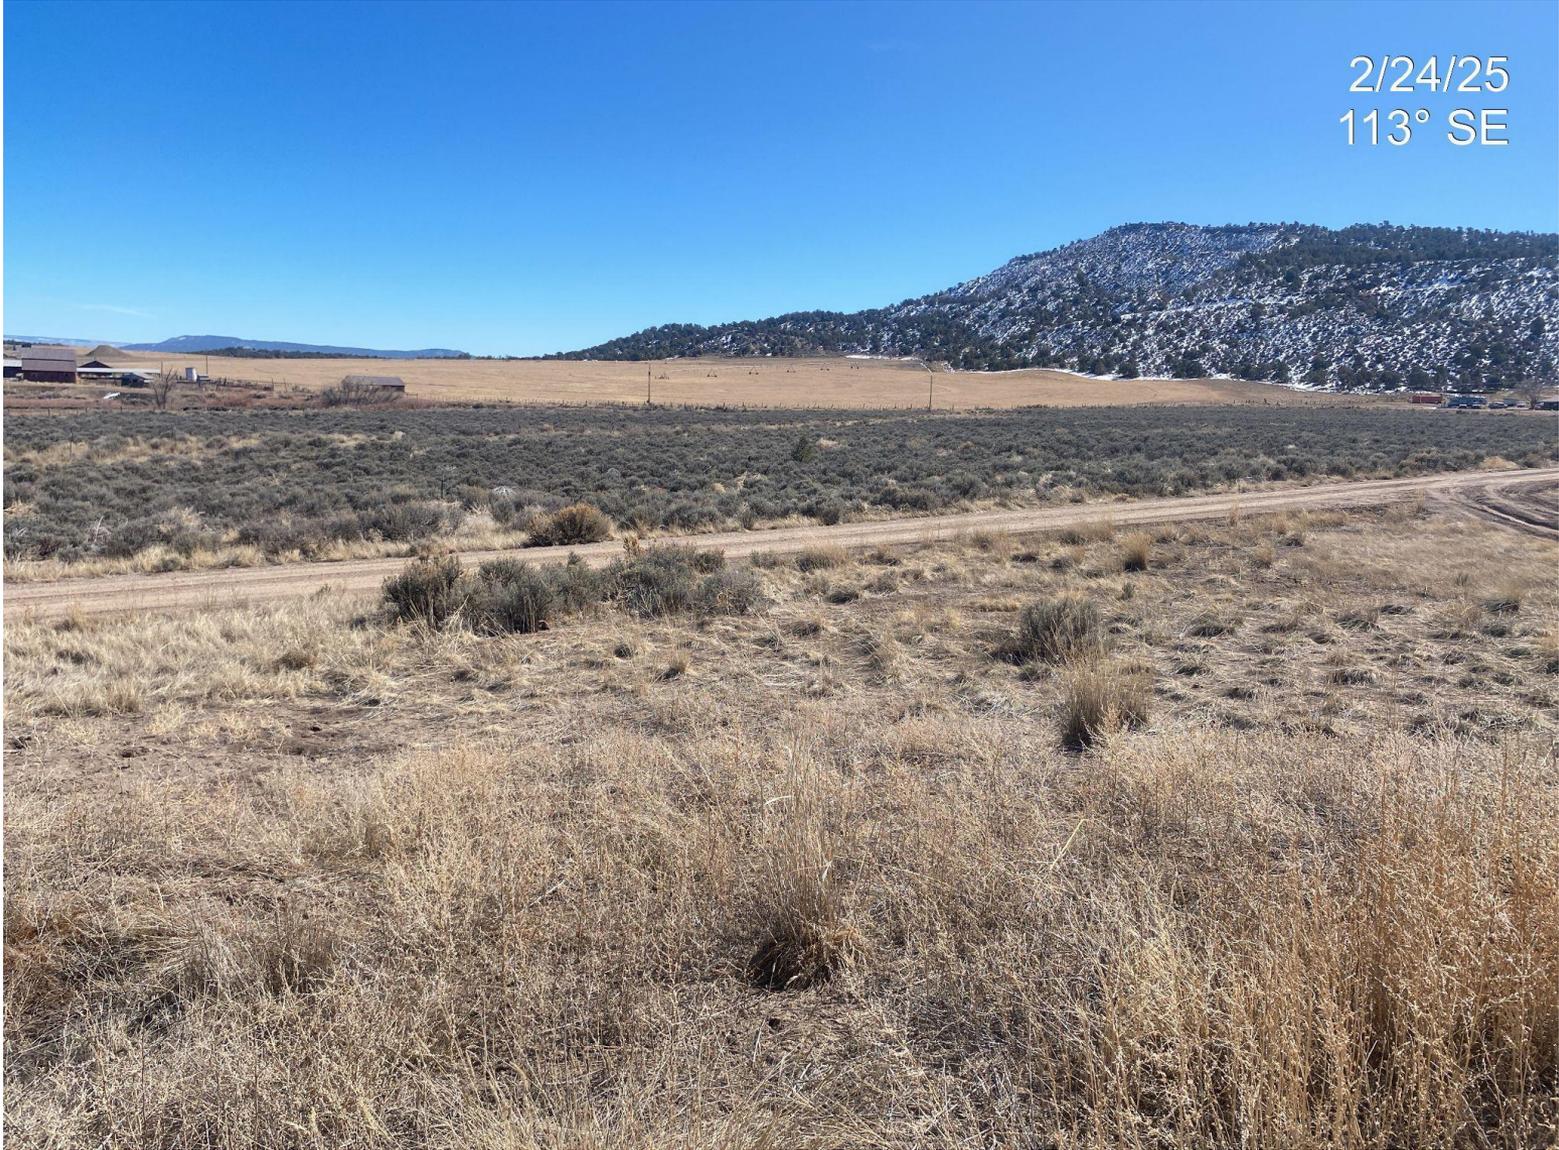
Photo 4. No vehicle tracking observed in the eastern interim reclamation area.

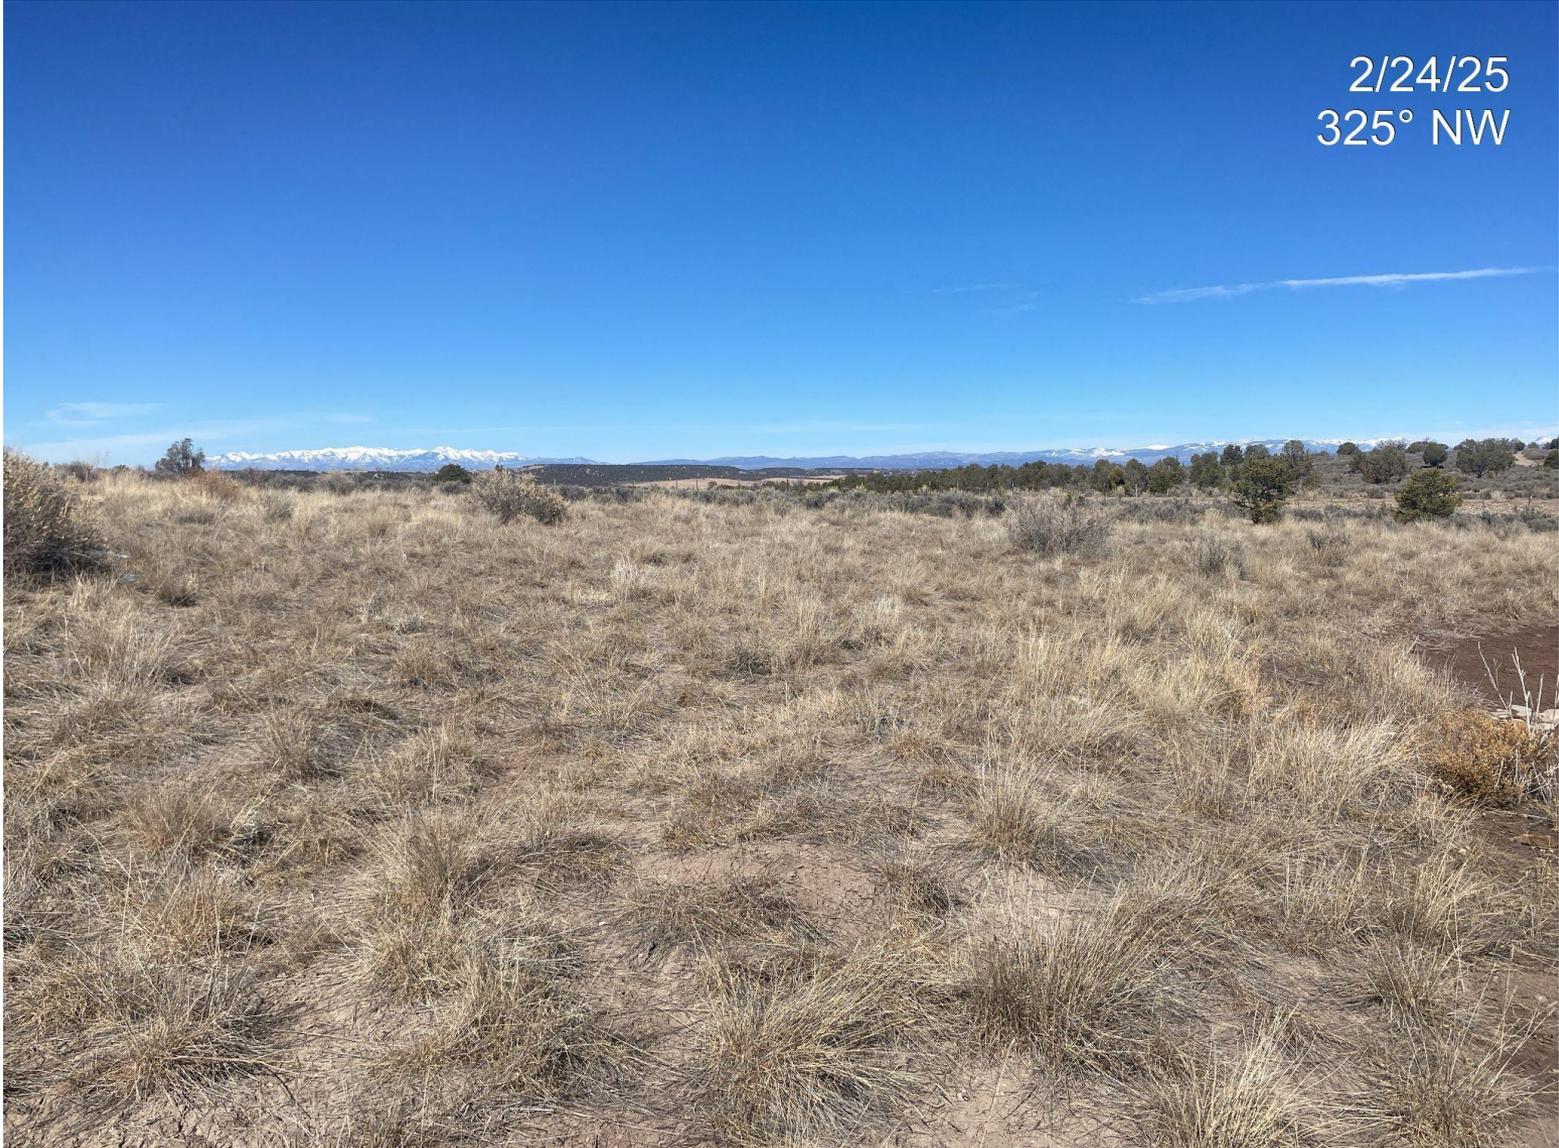
Photo 5. Interim reclamation area composed of Crested Wheatgrass, Western Wheatgrass, James Galleta and Rabbitbrush.

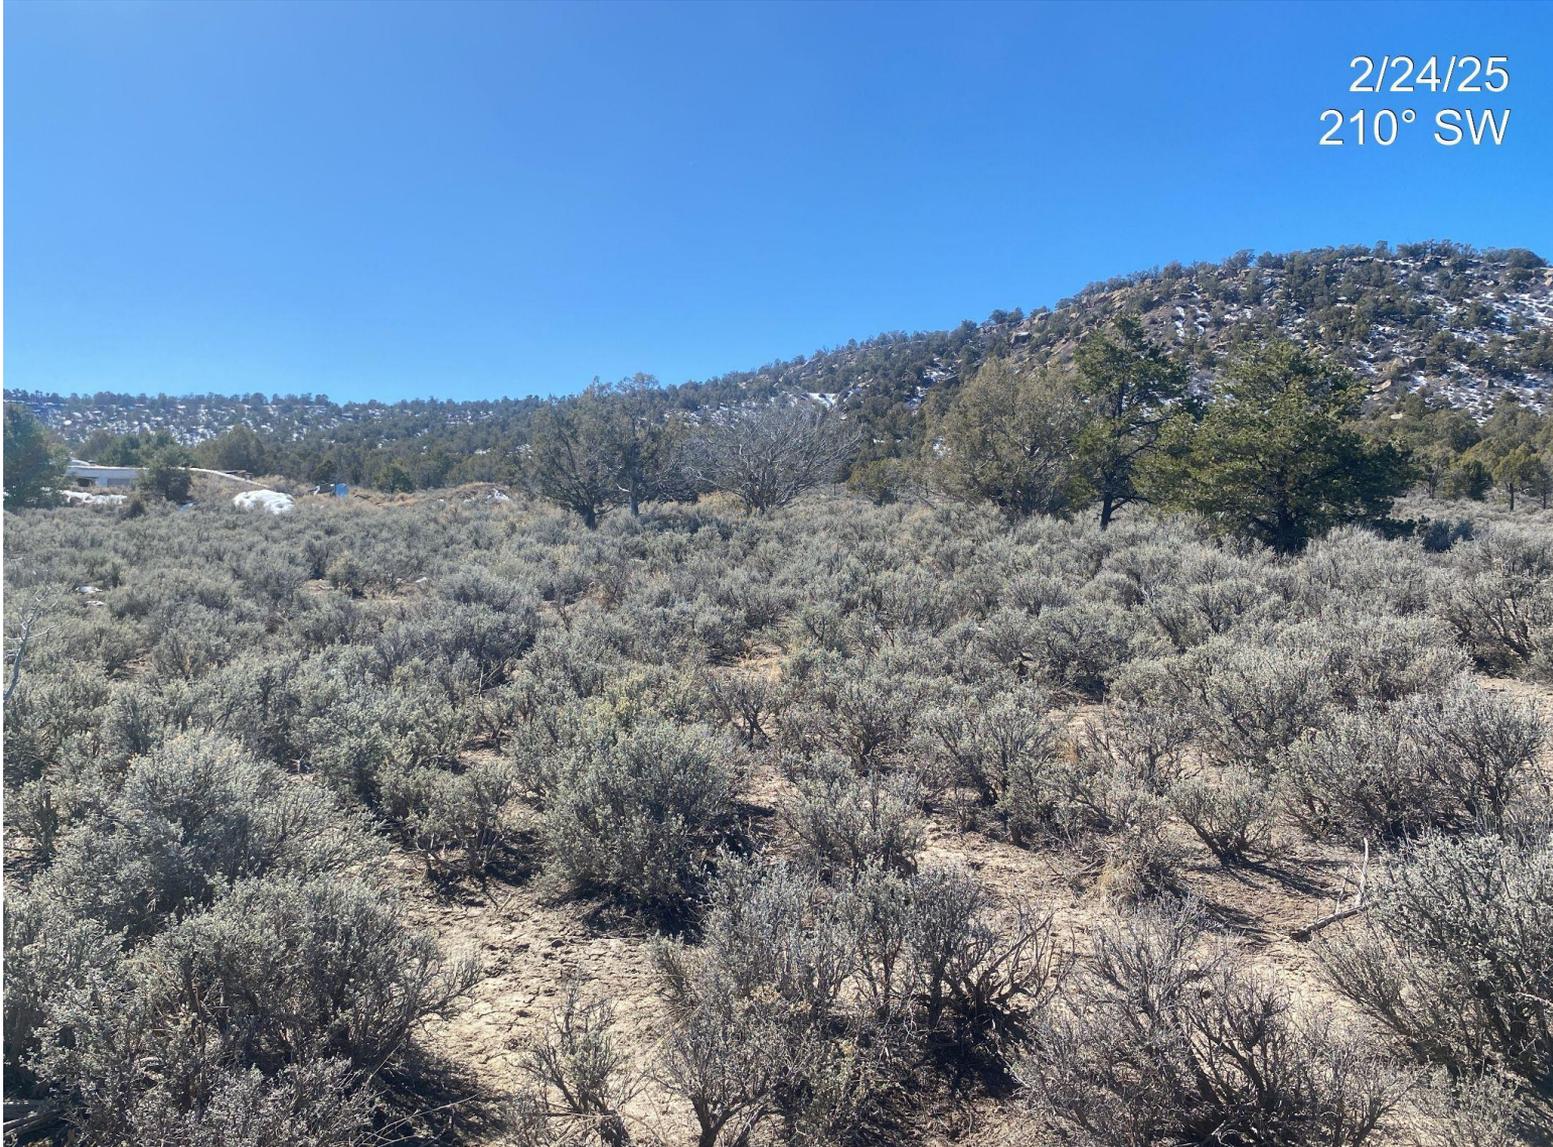
Photo 6. Reference area composed of Juniper, Sagebrush and James Galleta.
