Inspection Photos

Location Name: TEP ROCKY MOUNTAIN LLC, CHEVRON-66S96W/20SWSE

Location ID: 335313

Date: 2/24/2025

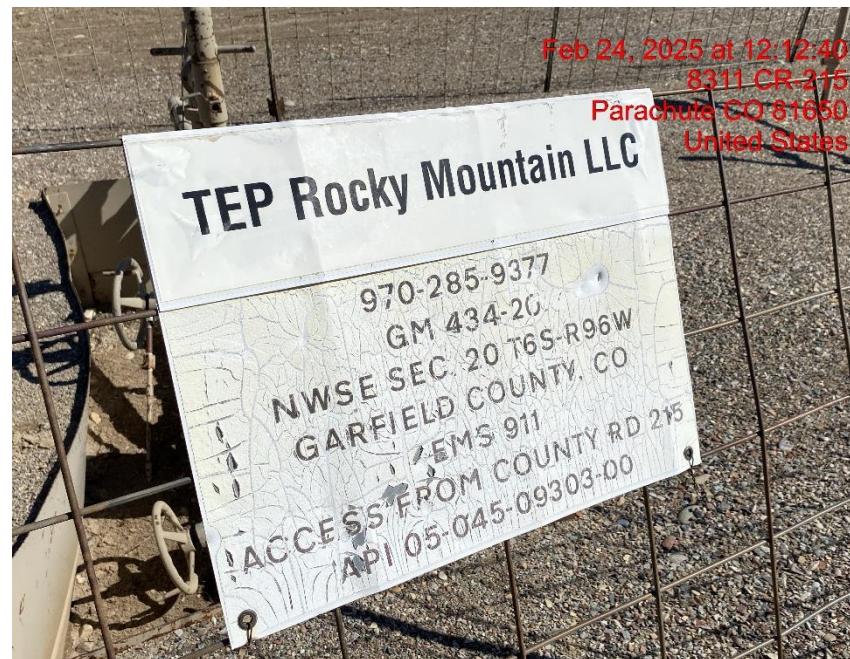
Weathered Wellhead Sign – Photo #06818

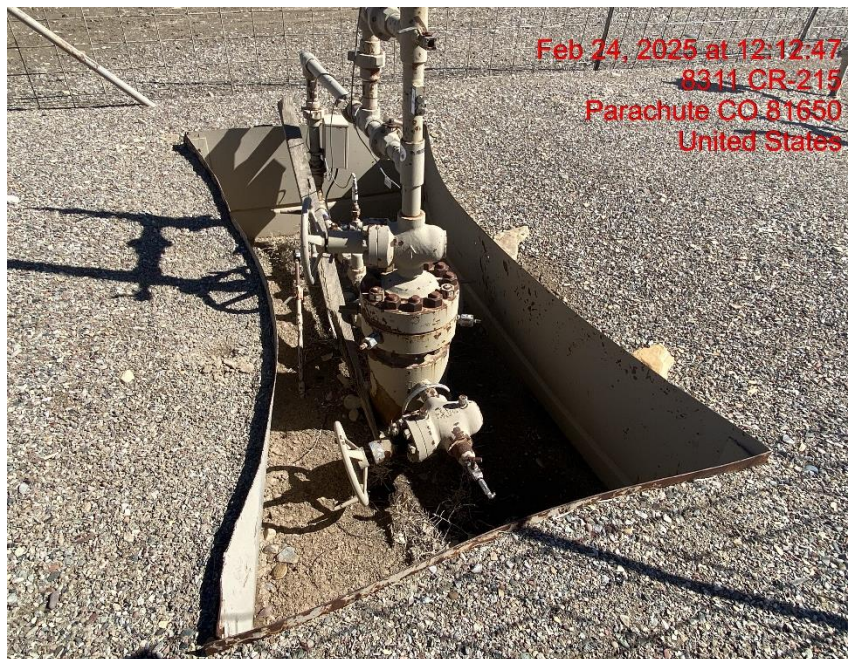
Open Wellhead Cellar – Photo #06819

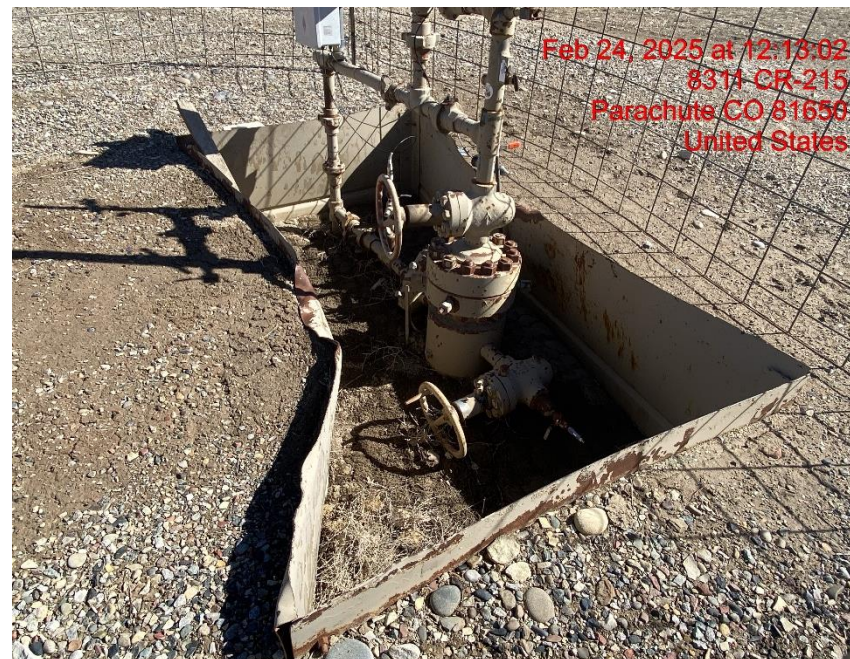
Open Wellhead Cellar – Photo #06820

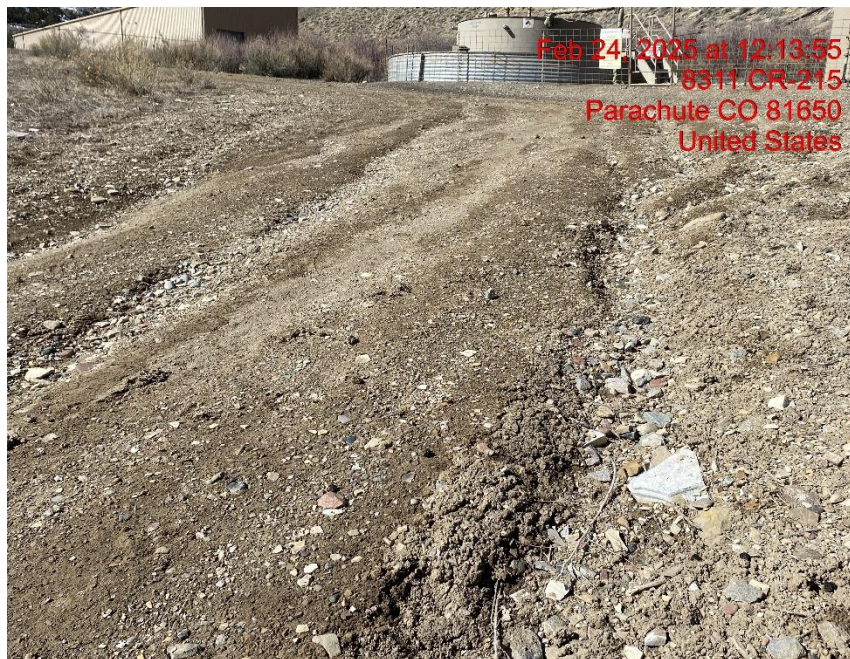
Rill Erosion on Access Road – Photo #06821

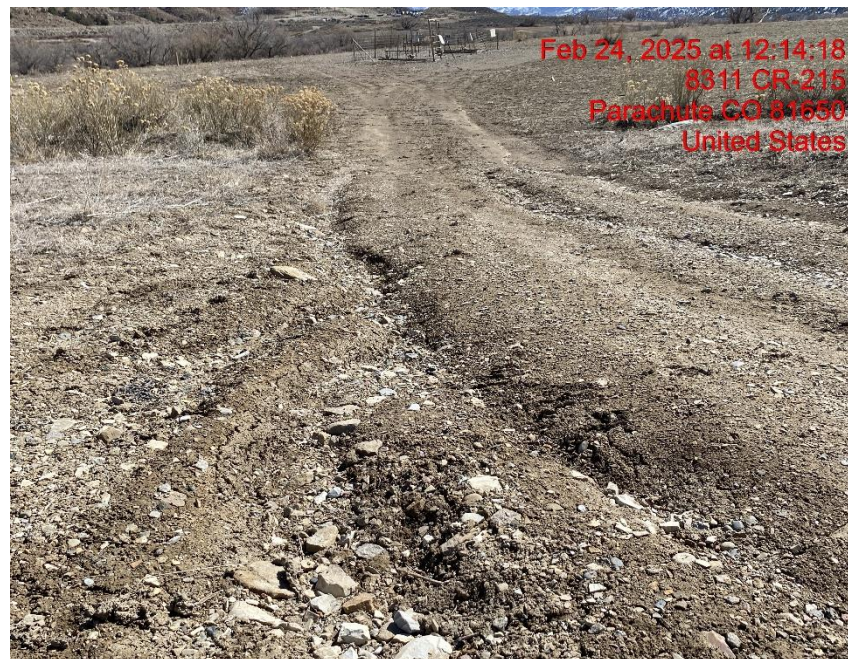
Rill Erosion on Access Road – Photo #06822
