Inspection Photos
Location: Stavelly 1-26
Location ID: 324837
API # 05-061-06394

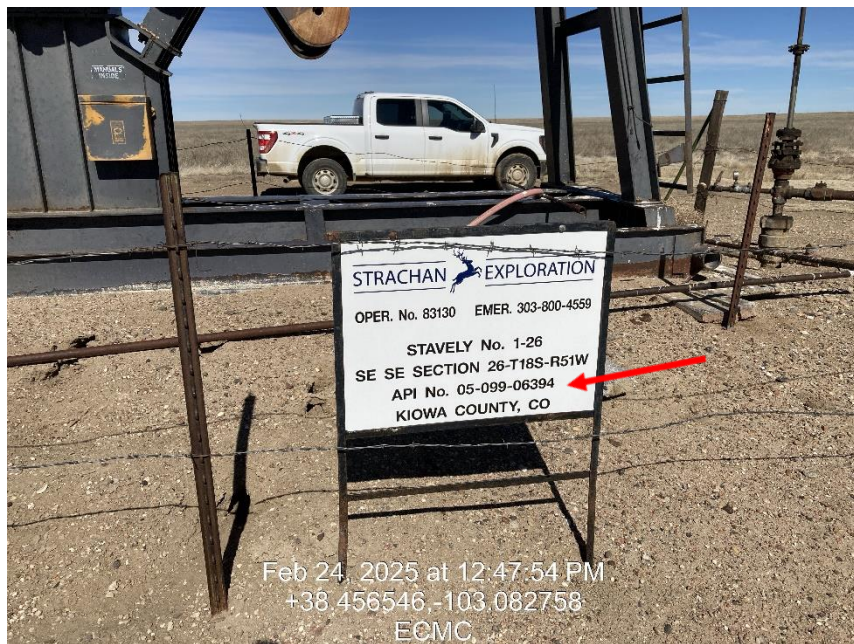
Photo 1 –Well placard, Wrong API # listed

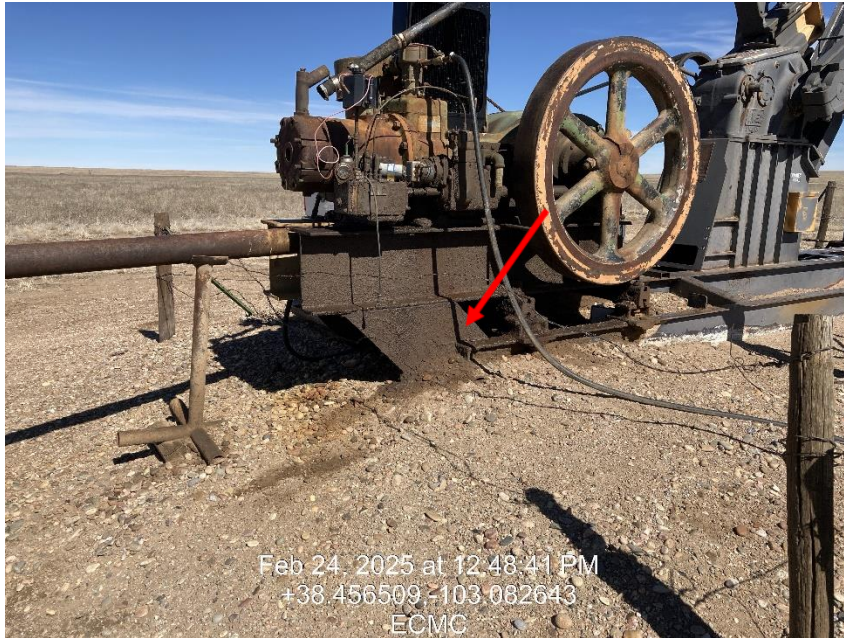
Photo 3 – Impacted soils at rear of pumping unit

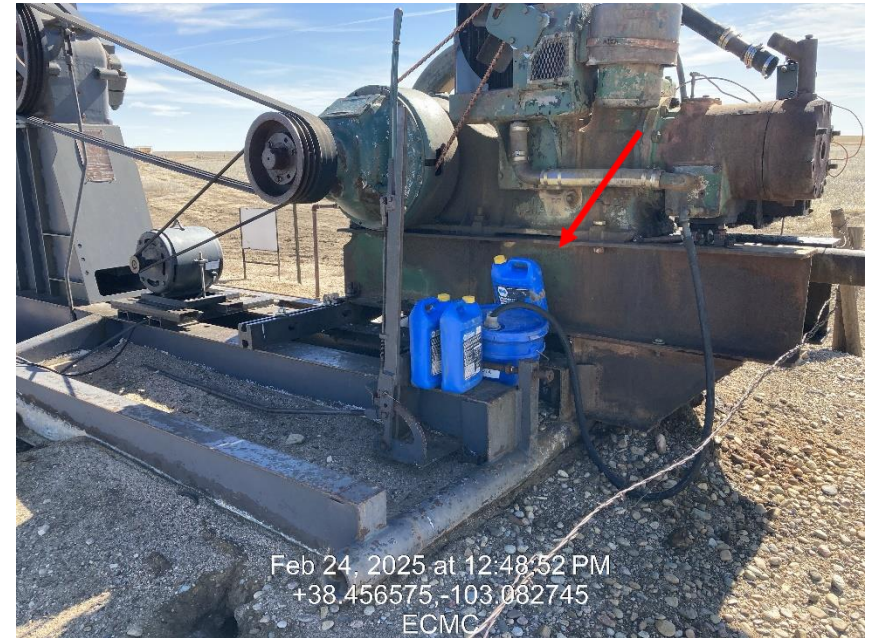
Photo 4 – Lube oil not in containment

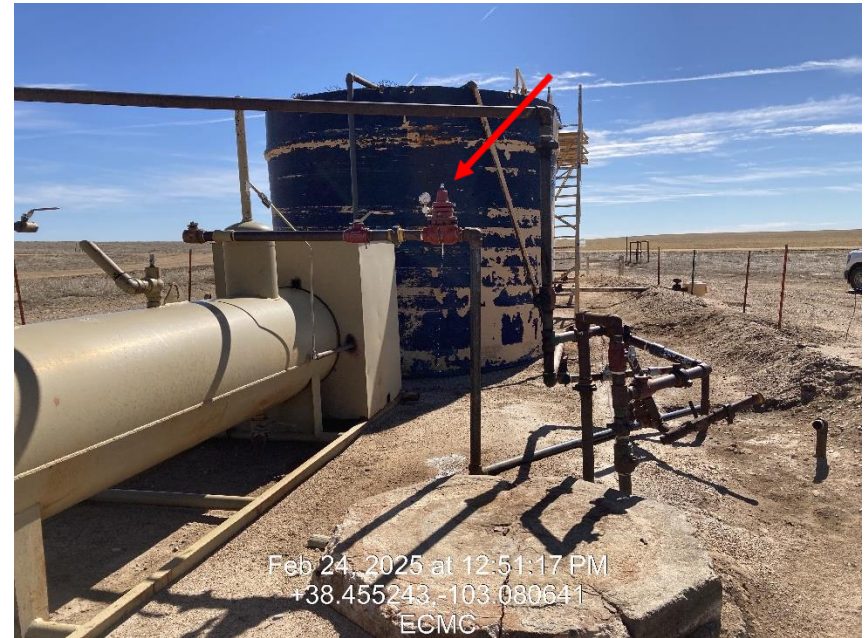
Photo 6 – Leaking valve
