WELL NAME: FLYING DUTCHMAN 14-35, API #: 071-08908, INSP. # 716300588

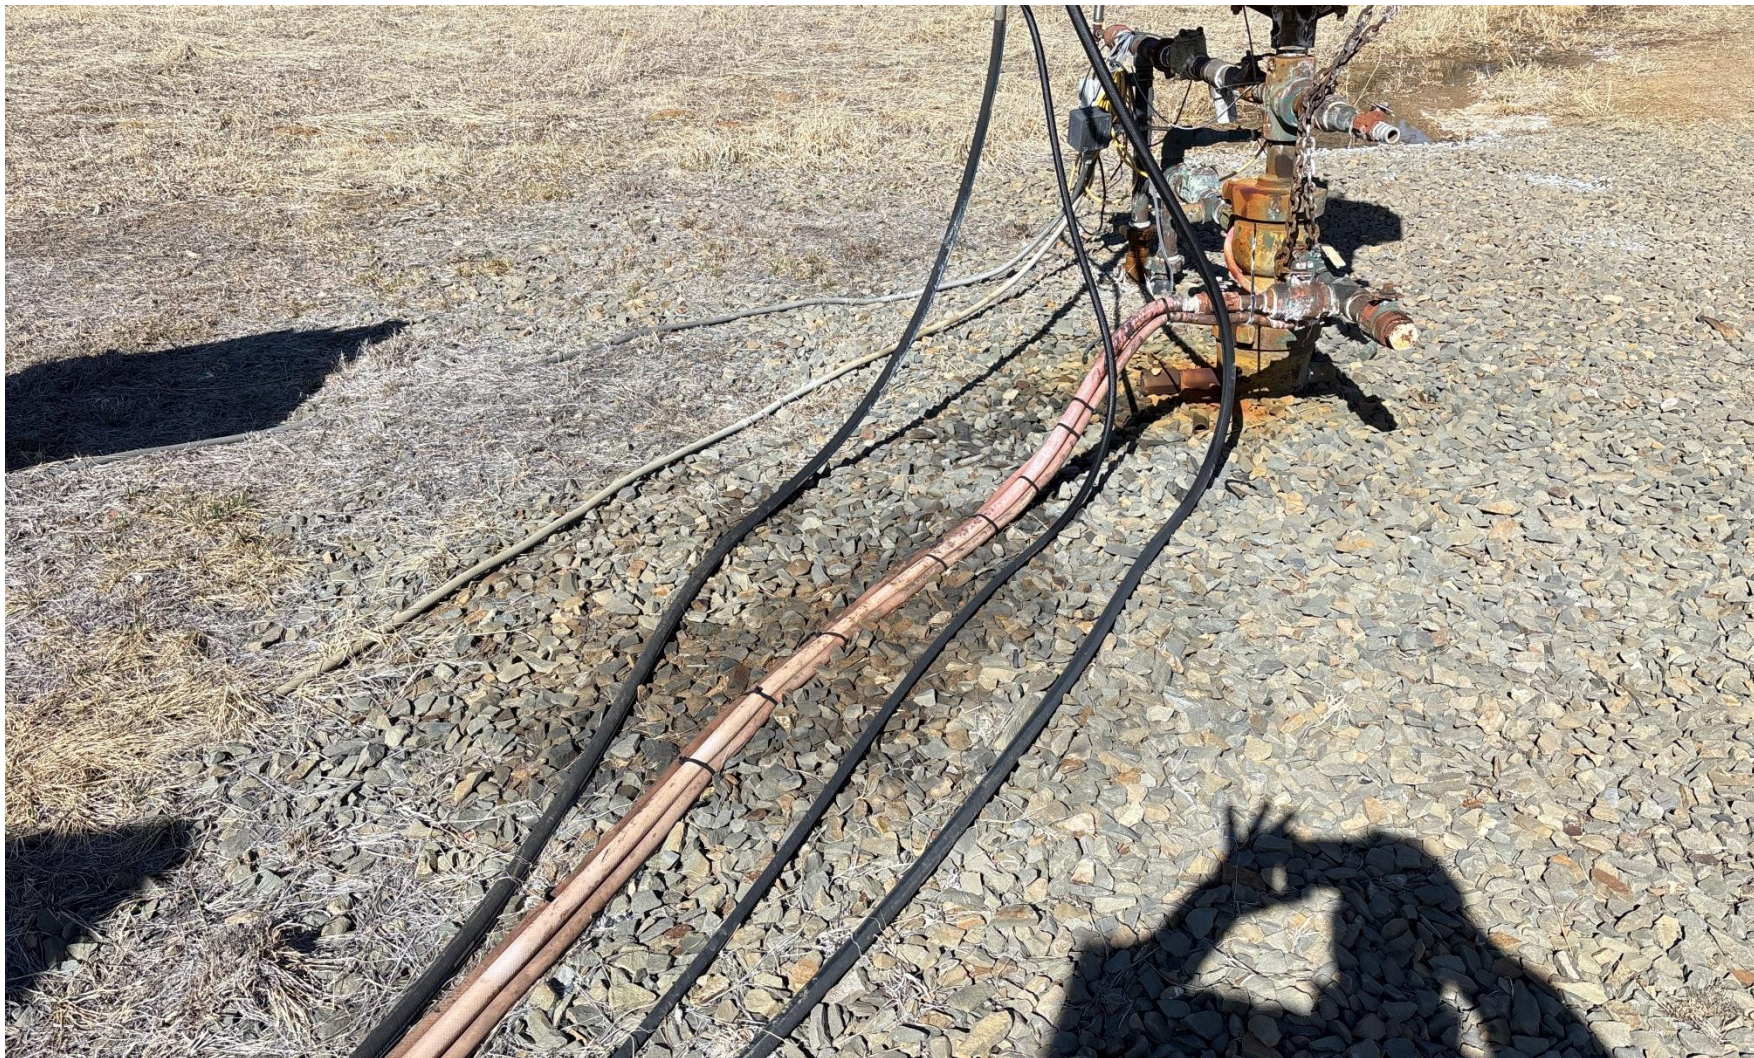
PHOTO 4: THERE IS AN AREA OF IMPACTED SOIL APPEARS TO BE FROM PREVIOUS HYDRO HOSE LEAK THAT APPEARS TO BE FIXED. Conduct maintenance on equipment, cleanup stained material and review self inspection processes. COMPLY WITH RULE 1002,(2).D CA DATE 3-5-2025.

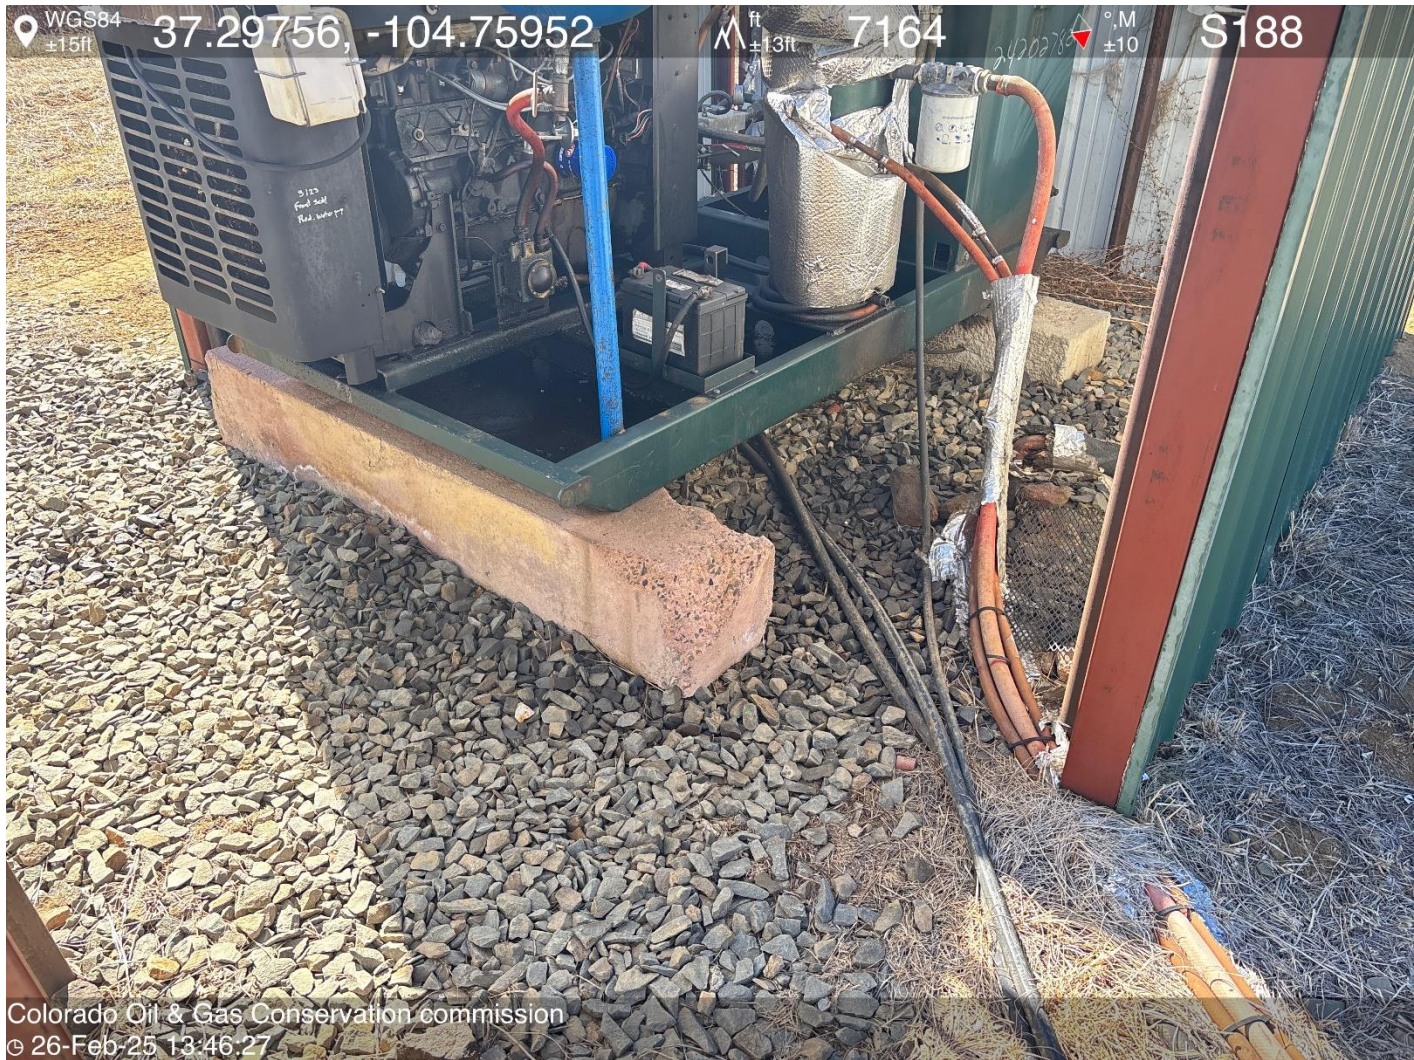
PHOTO 5: THERE IS AN AREA OF IMPACTED SOIL NEAR PRIME MOVER ENGINE SKID. Conduct maintenance on equipment (REPAIR LEAKS), cleanup stained material and review self inspection processes. COMPLY WITH RULE 1002,(2).D CA DATE 3-5-2025.
