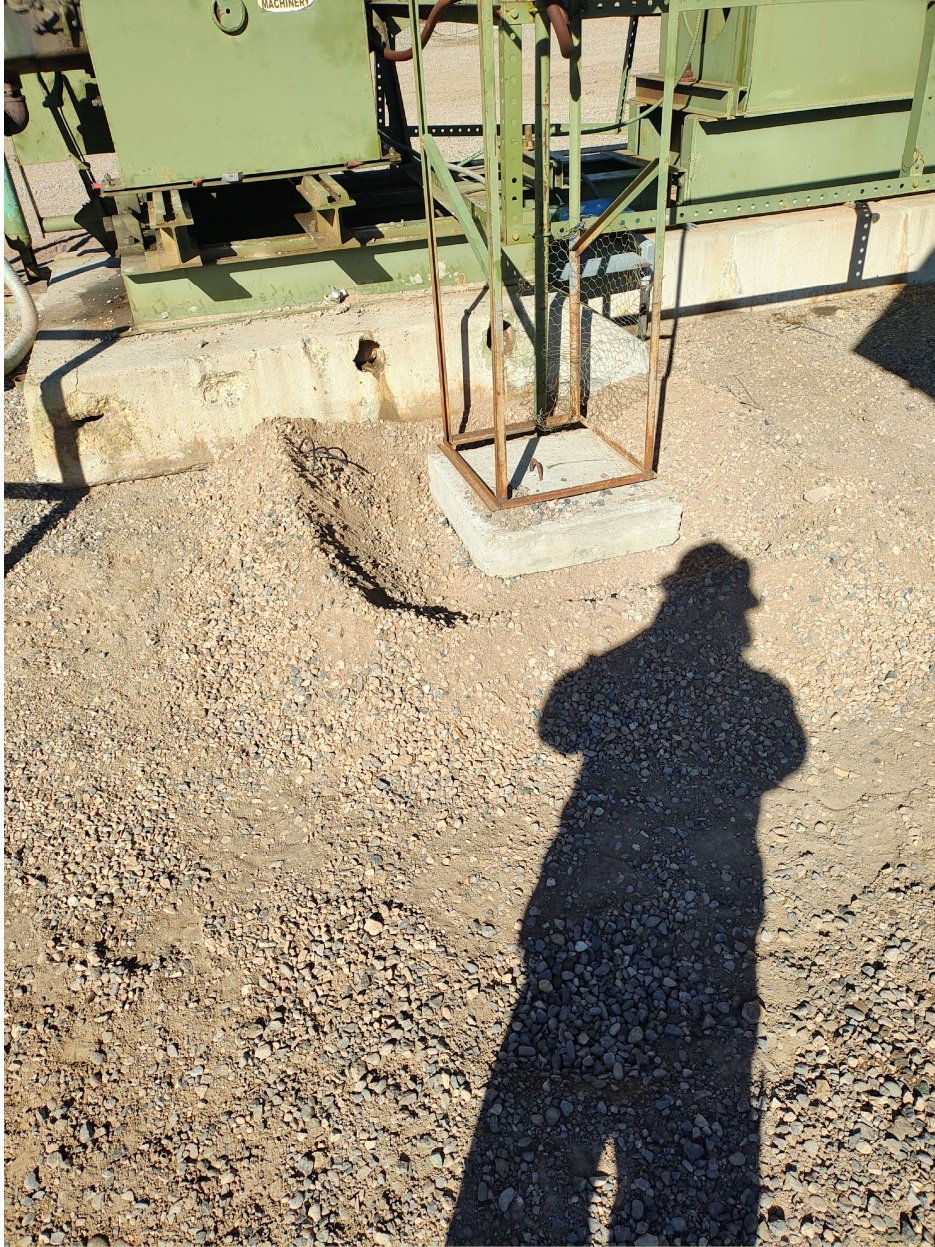
Comment: No spill prevention was observed at lube/oil tank at pump jack.

Corrective Action: Comply with rule 1002f. Install spill prevention at lube/oil tank.

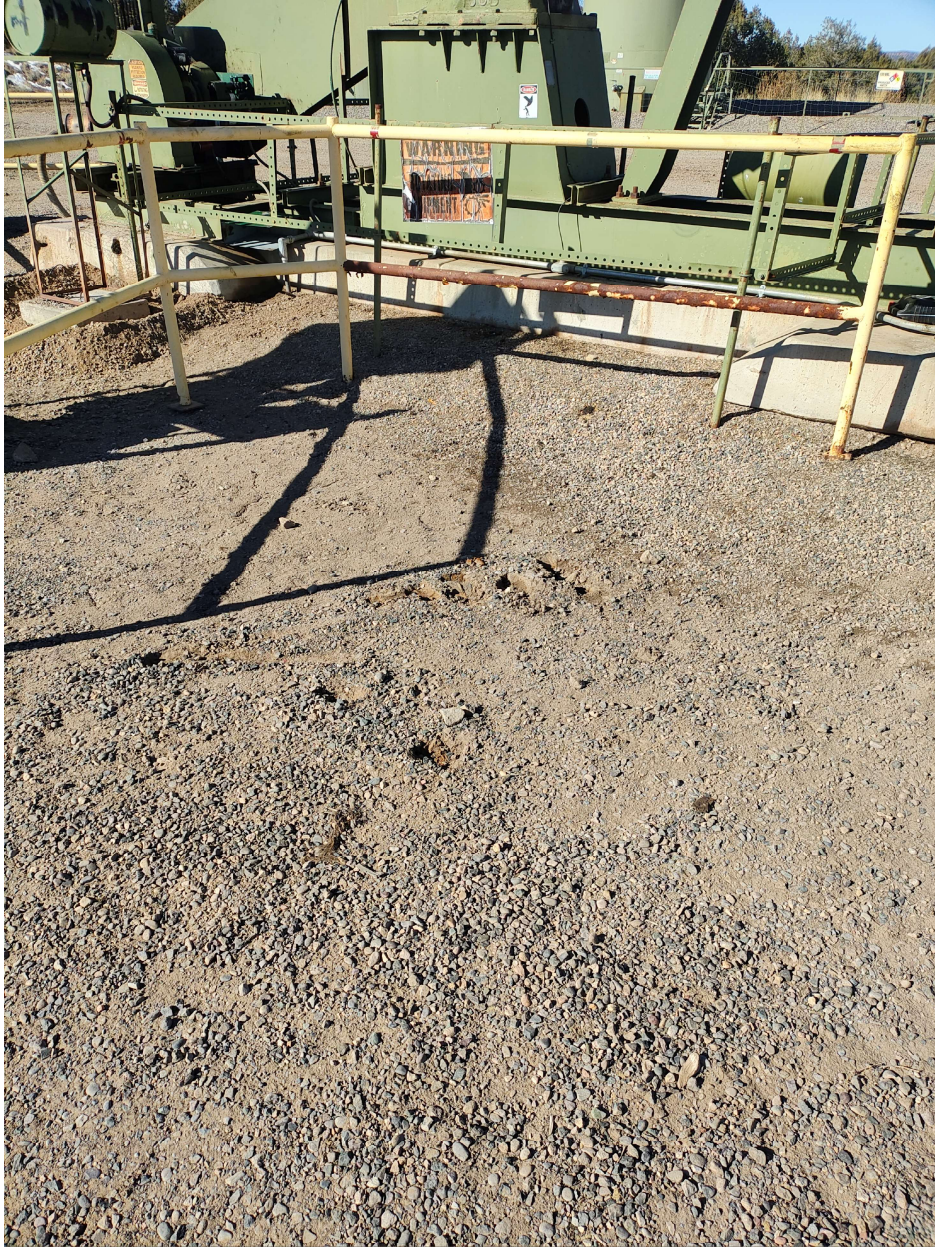
Comment: Unused oil and gas equipment observed at pump jack.

Corrective Action: Comply with rule 606. removed unused oil and gas equipment.

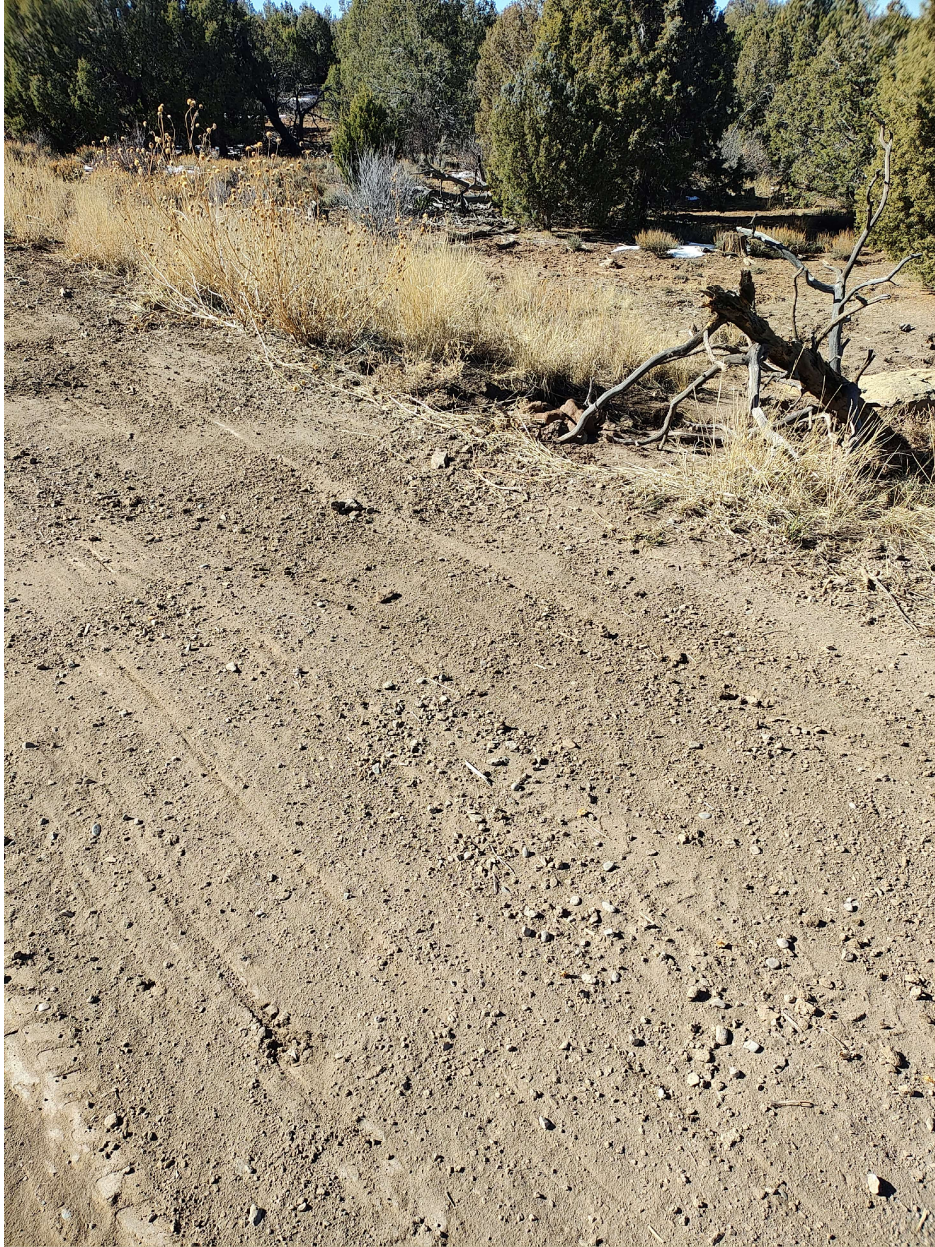
Comment: Erosion observed on the western edge of the pad.

Corrective Action: Comply with rule 1002f. Install or repair required BMPs.
