**Inspection Photos**  
**Location: Frazee 2-6**  
**Location ID: 324831**  
**API # 05-061-06365**

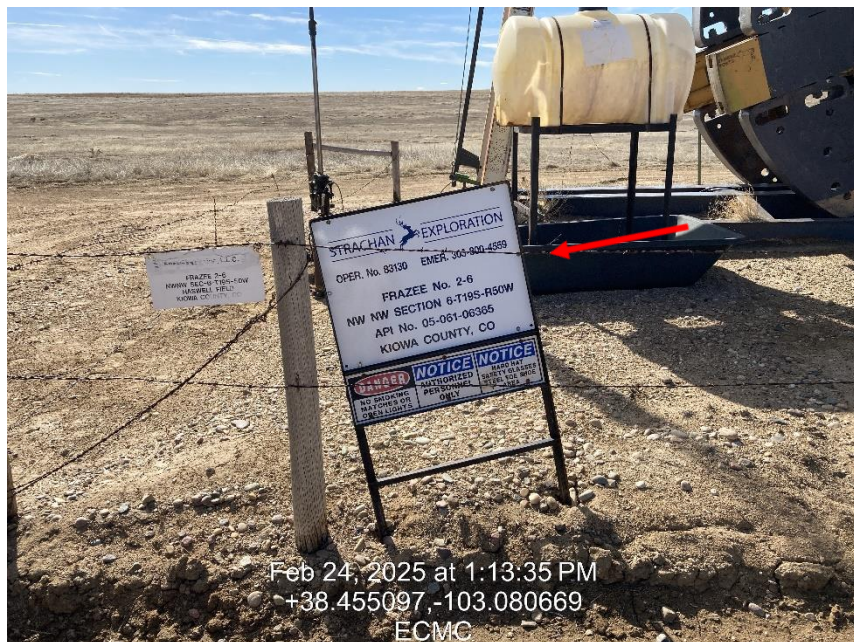
**Photo 1 –Well placard**

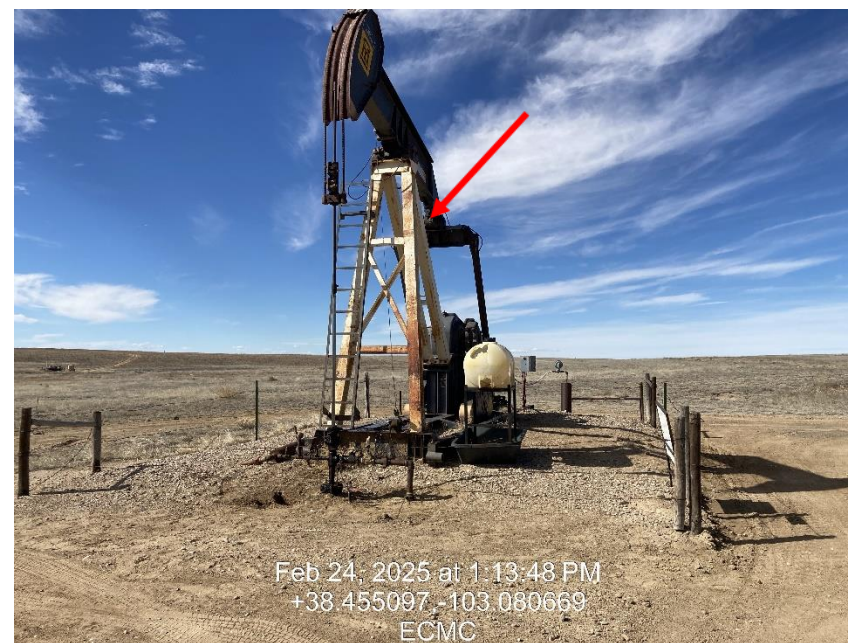
**Photo 2 – Wellhead and Pump Jack**

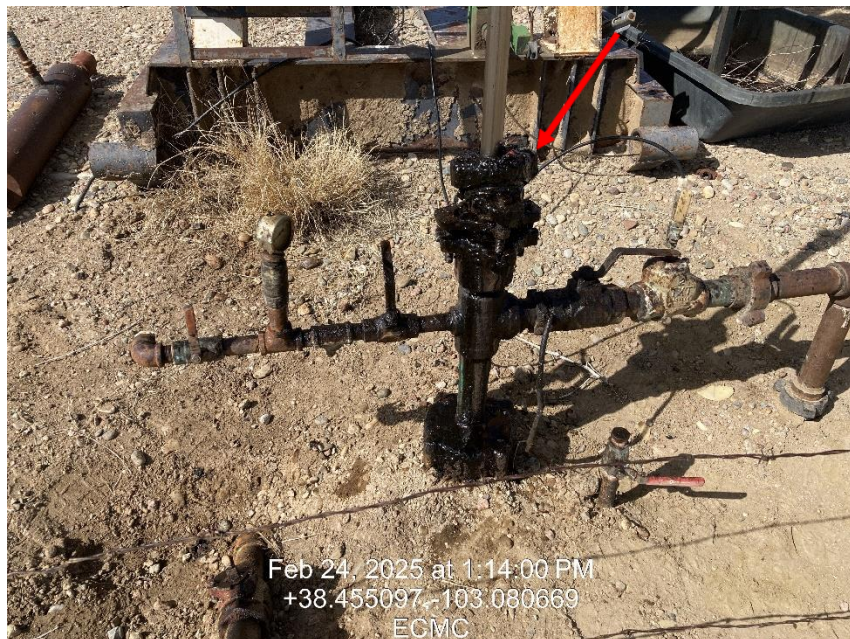
**Photo 3 – Wellhead covered in oily sludge**

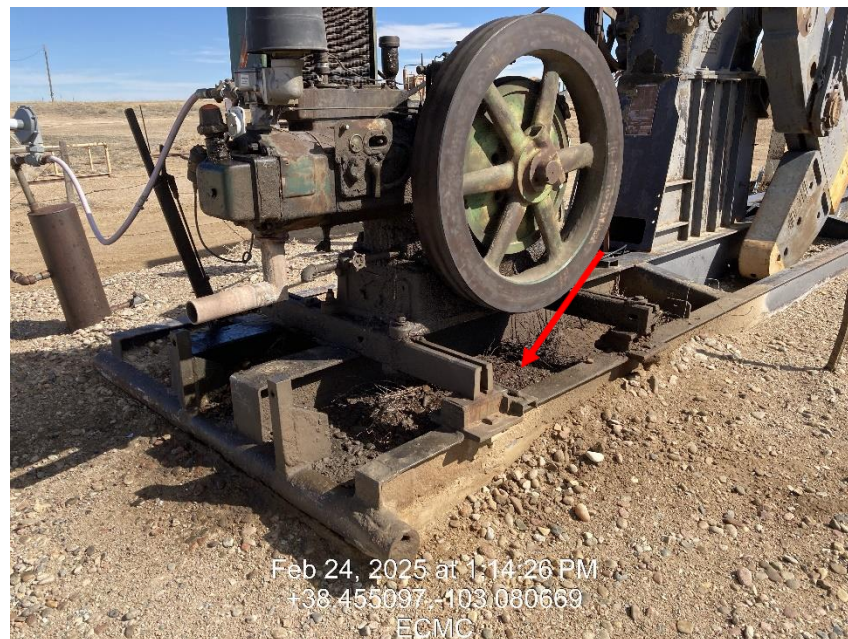
**Photo 4 – Stained oils**

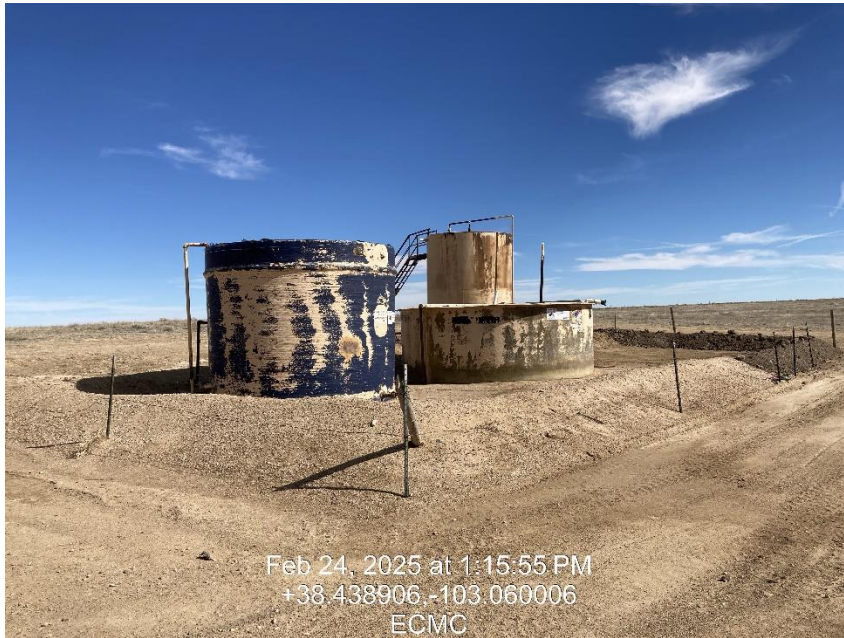
**Photo 5 –Tank Battery**

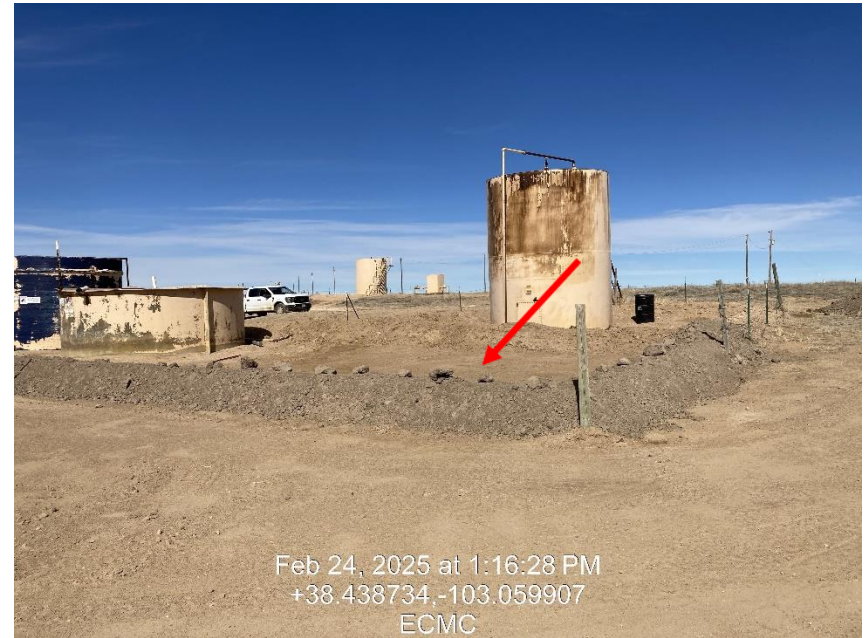
**Photo 6 – Containment reconstructed**

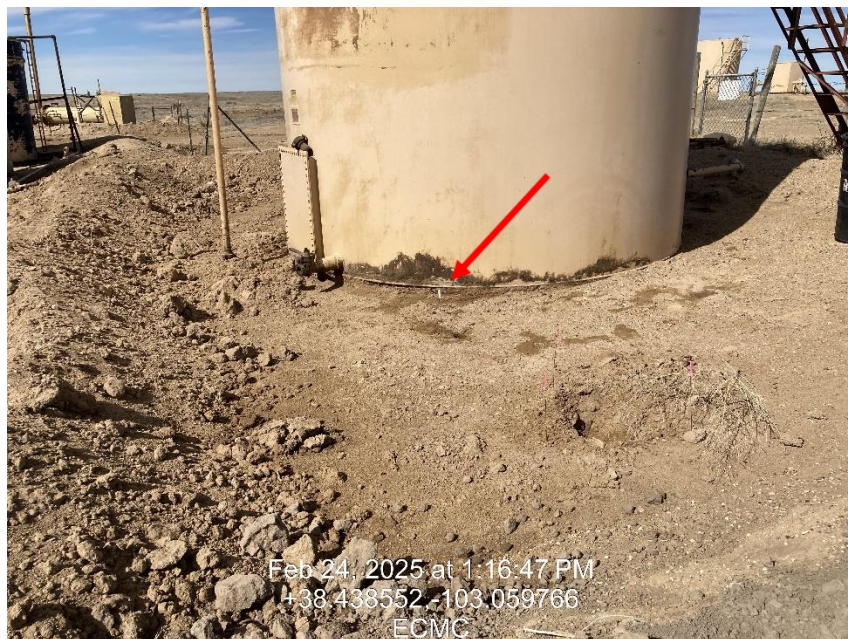
**Photo 7 – Impacted soils in tank containment, Spill Id 486875, Impacted soils observed at tank base**

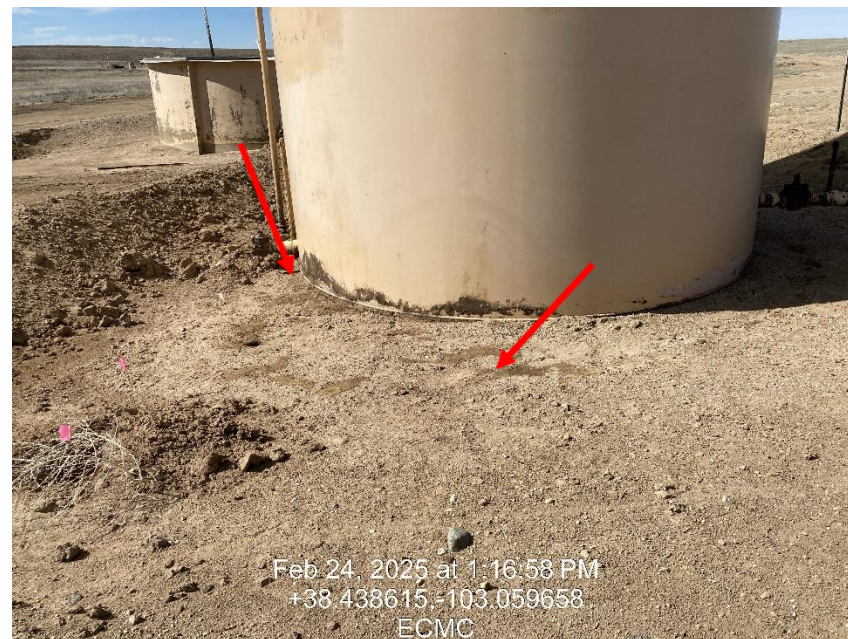
**Photo 8 – Impacted soils in tank containment, Spill Id 486875**

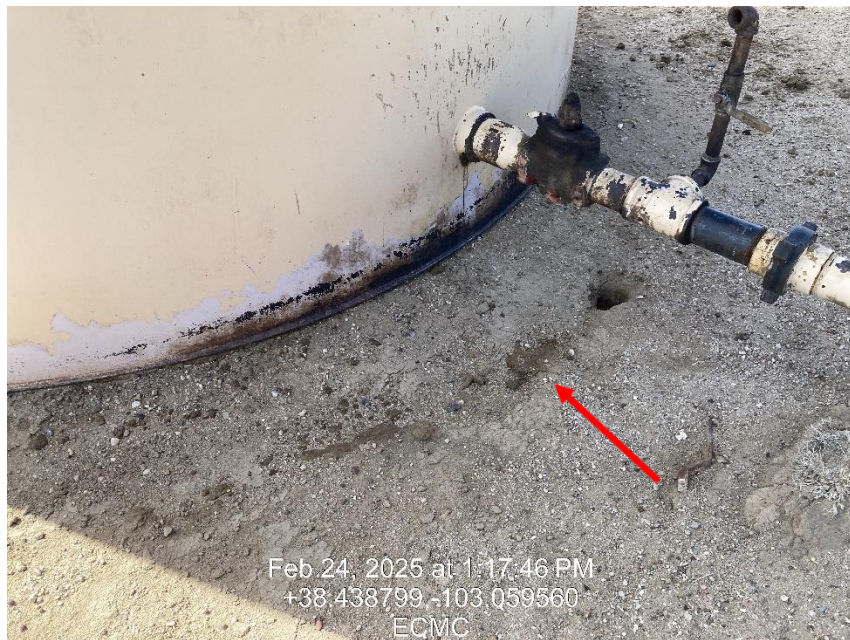
**Photo 9 – Impacted soils observed on north side of tank, Spill Id 486875**

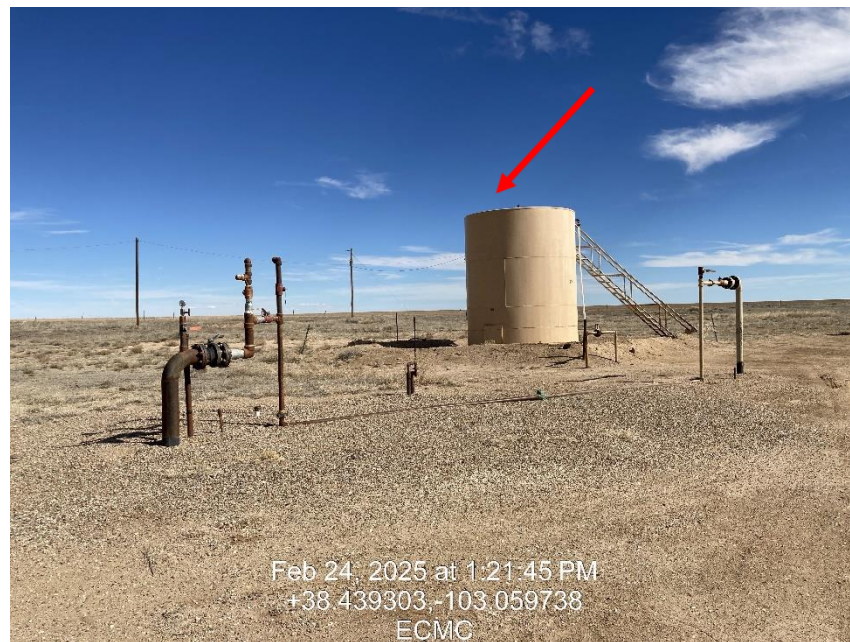
**Photo 10 – Tank battery and equipment on north side of road**

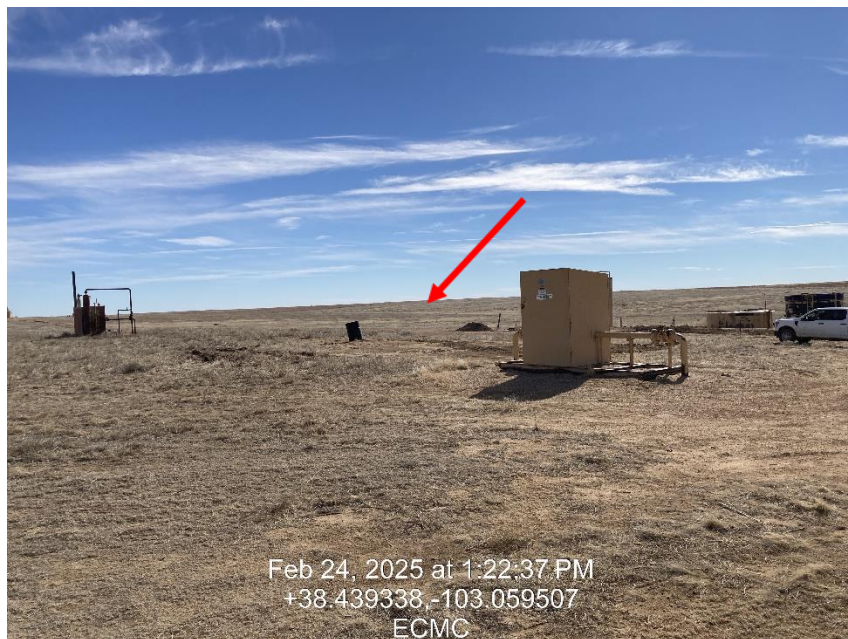
**Photo 11 –Tank had been removed**

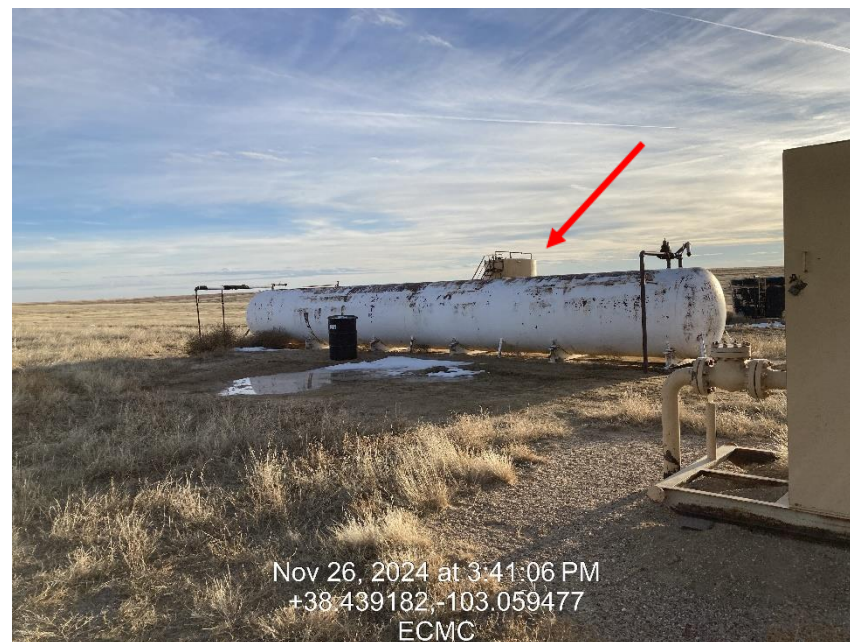
**Photo 12 – Historical Photo 11/26/2024**

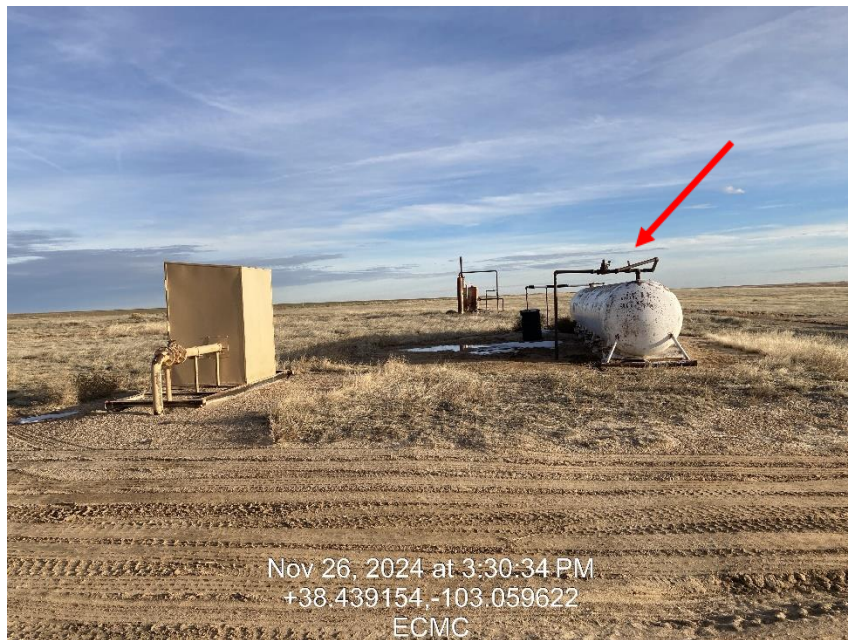
**Photo 13 –Historical Tank 11/26/2024**

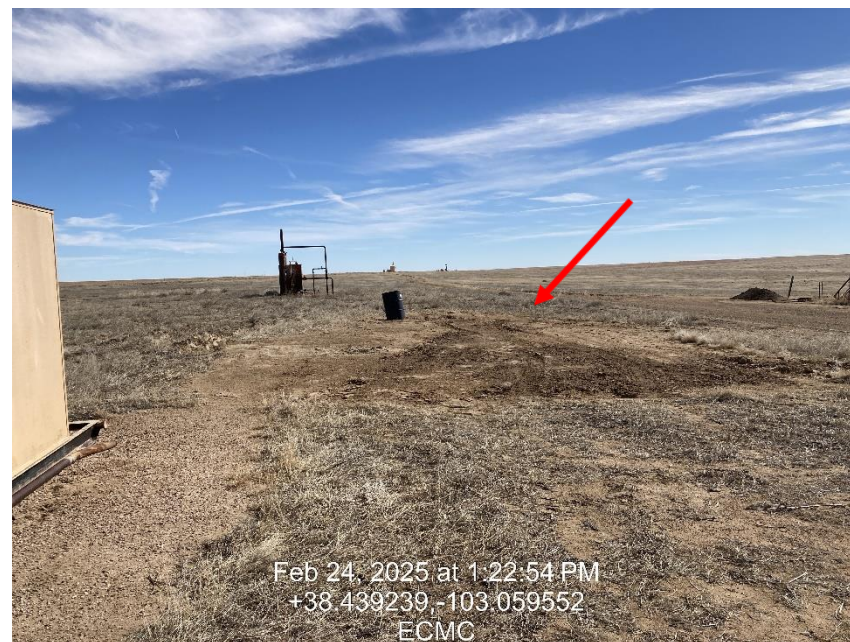
**Photo 14 – Tank has been removed**
