Inspection Photos

Operator: SCOUT ENERGY MANAGEMENT LLC
- 10779

Location ID: 315585

Inspection Doc: 718100266

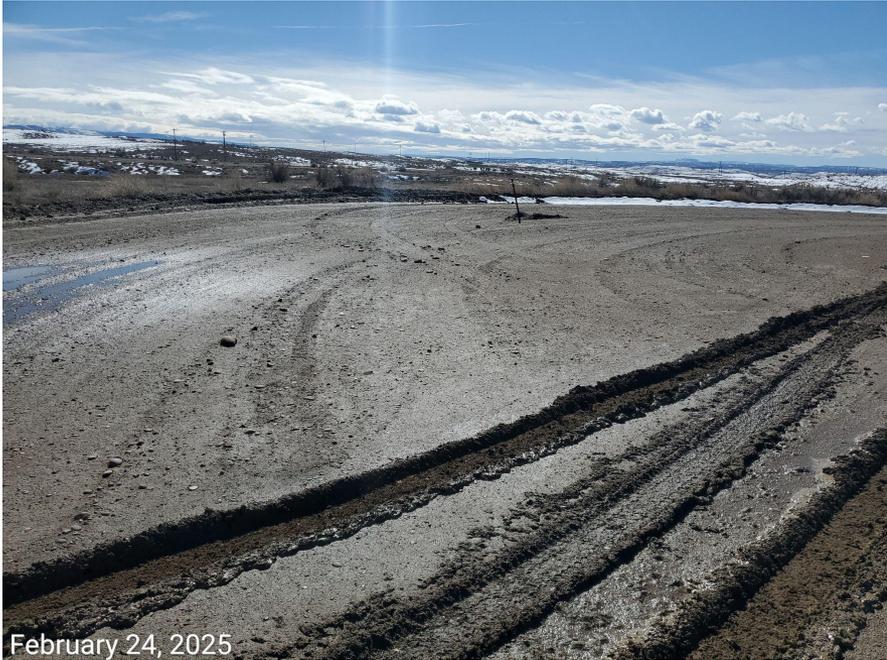
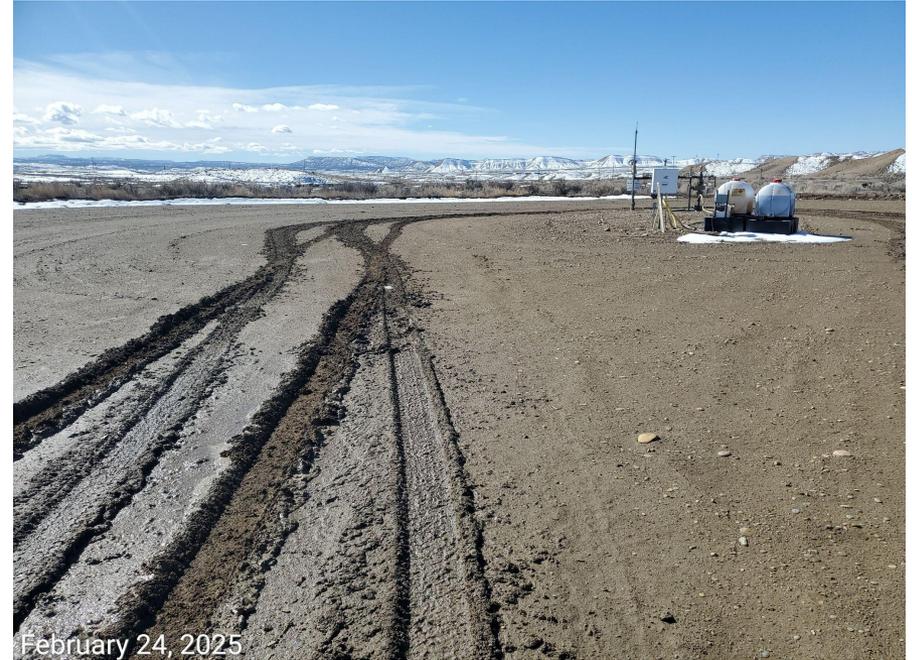
Photo 1: Photos 1-2 taken from the location entrance on the northeast end of the working pad surface. Photos provide an overview of the Location from south, southwest, west to northwest. Photos also examples showing vehicle tracking and sediment transport control measures are no longer in proper functioning condition, resulting in rutting, degradation and sediment transport.

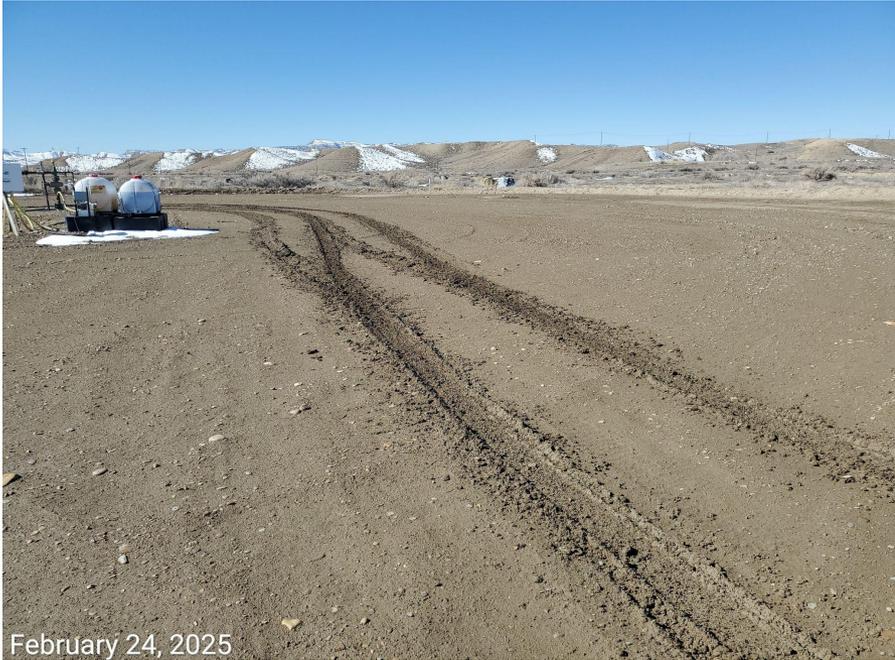
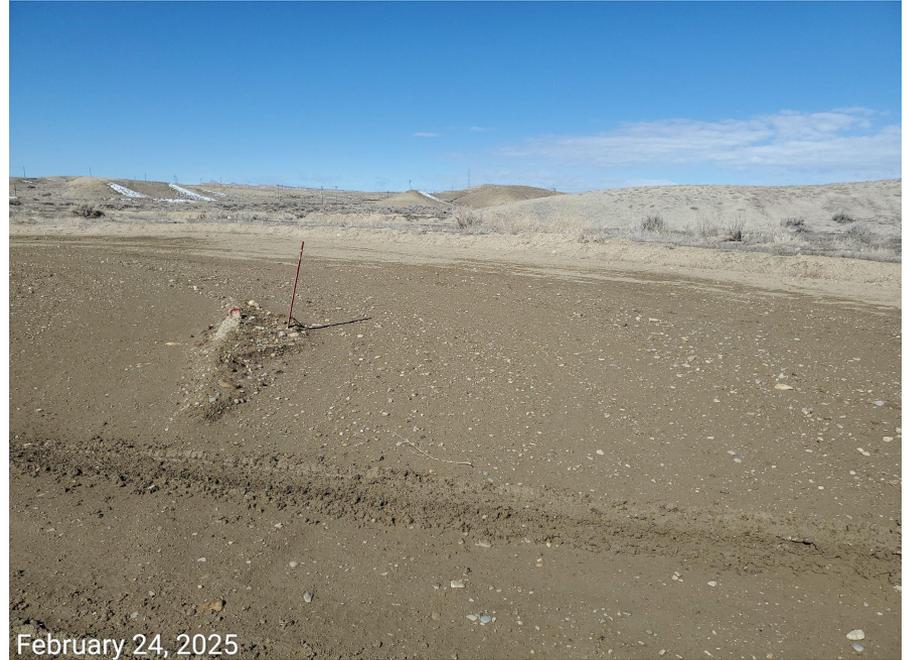
Photo 2: See comments under photo 1.

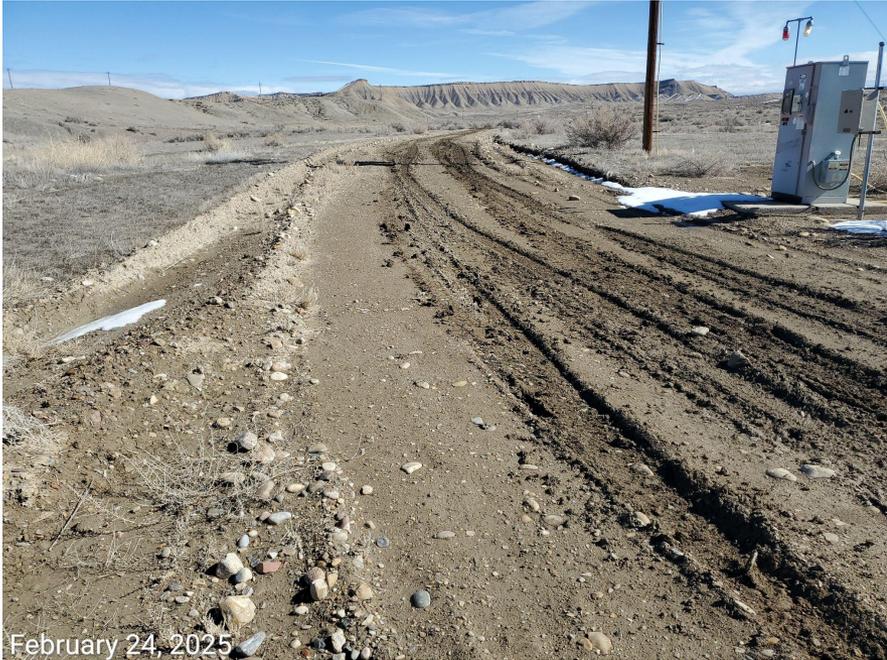
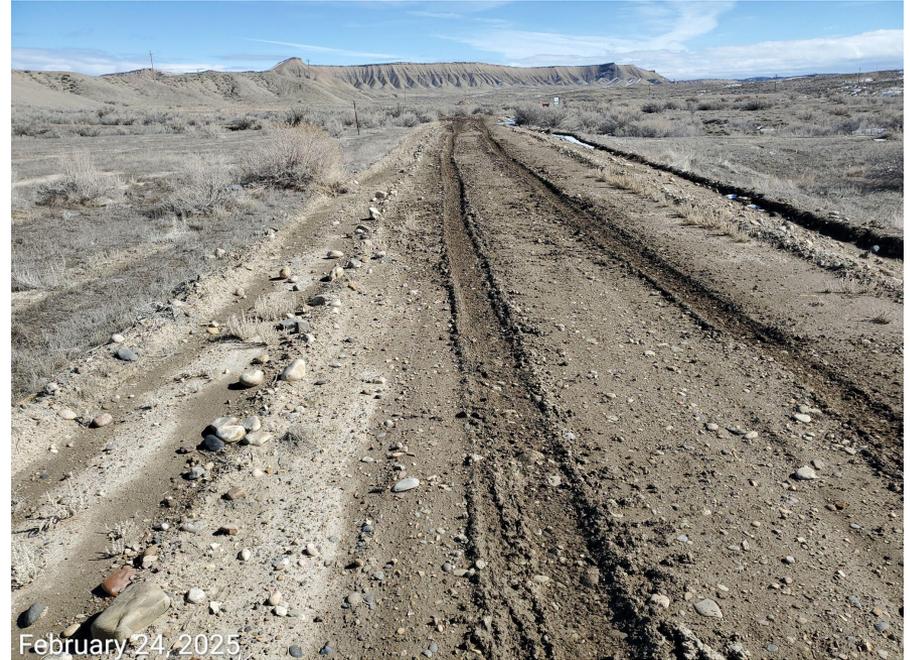
Photo 3: Photos taken from the access road, facing northeast. Photos examples showing vehicle tracking and sediment transport control measures are no longer in proper functioning condition, resulting in rutting, degradation and sediment transport.

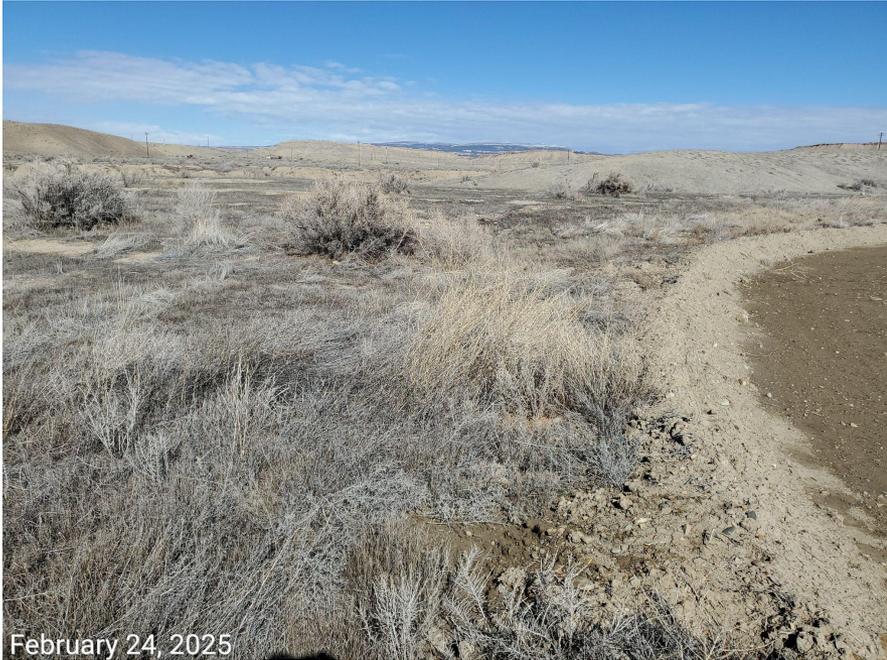
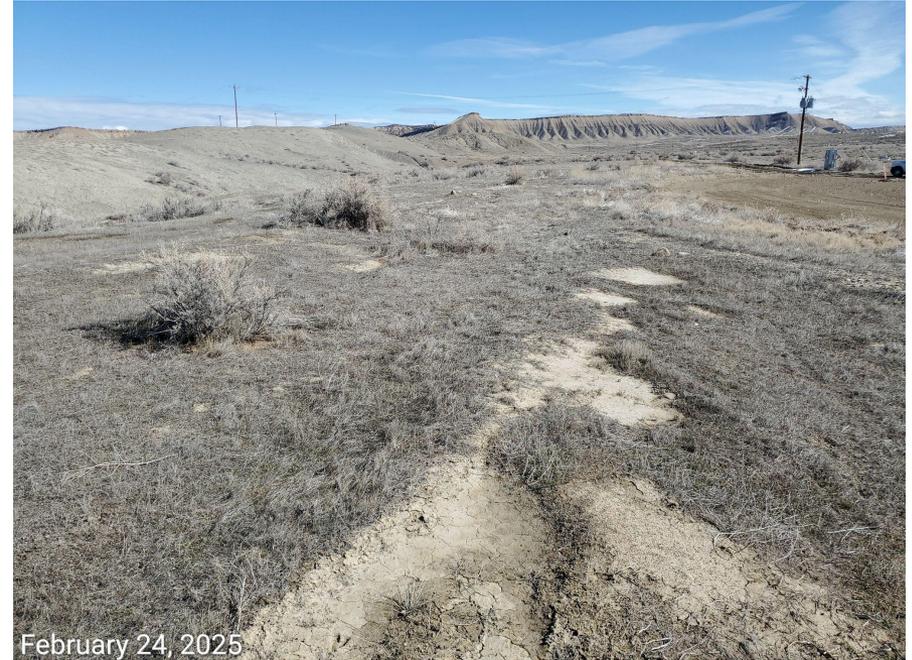
Photo 4: Photos examples of the interim areas of the Location. Vegetation throughout the interim areas are predominantly weedy annual species such as Annual Wheatgrass and Cheatgrass, however these species are also prevalent throughout the adjacent reference areas. See Photo 5.

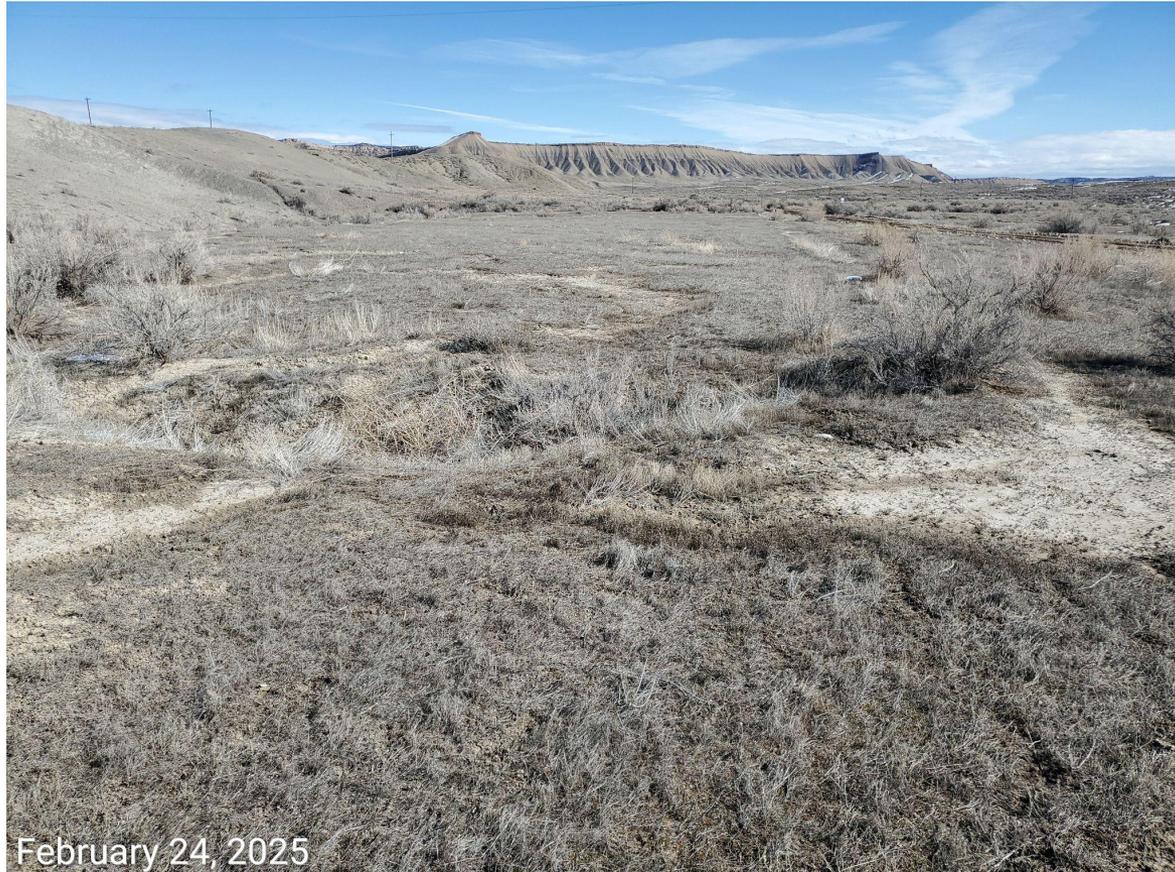
Photo 5: Photo taken from the adjacent reference areas for comparison.

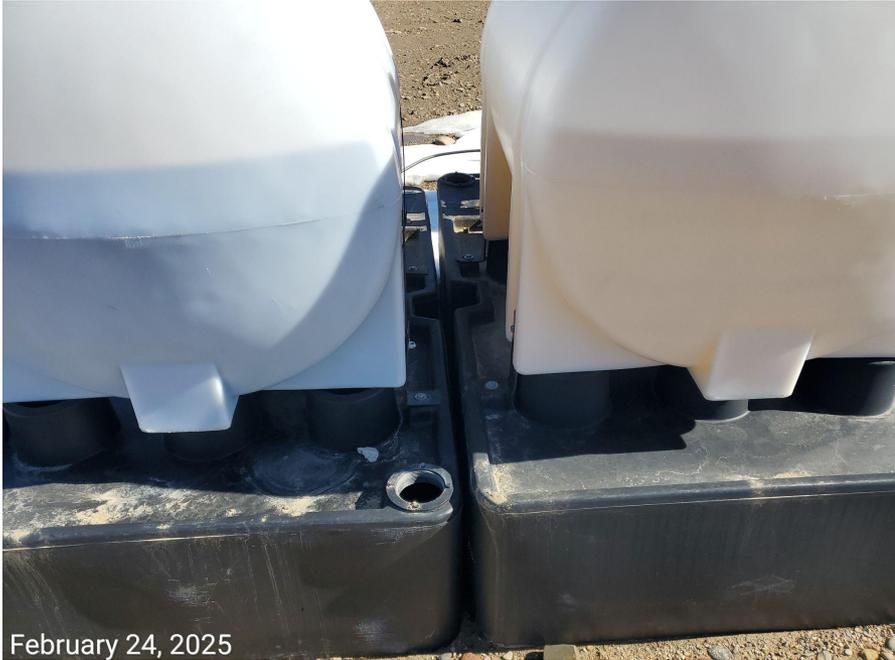
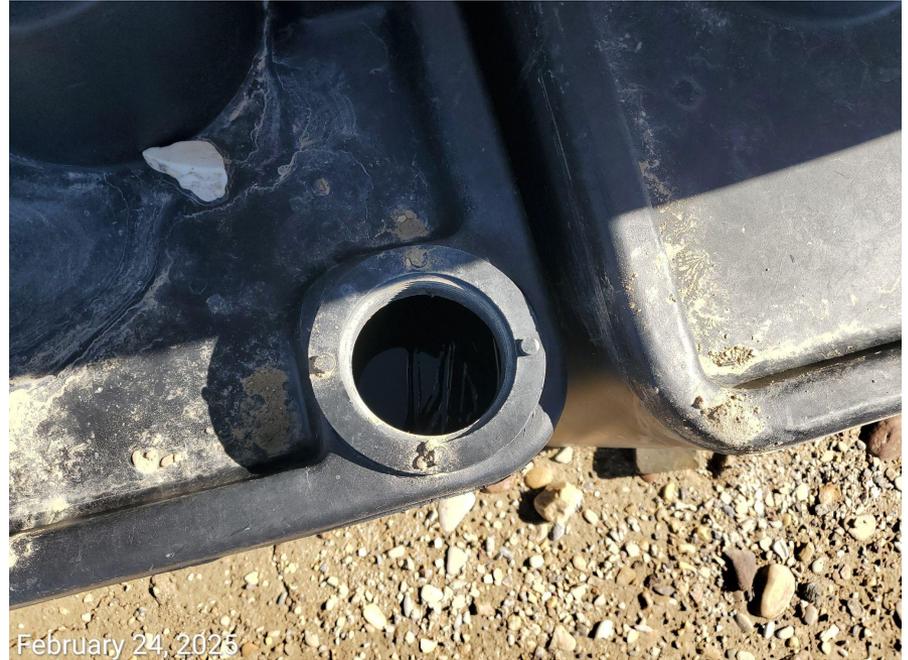
Photo 6: Photos show cap missing from the secondary containment BMPs. Fluids also observed within containment.

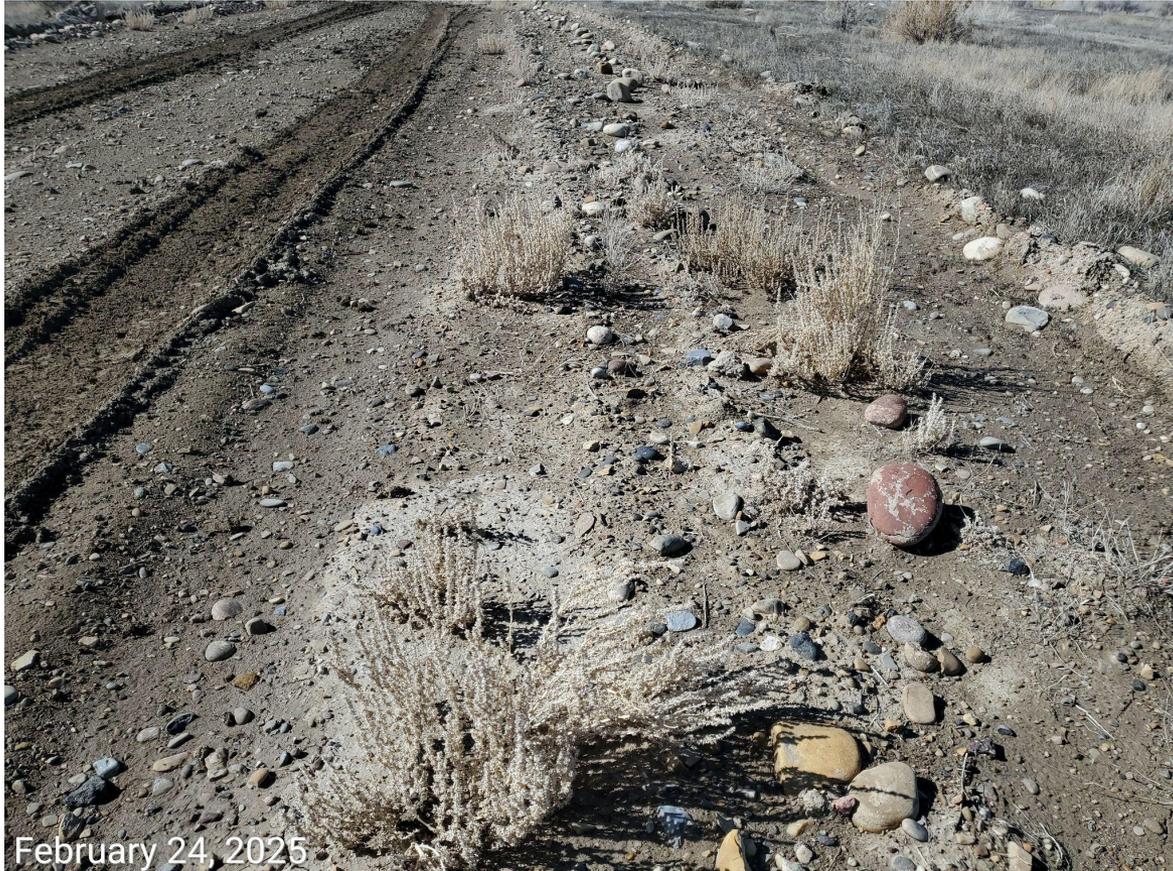
Photo 7: Photo example showing halogeton observed established along the access road.
