Inspection Photos
Location: Frontera Unit Gas Plant
Location ID: 480729, Spill ID 489242
API #

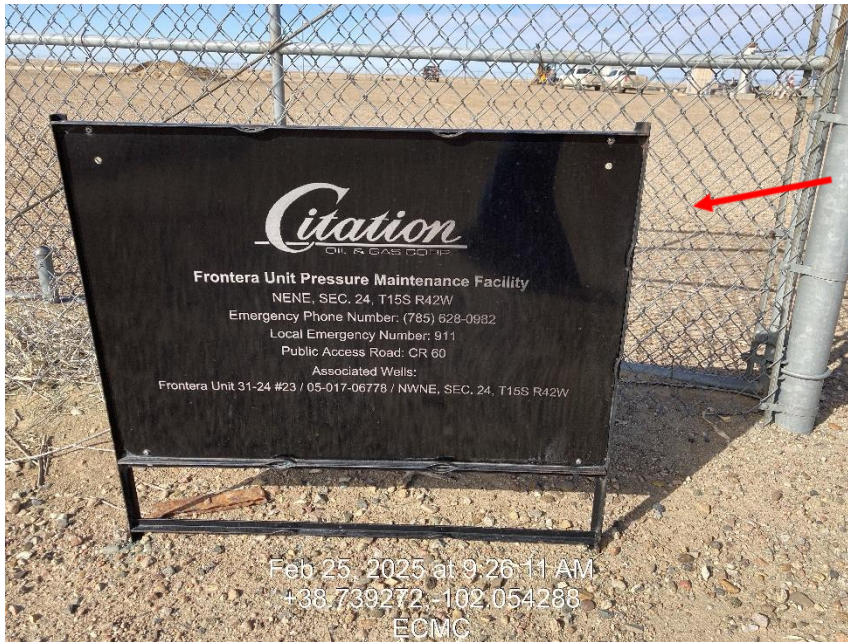
Photo 1 –Placard

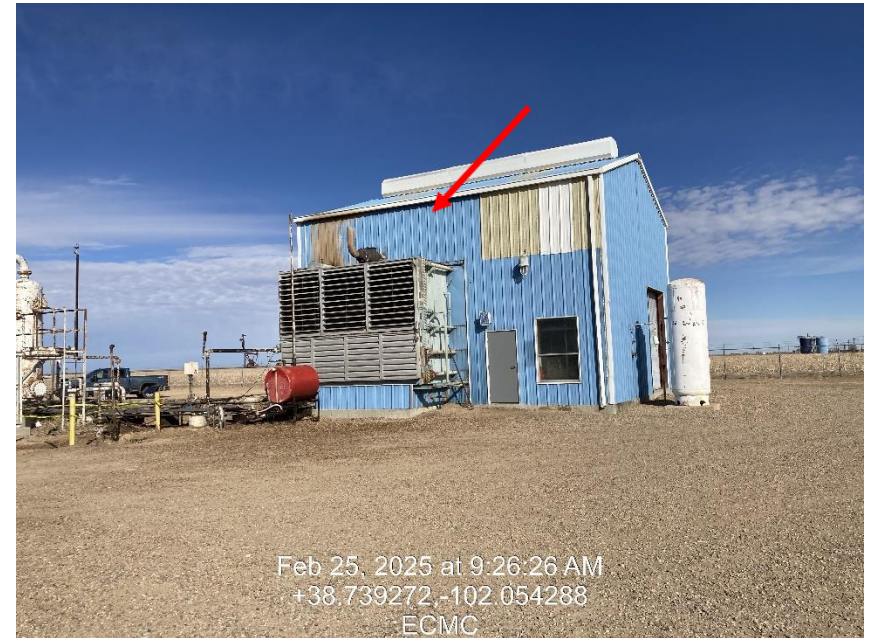
Photo 2 – Gas Plant

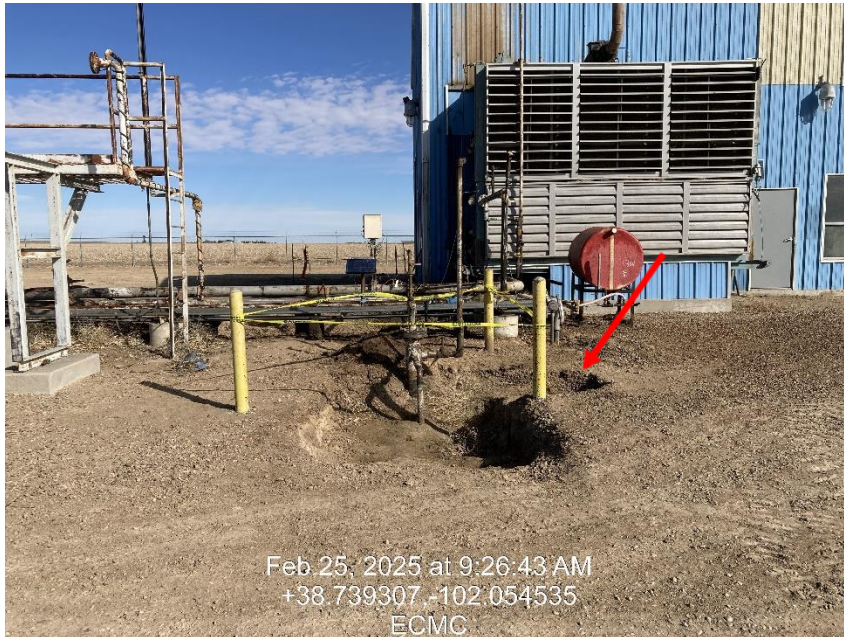
Photo 3 – Spill Remediation area

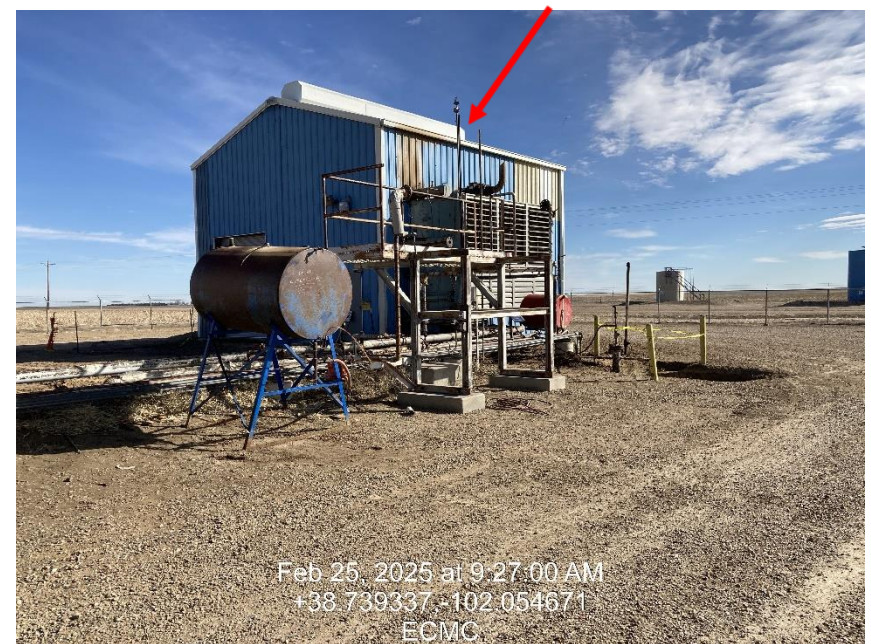
Photo 4 – Gas Plant

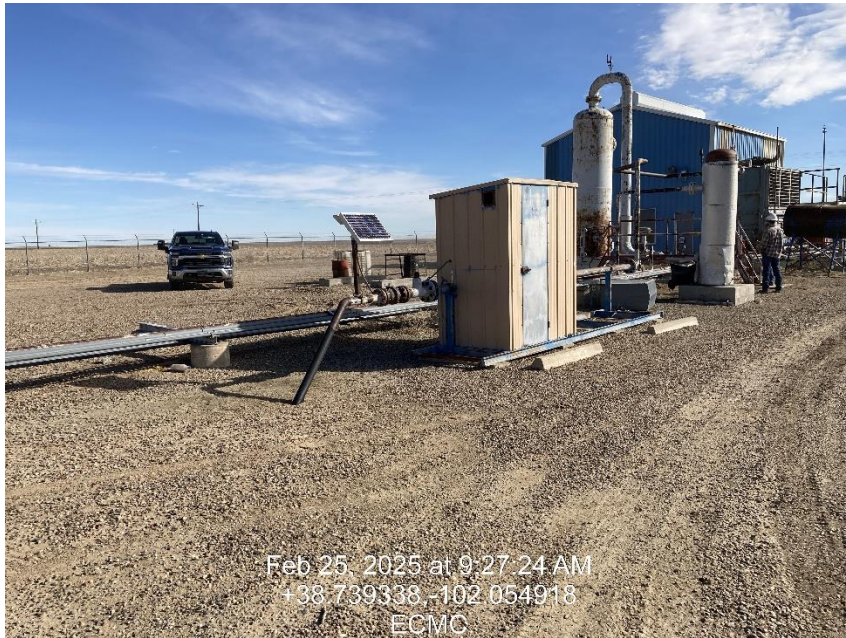
Photo 5 –Equipment

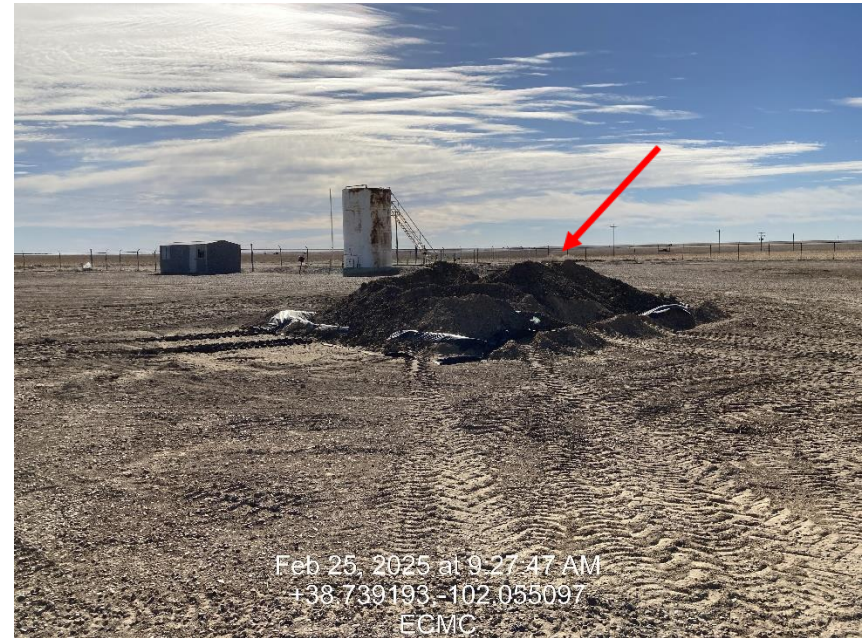
Photo 6 – Contaminated soils stored on liner

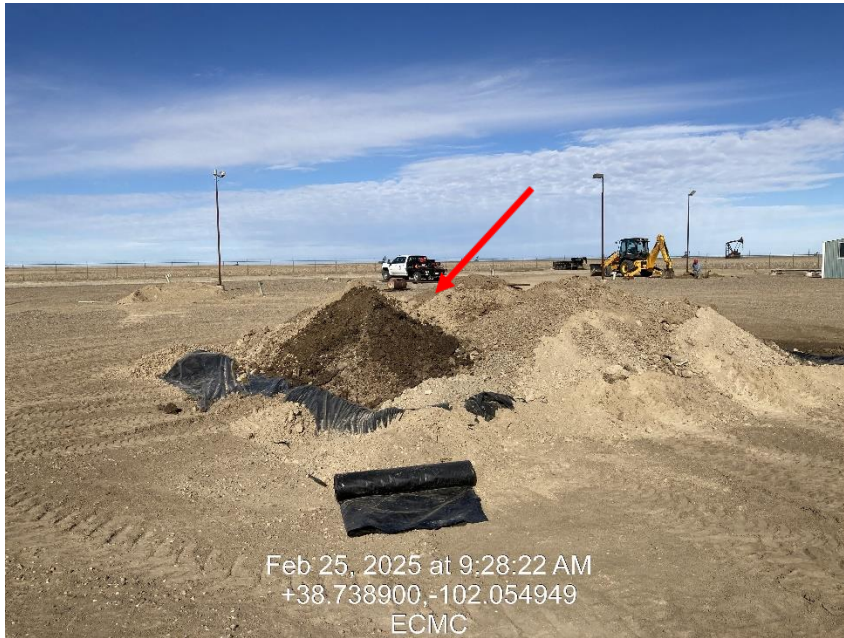
Photo 7 –Contaminated soils stored on liner

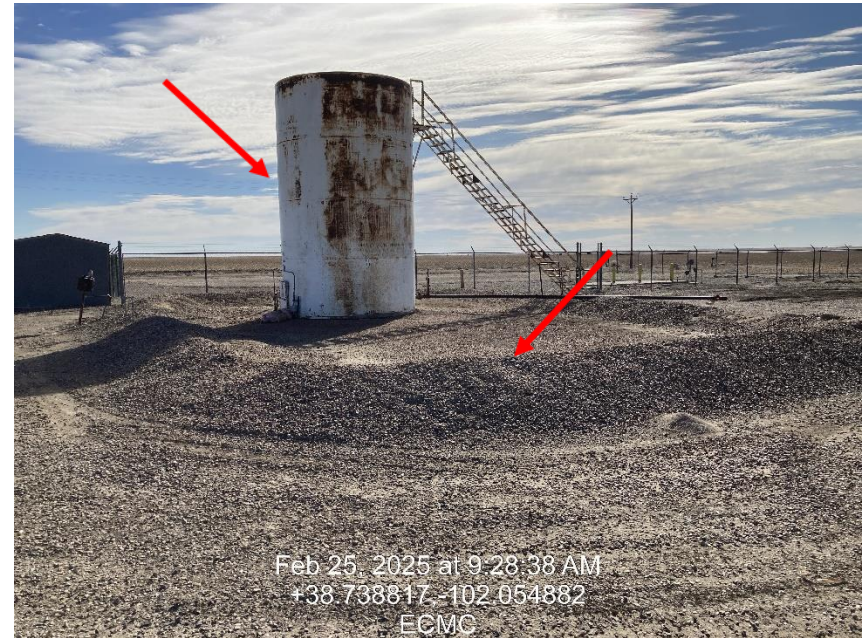
Photo 8 – Tank in containment

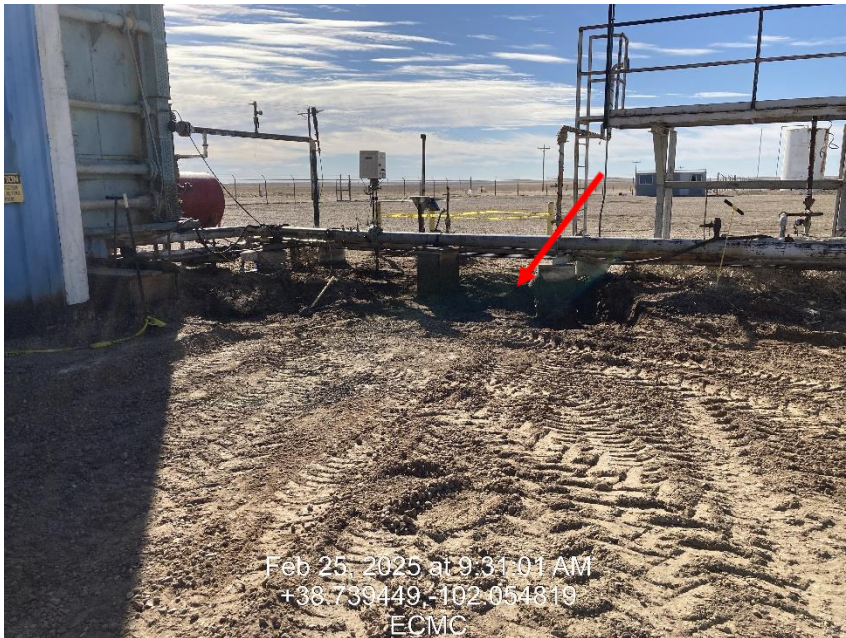
Photo 9 –Spill Remediation area

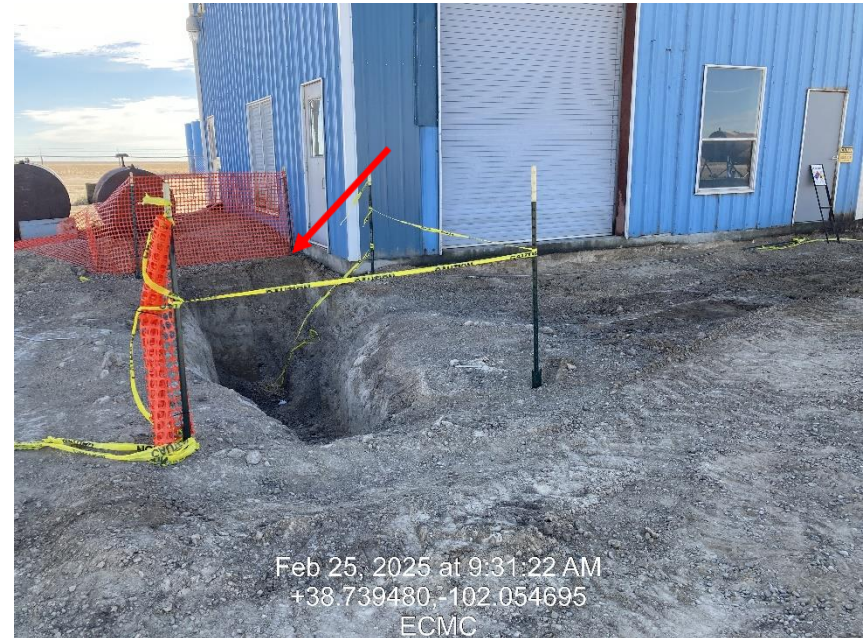
Photo 10 – Spill Remediation area

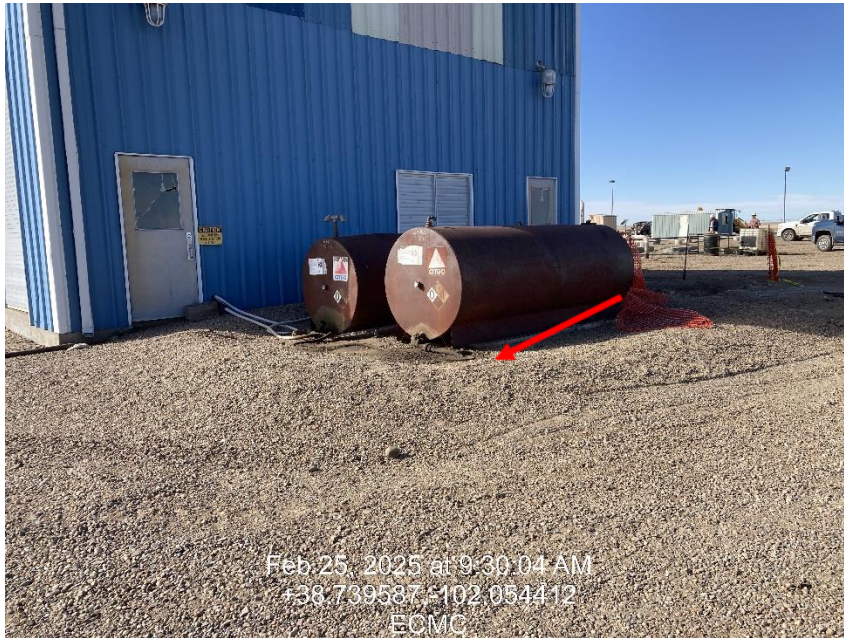
Photo 11 – Tanks with stained soils no secondary containment

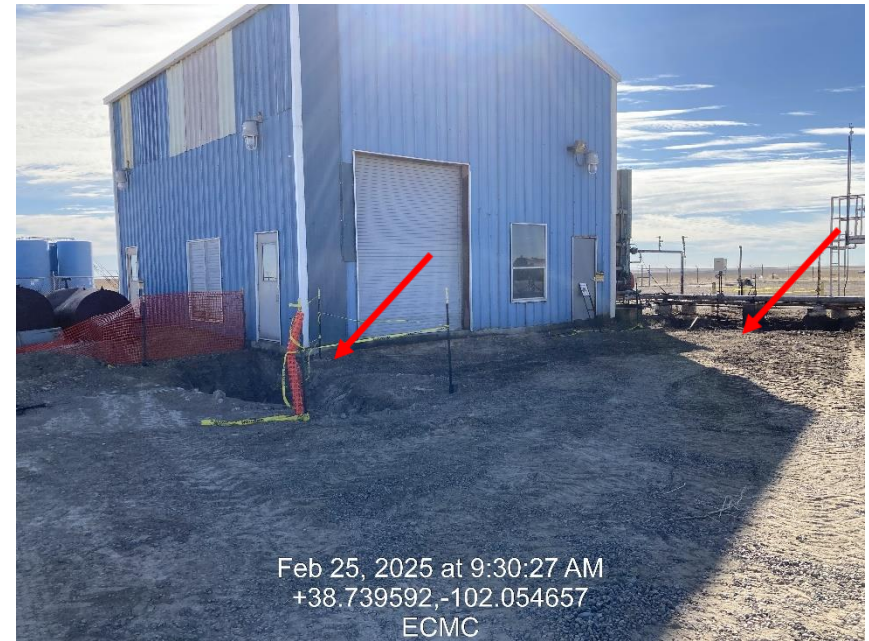
Photo 12 – Spill Remediation
