Inspection Photos

Loc: 485761

Operator: WAVETECH HELIUM INC

Inspection Date: 2/26/2025

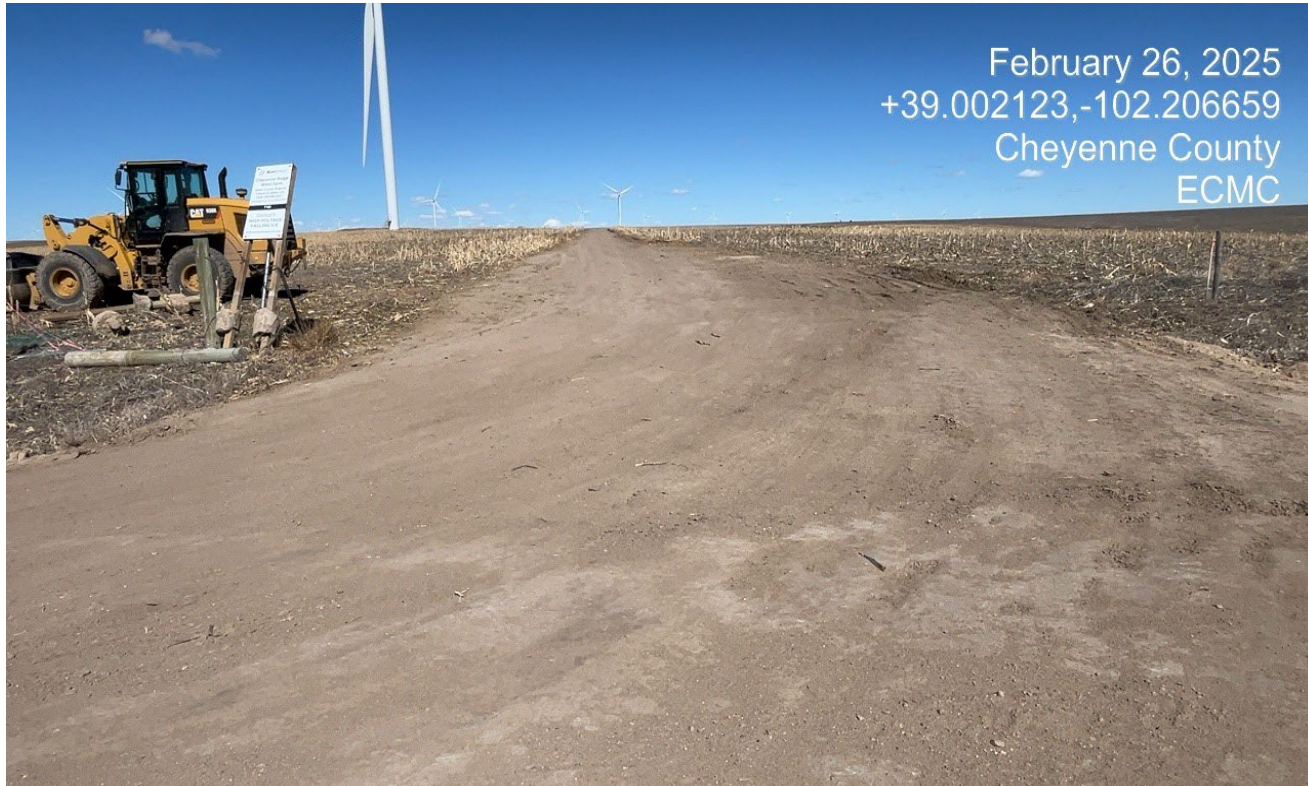
Photo 1. Facing north toward the access road.

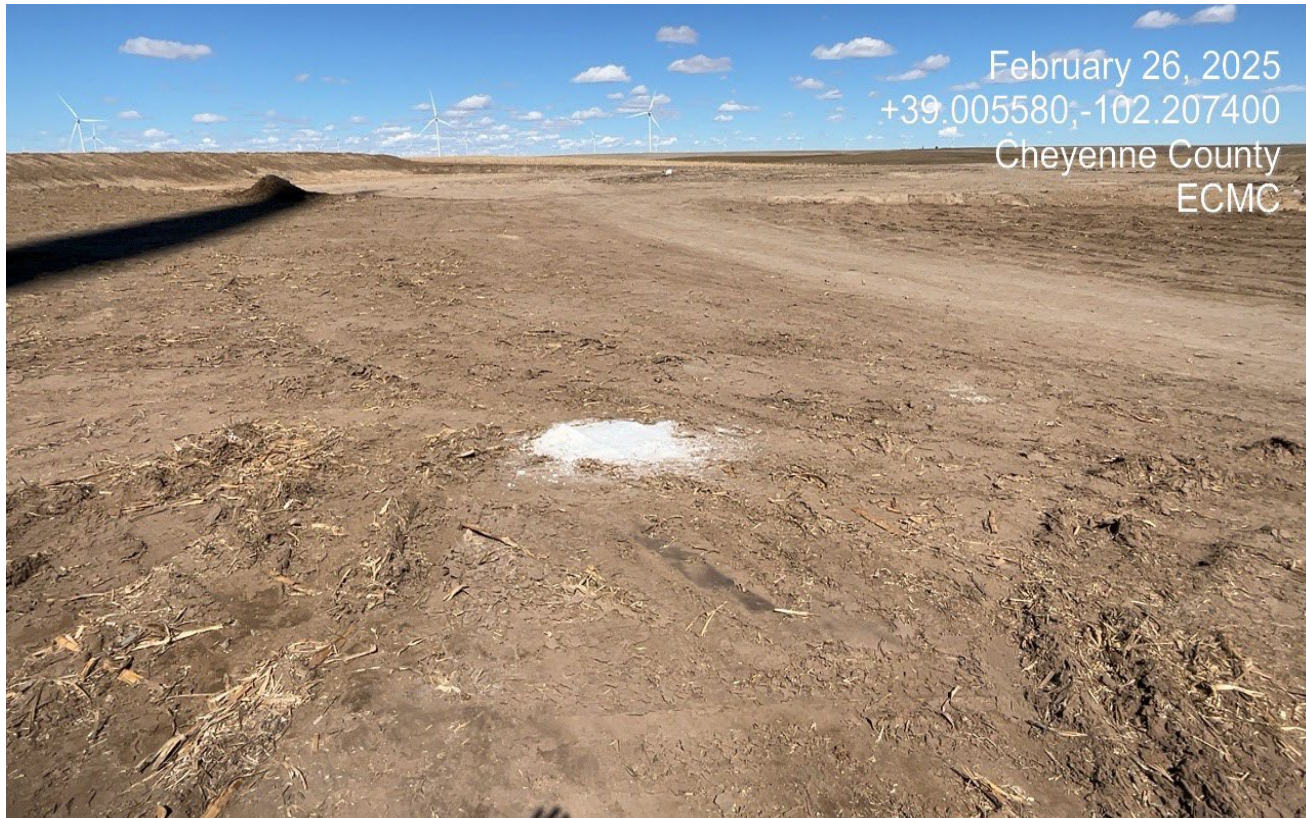
Photo 2. Facing north toward the location. There is a pile of a white substance spill on the ground that needs to be cleaned up. .

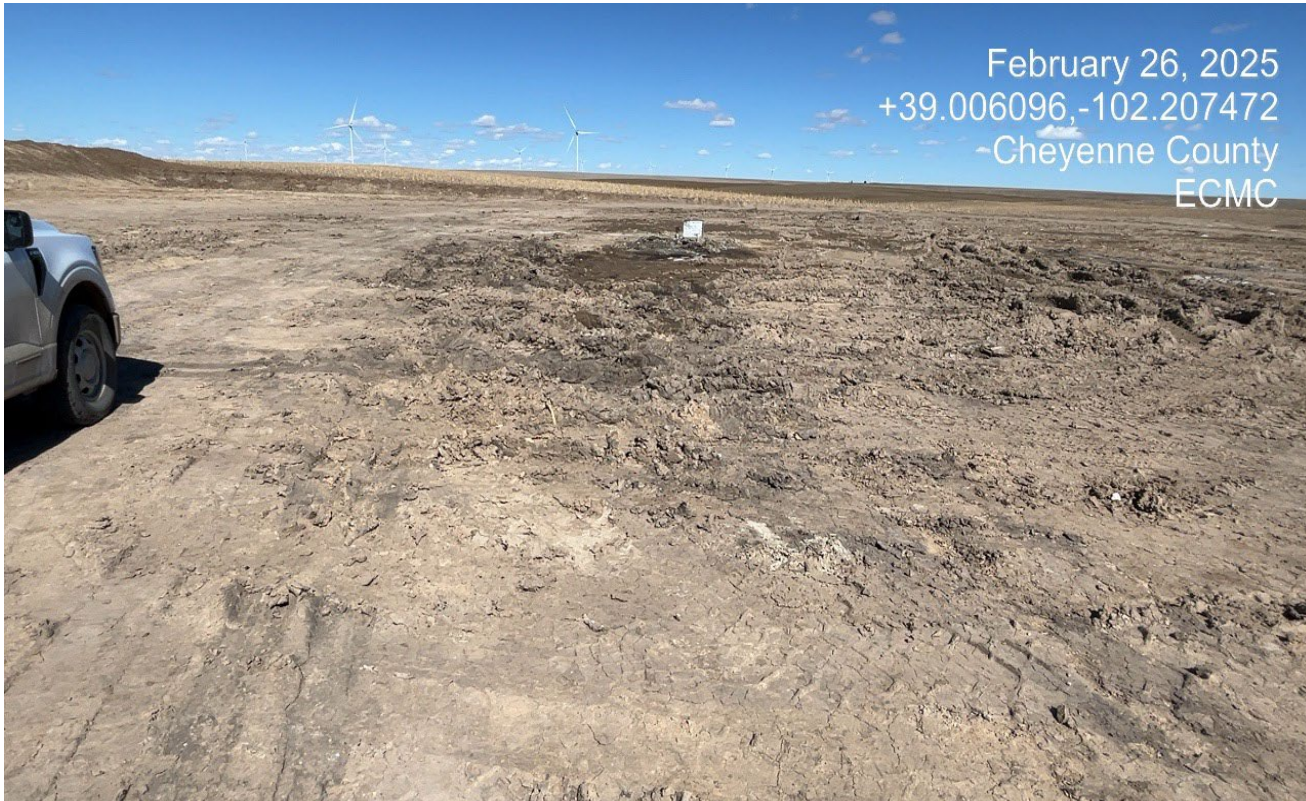
Photo 3. Facing north at the wellsite which has recently been drilled.

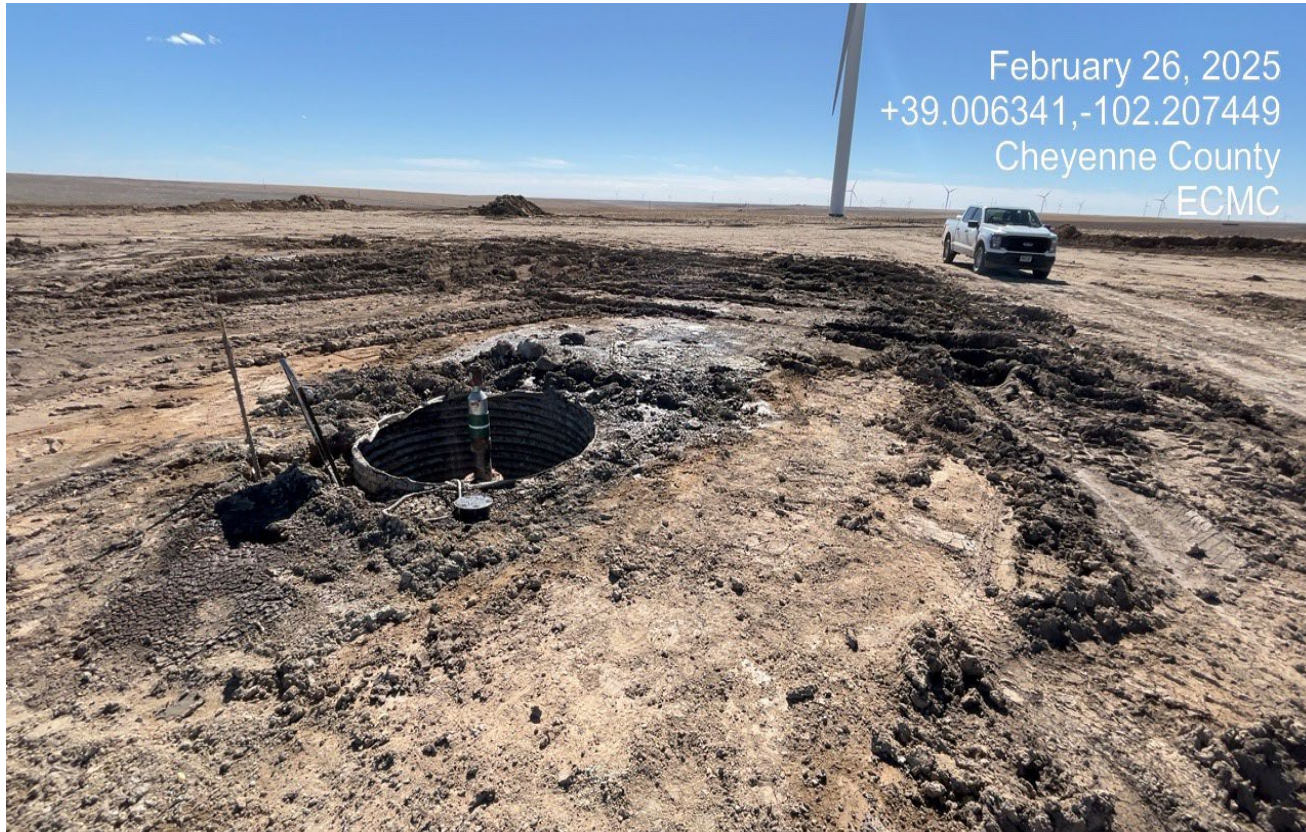
Photo 4. Facing back south at the wellhead. There is grey and blackened mud all around the wellhead. Drilling mud was not properly managed during the drilling process.

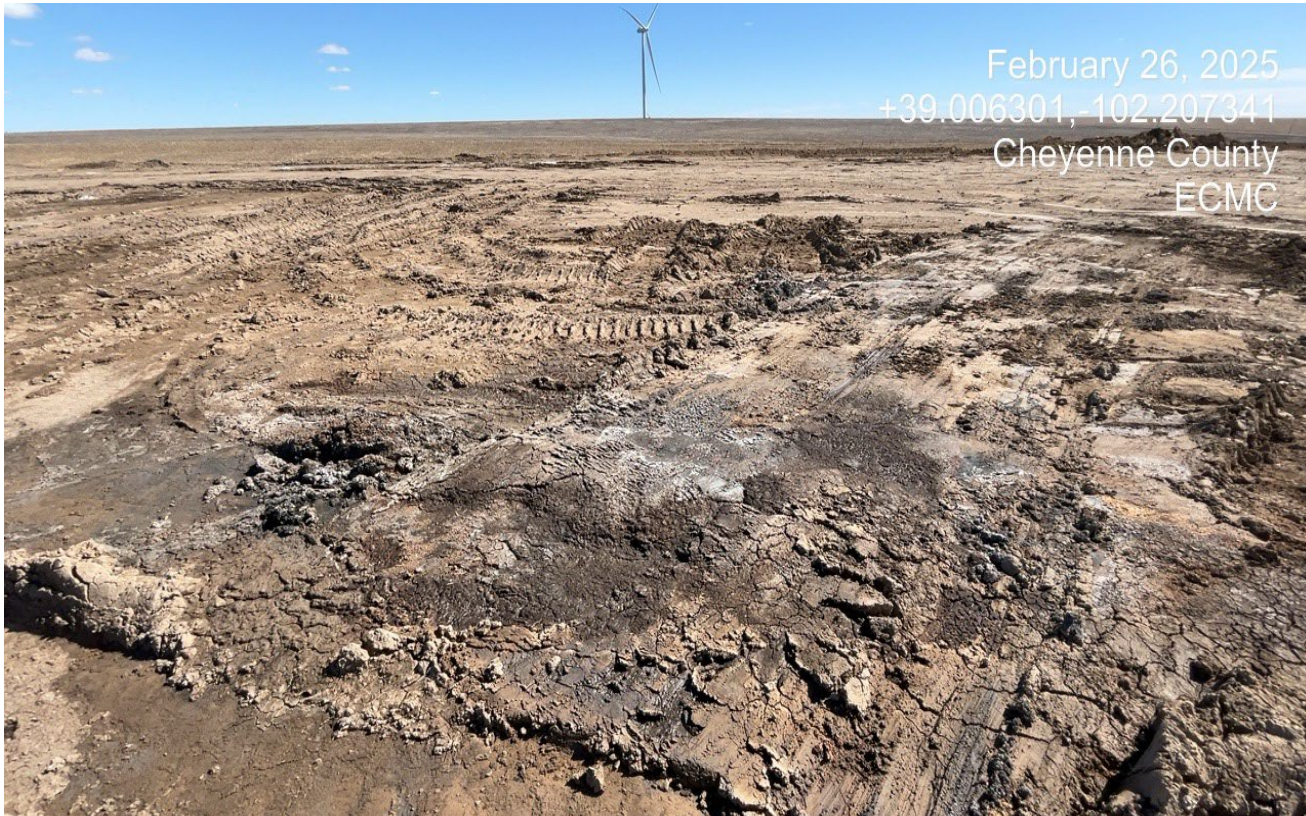
Photo 6. Facing east at the location. There is grey and blackened mud all around the wellhead. Drilling mud was not properly managed during the drilling process.

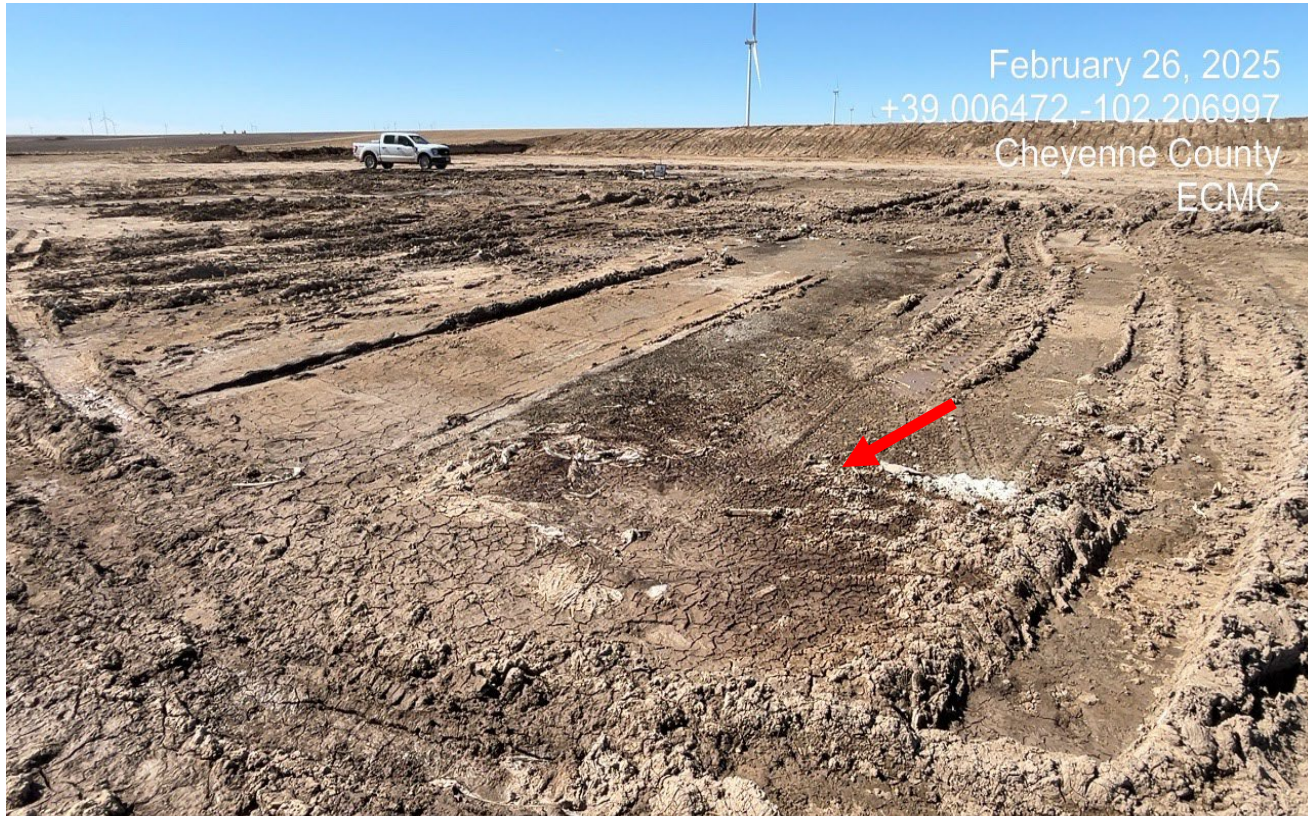
Photo 7. Facing southwest at the location. There are stained soils shown at red arrow..

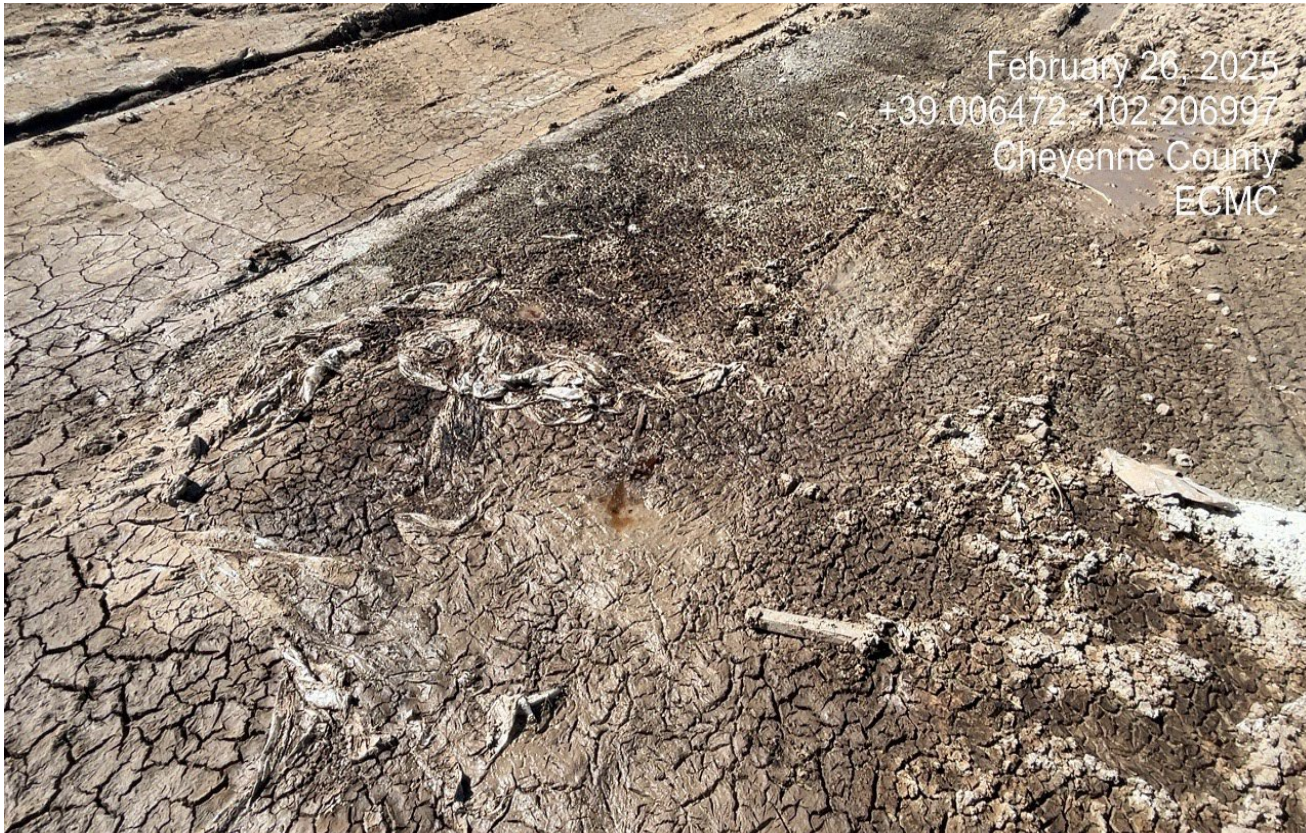
Photo 8. Close up view of the previous photos shows oily impacts on the surface including plastic and a white substance.

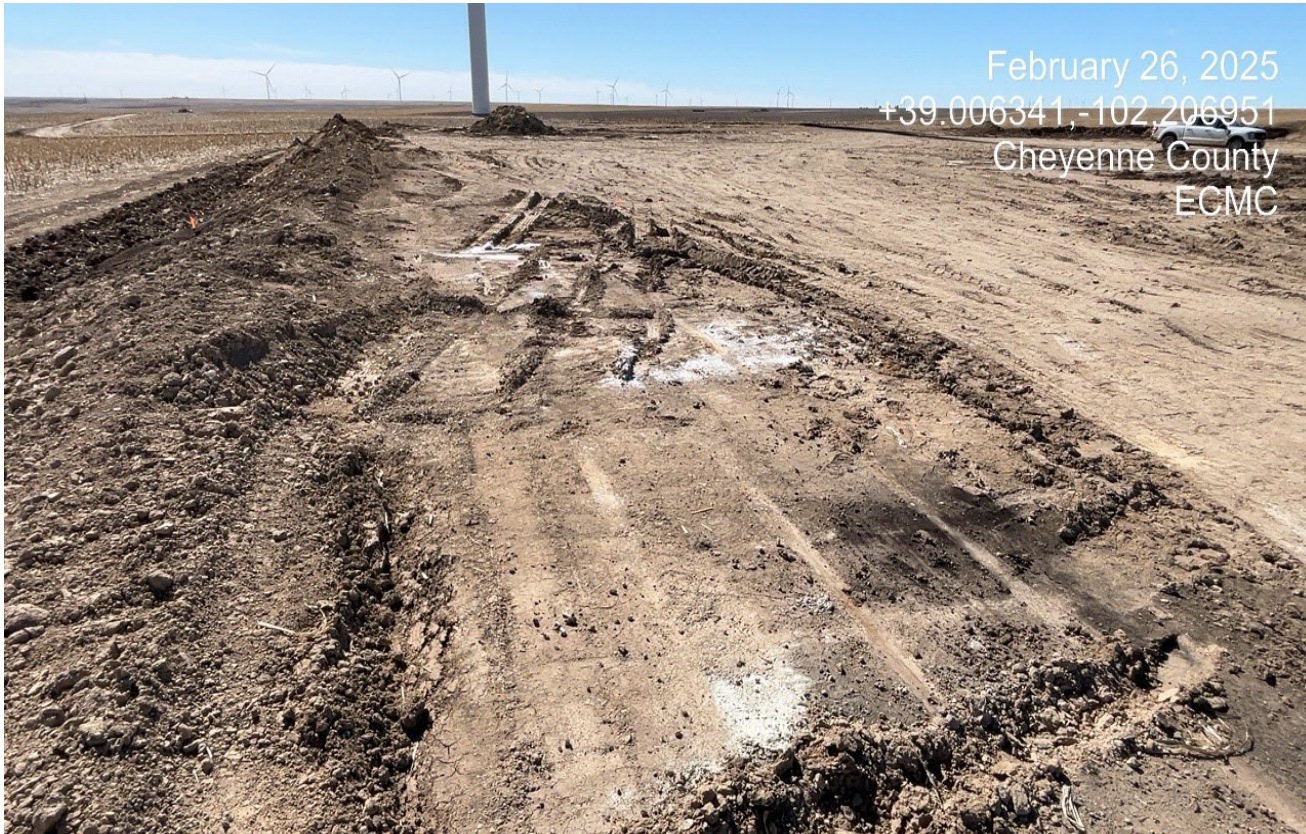
Photo 9. East side of the location facing south. There is a white substance spill on the surface along this area.

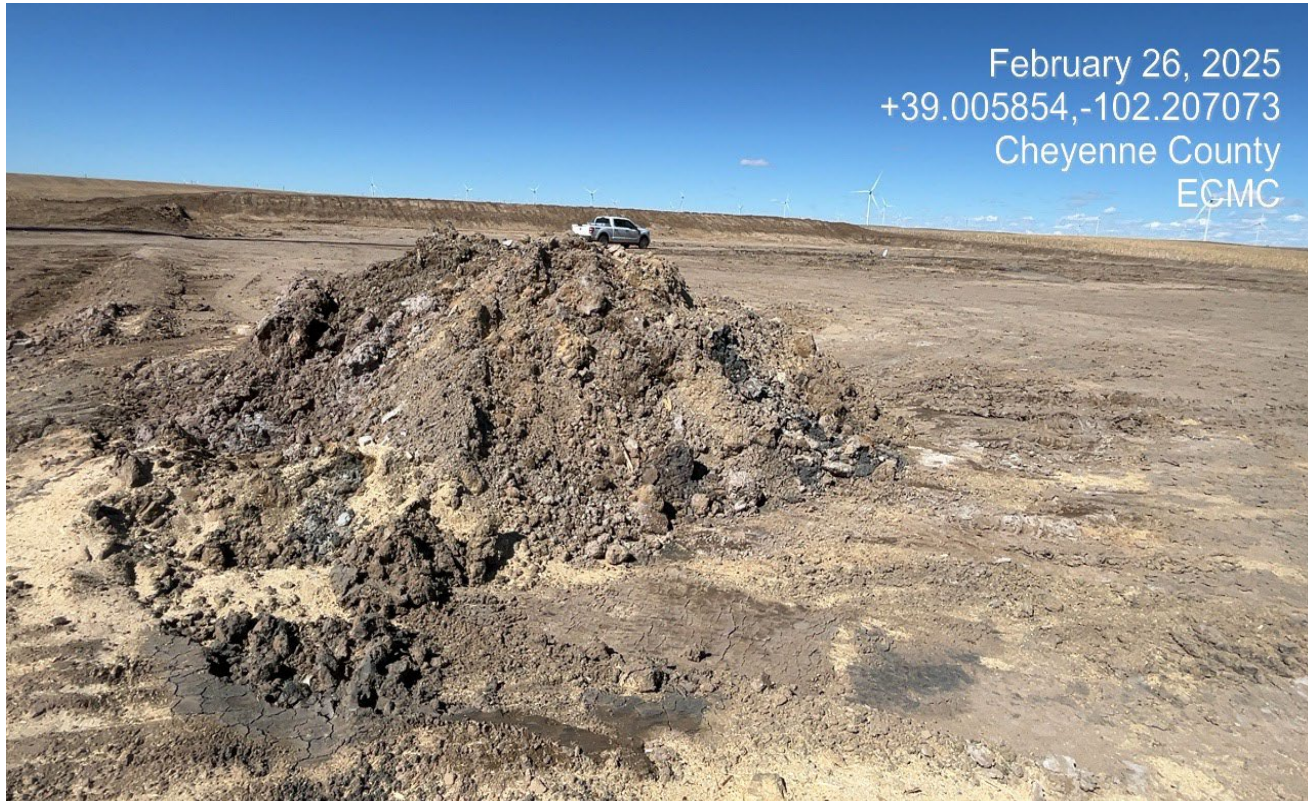
Photo 10. There is a pile of drill cuttings and mud mixed with sawdust at the southeast corner of the location..

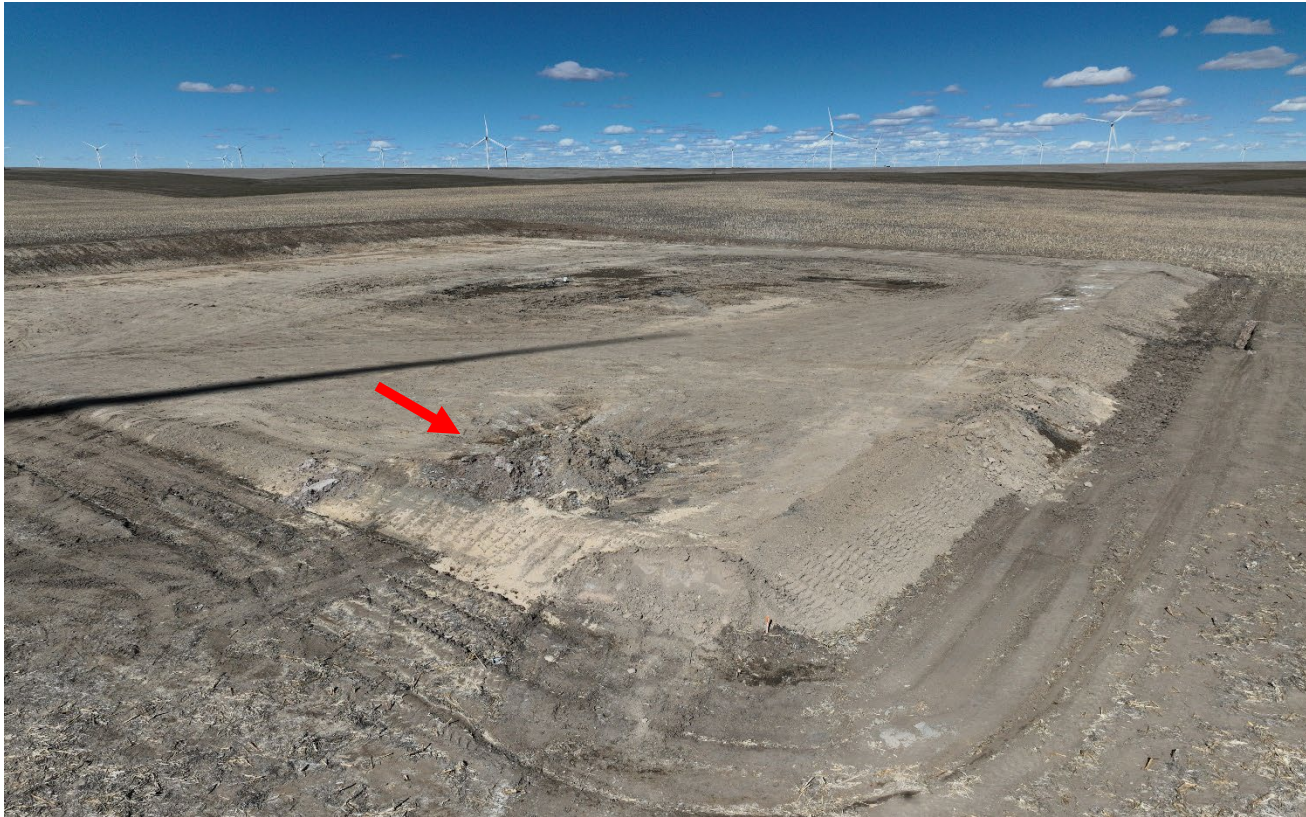
Photo 11. Drone aerial photo facing northwest. Red arrow points to the drill cuttings pile shown in the previous photo.

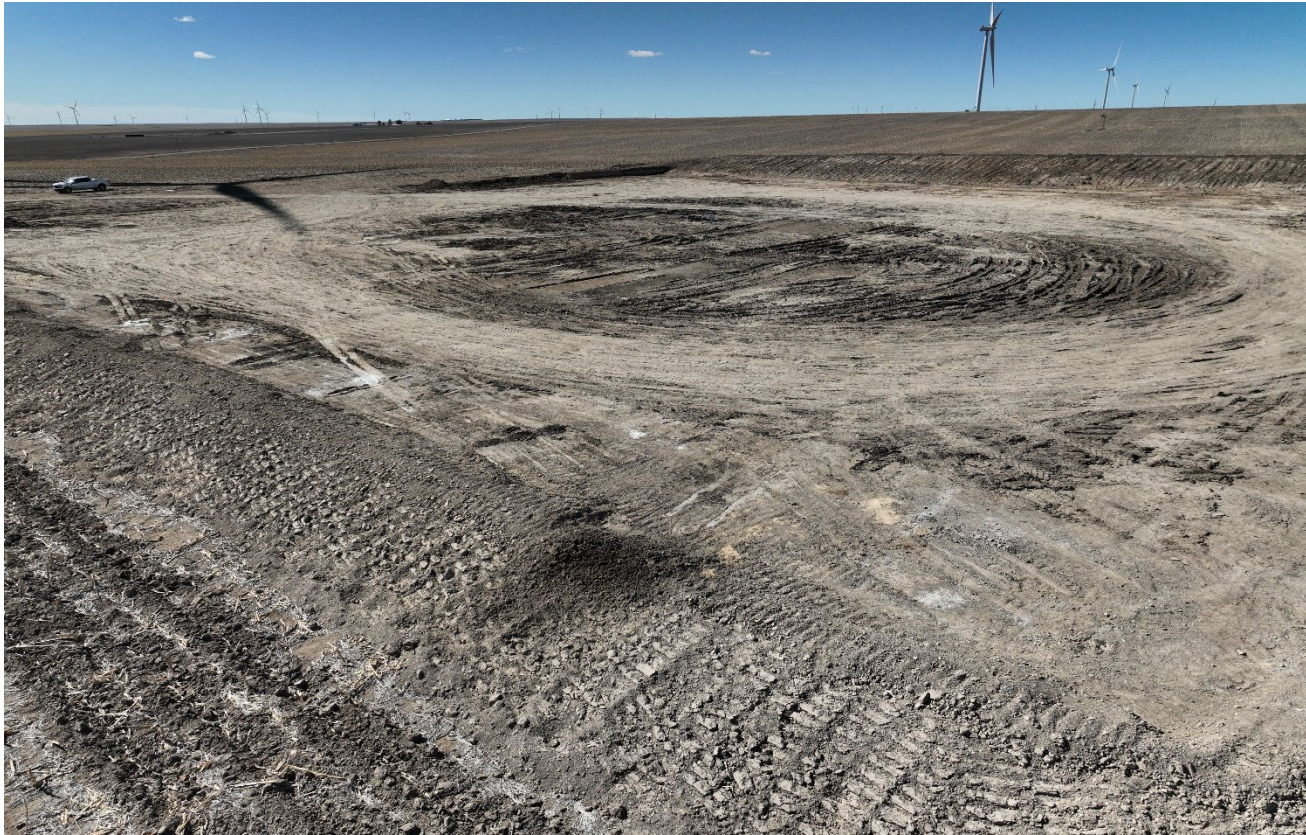
Photo 12. Drone aerial photo facing southwest. There are various white substance spills along the east side of the pad.

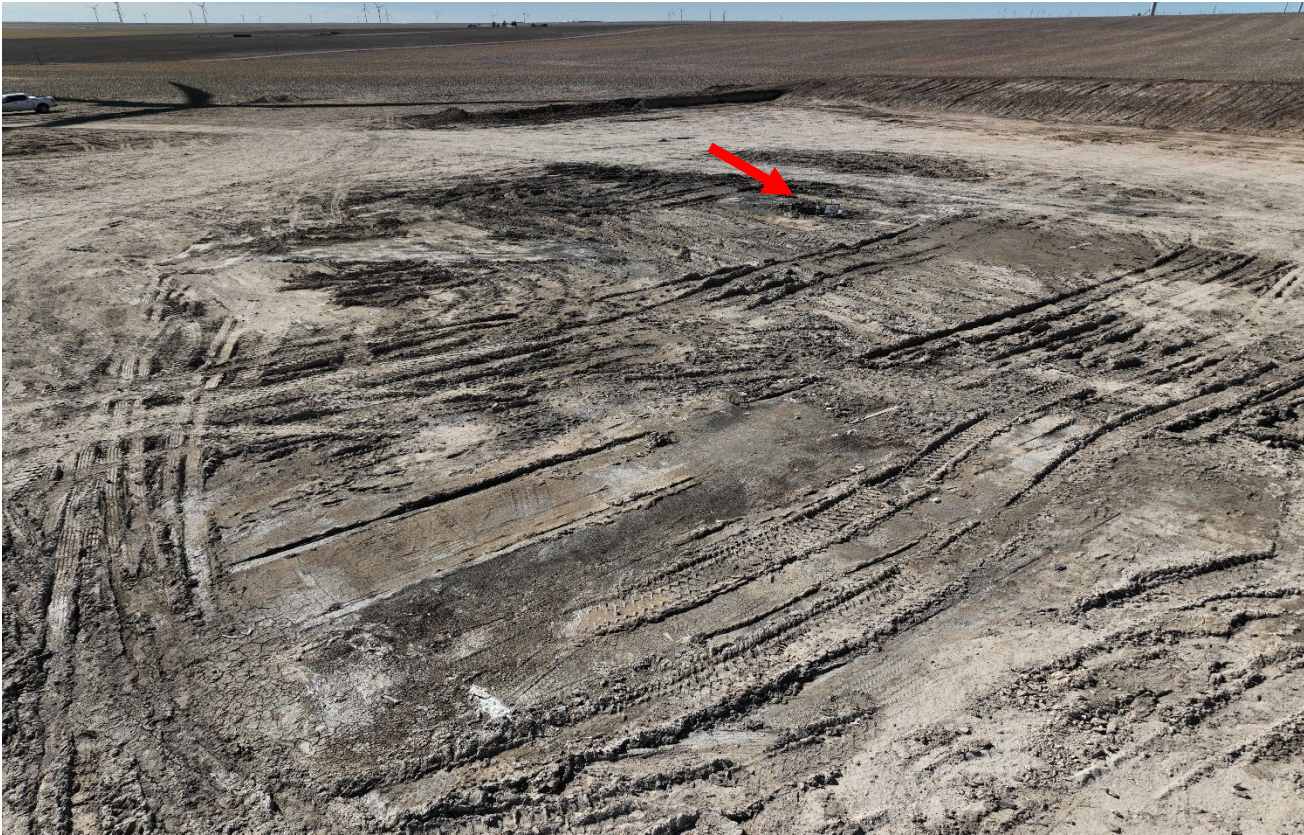
Photo 13. Drone aerial photo facing southwest. There is grey and blackened mud all around the wellhead. Drilling mud was not properly managed during the drilling process.

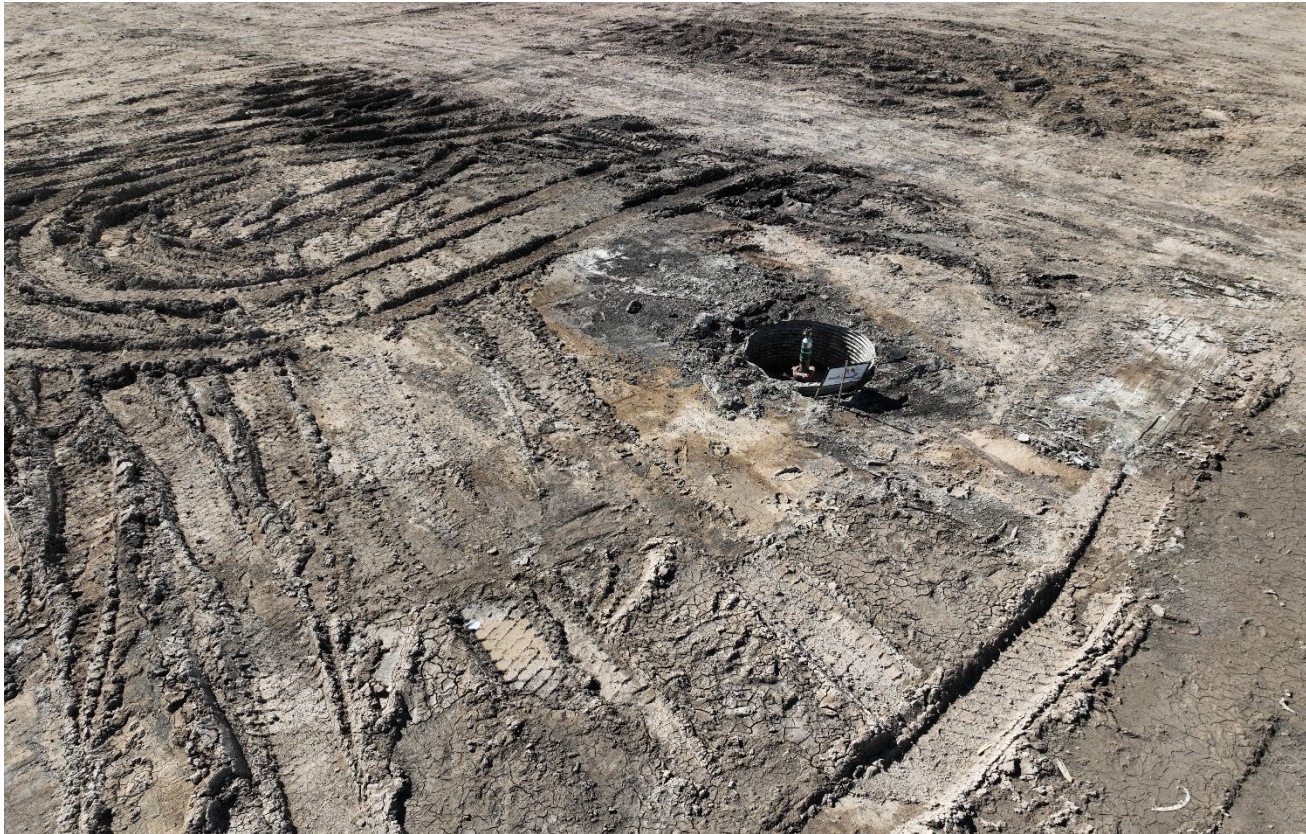
Photo 14. Drone aerial photo facing down toward the wellhead. There is grey and blackened mud all around the wellhead. Drilling mud was not properly managed during the drilling process.
