Inspection Photos

Loc: 485921

Operator: WAVETECH HELIUM INC

Inspection Date: 2/27/2025

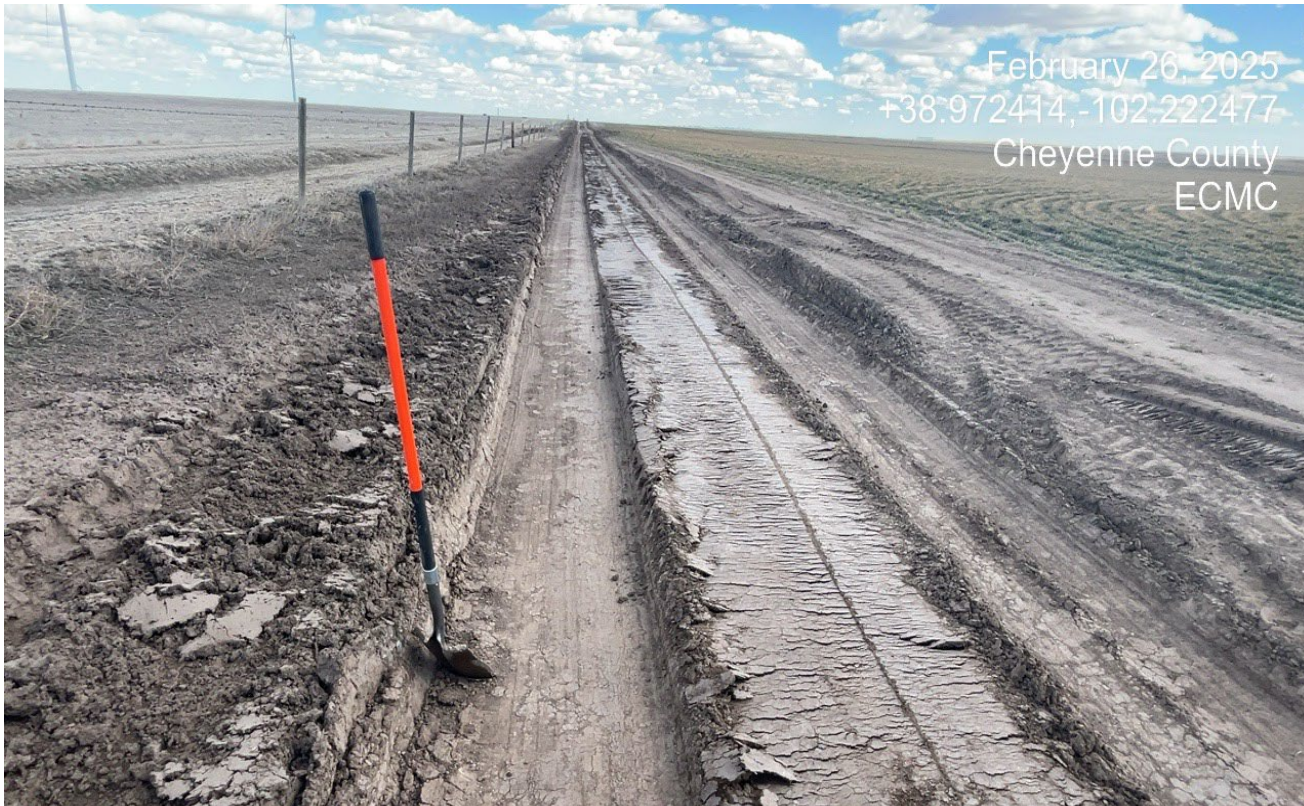
Photo 1. Facing east along the access road. The road has become rutted and damaged due to driving in wet conditions without adequate BMP's

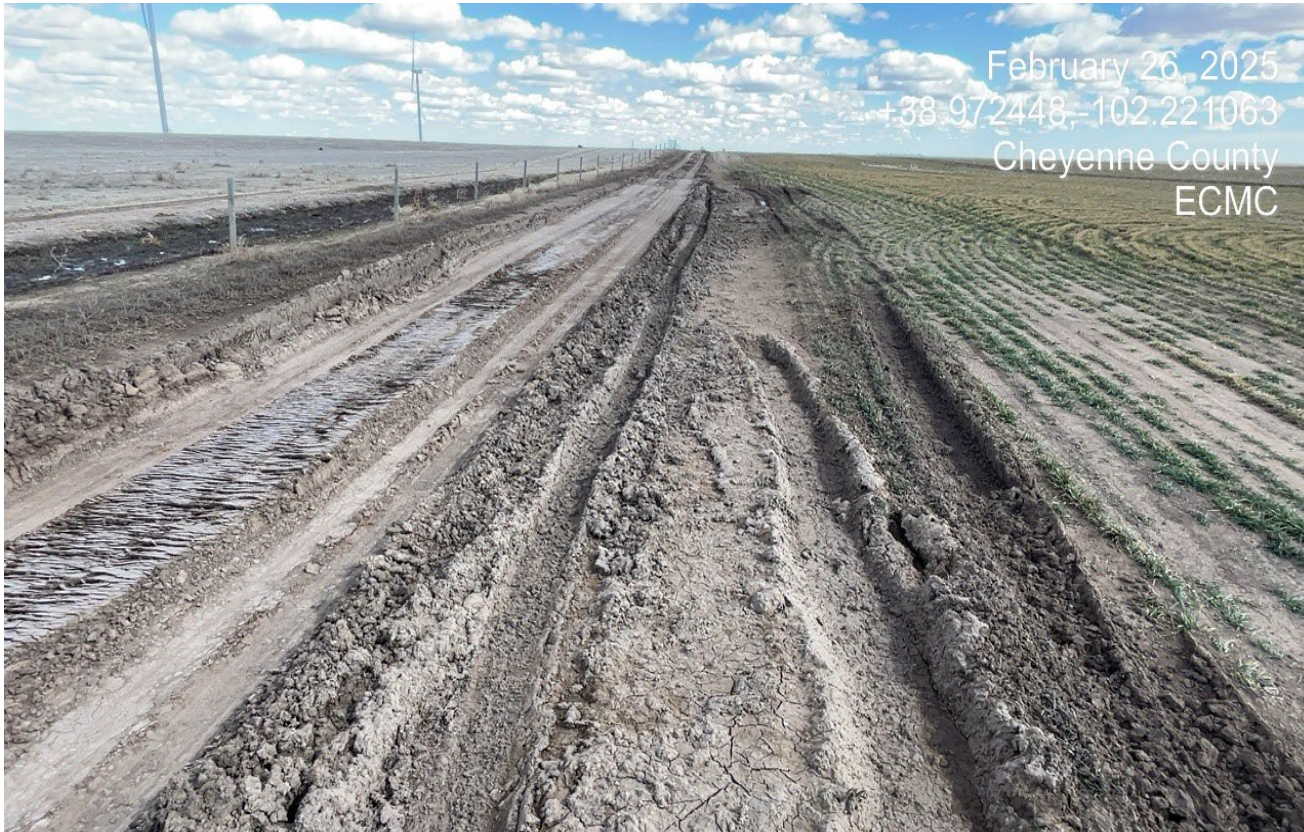
Photo 2. There are vehicle tracks that went off road and damage the adjacent crop field.

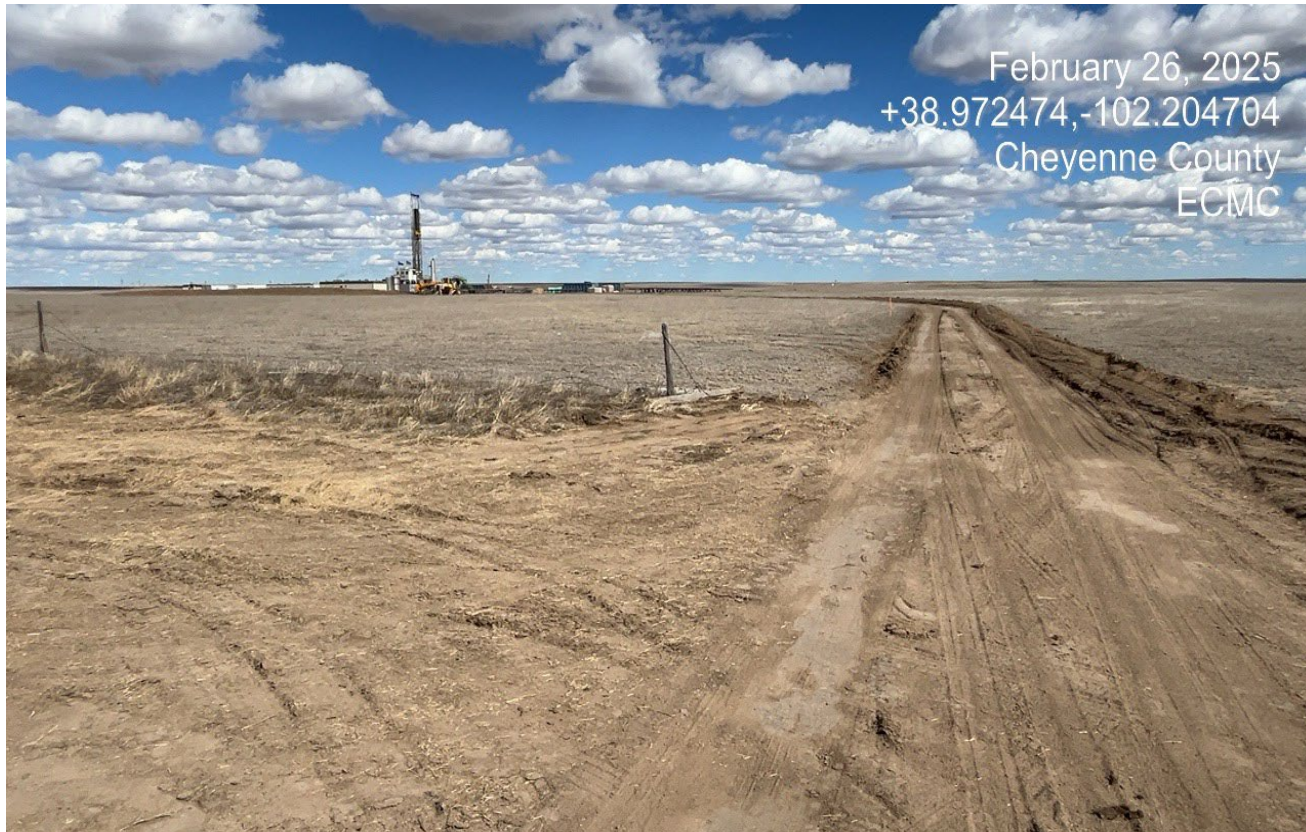
Photo 3. Facing northeast along the access road toward the drill site. Vehicles have driven off the access road causing unnecessary disturbance.

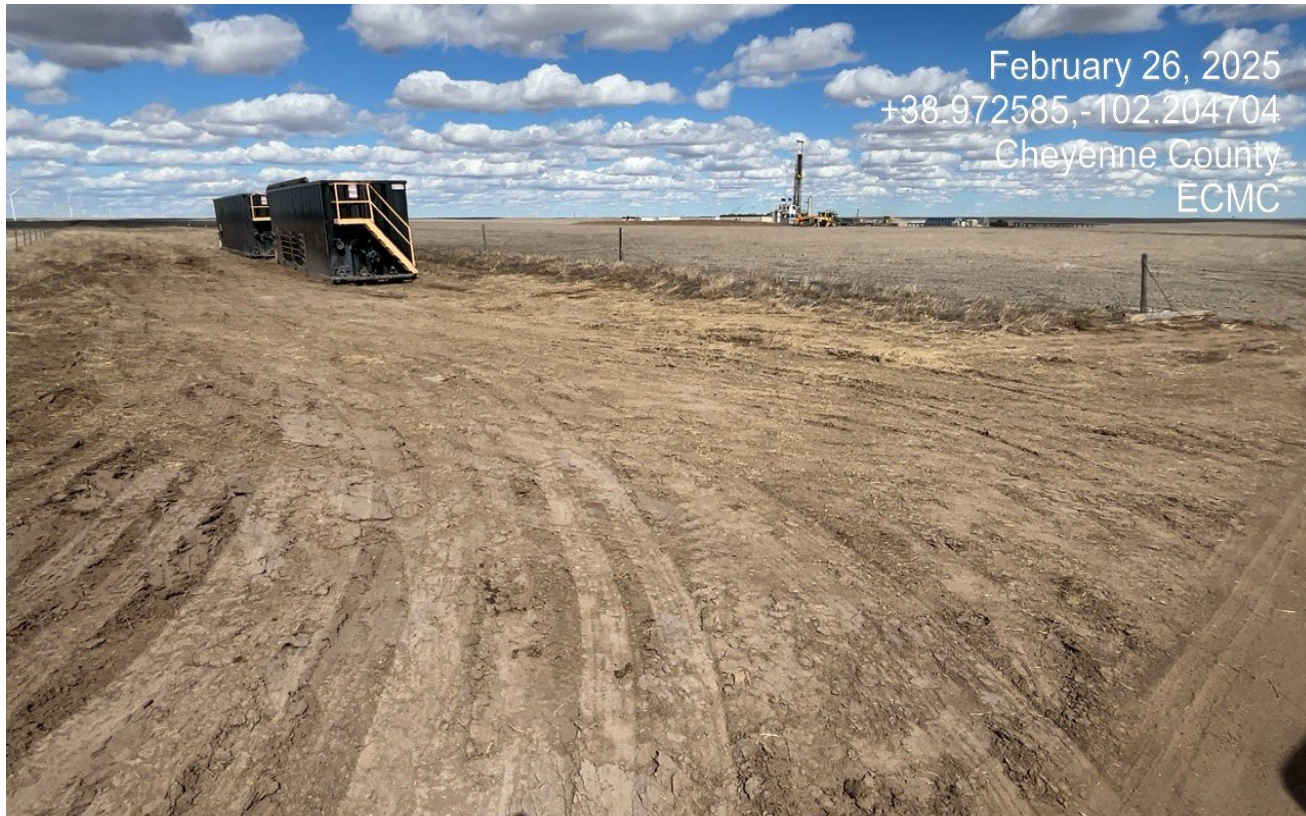
Photo 4. There has been unpermitted disturbance which has occurred where vehicles and equipment were parking off the location. This area will need to be reclaimed.

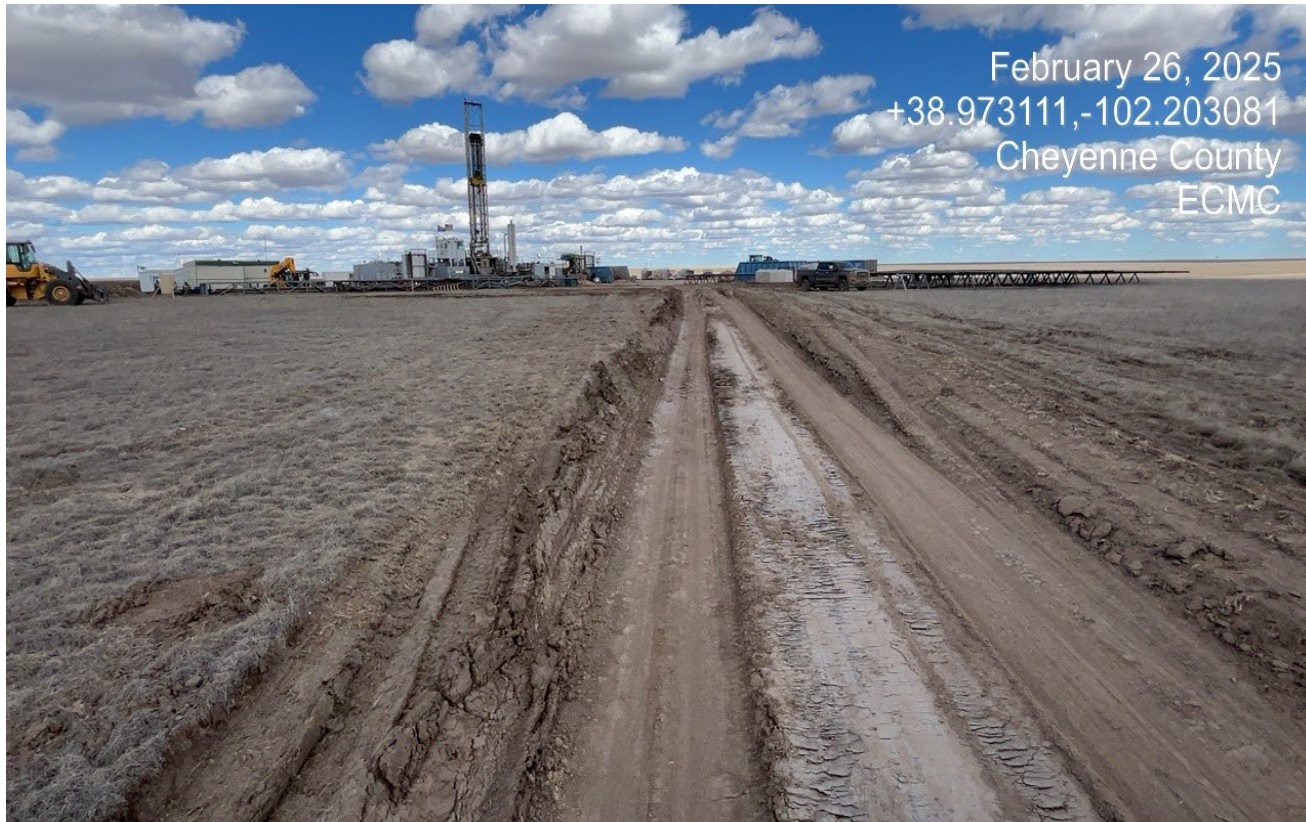
Photo 5. Facing northeast along the access road. Vehicle were driving off the road causing unnecessary disturbance.

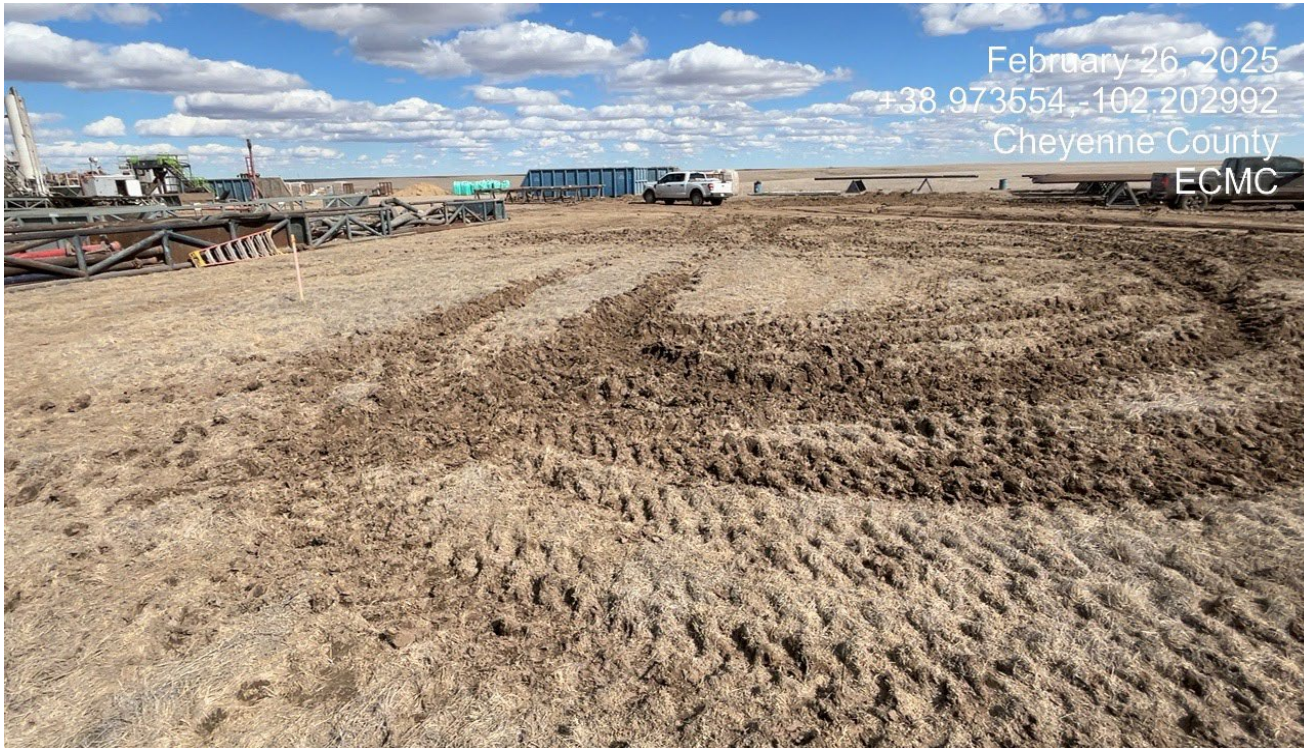
Photo 6. Vehicles and equipment were driving off the road and location causing unnecessary disturbance.

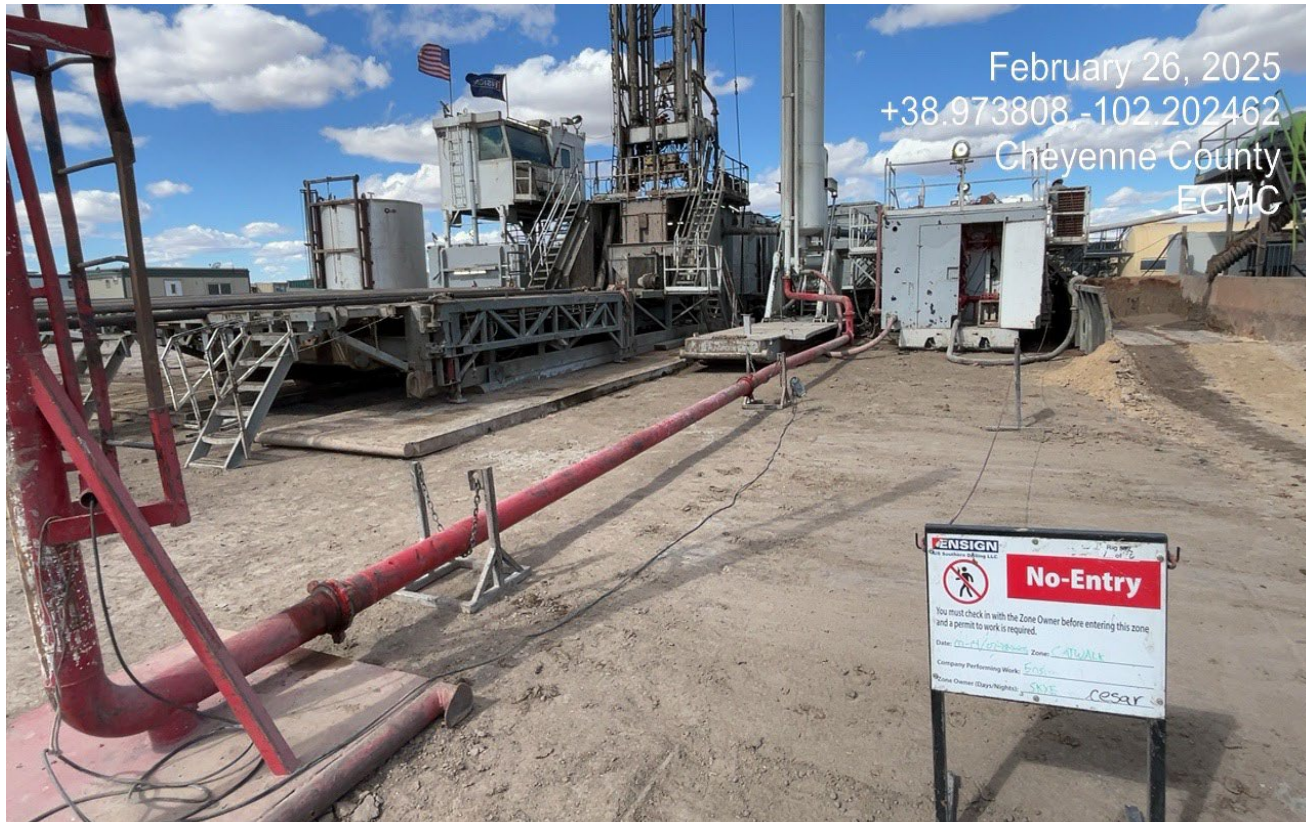
Photo 7. Facing toward the drill rig. There was no liner of other BMPs under the rig to prevent contamination.

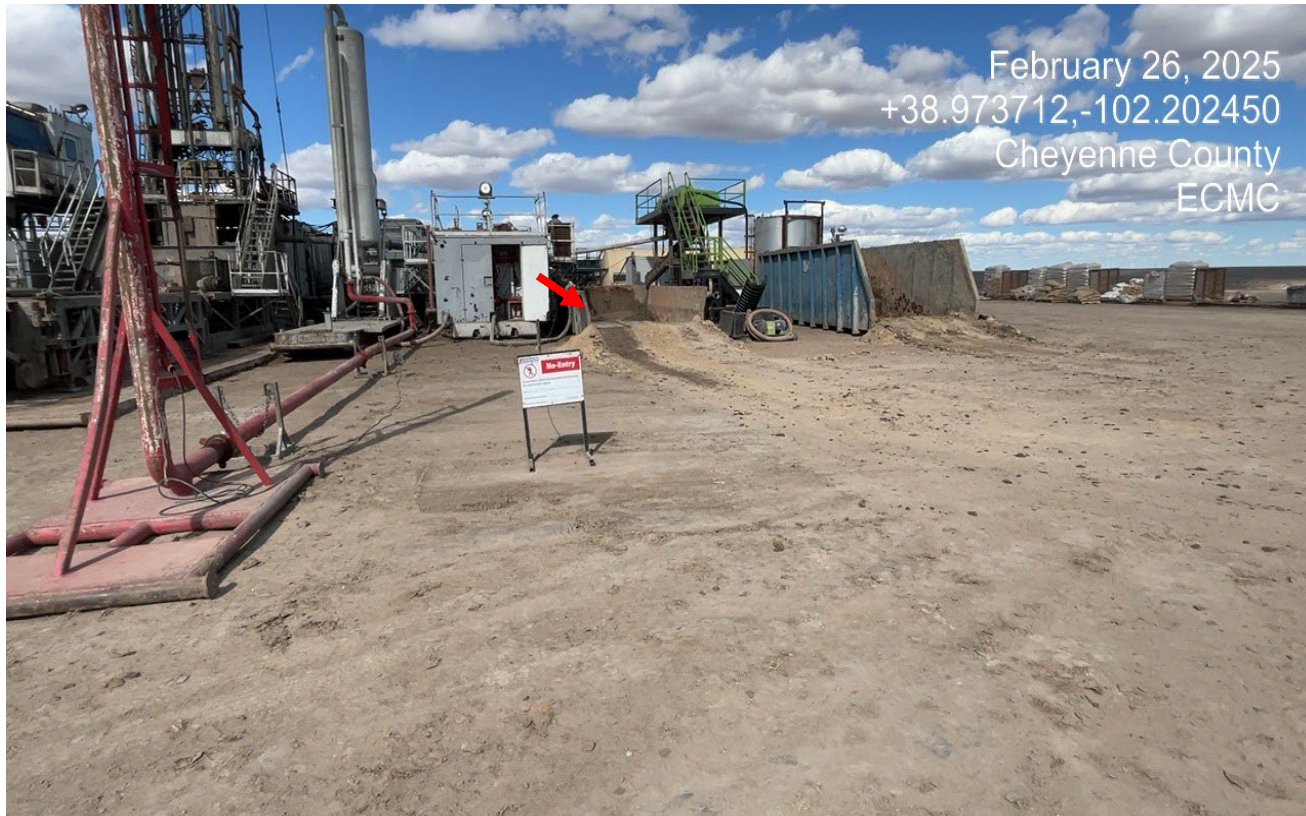
Photo 8. Facing north toward the drill rig and cutting/ mud management area. A loader was moving the drill mud/cuttings from the container at red arrow and tracking the E&P waste over to the containers shown in the next photo.

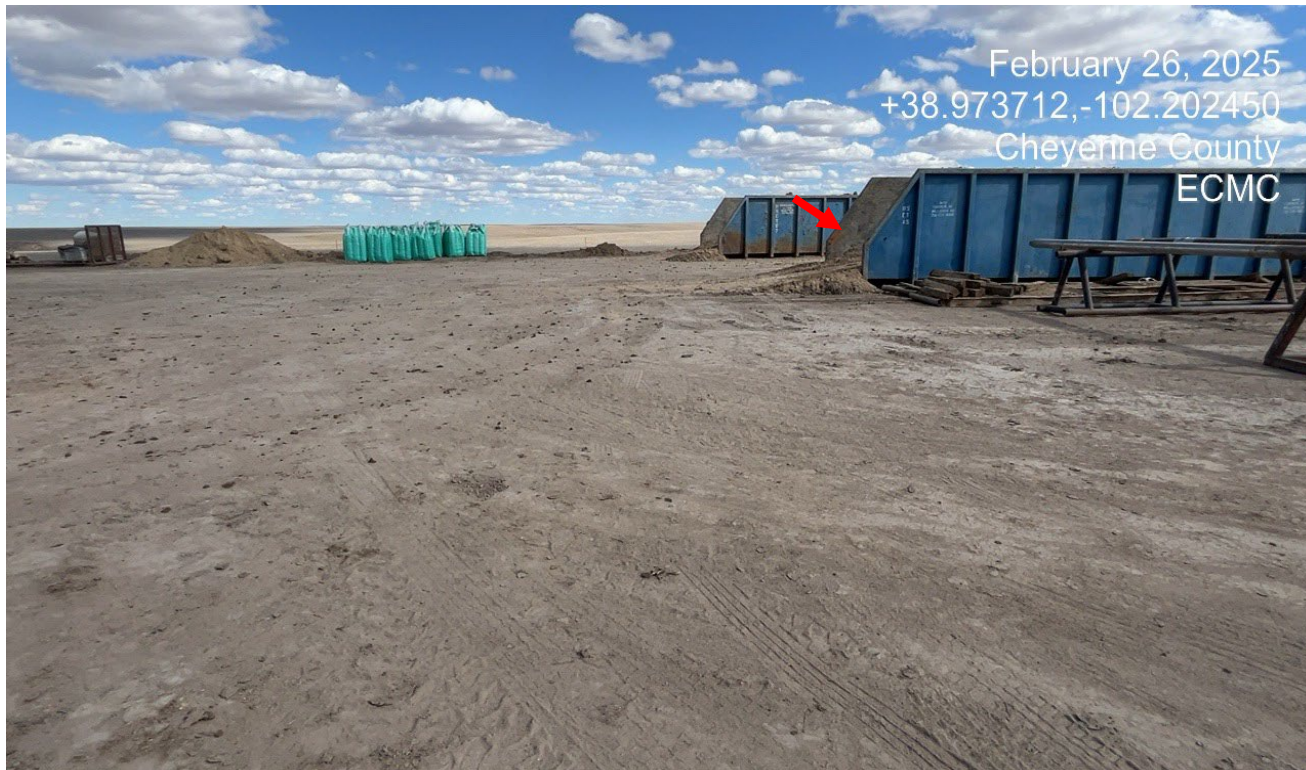
Photo 9. This photo shows that the loader is tracking the E&P waste from the tires all over the surface of the location. E&P Waste management is not being performed in a protective manner.

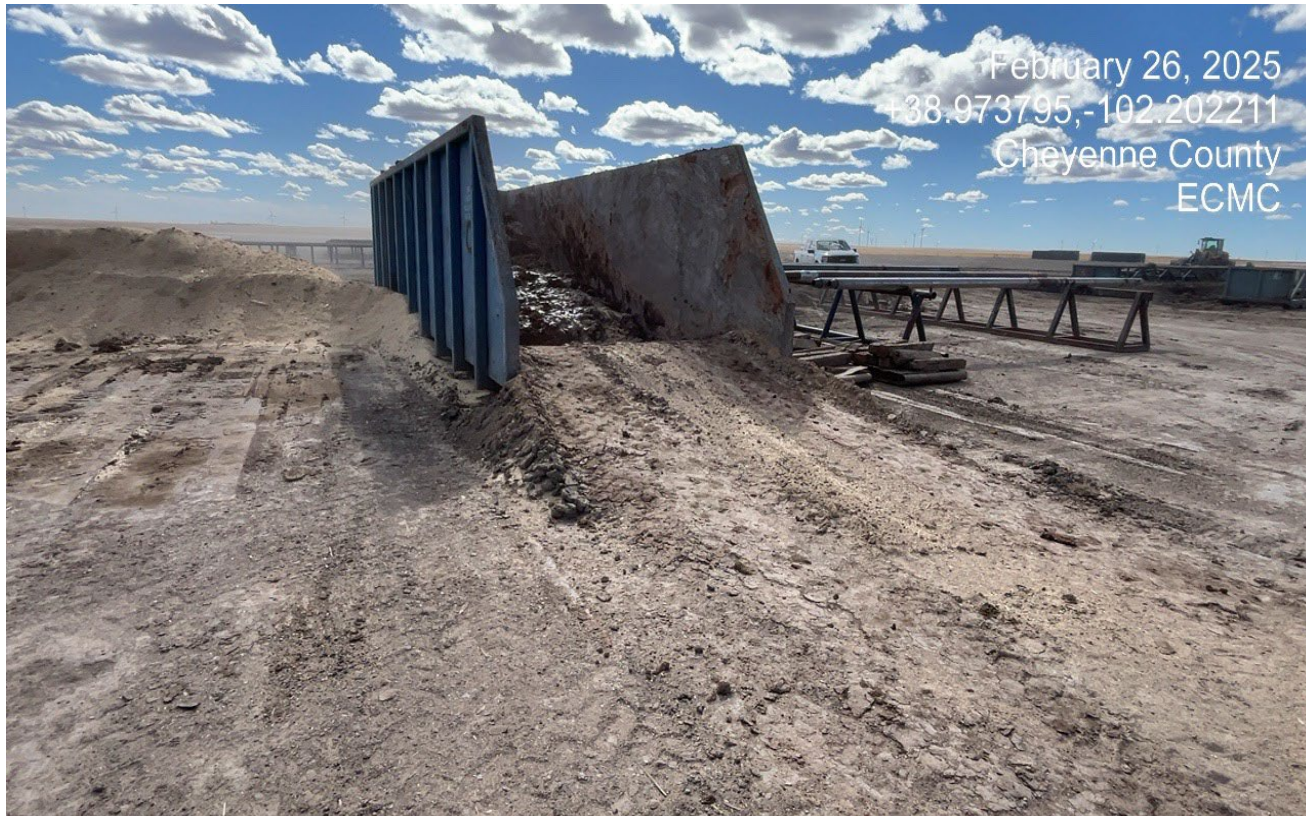
Photo 10. The drill cuttings/mud is being mixed with sawdust on the left and dumped into this open end container. The mud is being tracked along this area and onto the surface. E&P Waste management is not being performed in a protective manner.

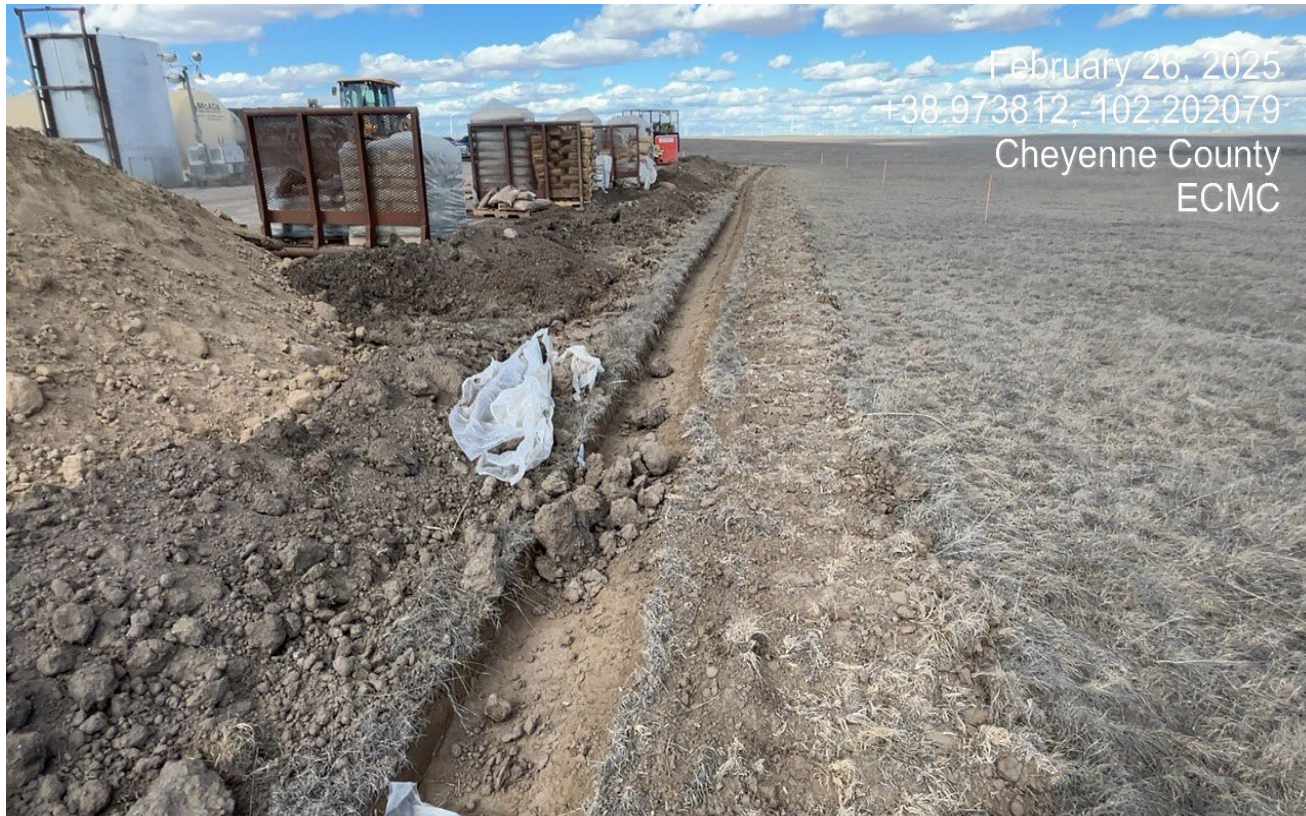
Photo 11. East side of the location facing north. There is trash debris not contained and dirt clouds have fallen into the stormwater ditch.

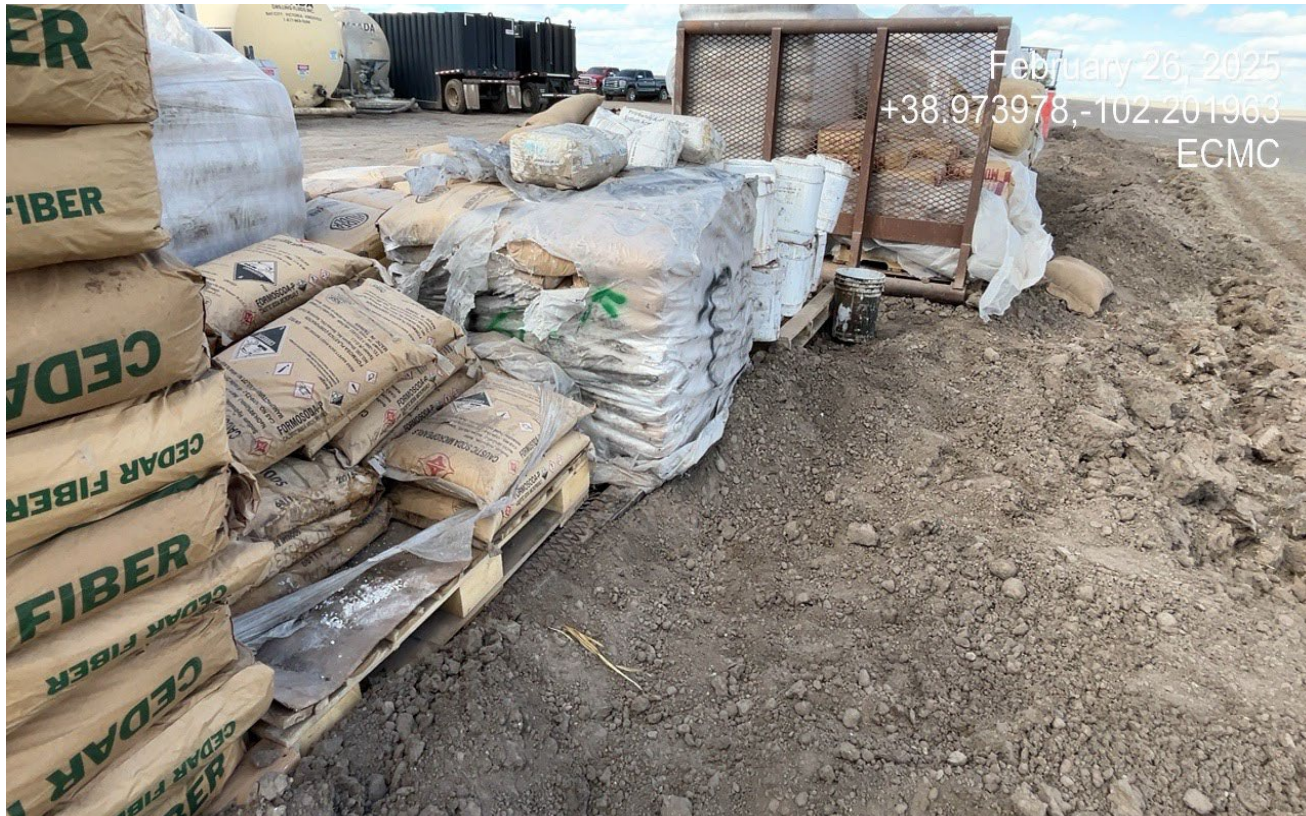
Photo 12. The bags of chemical products are not stored with containment and some of the contents have spilled onto the ground.

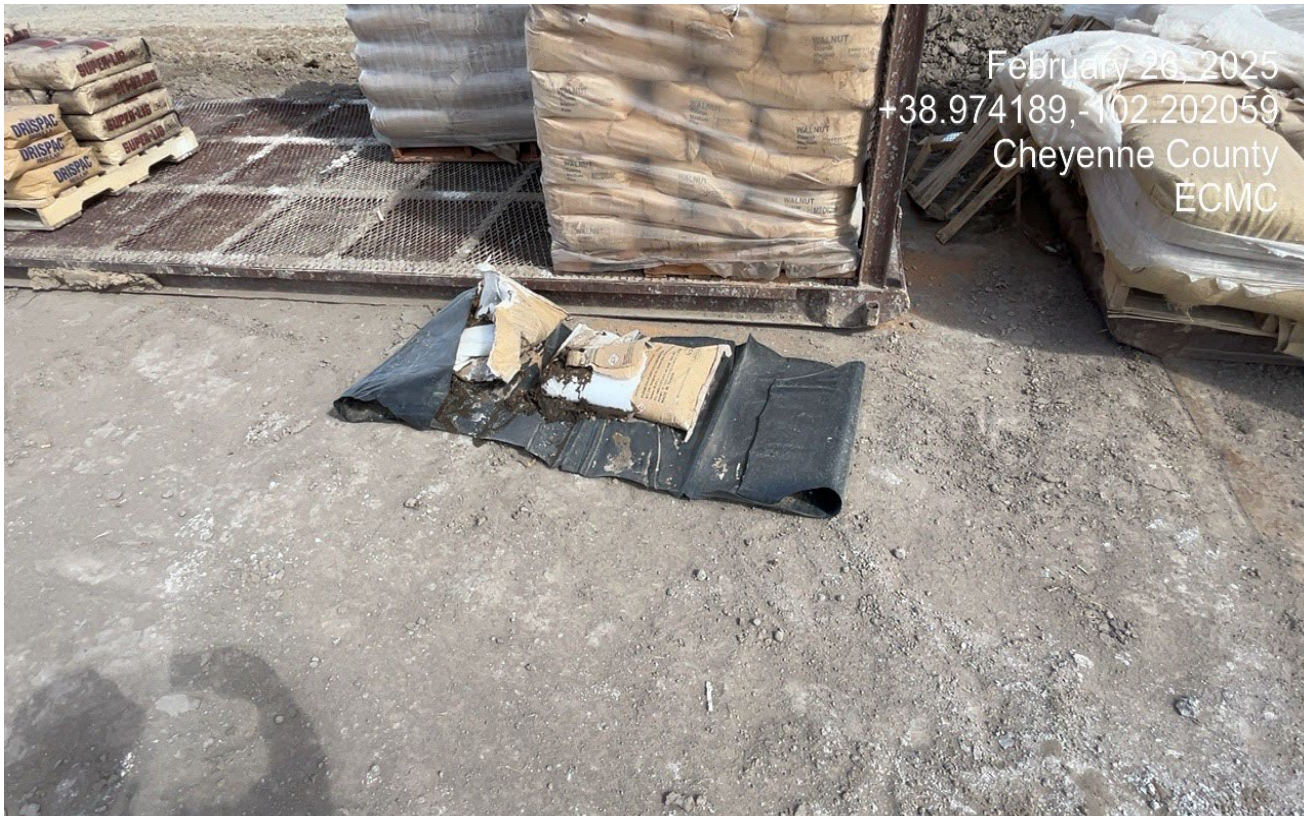
Photo 13. The bags of chemical products are not stored with containment and some of the contents have spilled onto the ground.

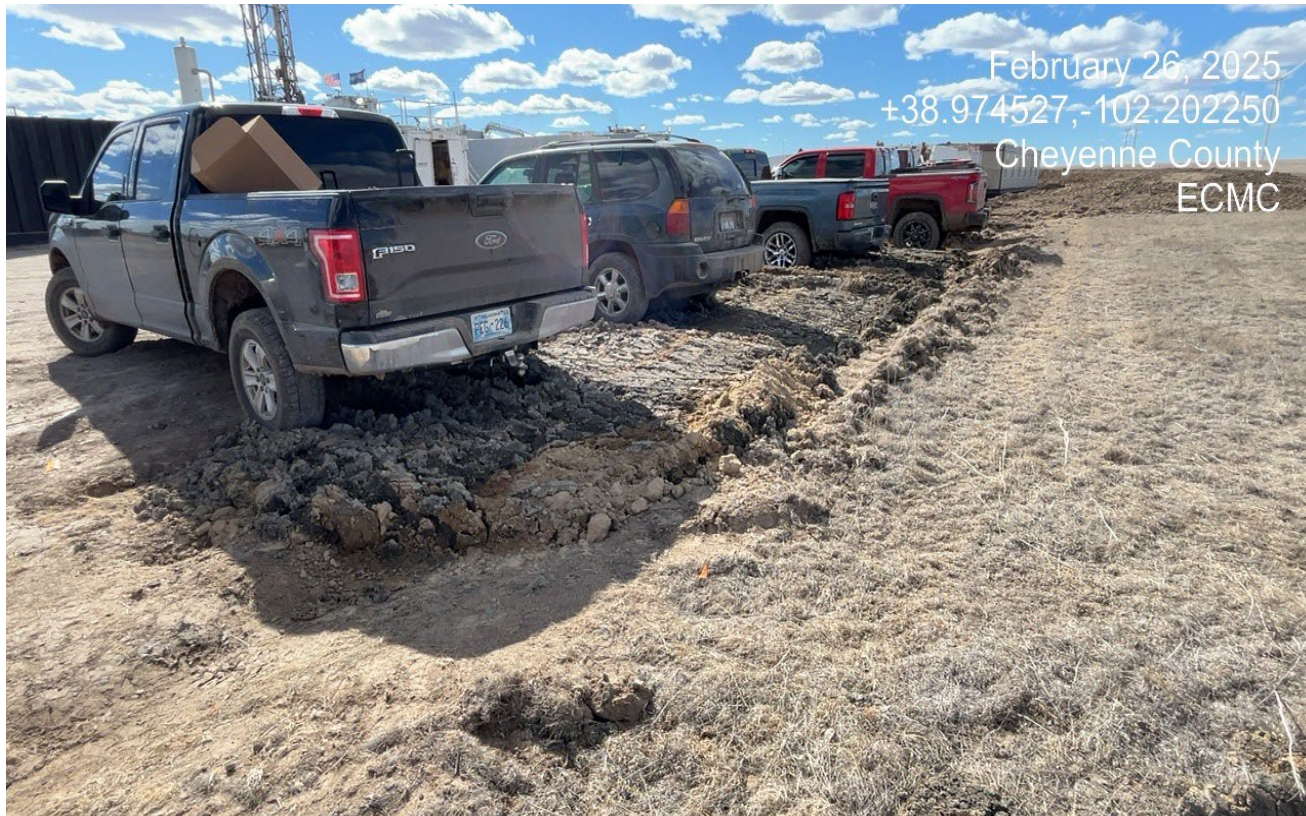
Photo 14. North side of the location facing southwest. The perimeter stormwater ditch has been filled in. The material that was dumped in this area is greyish with sawdust resembling drill cuttings and mud.

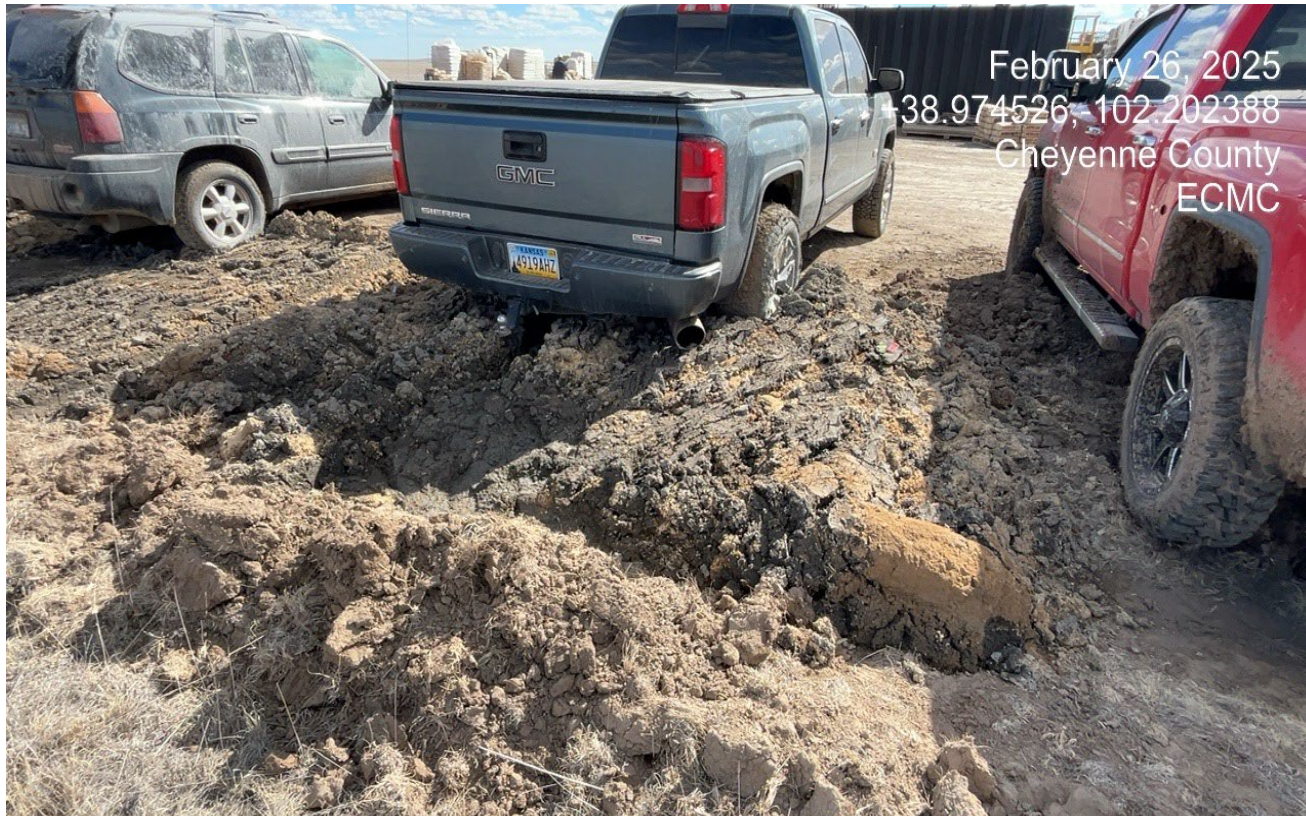
Photo 15. Vehicles are parking and tracking the drill cuttings and mud that was dumped in this area. E&P waste is not being properly handled and disposed and has caused further contamination on the surface.

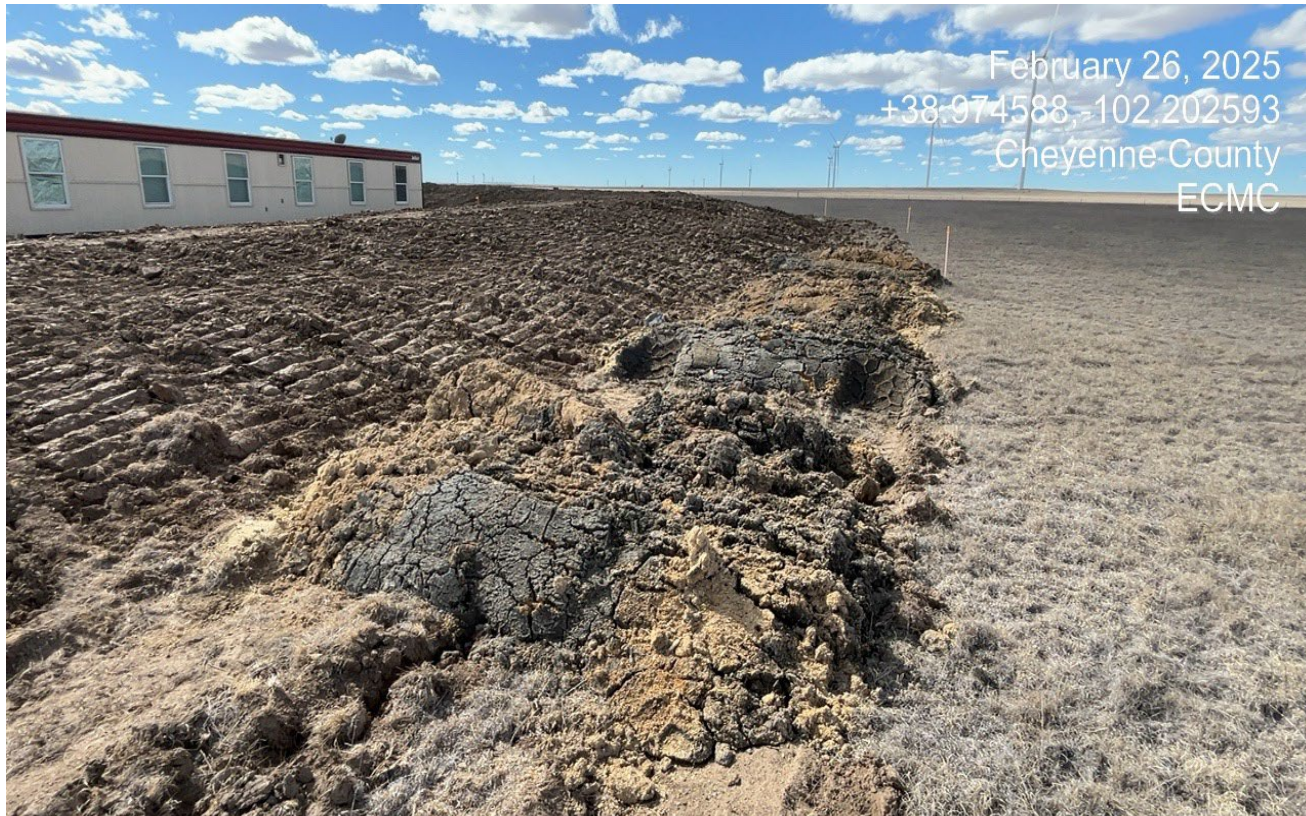
Photo 16. Facing toward the northwest side of the location. There is more drill cuttings and mud that was dumped along the back side of the topsoil pile. E&P waste is not being properly handled and disposed and has caused further contamination on the surface.

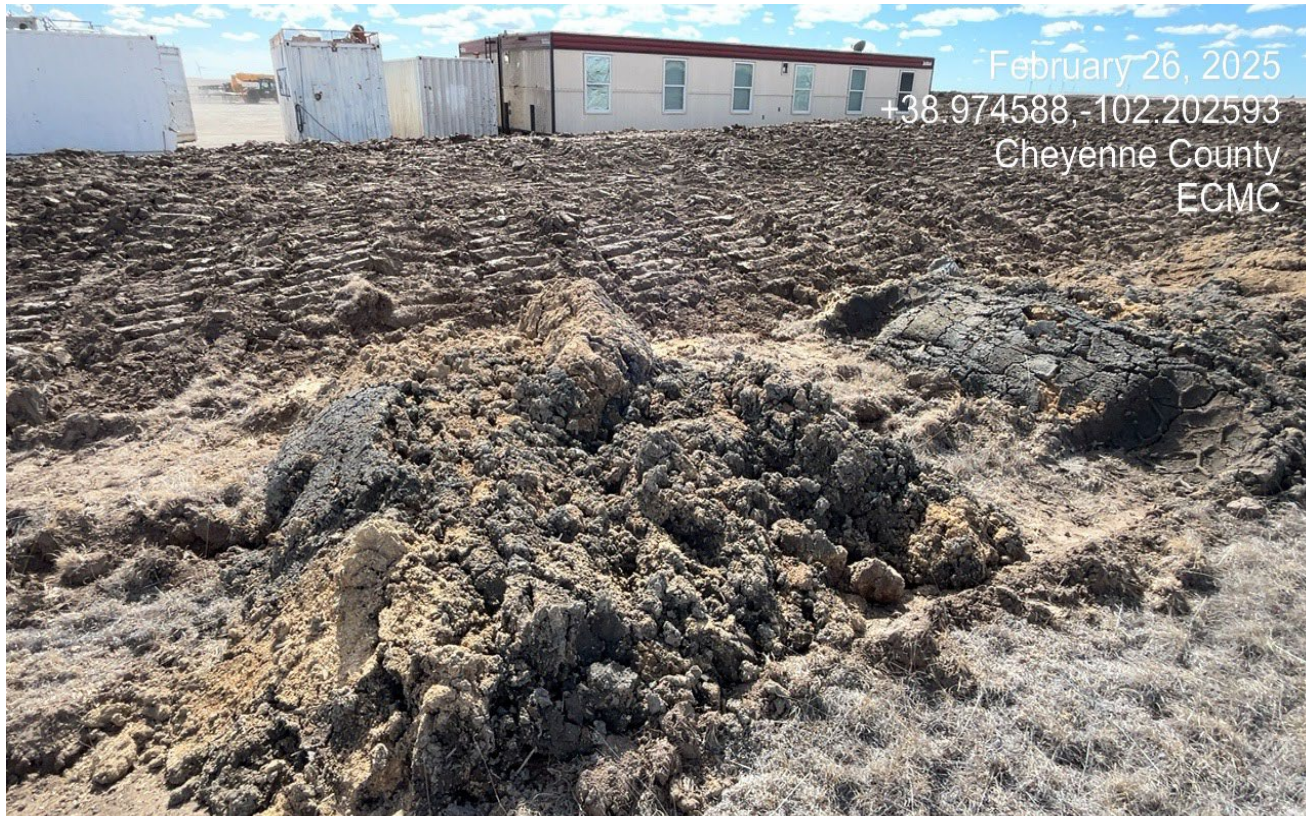
Photo 17. View of drill cuttings and mud that was dumped along the back side of the topsoil pile. E&P waste is not being properly handled and disposed and has caused further contamination on the surface.
