Inspection Photos

Loc: 485760

Operator: WAVETECH HELIUM INC

Inspection Date: 2/26/2025

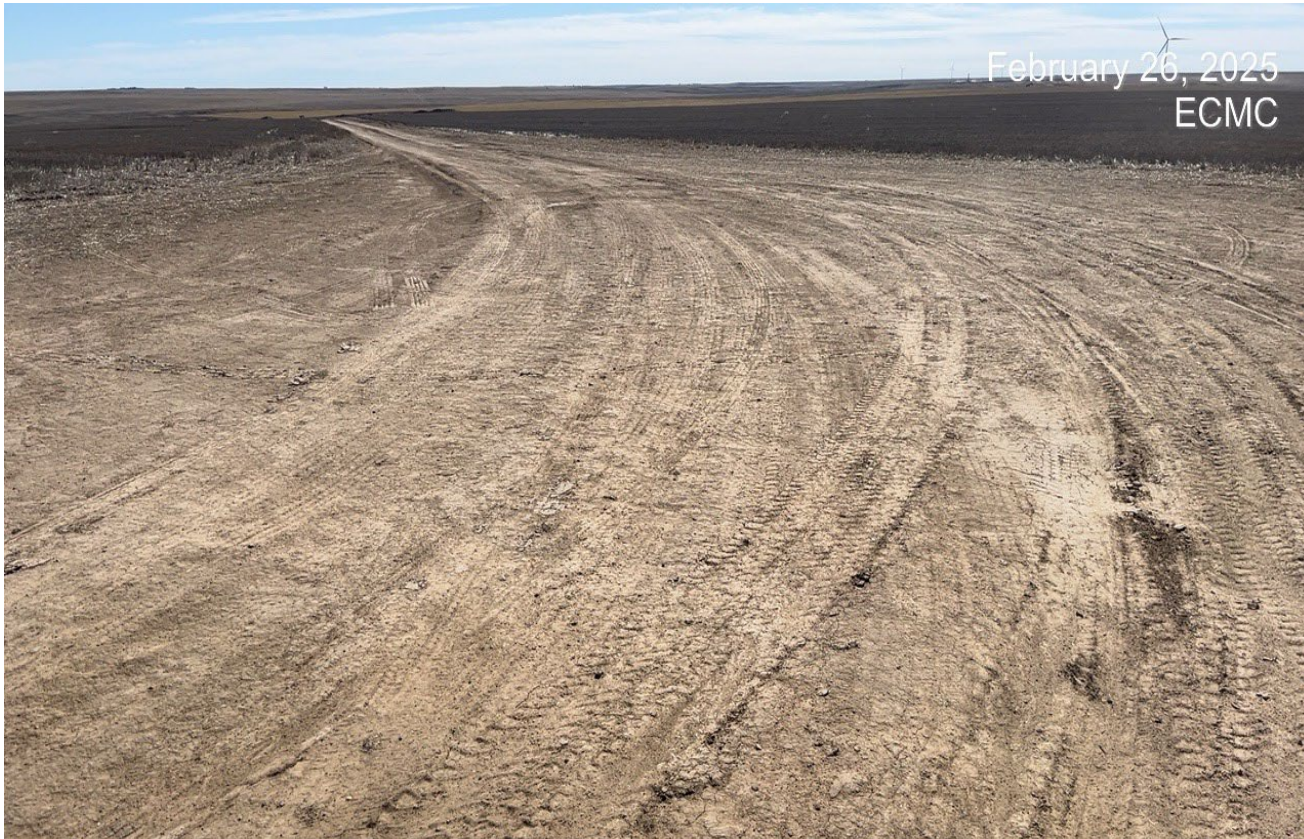
Photo 1. Facing south along the access road. The access road needs to be reduced in size by reclaiming and decompacting soils.

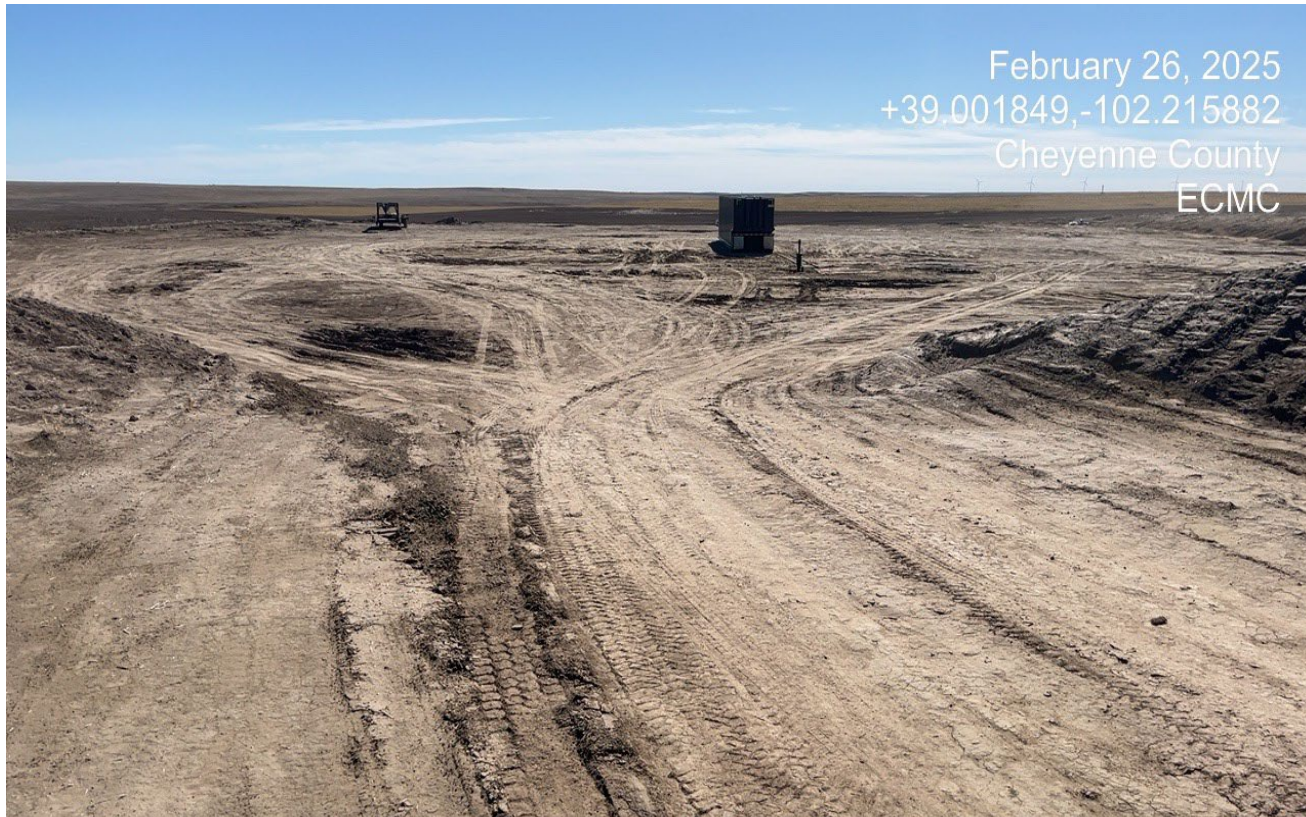
Photo 2. Facing south toward the wellsite.

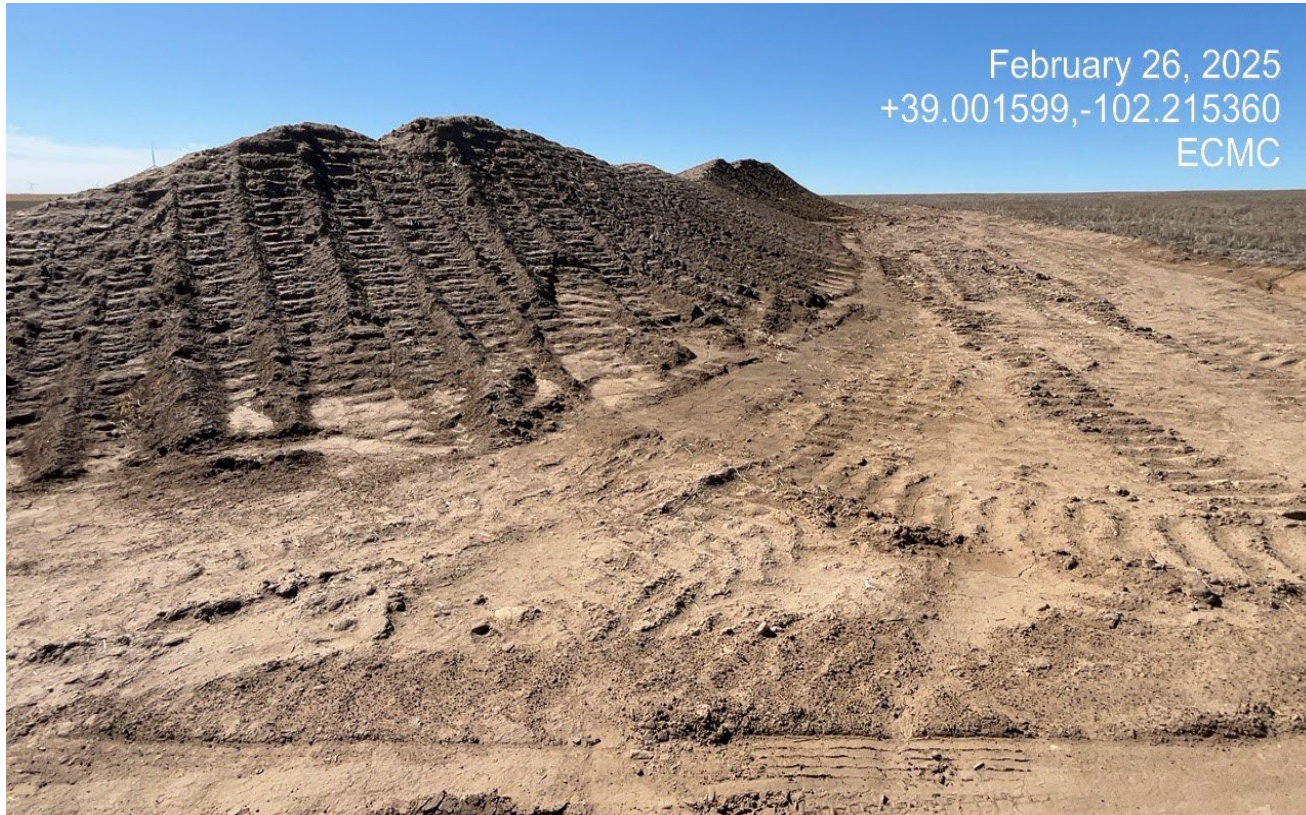
Photo 3. North side of the location facing east. Topsoil is stored along the north side of the location and has not been stabilized or replaced for interim reclamation.

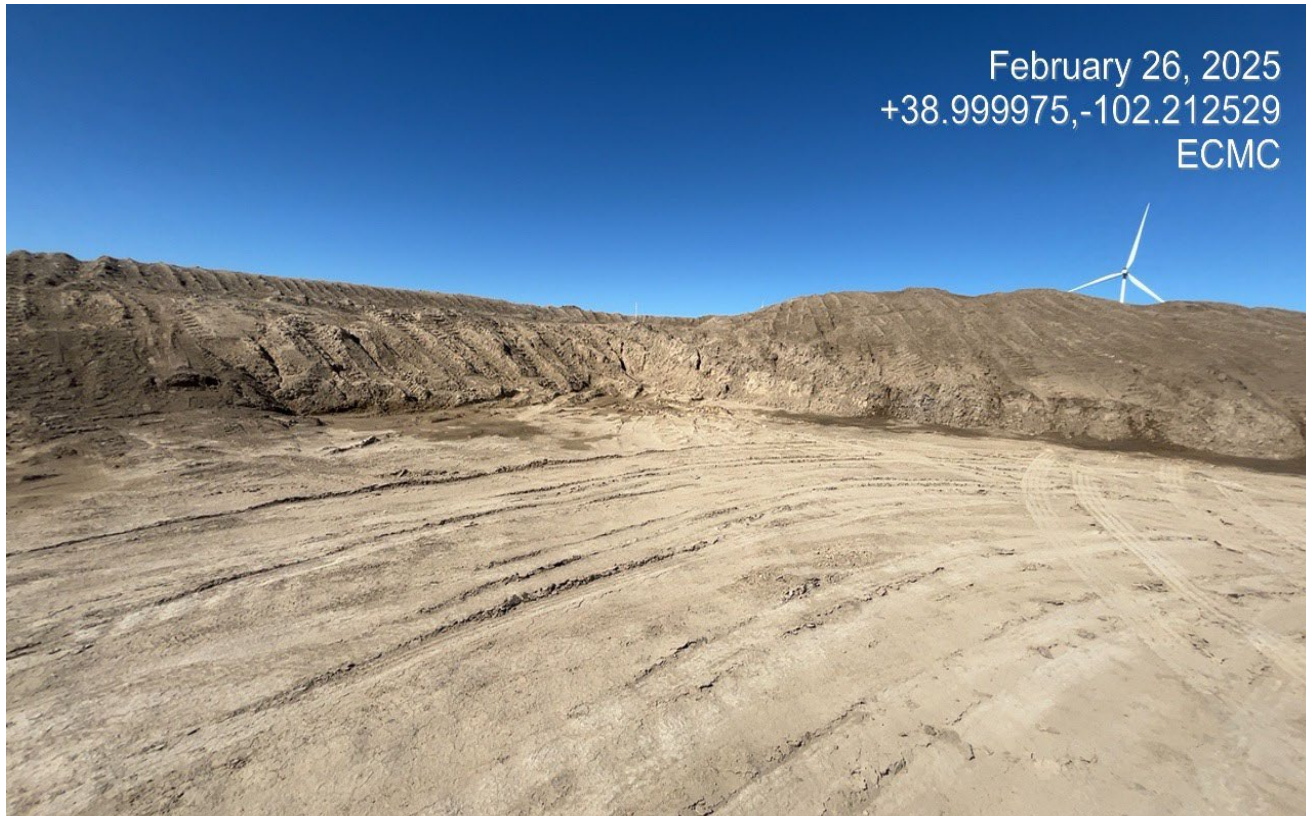
Photo 4. Facing toward the northeast side of the location. There is erosion along the topsoil pile which is mixing soil into the pad surface and subsoils. The topsoil is not stabilized or protected.

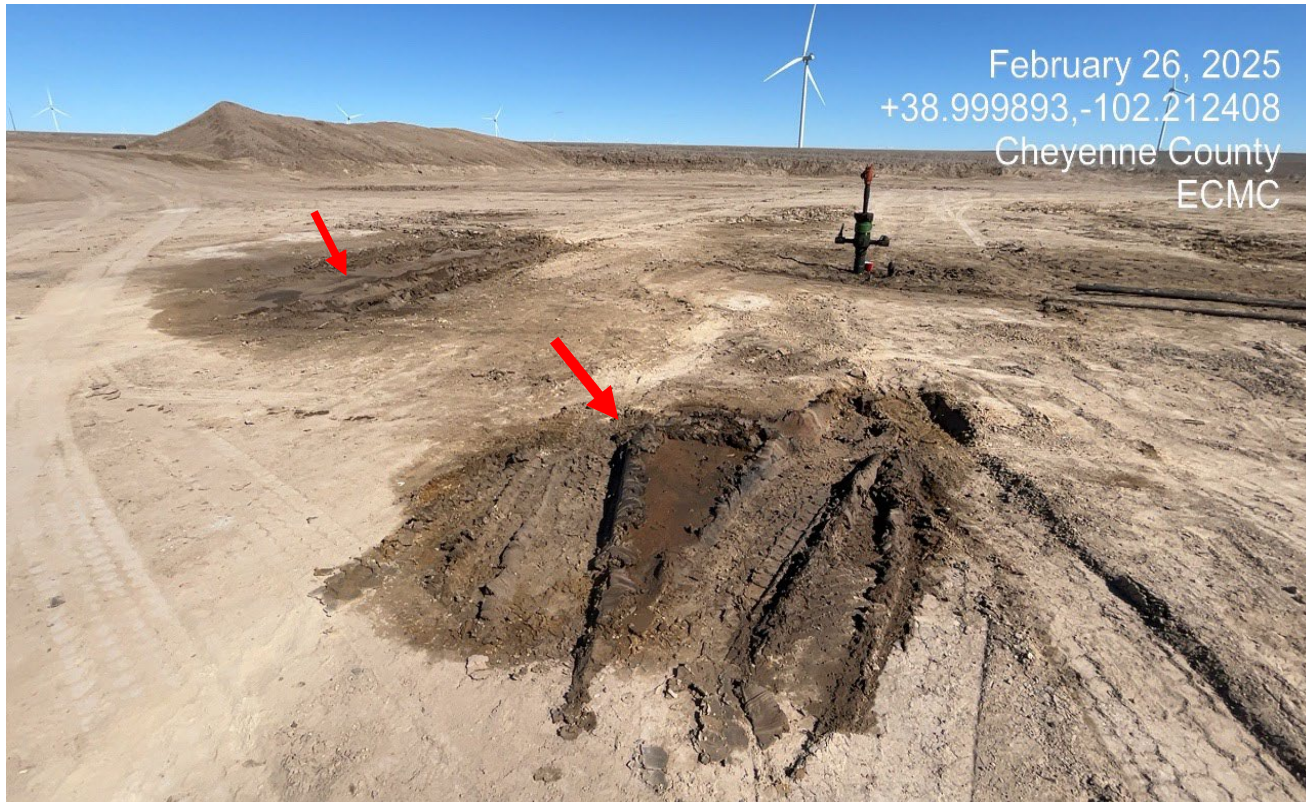
Photo 5. Facing northeast at the wellhead. There are multiple areas of impacted soils that need to be cleaned up and properly disposed. Red arrows point to areas of oily impacted soils.

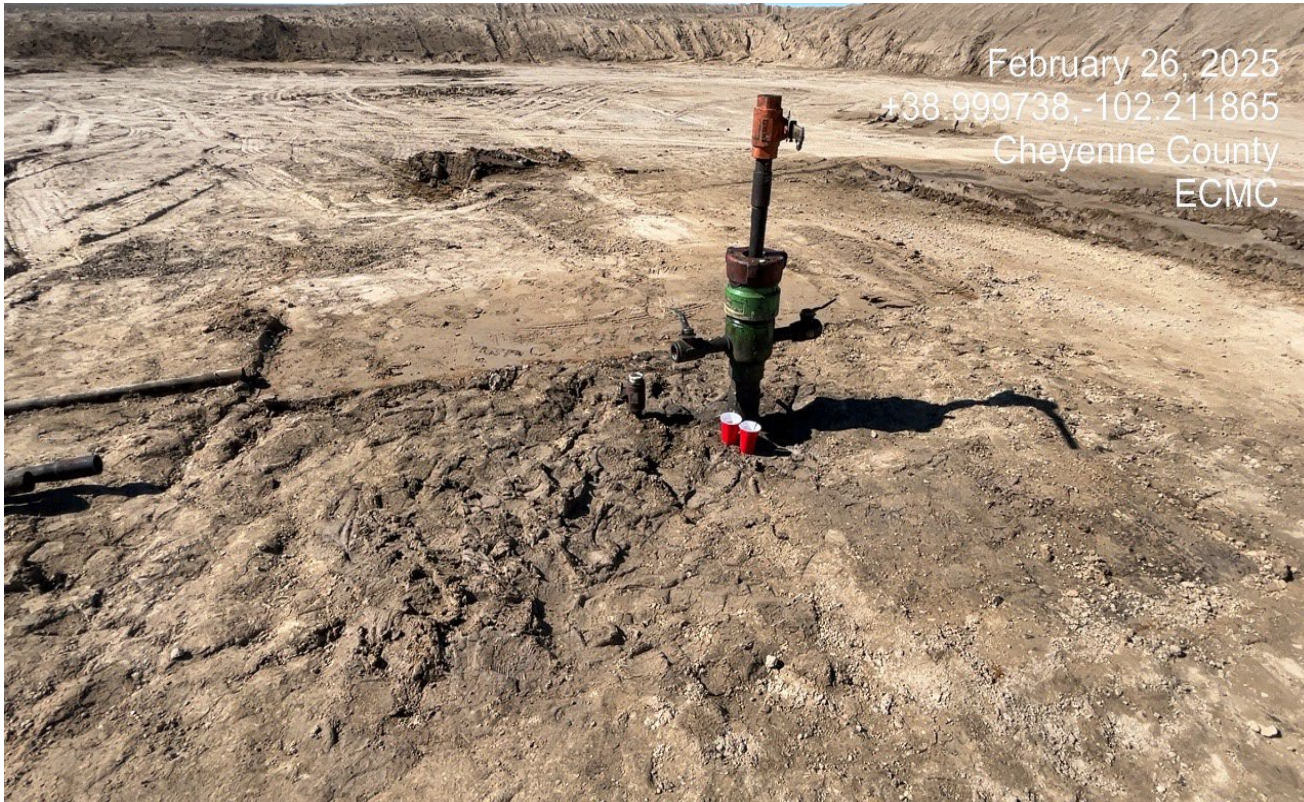
Photo 6. Facing toward the wellhead. There are stained soils around the wellhead.

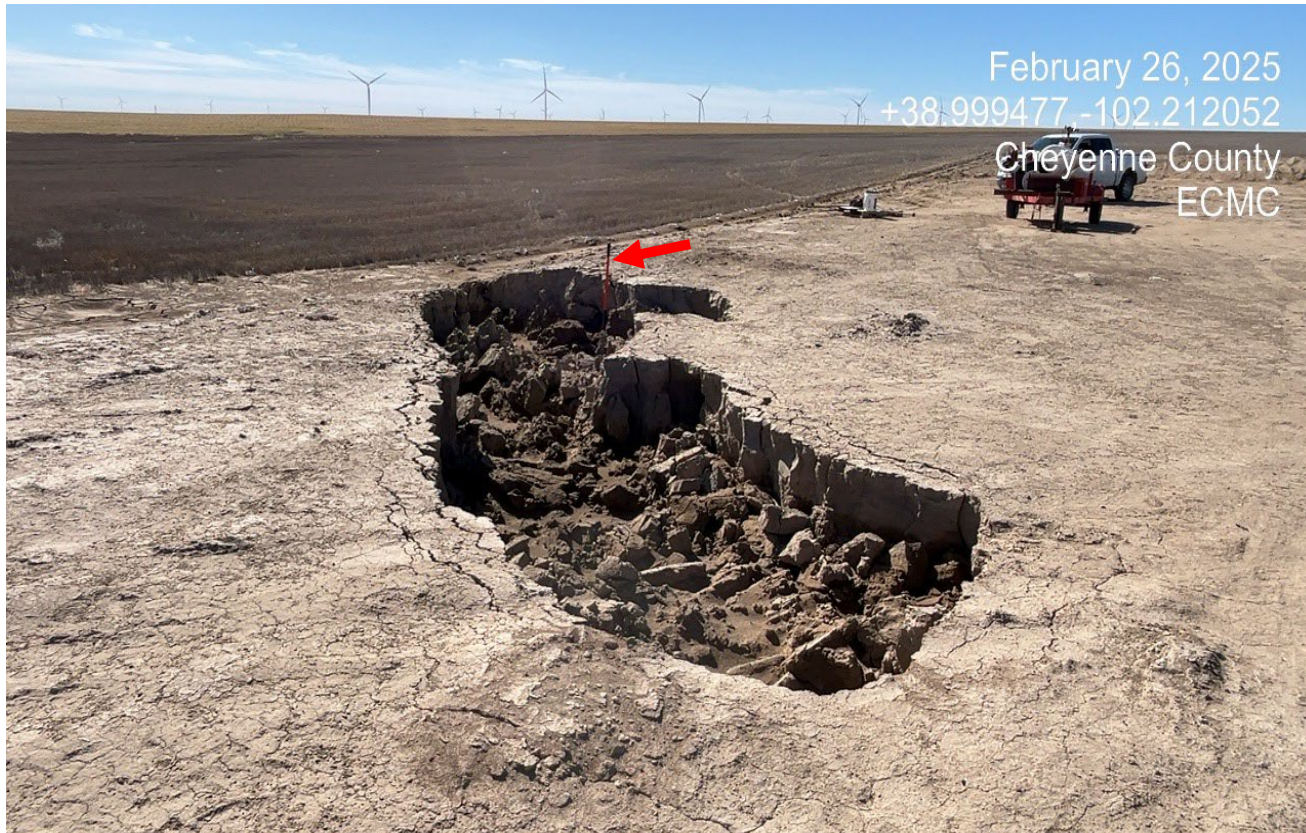
Photo 7. There is significant gully erosion along the fill slope which has washed sediment out into the adjacent crop field. Red arrow points to 4.5 ft. shovel. Previous CA was not completed.

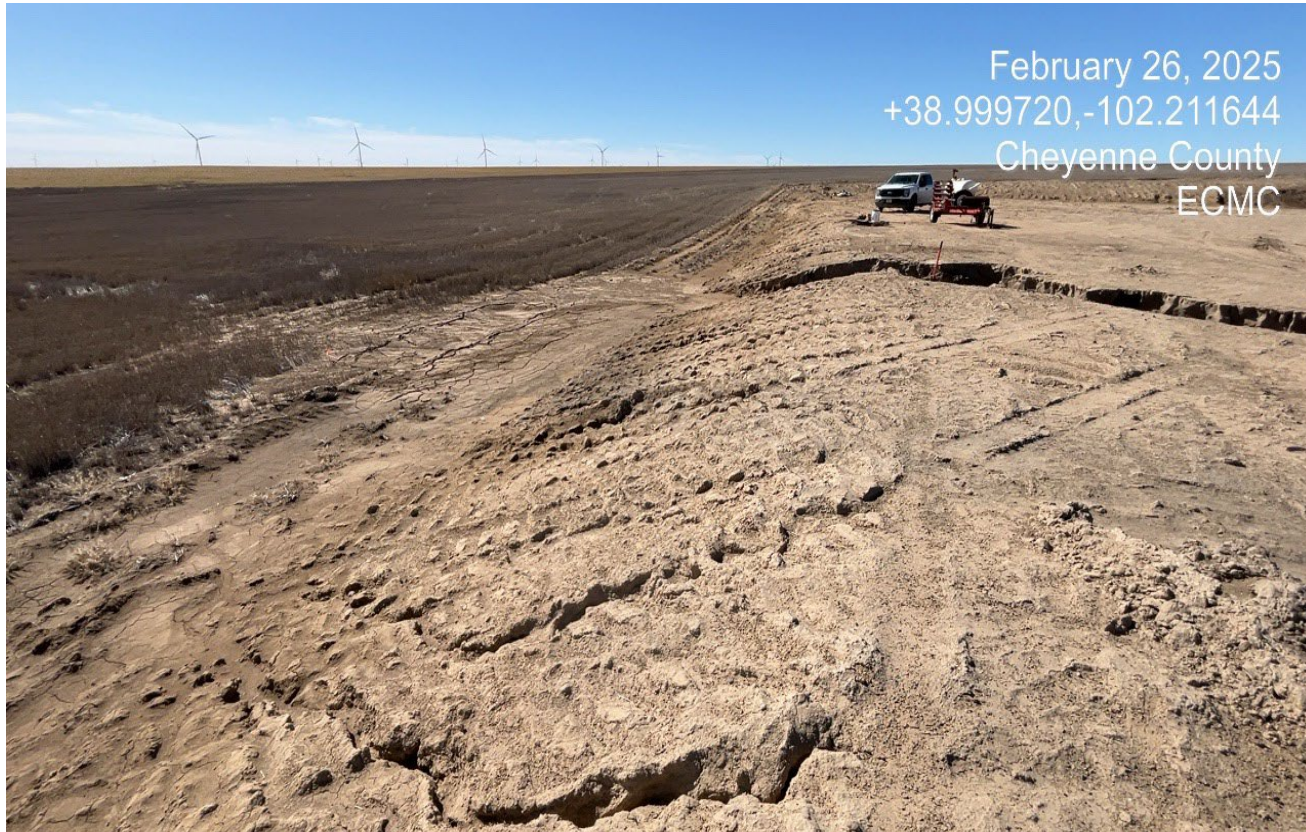
Photo 8. Facing southwest toward the fill slope which has eroded and transported sediment offsite. Previous CA was not completed.

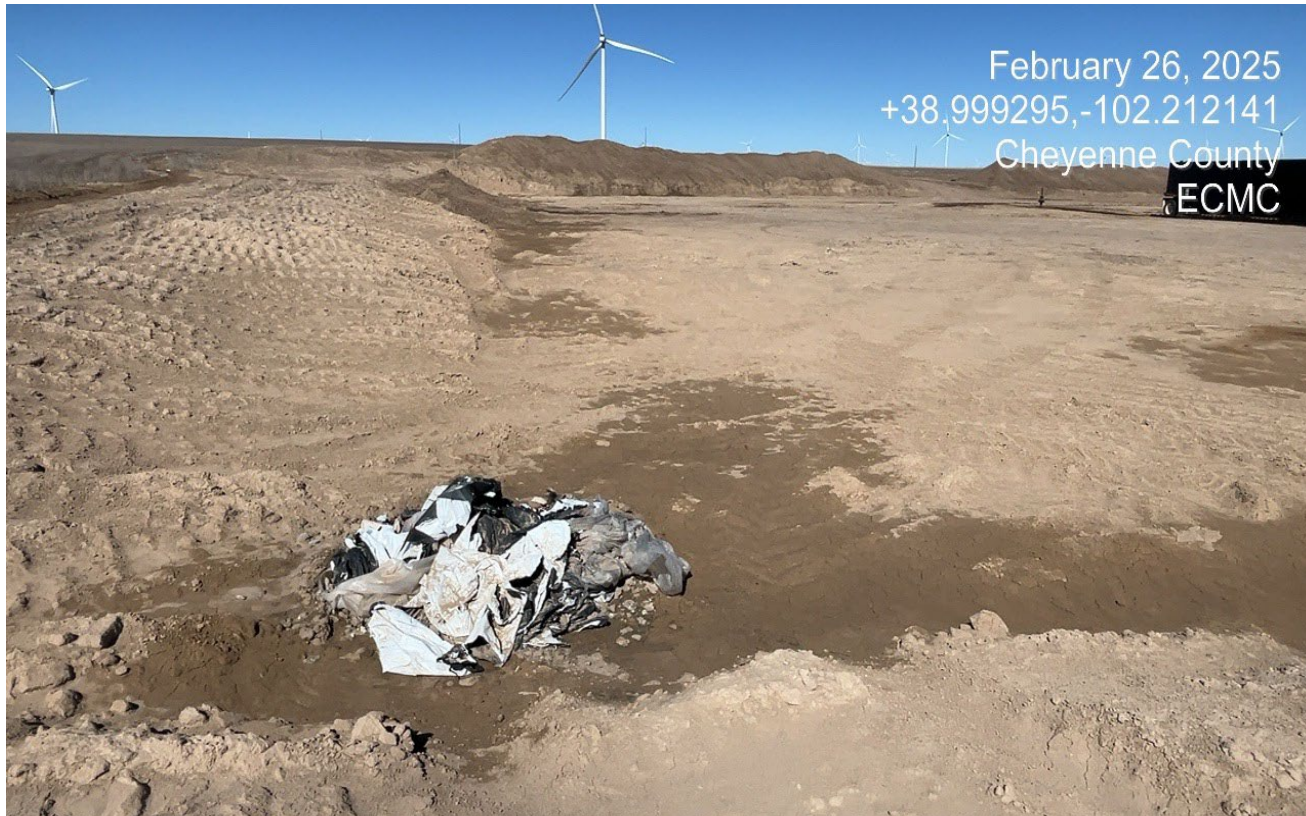
Photo 9. Southwest side of the location facing north. There is plastic trash that need to be removed. Previous CA was not completed.

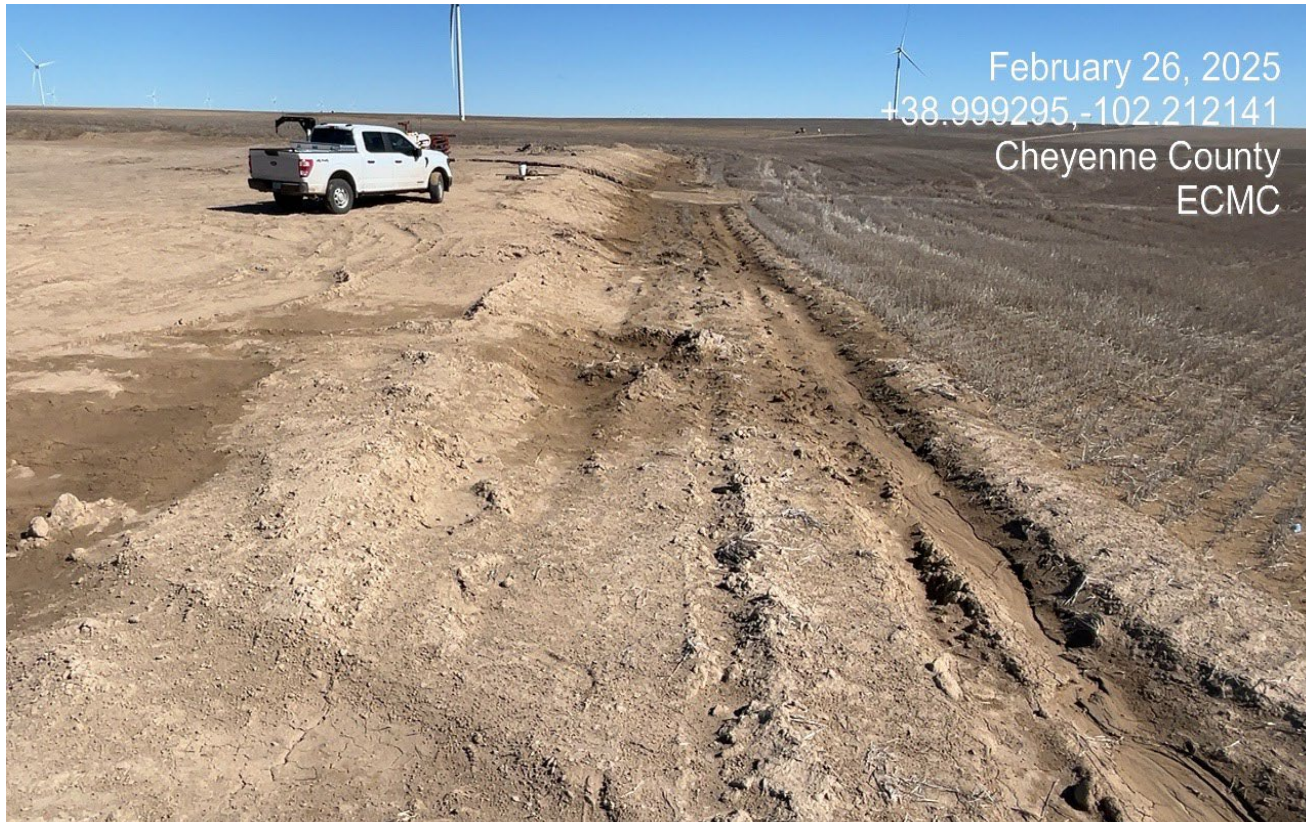
Photo 10. Facing east along the south side of the location. There are insufficient BMP's on the down hill side to stormwater control. The perimeter ditch has filled in with sediment.
